DISTRICT 2 REPORT
JUNE 2015

STATEWIDE
**Airfield
Pavement
Management**
PROGRAM

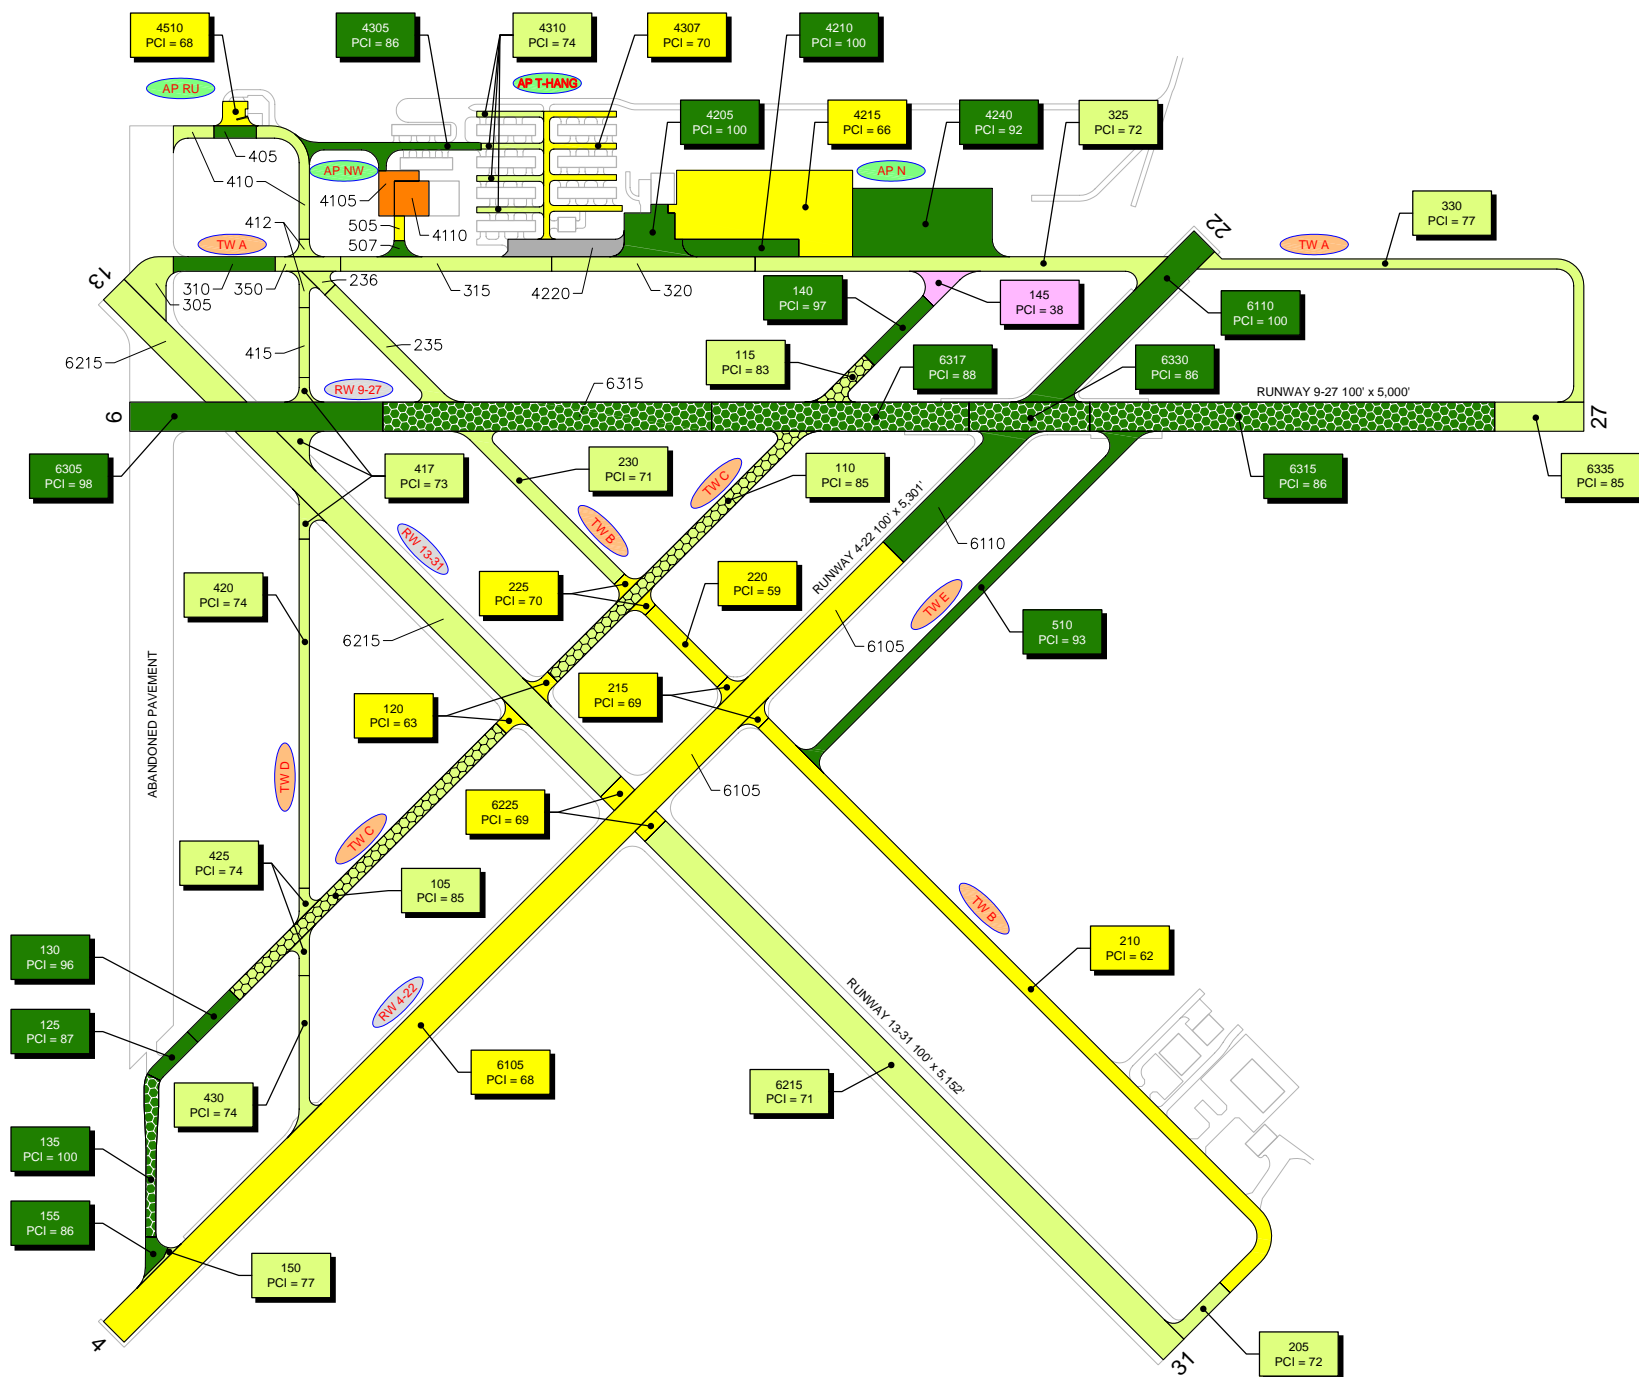
AIRFIELD PAVEMENT CONDITION INDEX RATING EXHIBIT
CROSS CITY AIRPORT
DIXIE COUNTY, FLORIDA
 FLORIDA DEPARTMENT OF TRANSPORTATION - AVIATION AND SPACEPORT OFFICE

TAXIWAYS				
235 PCI = 72	236 PCI = 76	305 PCI = 75	310 PCI = 90	315 PCI = 82
320 PCI = 80	350 PCI = 76	405 PCI = 91	410 PCI = 84	412 PCI = 76
415 PCI = 81	505 PCI = 65	507 PCI = 86

OTHERS		
4105 PCI = 41	4110 PCI = 50	4220 PCI = 0

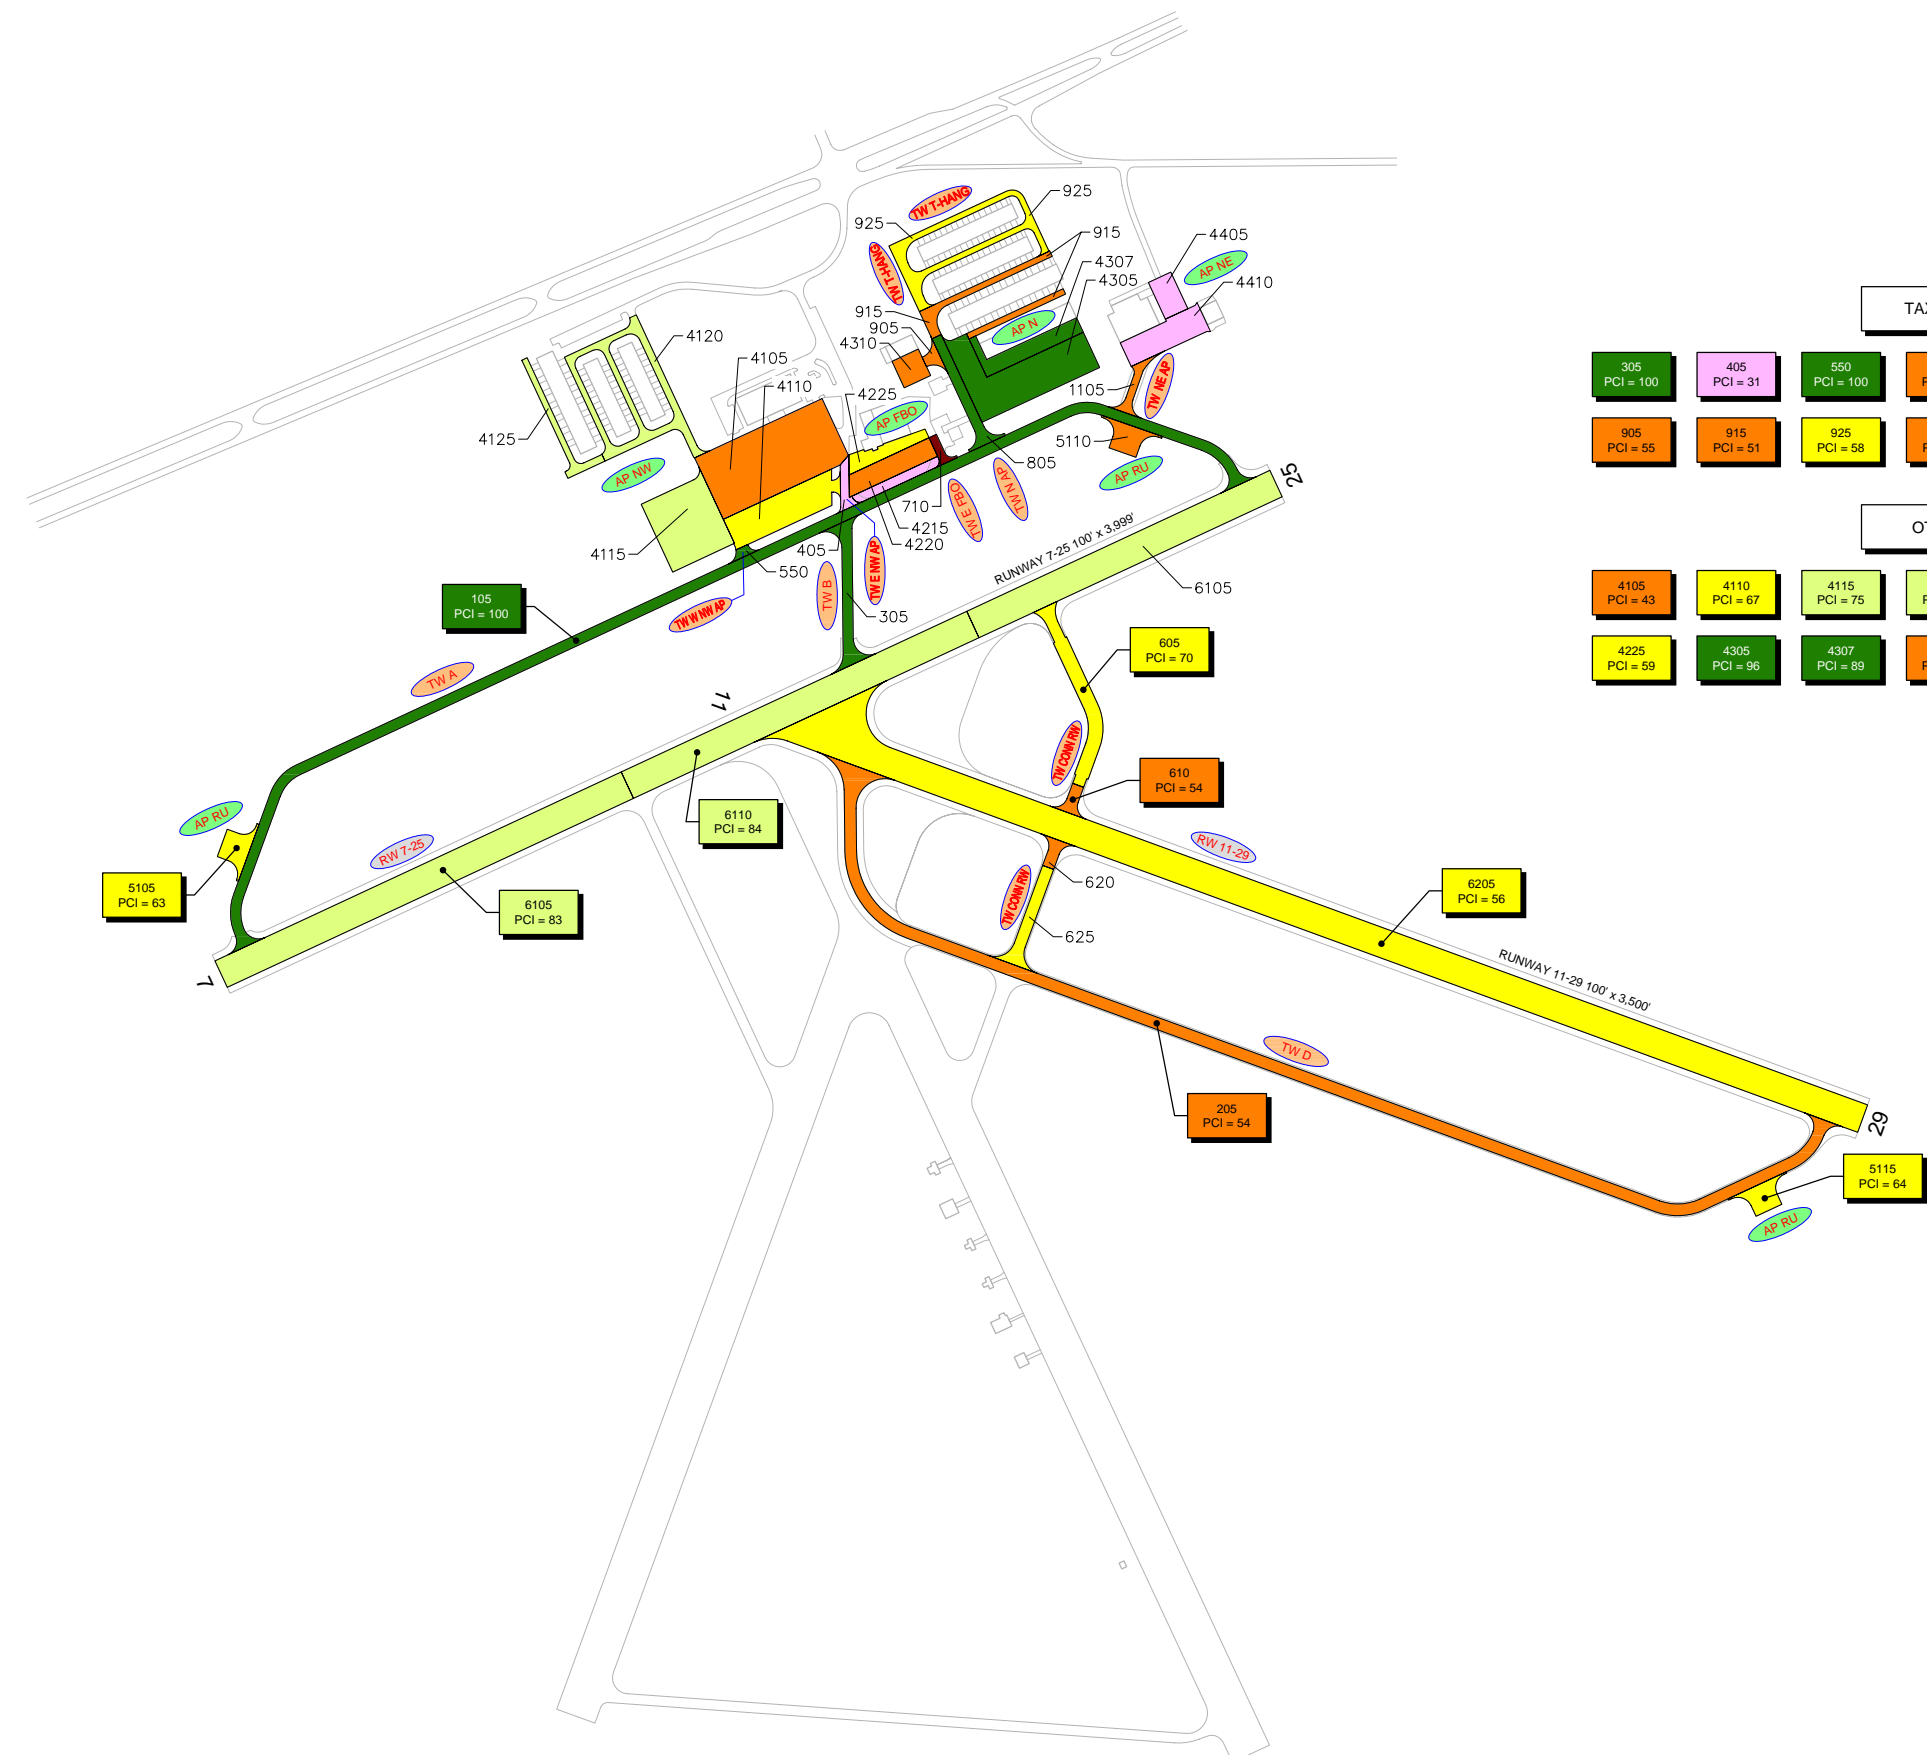
AIRFIELD PAVEMENT CONDITION INDEX RATING EXHIBIT
GAINESVILLE REGIONAL AIRPORT
ALACHUA COUNTY, FLORIDA
 FLORIDA DEPARTMENT OF TRANSPORTATION - AVIATION AND SPACEPORT OFFICE

TAXIWAYS						
305 PCI = 100	405 PCI = 31	550 PCI = 100	620 PCI = 53	625 PCI = 70	710 PCI = 16	805 PCI = 95
905 PCI = 55	915 PCI = 51	925 PCI = 58	1105 PCI = 41

OTHERS						
4105 PCI = 43	4110 PCI = 67	4115 PCI = 75	4120 PCI = 71	4125 PCI = 79	4215 PCI = 39	4220 PCI = 48
4225 PCI = 59	4305 PCI = 96	4307 PCI = 89	4310 PCI = 52	4405 PCI = 35	4410 PCI = 31	5110 PCI = 44

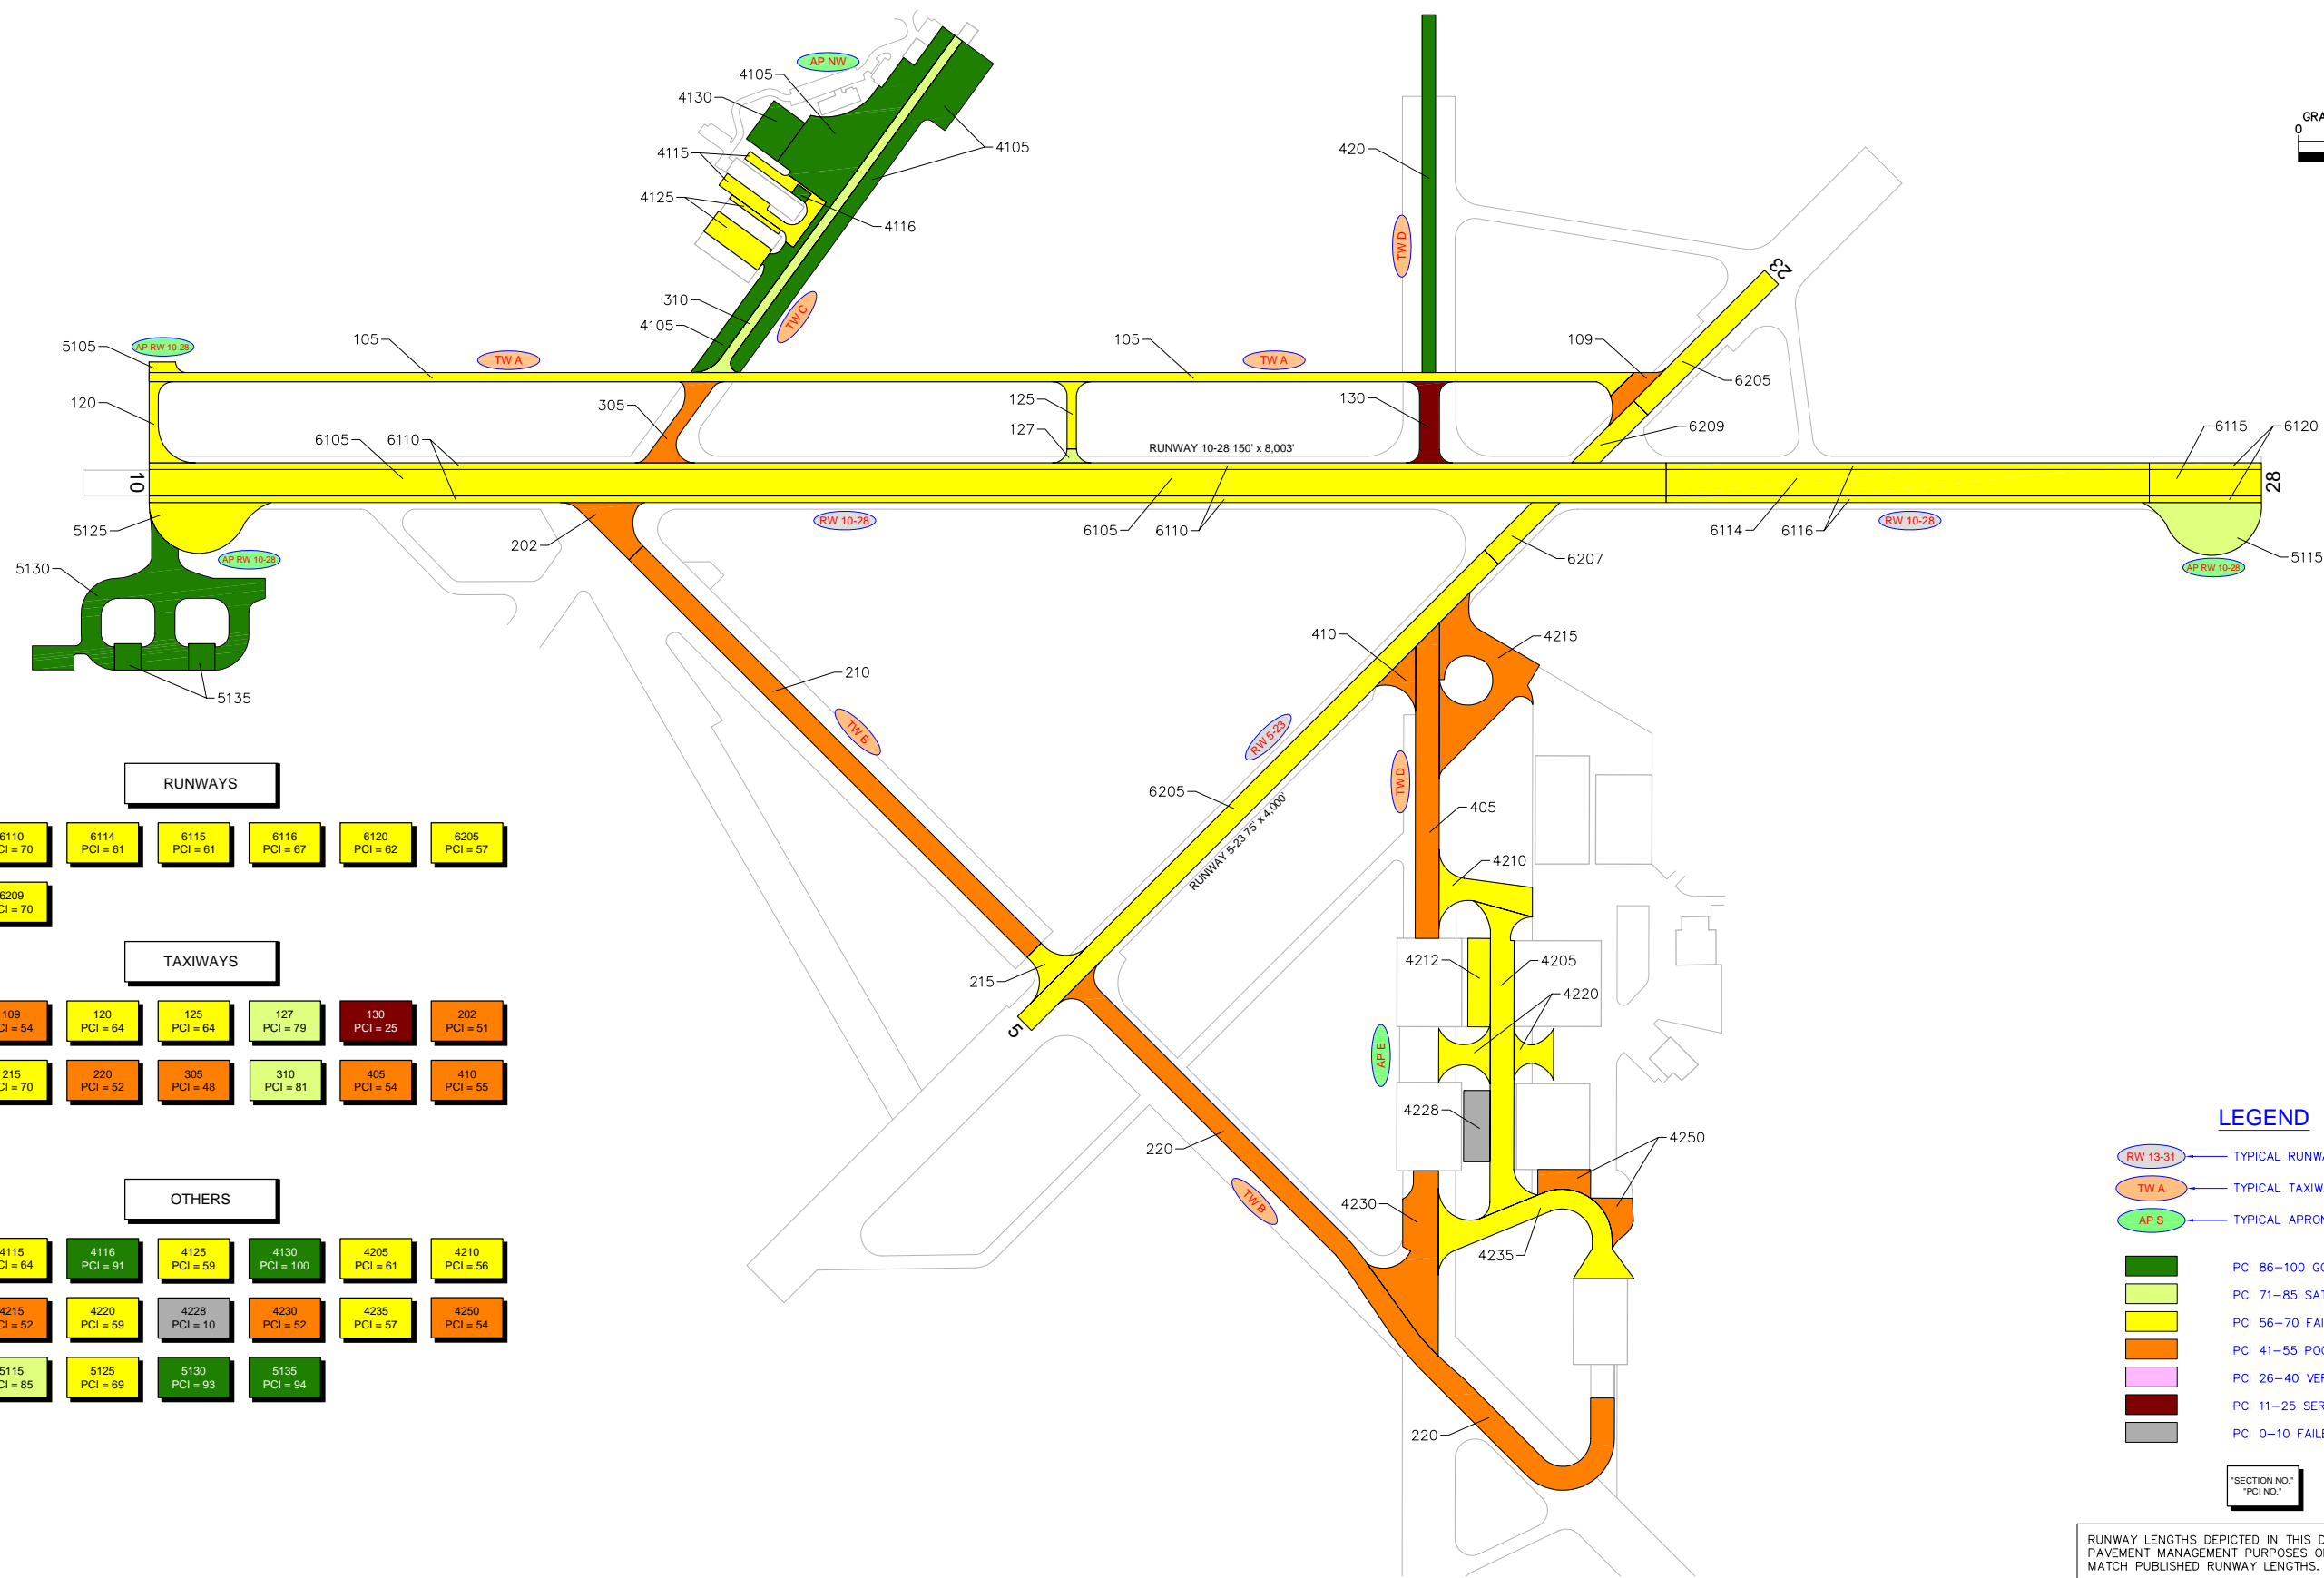
AIRFIELD PAVEMENT CONDITION INDEX RATING EXHIBIT
JACKSONVILLE INTERNATIONAL AIRPORT
 DUVAL COUNTY, FLORIDA
 FLORIDA DEPARTMENT OF TRANSPORTATION - AVIATION AND SPACEPORT OFFICE

6105 PCI = 64	6110 PCI = 70	6114 PCI = 61	6115 PCI = 61	6116 PCI = 67	6120 PCI = 62	6205 PCI = 57
6207 PCI = 64	6209 PCI = 70
