DISTRICT 3 REPORT
JUNE 2015

STATEWIDE
**Airfield
Pavement
Management**
PROGRAM

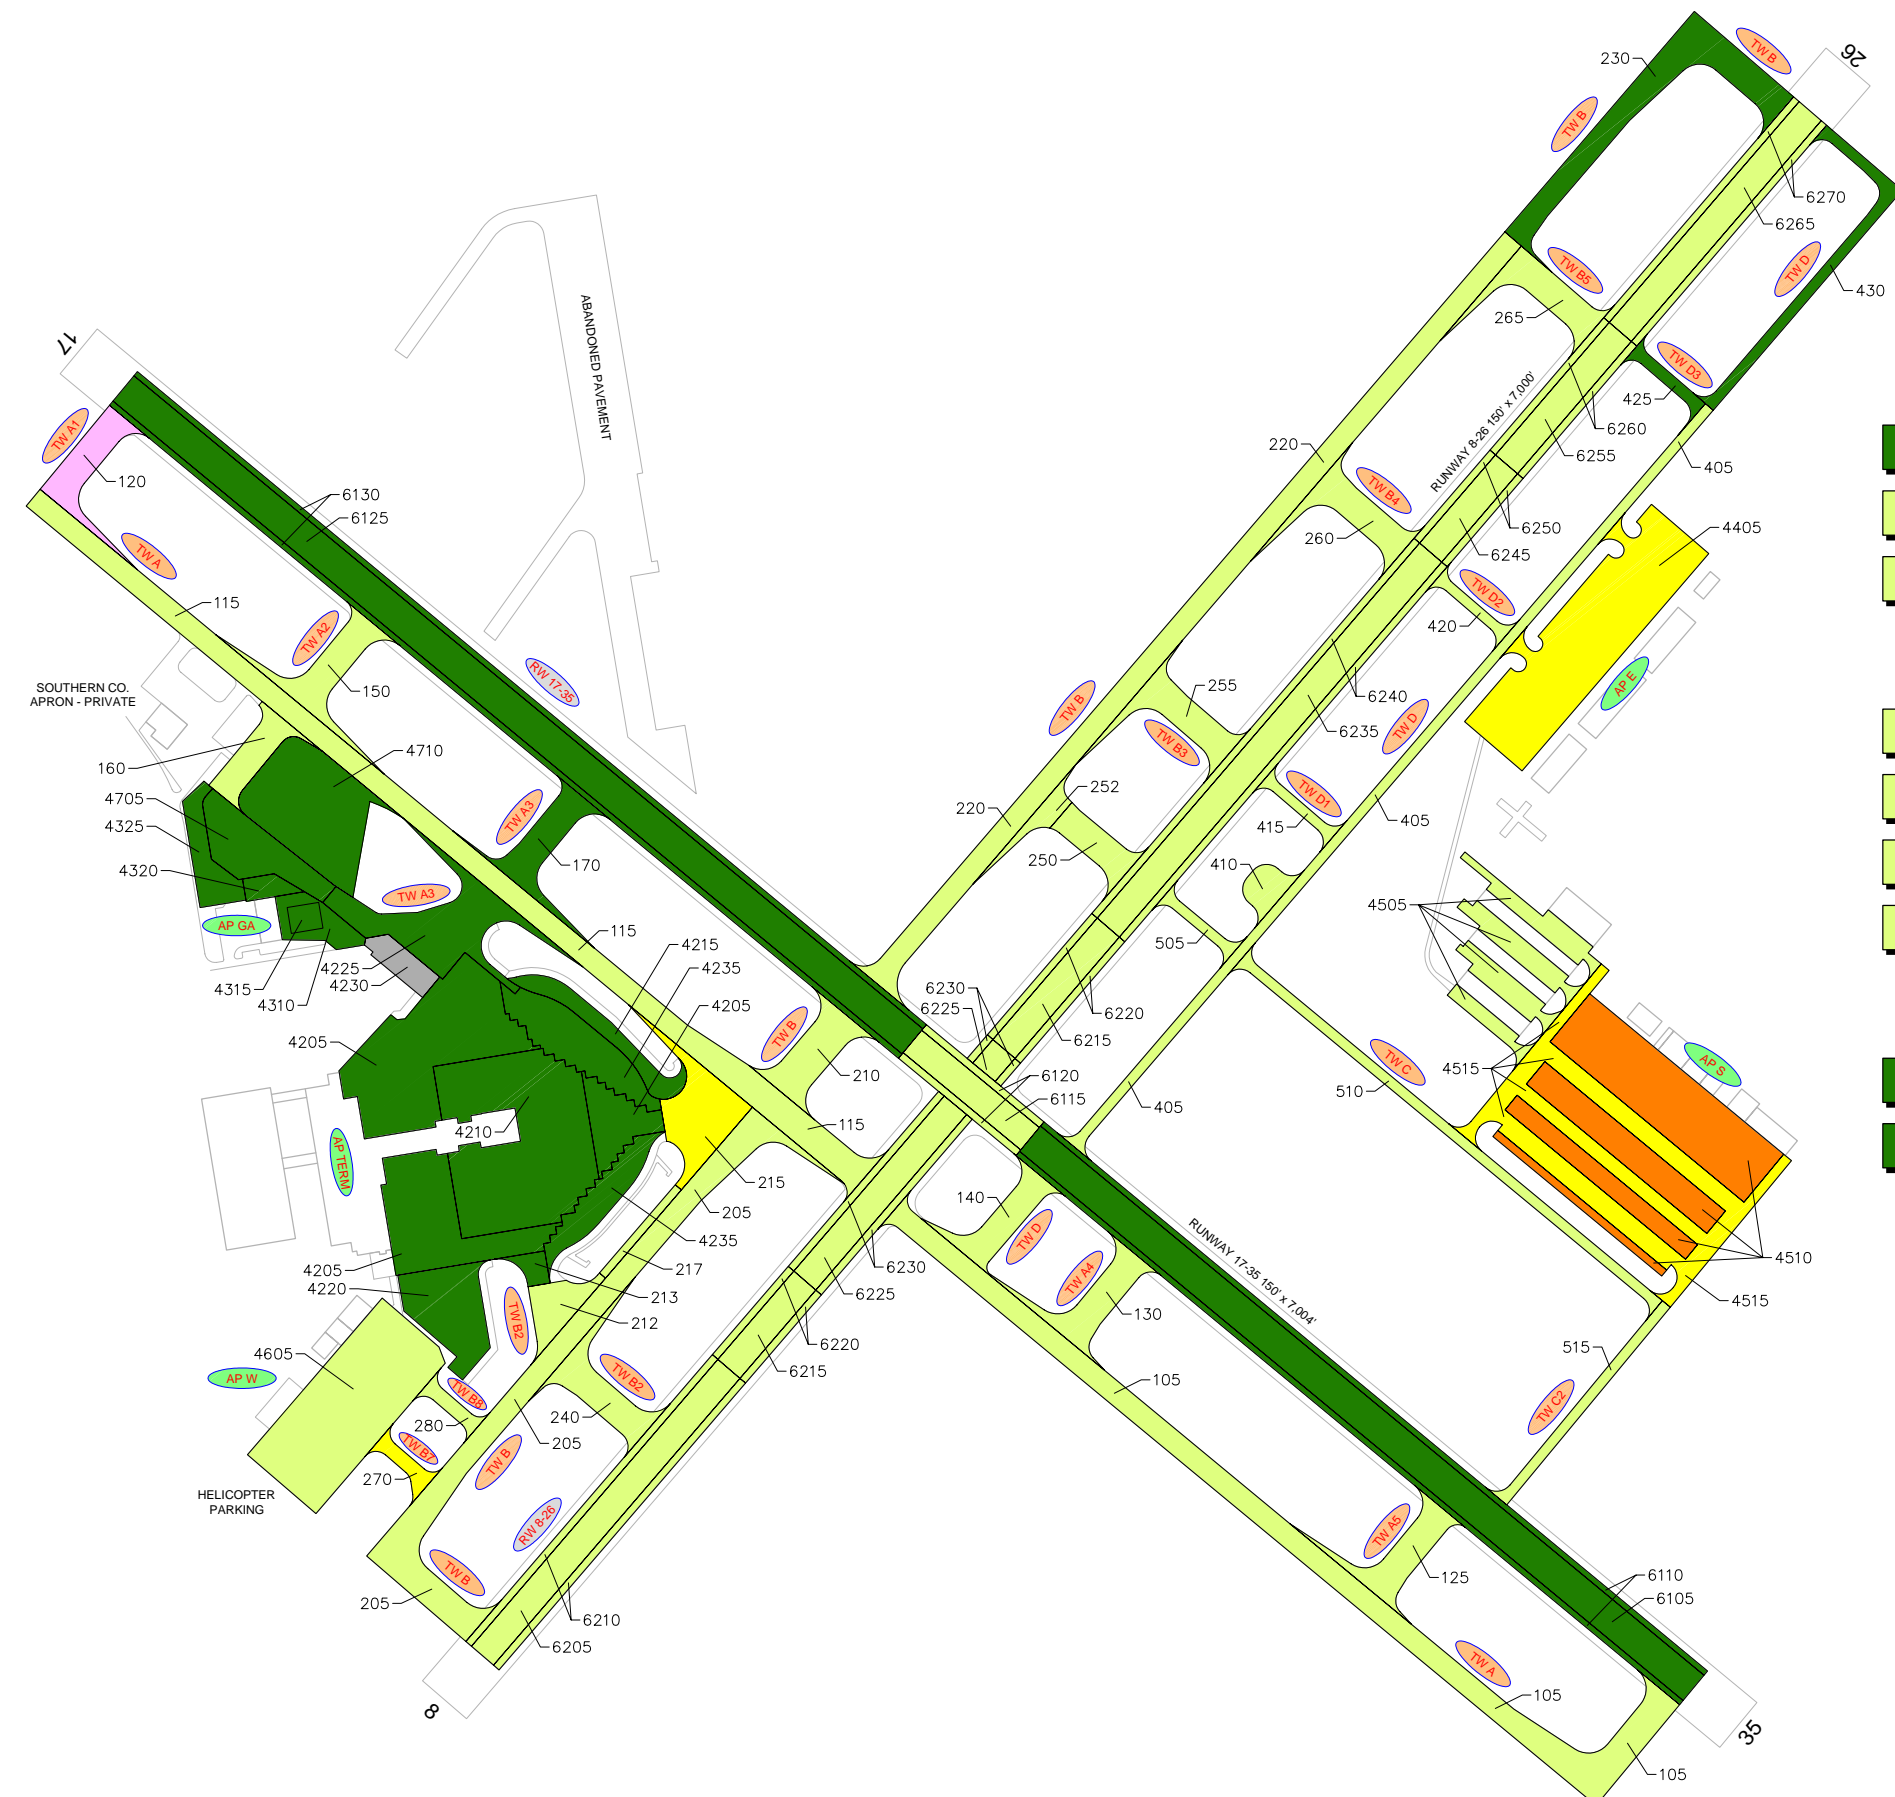
AIRFIELD PAVEMENT CONDITION INDEX RATING EXHIBIT
PENSACOLA INTERNATIONAL AIRPORT
ESCAMBIA COUNTY, FLORIDA
 FLORIDA DEPARTMENT OF TRANSPORTATION - AVIATION AND SPACEPORT OFFICE

RUNWAYS

6105 PCI = 91	6110 PCI = 93	6115 PCI = 75	6120 PCI = 78	6125 PCI = 92	6130 PCI = 91	6205 PCI = 75	6210 PCI = 77	6215 PCI = 72
6220 PCI = 76	6225 PCI = 74	6230 PCI = 83	6235 PCI = 72	6240 PCI = 79	6245 PCI = 73	6250 PCI = 83	6255 PCI = 74	6260 PCI = 79
6265 PCI = 80	6270 PCI = 84

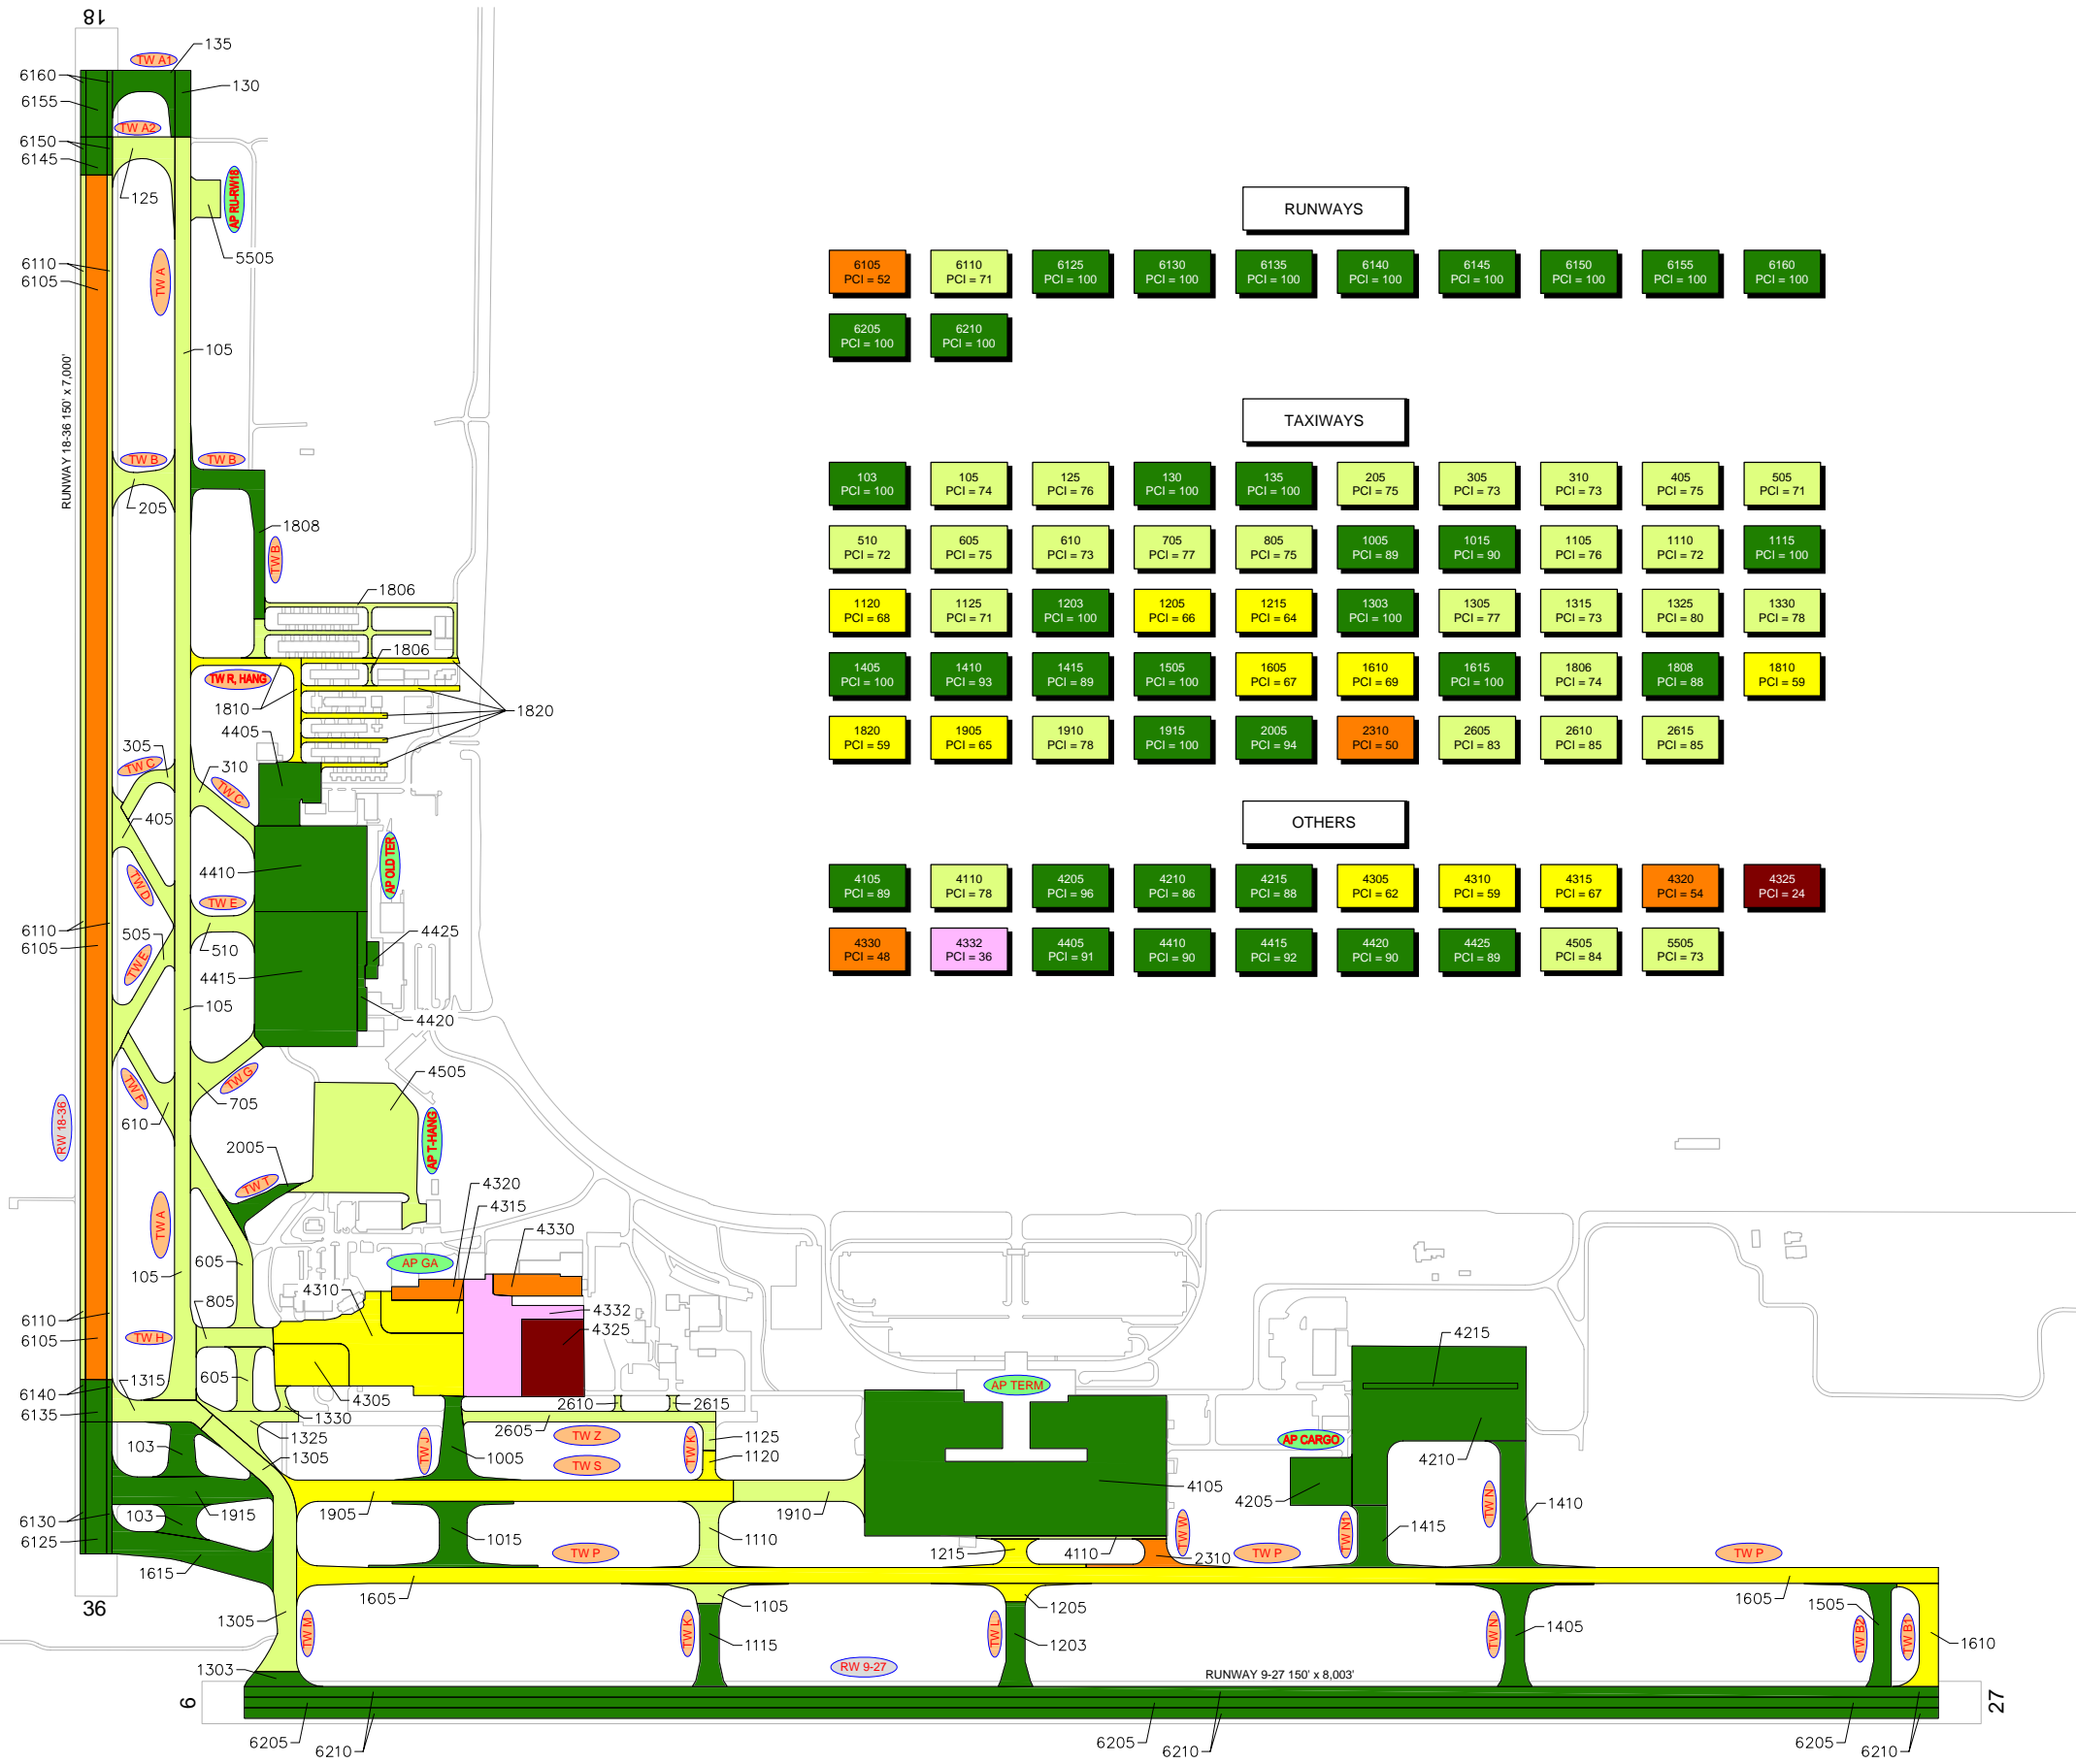
RUNWAYS									
6105 PCI = 52	6110 PCI = 71	6125 PCI = 100	6130 PCI = 100	6135 PCI = 100	6140 PCI = 100	6145 PCI = 100	6150 PCI = 100	6155 PCI = 100	6160 PCI = 100
6205 PCI = 100	6210 PCI = 100

TAXIWAYS									
103 PCI = 100	105 PCI = 74	125 PCI = 76	130 PCI = 100	135 PCI = 100	205 PCI = 75	305 PCI = 73	310 PCI = 73	405 PCI = 75	505 PCI = 71
510 PCI = 72	605 PCI = 75	610 PCI = 73	705 PCI = 77	805 PCI = 75	1005 PCI = 89	1015 PCI = 90	1105 PCI = 76	1110 PCI = 72	1115 PCI = 100
1120 PCI = 68	1125 PCI = 71	1203 PCI = 100	1205 PCI = 66	1215 PCI = 64	1303 PCI = 100	1305 PCI = 77	1315 PCI = 73	1325 PCI = 80	1330 PCI = 78
1405 PCI = 100	1410 PCI = 93	1415 PCI = 89	1505 PCI = 100	1605 PCI = 67	1610 PCI = 69	1615 PCI = 100	1806 PCI = 74	1808 PCI = 88	1810 PCI = 59
1820 PCI = 59	1905 PCI = 65	1910 PCI = 78	1915 PCI = 100	2005 PCI = 94	2310 PCI = 50	2605 PCI = 83	2610 PCI = 85	2615 PCI = 85
