DISTRICT 6 REPORT
JUNE 2015

STATEWIDE
**Airfield
Pavement
Management**
PROGRAM

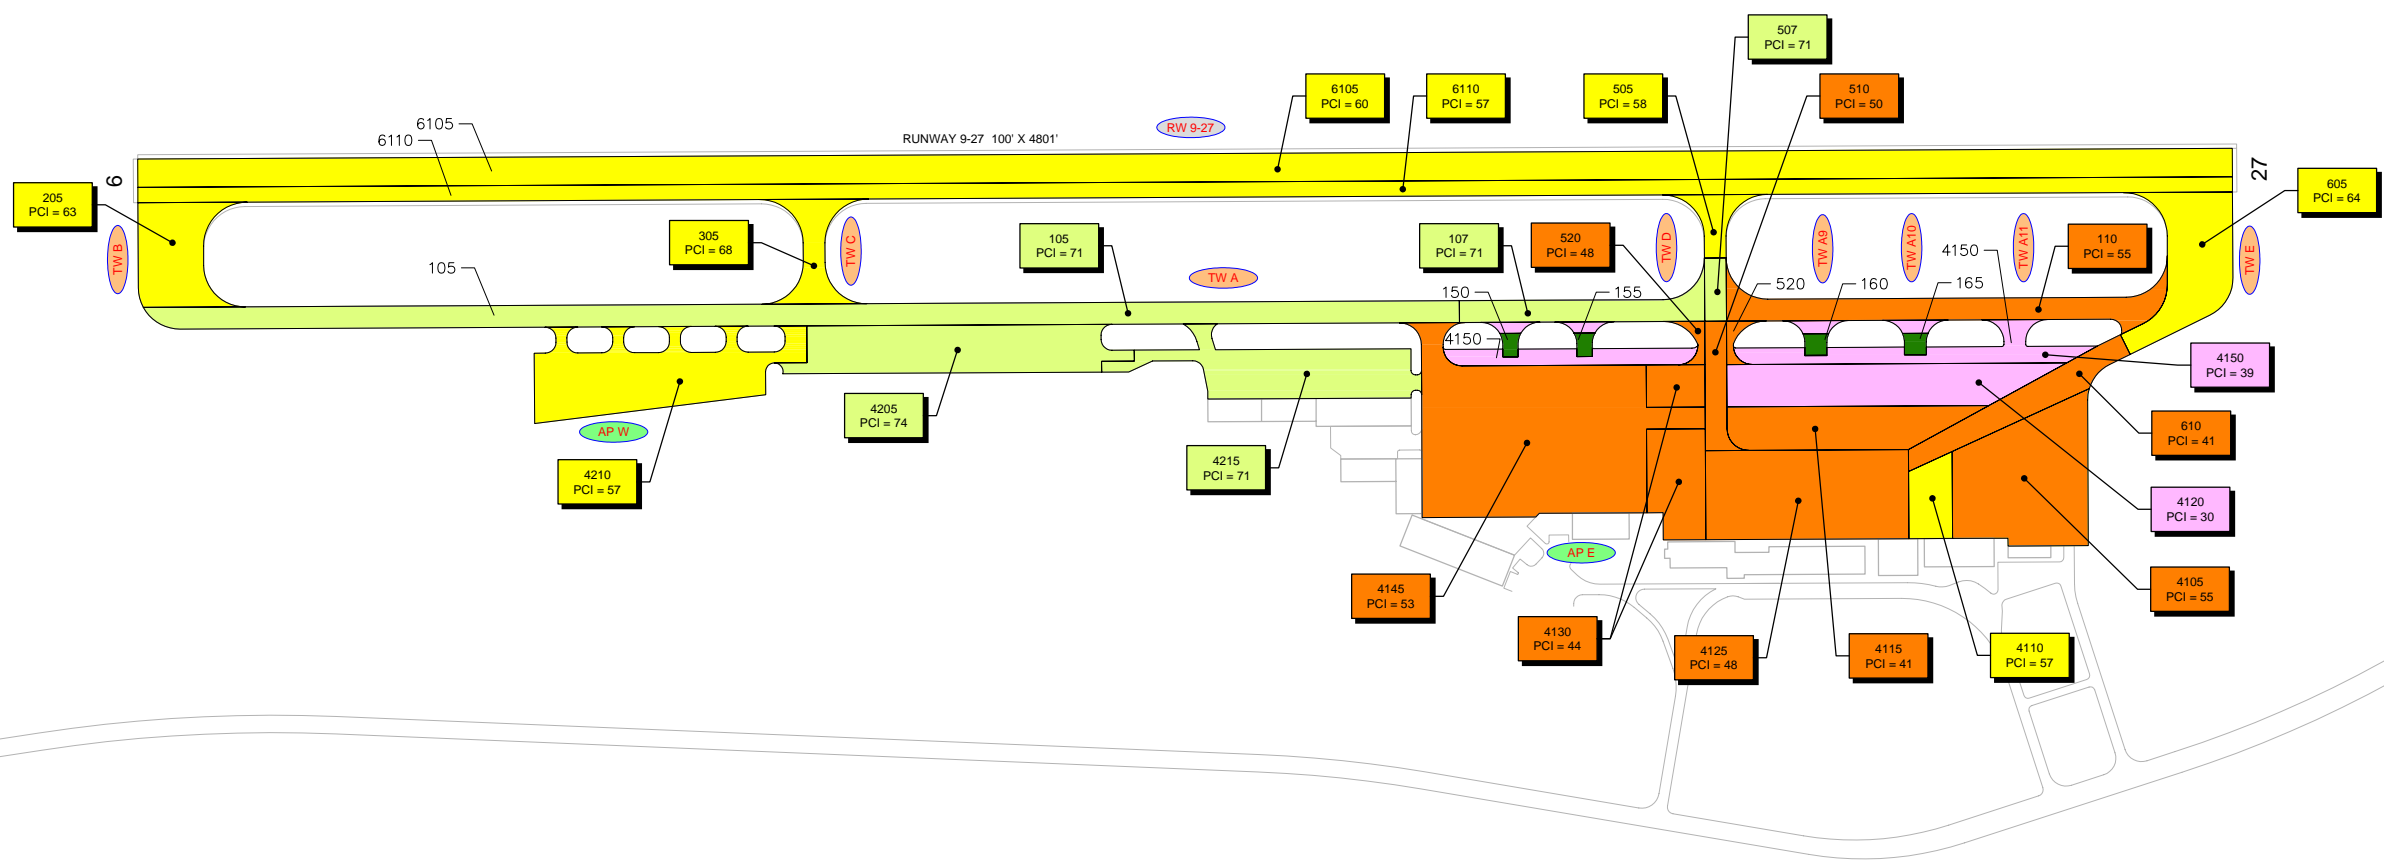
TAXIWAYS			
150 PCI = 100	155 PCI = 100	160 PCI = 100	165 PCI = 100

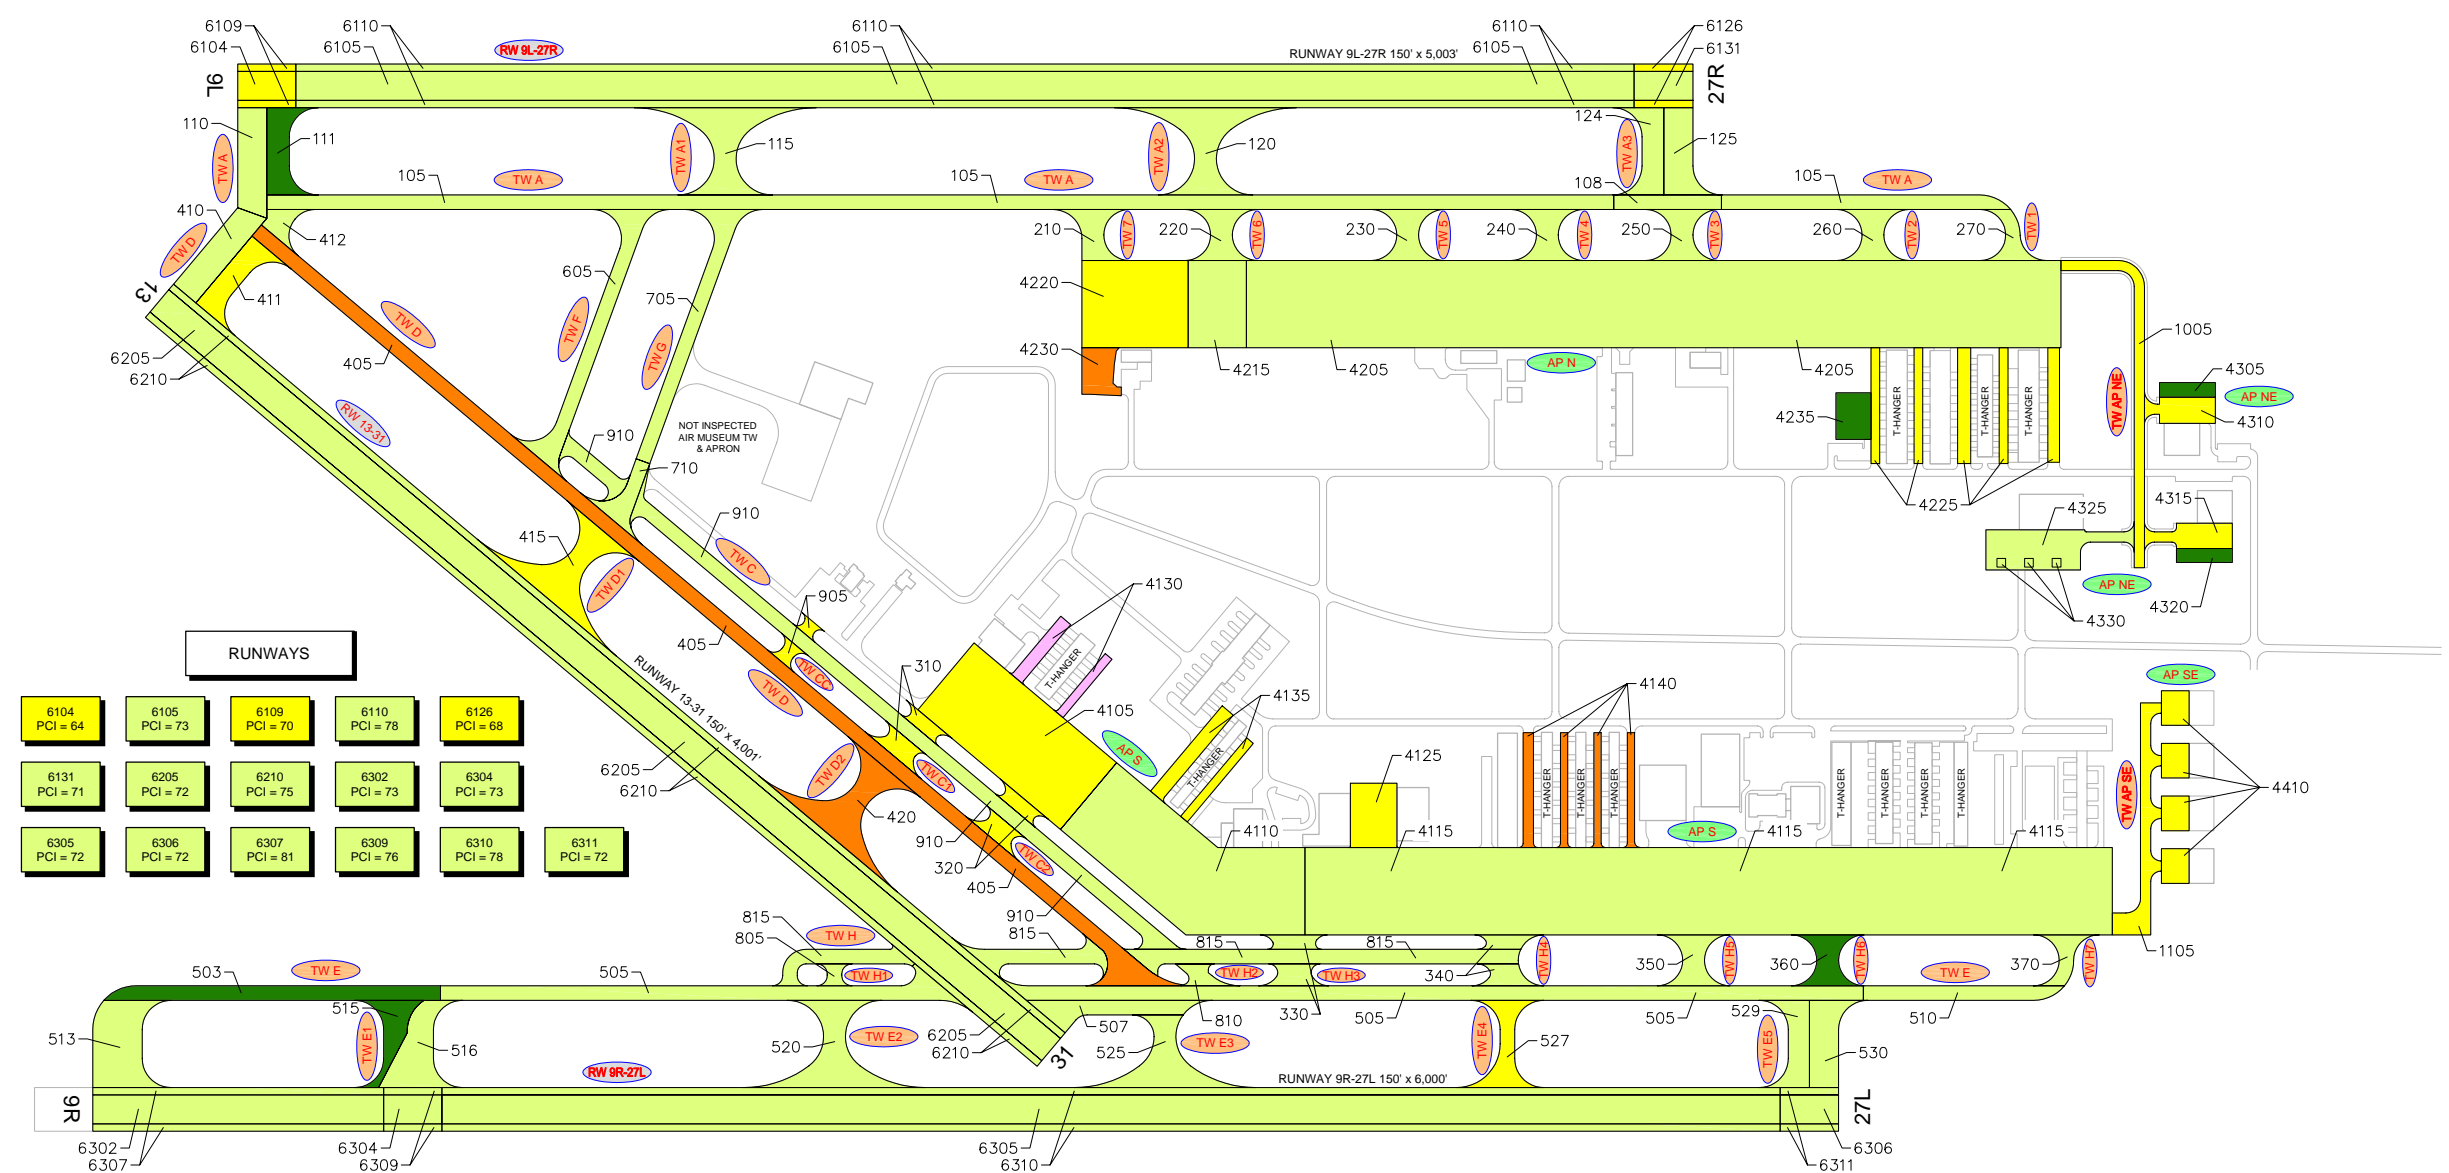
6104 PCI = 64	6105 PCI = 73	6109 PCI = 70	6110 PCI = 78	6126 PCI = 68
6131 PCI = 71	6205 PCI = 72	6210 PCI = 75	6302 PCI = 73	6304 PCI = 73
6305 PCI = 72	6306 PCI = 72	6307 PCI = 81	6309 PCI = 76	6310 PCI = 78
			6311 PCI = 72

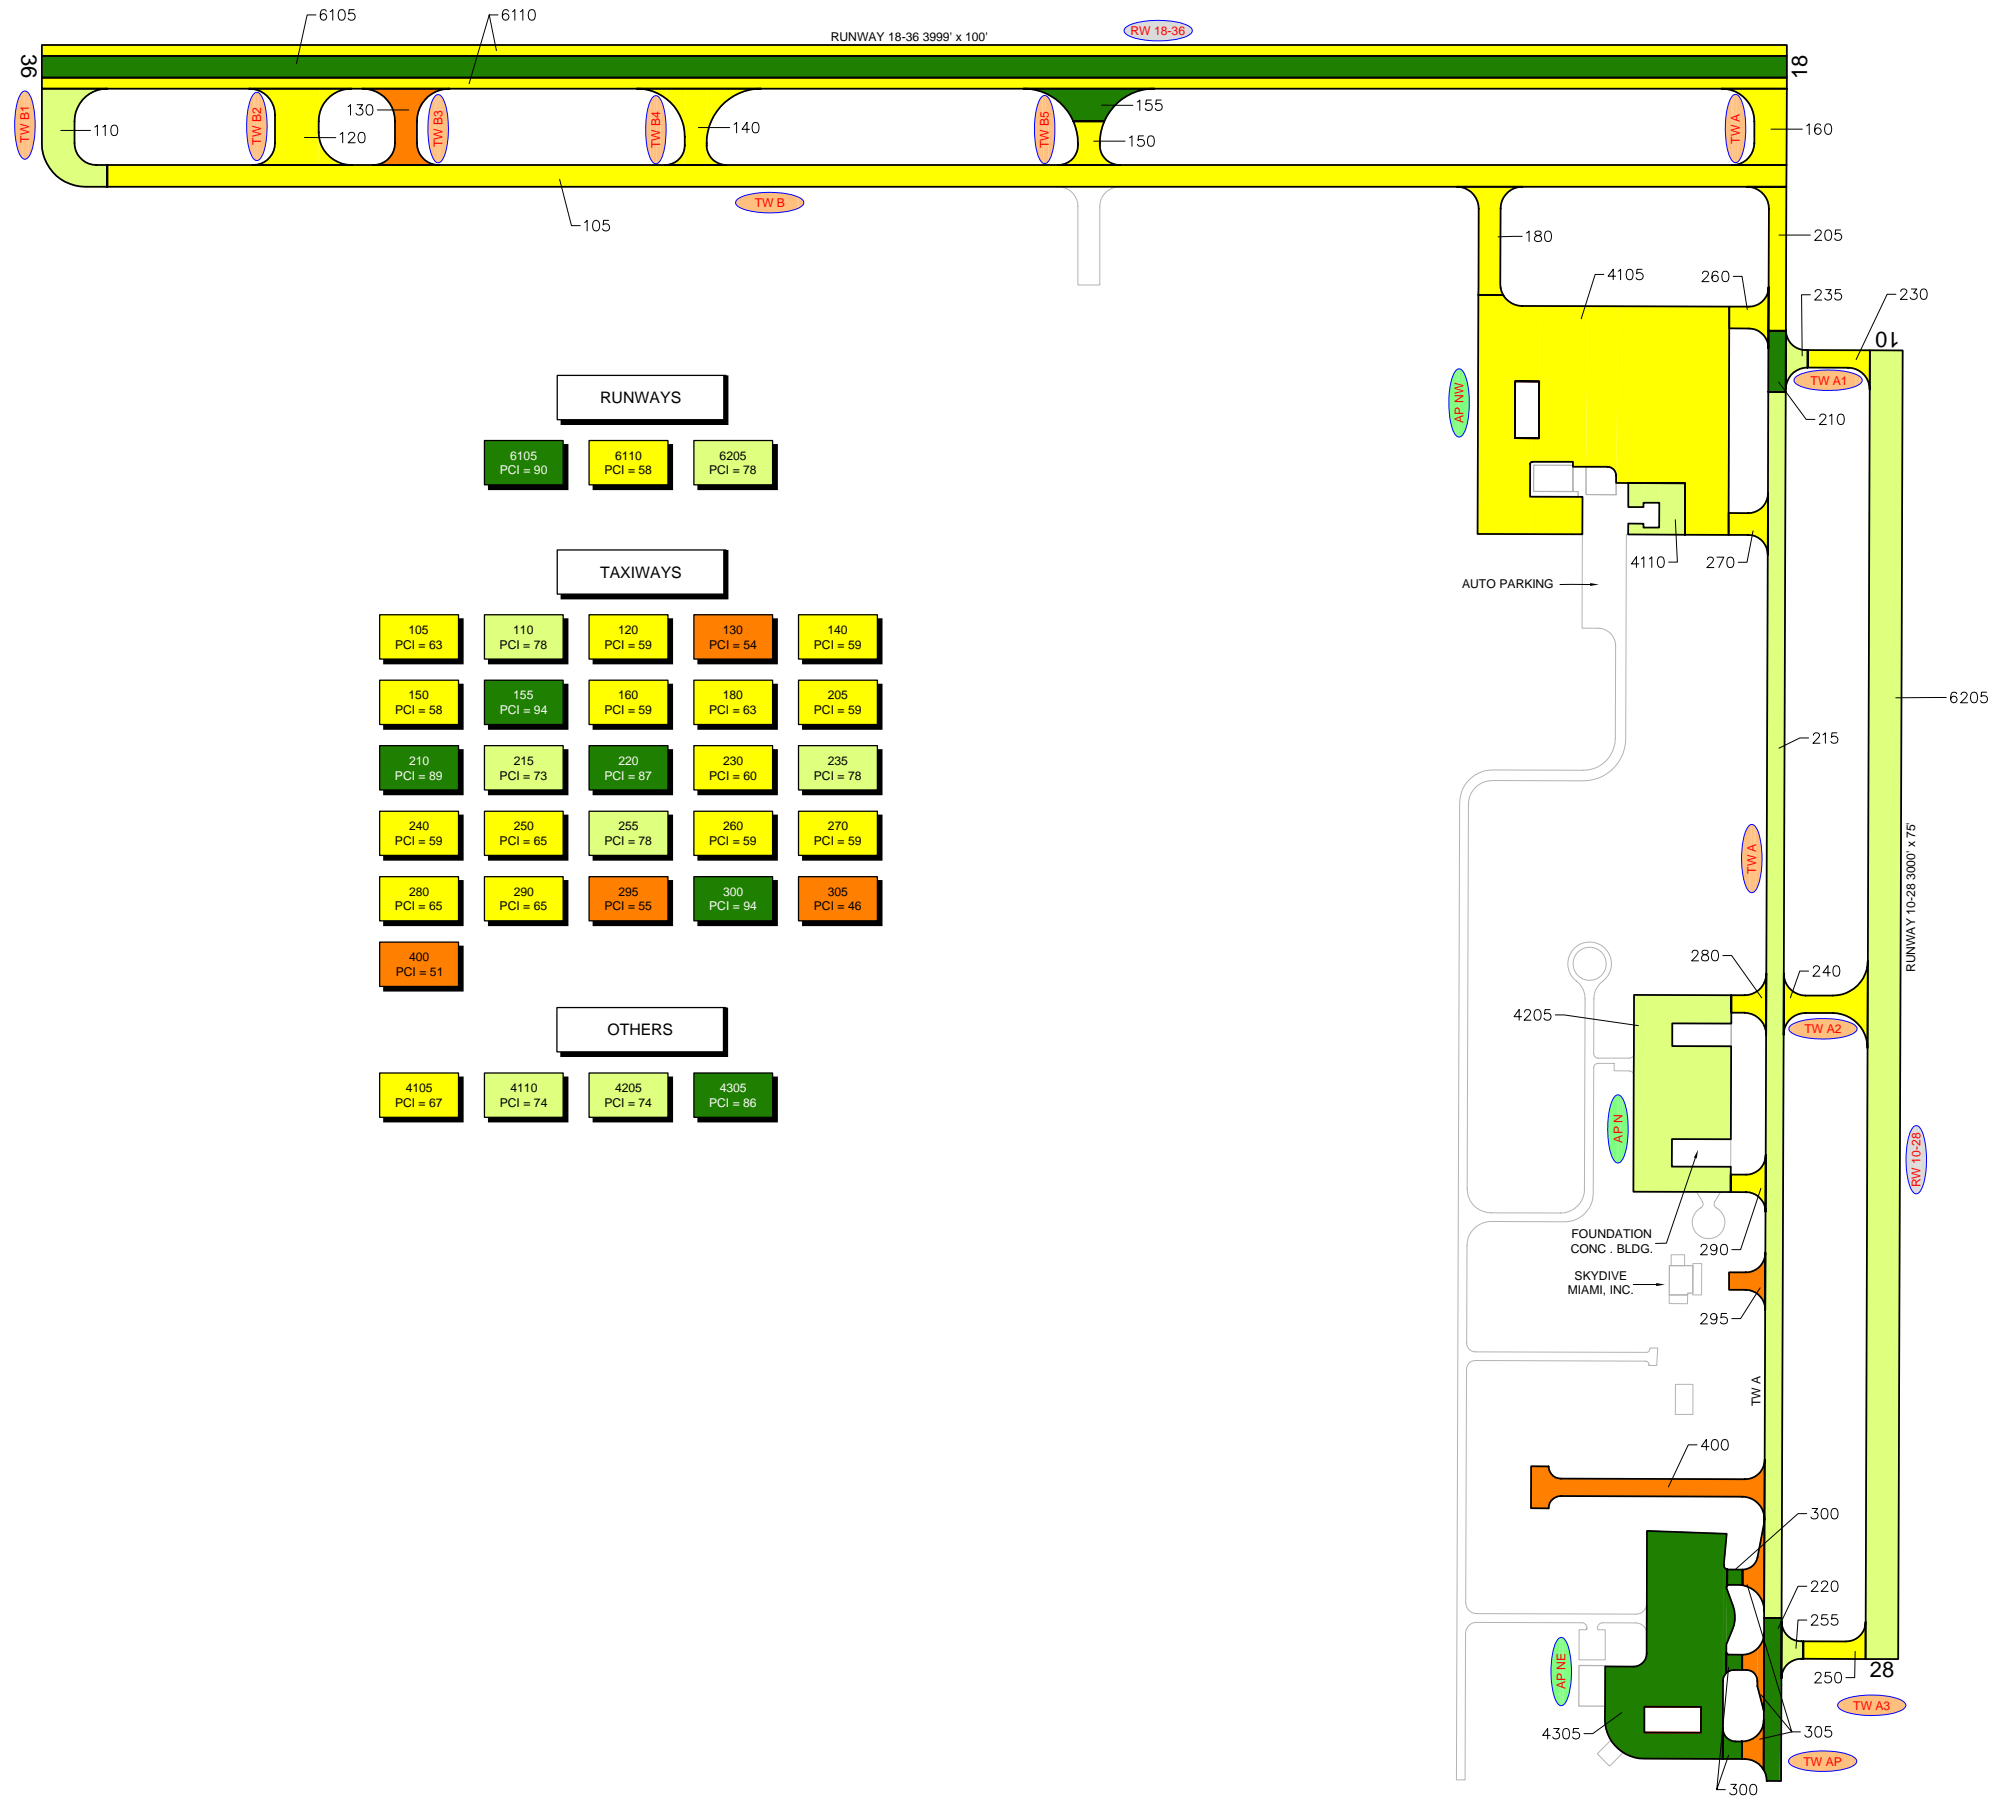
AIRFIELD PAVEMENT CONDITION INDEX RATING EXHIBIT
DADE-COLLIER TRAINING & TRANSITION AIRPORT
 MIAMI-DADE COUNTY, FLORIDA
 FLORIDA DEPARTMENT OF TRANSPORTATION - AVIATION AND SPACEPORT OFFICE

RUNWAYS				
6105 PCI = 90	6110 PCI = 58	6205 PCI = 78		
TAXIWAYS				
105 PCI = 63	110 PCI = 78	120 PCI = 59	130 PCI = 54	140 PCI = 59
150 PCI = 58	155 PCI = 94	160 PCI = 59	180 PCI = 63	205 PCI = 59
210 PCI = 89	215 PCI = 73	220 PCI = 87	230 PCI = 60	235 PCI = 78
240 PCI = 59	250 PCI = 65	255 PCI = 78	260 PCI = 59	270 PCI = 59
280 PCI = 65	290 PCI = 65	295 PCI = 55	300 PCI = 94	305 PCI = 46
400 PCI = 51				
OTHERS				
4105 PCI = 67	4110 PCI = 74	4205 PCI = 74	4305 PCI = 86
