DISTRICT 7 REPORT
JUNE 2015

STATEWIDE
**Airfield
Pavement
Management**
PROGRAM

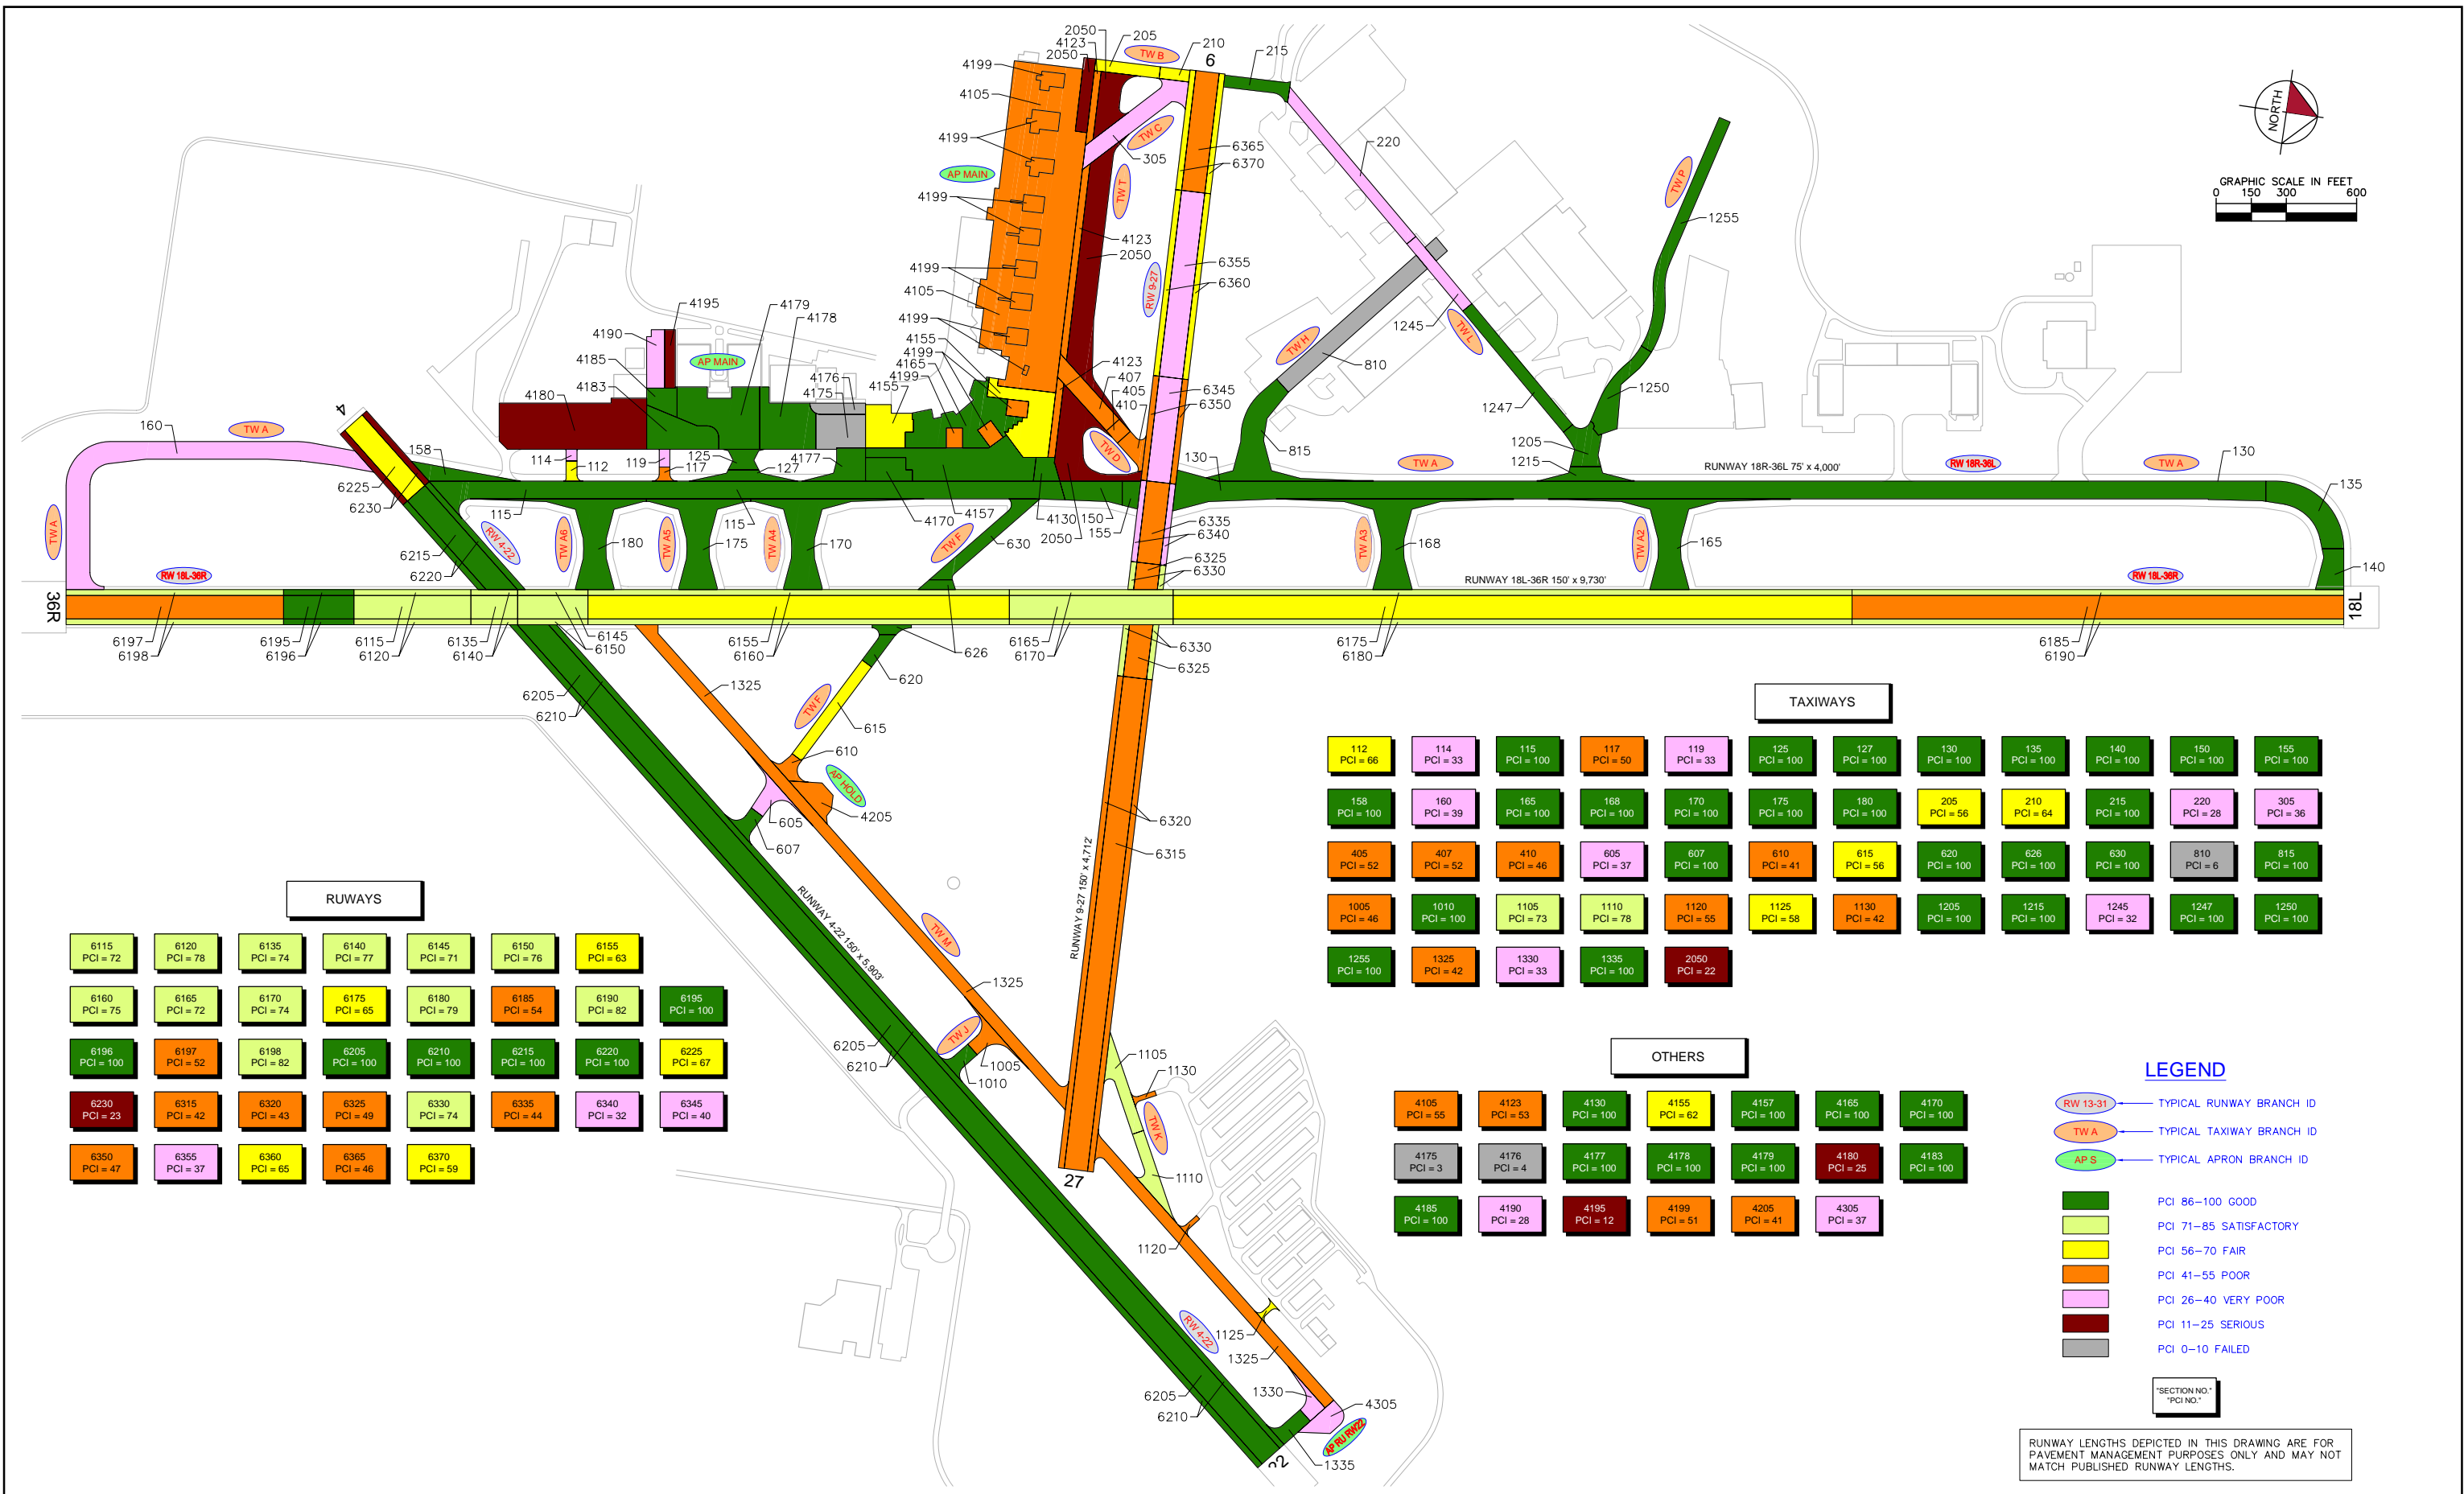
| 6115 PCI = 72 | 6120 PCI = 78 | 6135 PCI = 74 | 6140 PCI = 77 | 6145 PCI = 71 | 6150 PCI = 76 | 6155 PCI = 63 |

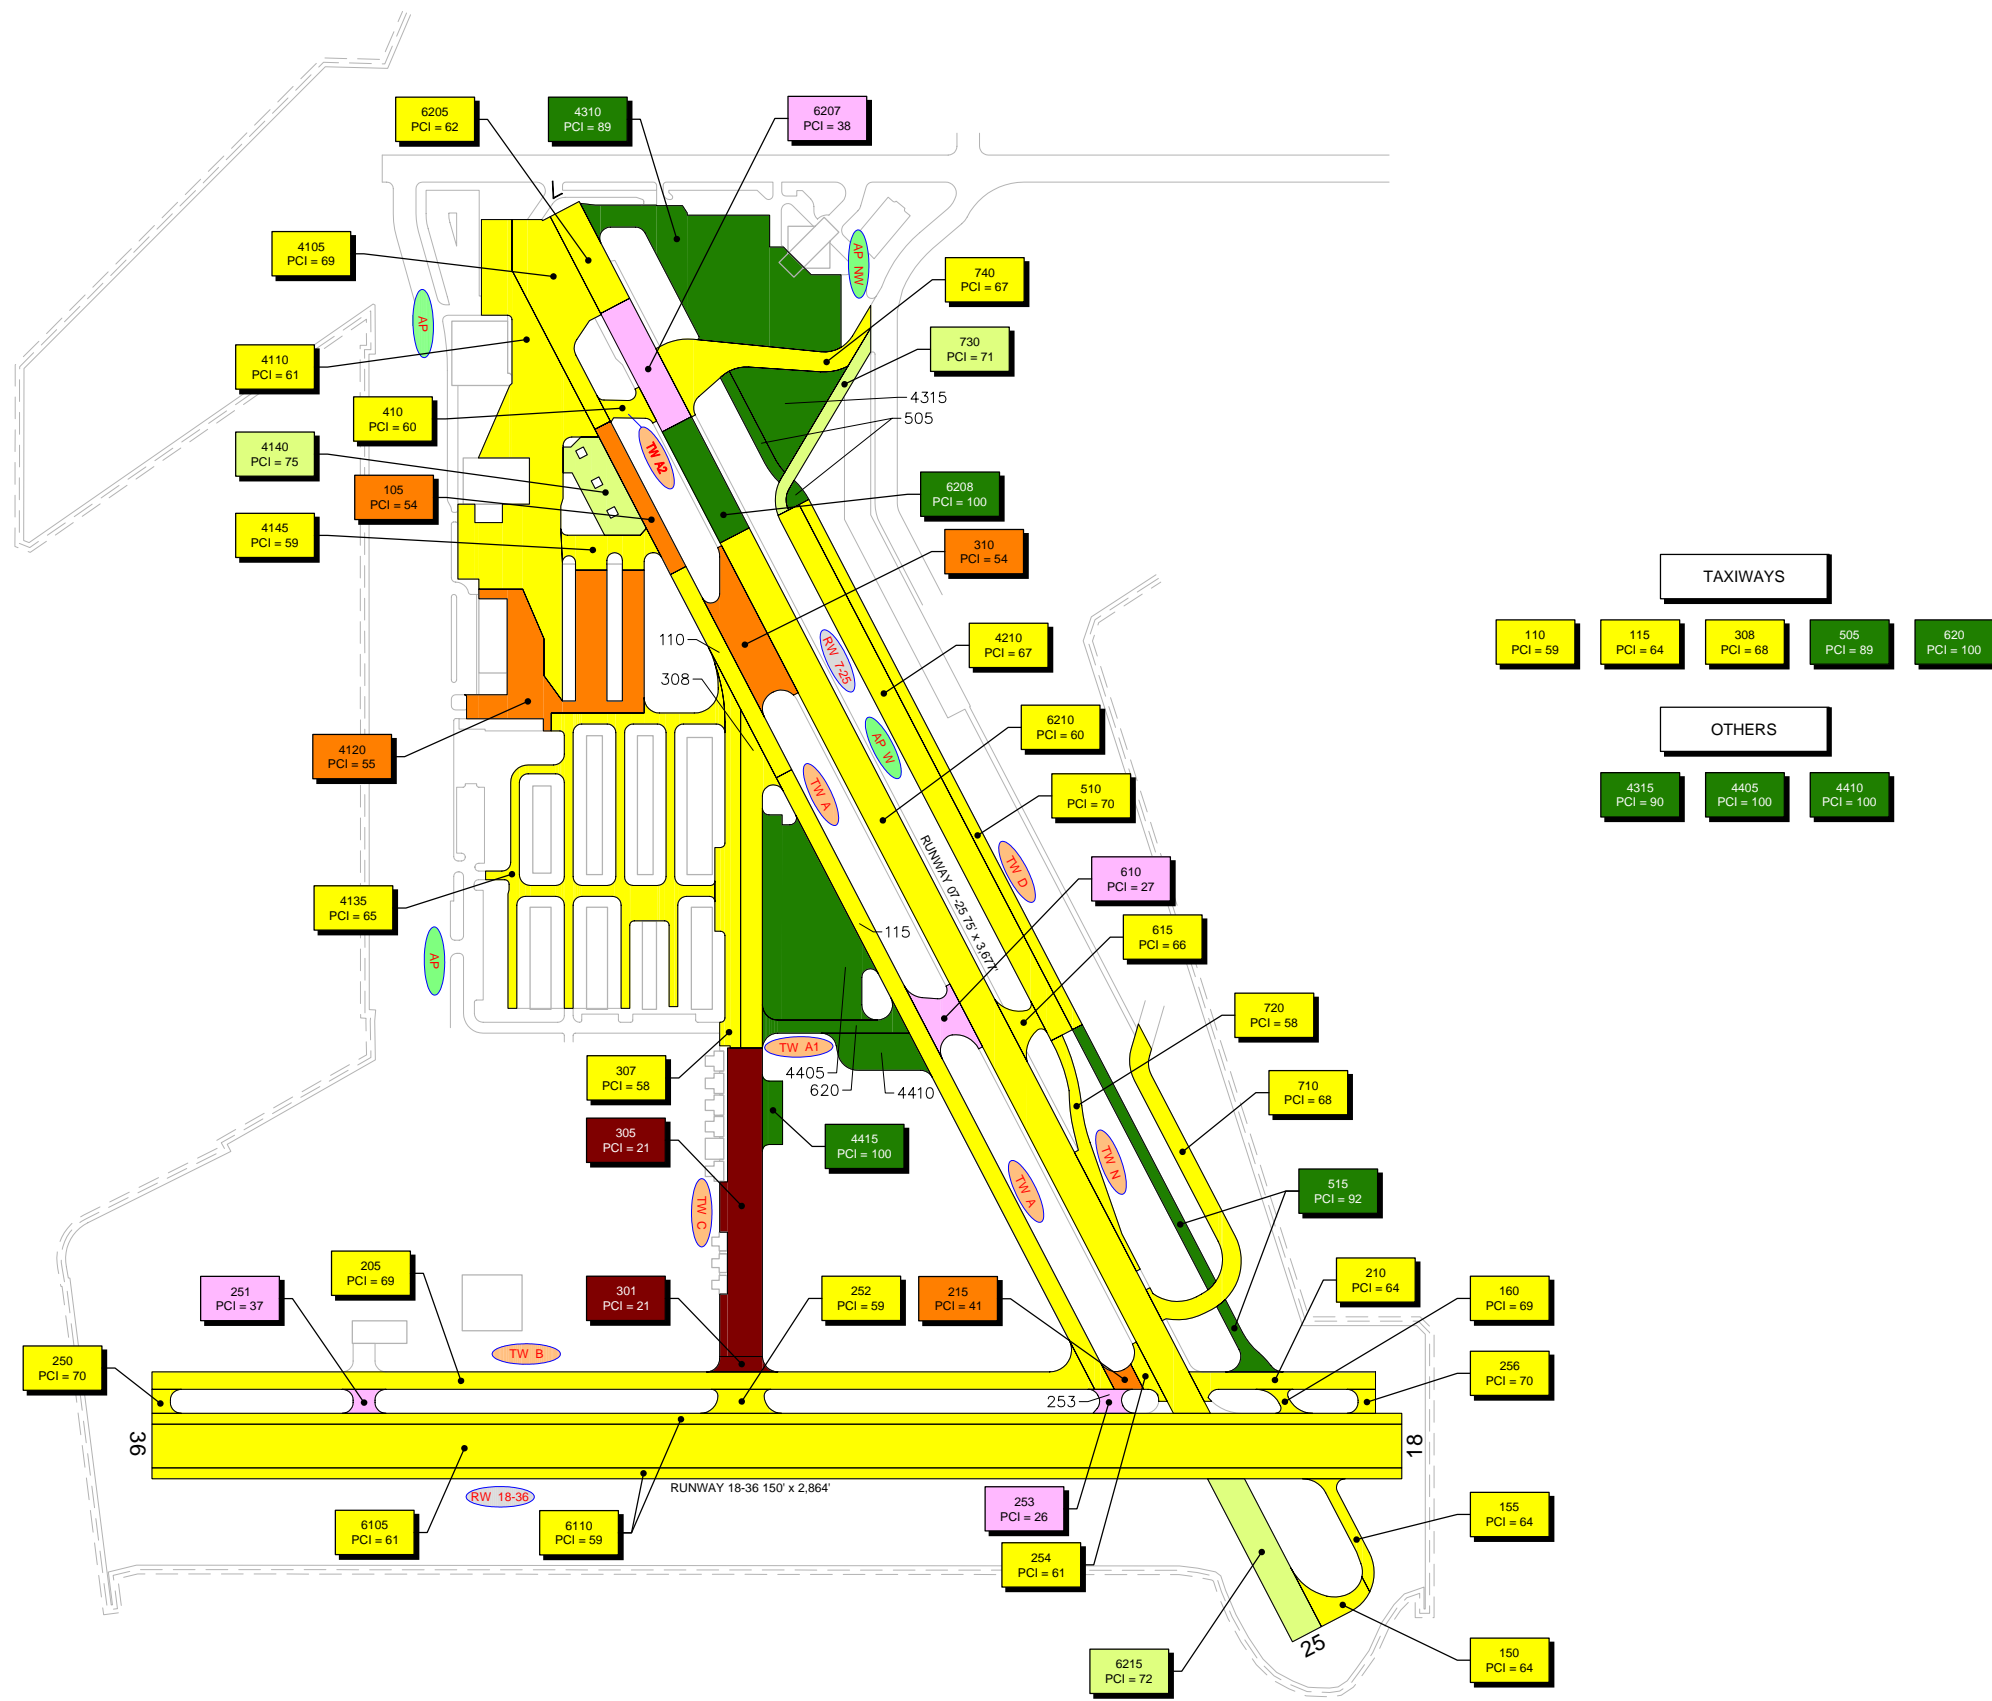
- TAXIWAYS**
- 110 PCI = 59
 - 115 PCI = 64
 - 308 PCI = 68
 - 505 PCI = 89
 - 620 PCI = 100
- OTHERS**
- 4315 PCI = 90
 - 4405 PCI = 100
 - 4410 PCI = 100
