**STATE OF FLORIDA
DEPARTMENT OF TRANSPORTATION
AVIATION OFFICE**

**Statewide Airfield Pavement
Management Program**

**Quincy Municipal Airport– 2J9
(General Aviation)
Quincy, Florida
(District 3)**

May 2011

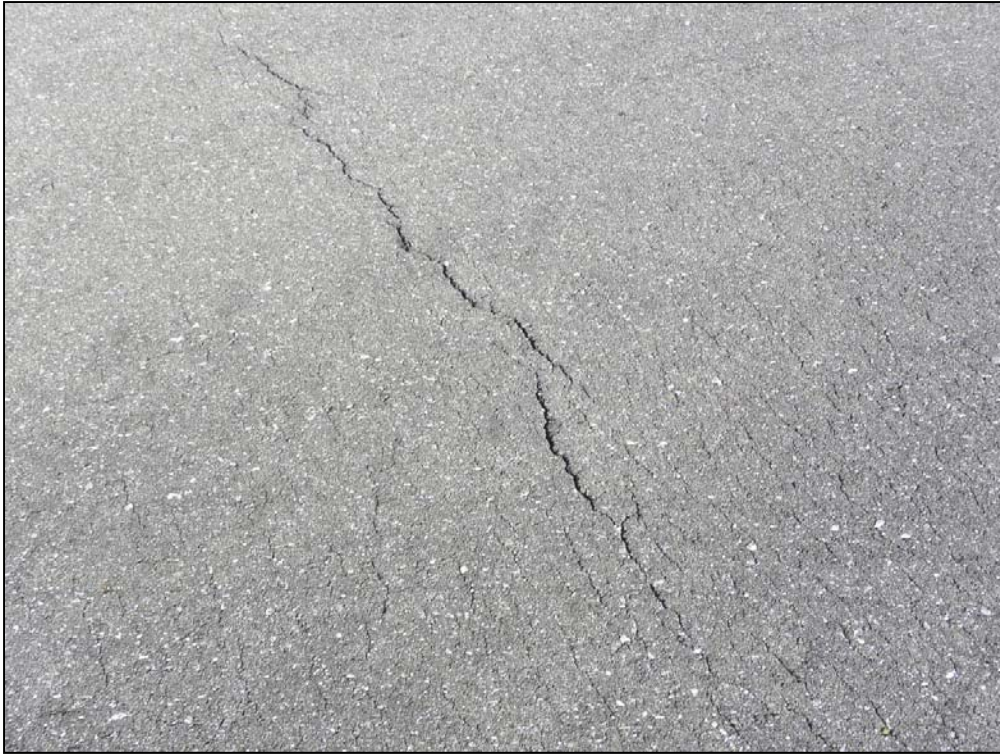
Runway 14-32, Section 6105, Sample Unit 154 – Low severity (52) Weathering and Raveling, low severity (48) Longitudinal and Transverse Cracking

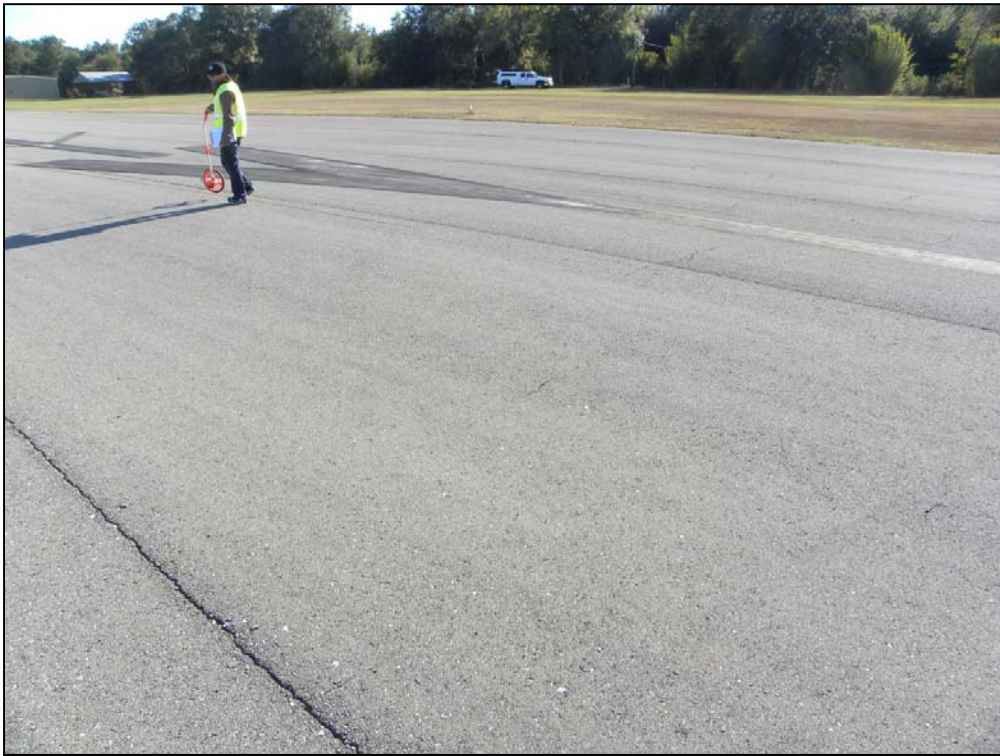
Runway 14-32, Section 6105, Sample Unit 154 – Low severity (52) Weathering and Raveling, low severity (48) Longitudinal and Transverse Cracking

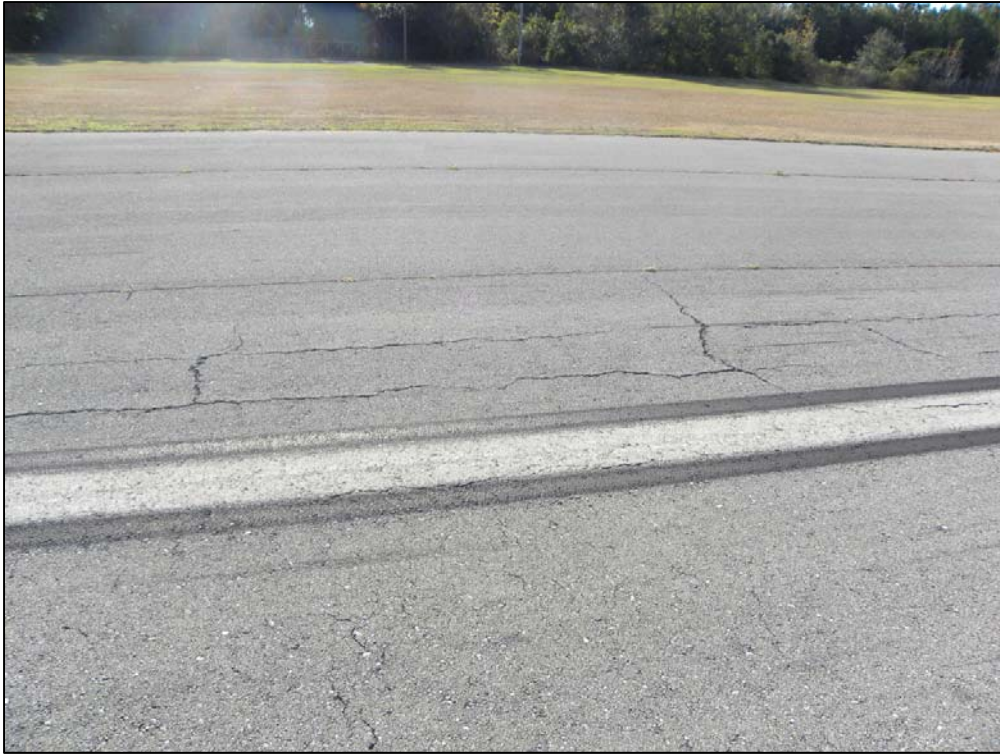
Runway 14-32, Section 6105, Sample Unit 144 – Medium severity (43) Block Cracking, medium severity (48) Longitudinal and Transverse Cracking, low and medium severity (52) Weathering and Raveling

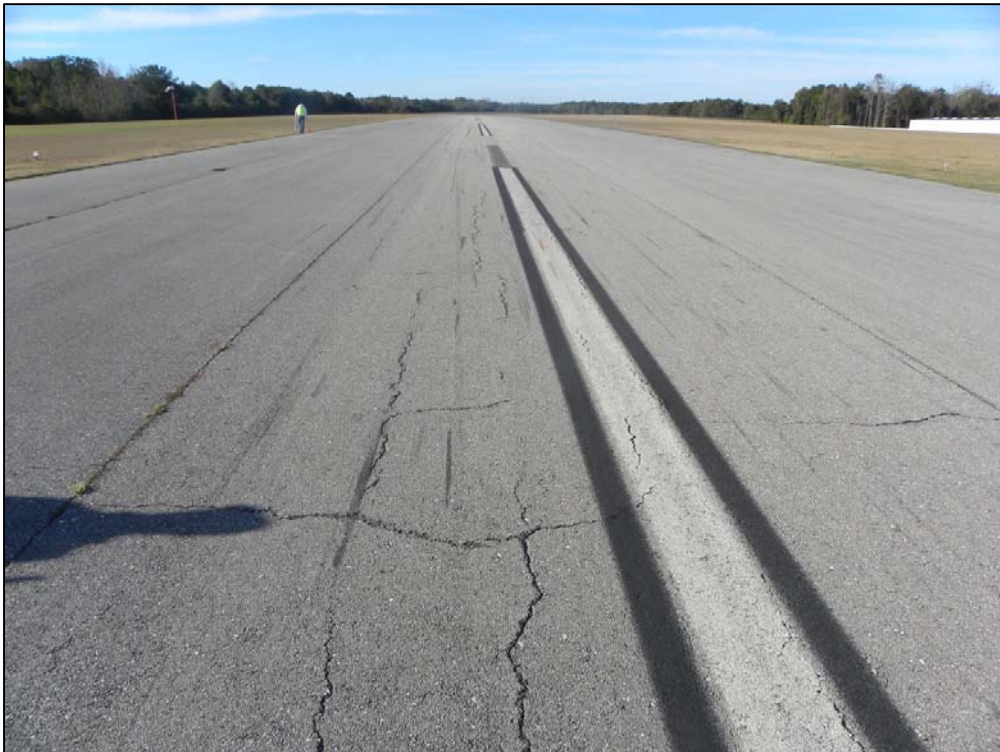
Runway 14-32, Section 6105, Sample Unit 144 – Medium severity (43) Block Cracking, medium severity (48) Longitudinal and Transverse Cracking, low and medium severity (52) Weathering and Raveling

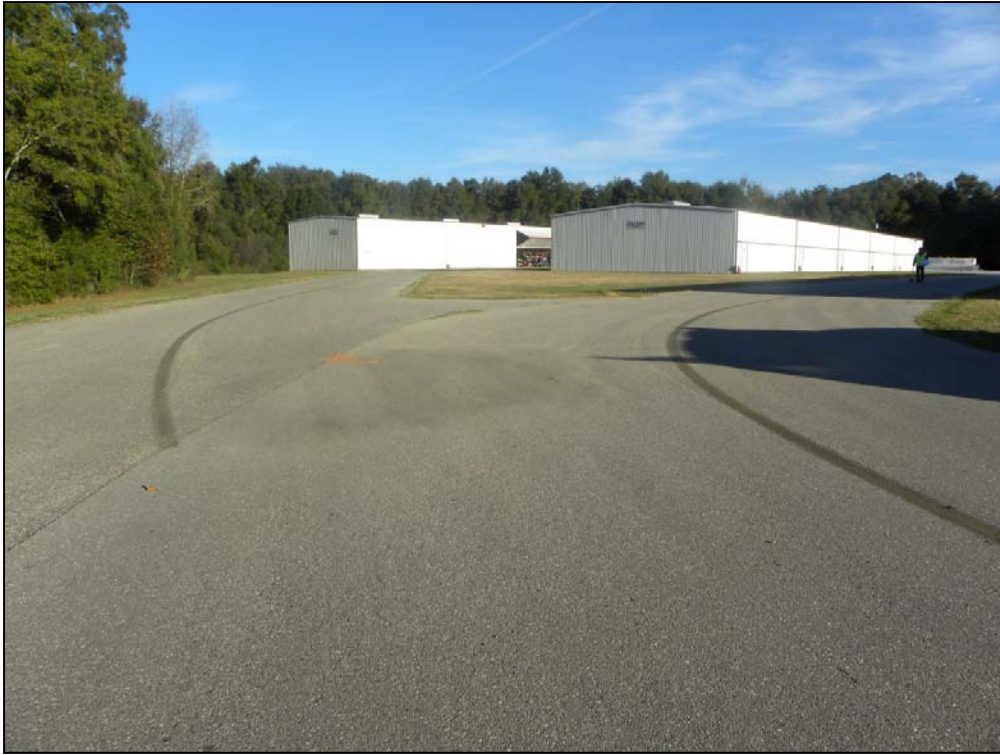
Taxiway Hangars, Section 125, Sample Unit 202 – Low severity (52) Weathering and Raveling, low severity (48) Longitudinal and Transverse Cracking

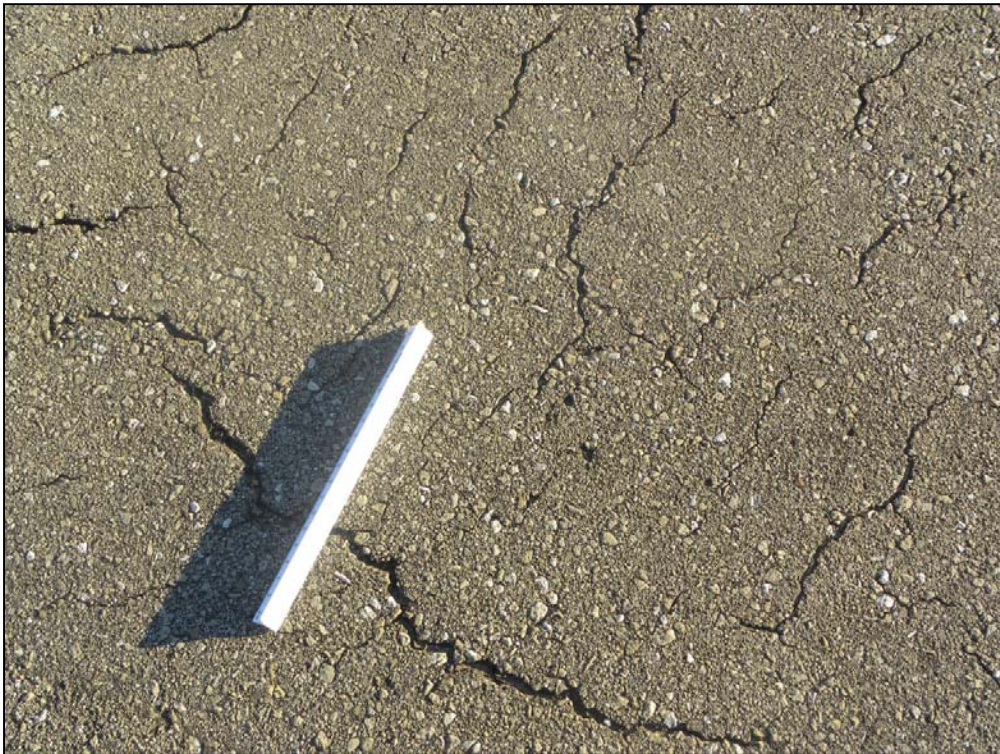
Taxiway Hangars, Section 125, Sample Unit 202 – Low severity (52) Weathering and Raveling, low severity (48) Longitudinal and Transverse Cracking
