**STATE OF FLORIDA
DEPARTMENT OF TRANSPORTATION
AVIATION OFFICE**

**Statewide Airfield Pavement Management Program
Palm Beach County Park Airport
(Regional Reliever)
West Palm Beach, Florida
(District 4)**

February 15, 2008

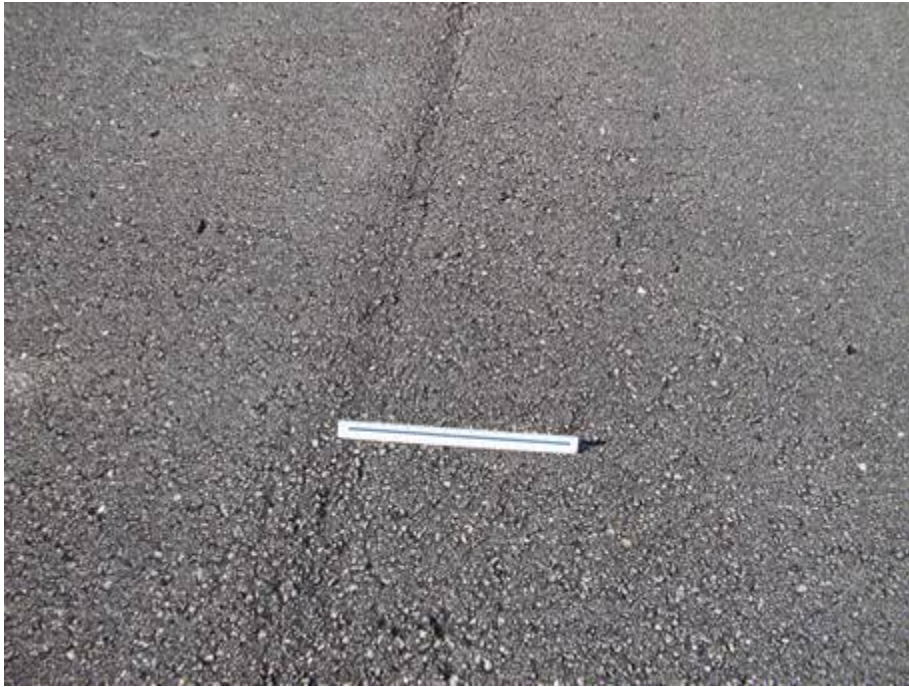
RW 3-21 Section 6305 SU 102: Low Severity Weathering (October 10, 2007)

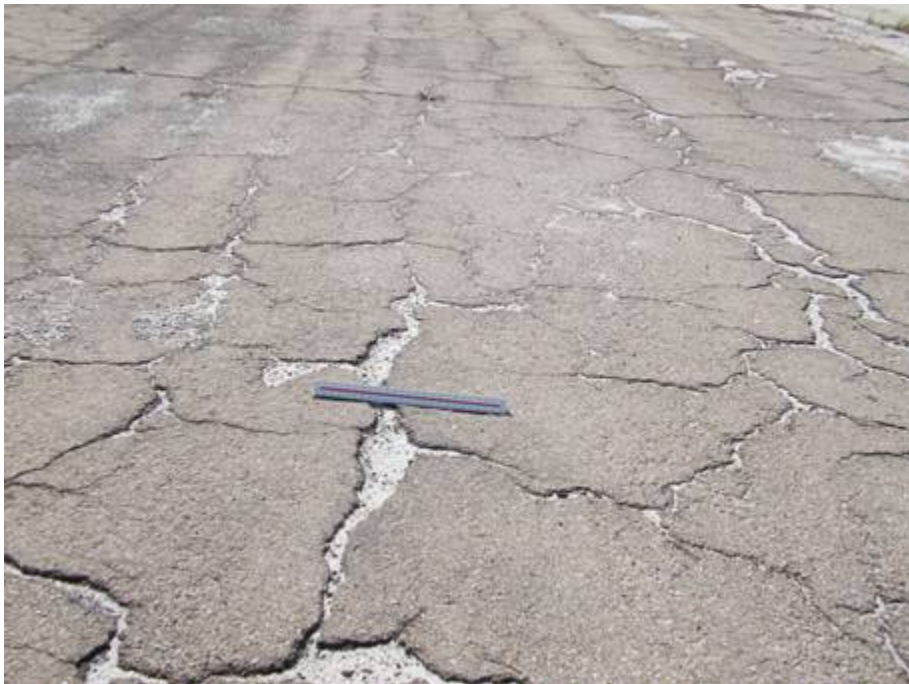
AP RU RW 15 Section 4405 SU 101: High Severity Block Cracking (October 10, 2007)

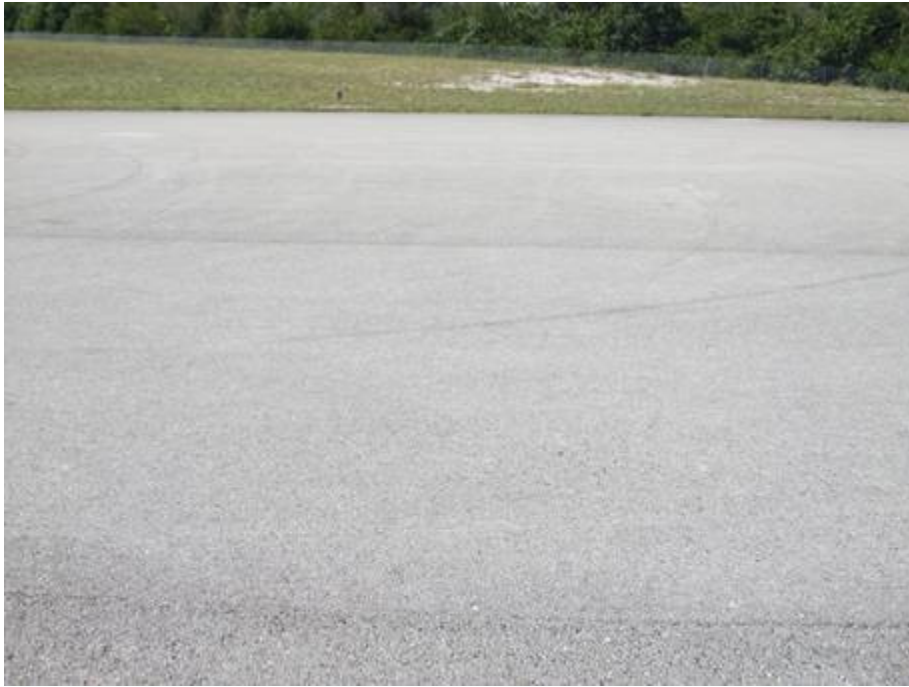
AP RU RW 15 Section 4305 SU 100: Section Overview (October 10, 2007)

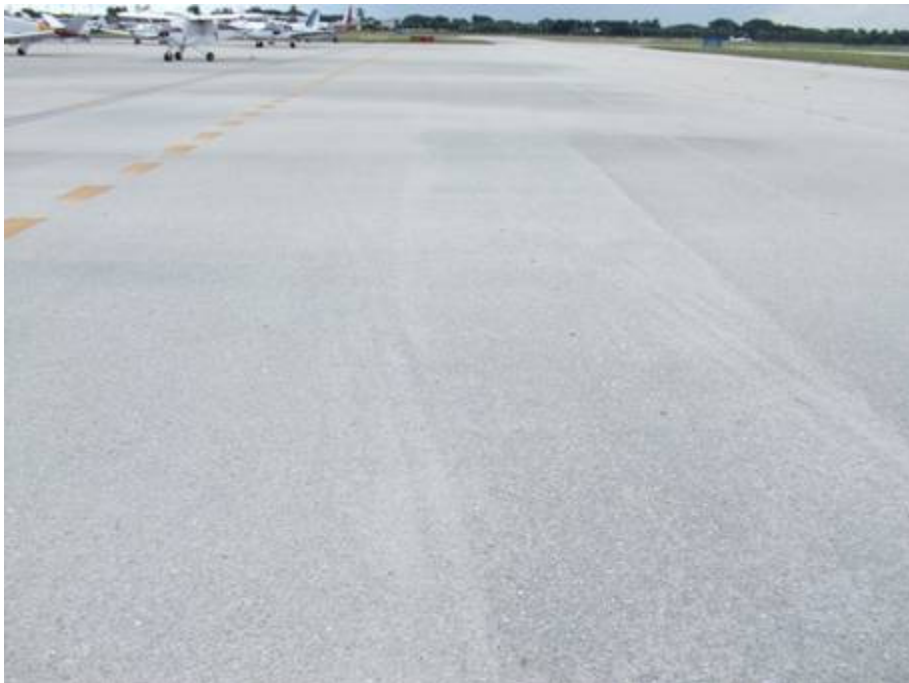
AP GA Section 4105 SU 705: Section Overview (October 10, 2007)

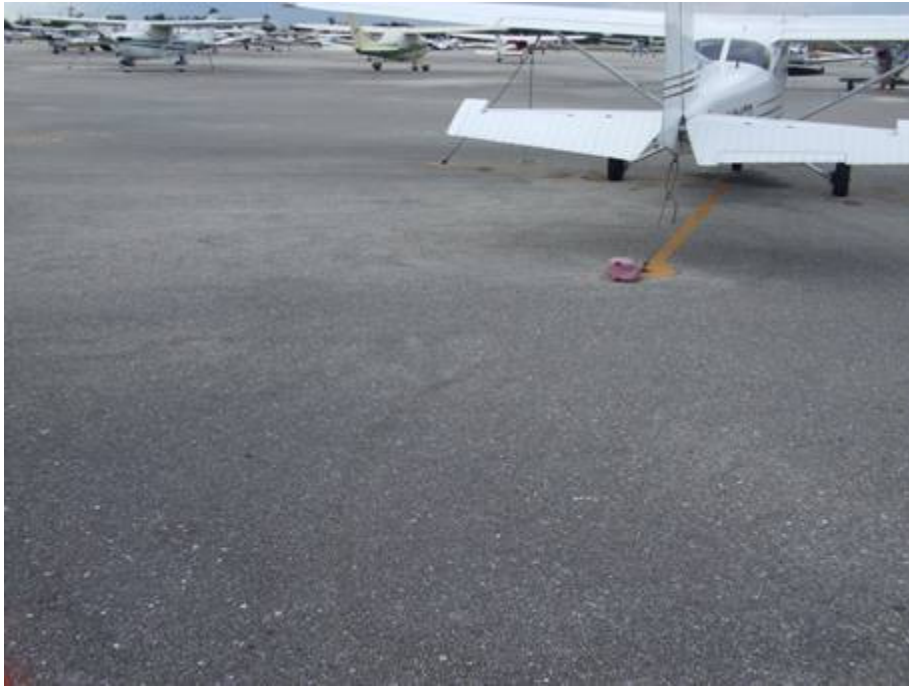
AP GA Section 4110 SU 457: Low Severity Weathering (October 10, 2007)

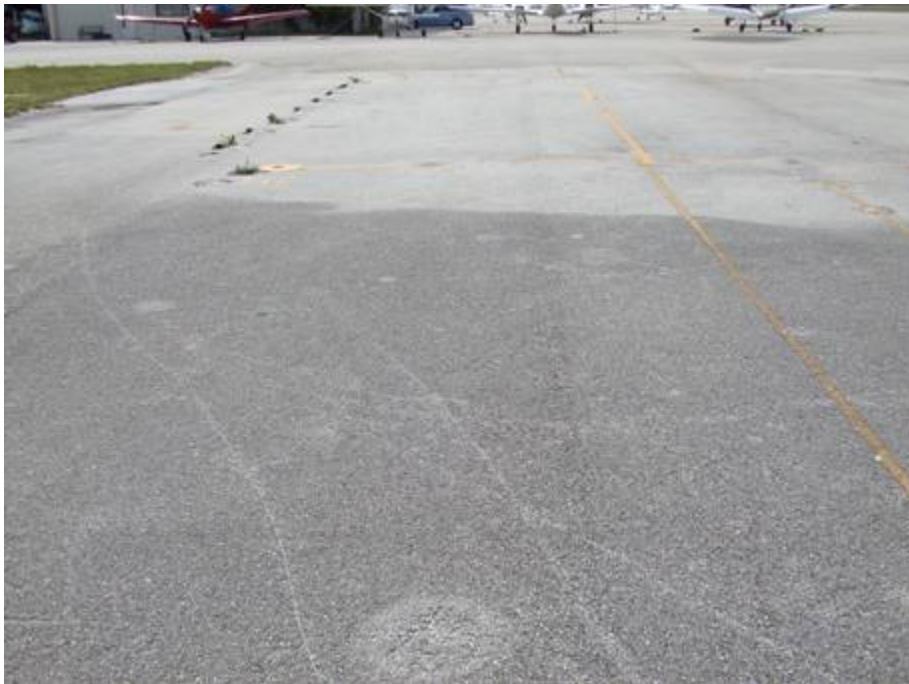
AP GA Section 4125 SU 619: Section Overview (October 10, 2007)

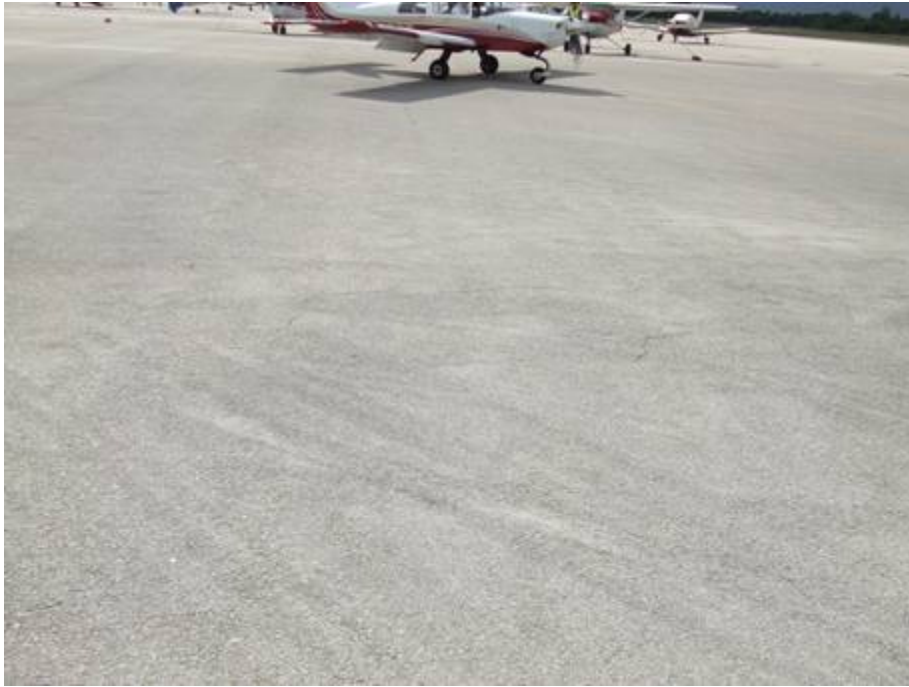
AP GA Section 4115 SU 609: Low Severity Weathering (October 10, 2007)

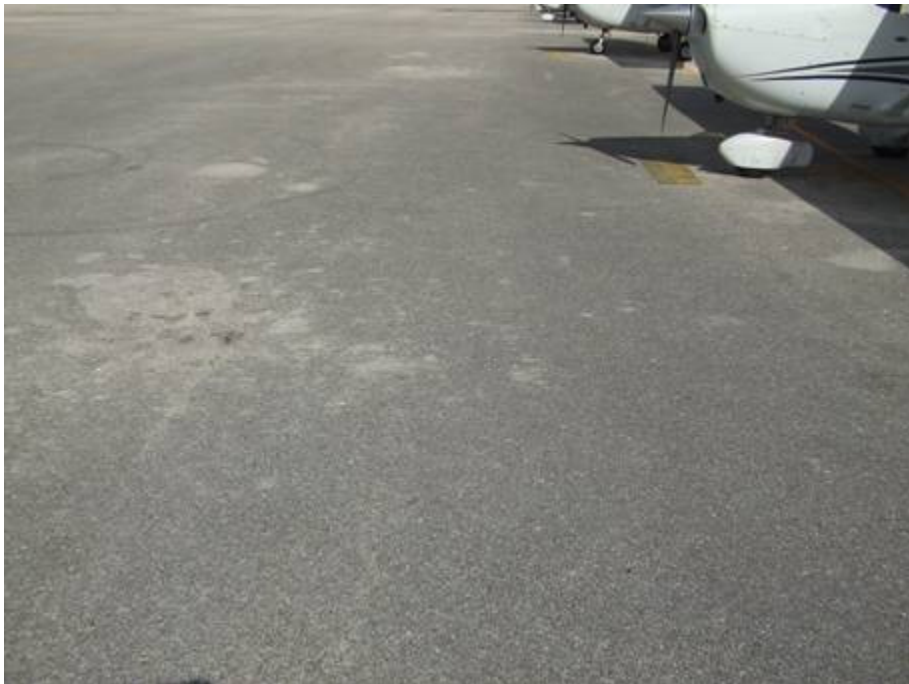
AP GA Section 4115 SU 460: Low Severity Weathering (October 10, 2007)
