**STATE OF FLORIDA
DEPARTMENT OF TRANSPORTATION
AVIATION OFFICE**

**Statewide Airfield Pavement Management Program
Palm Beach County Glades Airport
(General Aviation)
Pahokee, Florida
(District 4)**

February 13, 2008

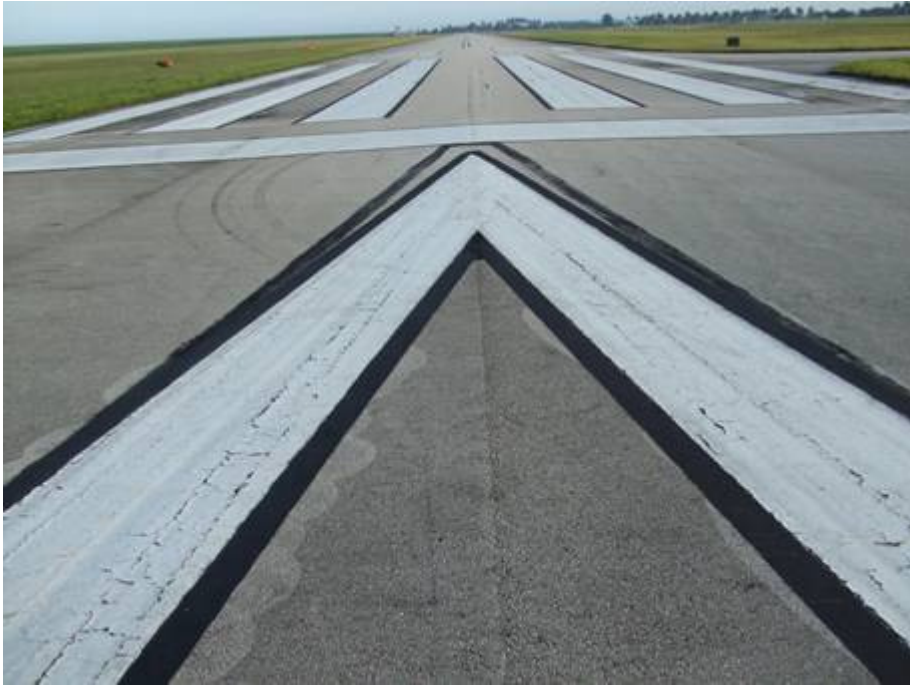
RW 17-35 Section 6105 SU 101: Section Overview (September 17, 2007)

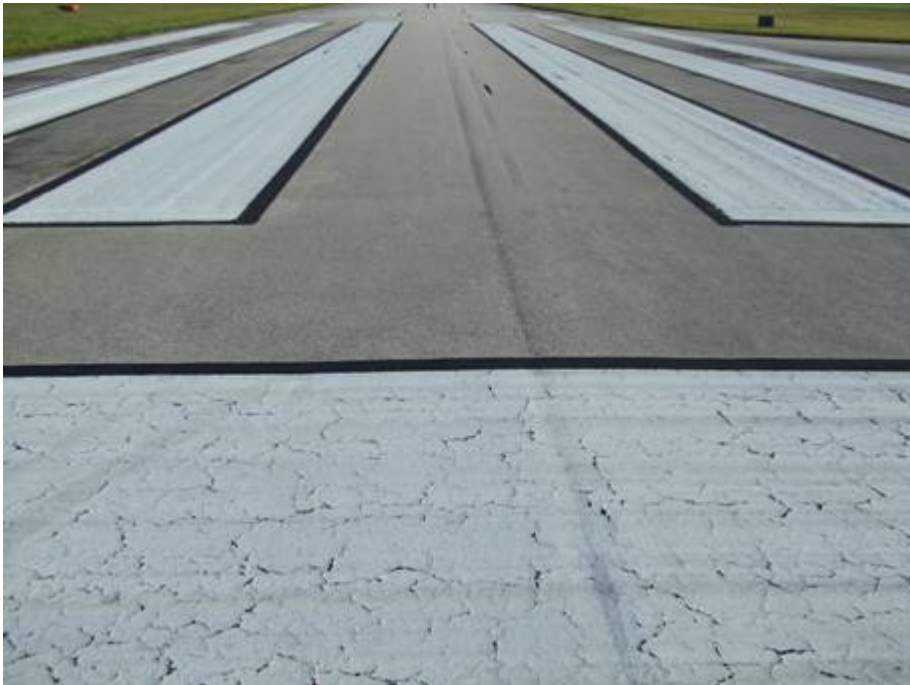
RW 17-35 Section 6105 SU 101: Section Overview (September 17, 2007)

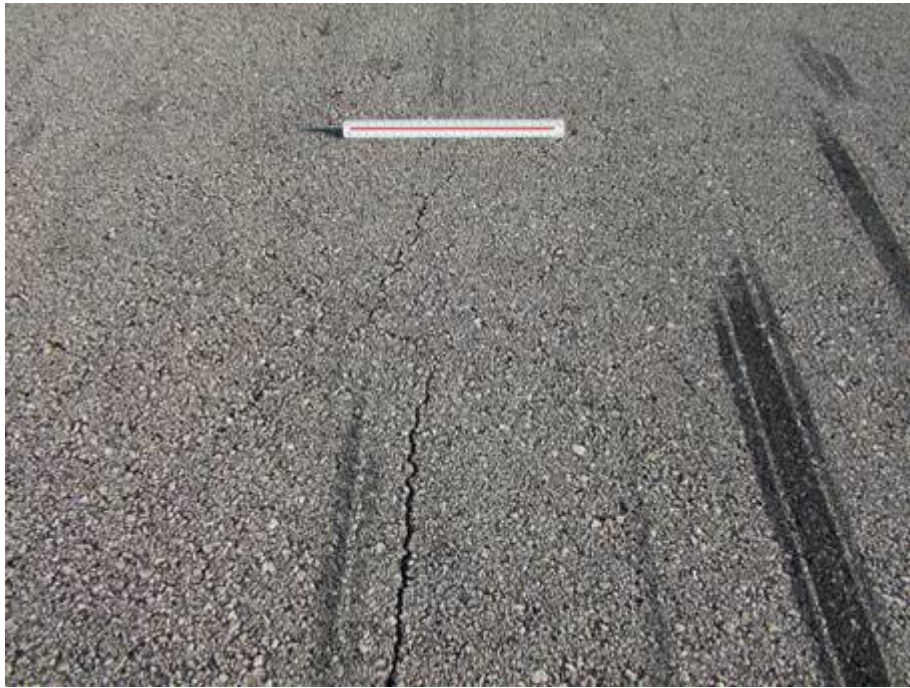
RW 17-35 Section 6105 SU 109: Low Severity L/T Cracking (September 17, 2007)

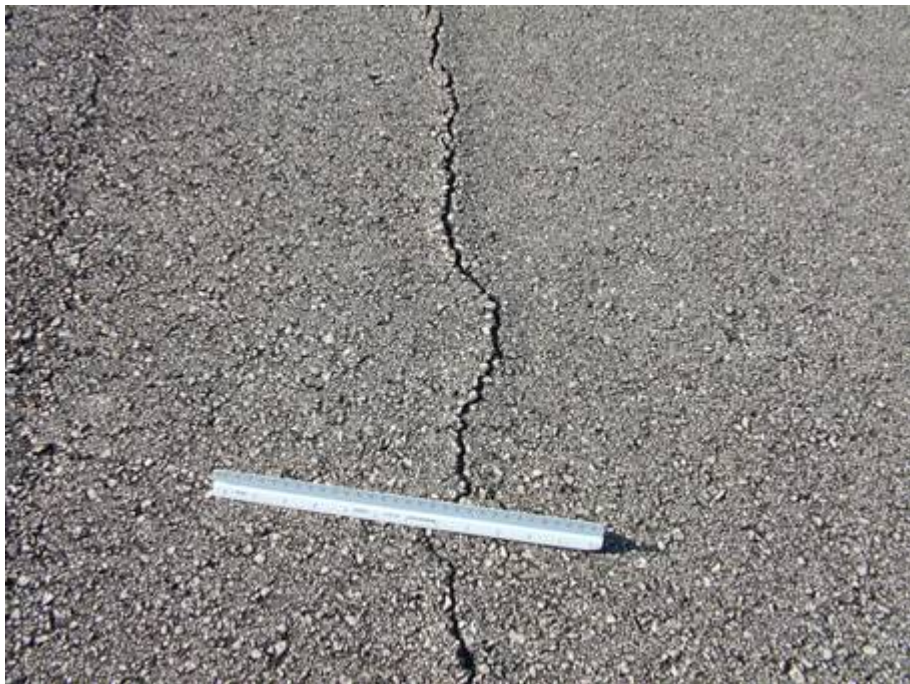
RW 17-35 Section 6110 SU 155: Low Severity L/T Cracking (September 17, 2007)

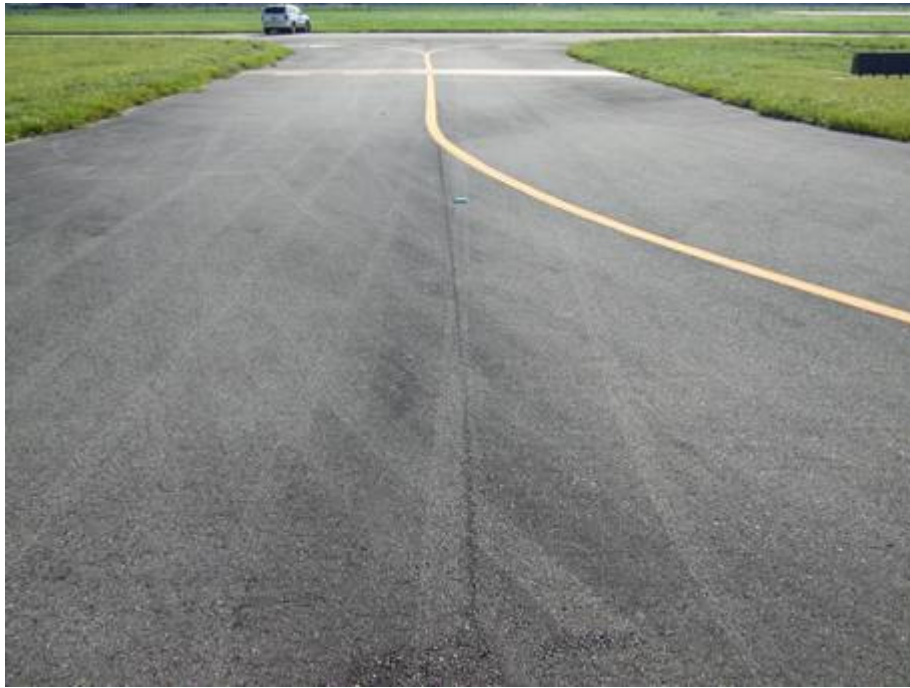
TW Section 125 SU 100: Low Severity L/T Cracking (September 17, 2007)

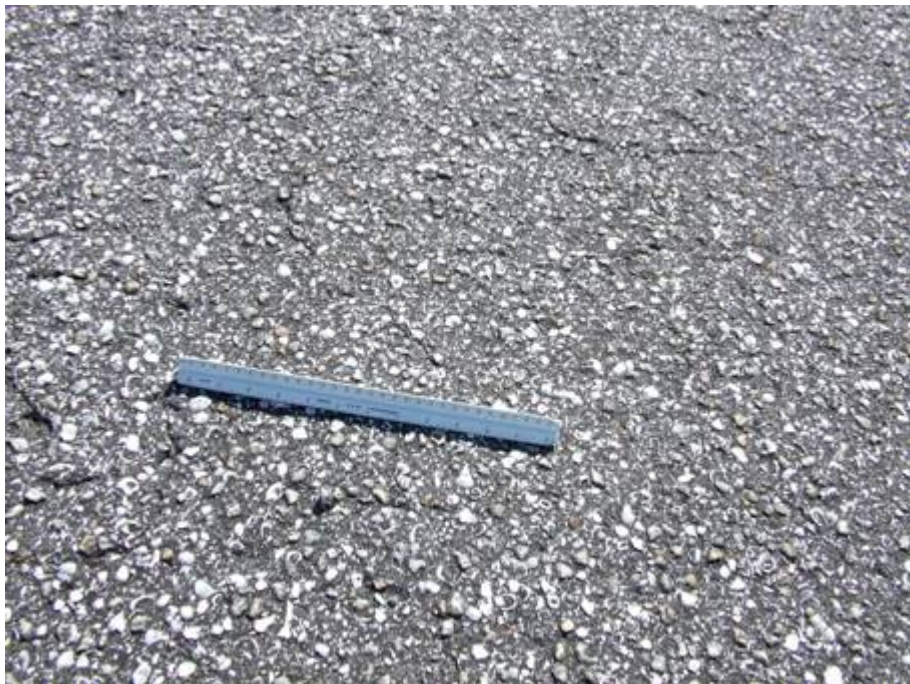
AP T-Hang Section 4205 SU 101: Low Severity Weathering (September 17, 2007)
