**STATE OF FLORIDA
DEPARTMENT OF TRANSPORTATION
AVIATION OFFICE**

**Statewide Airfield Pavement Management Program
Sebring Regional Airport
(General Aviation)
Sebring, Florida
(District 1)**

February 8, 2008

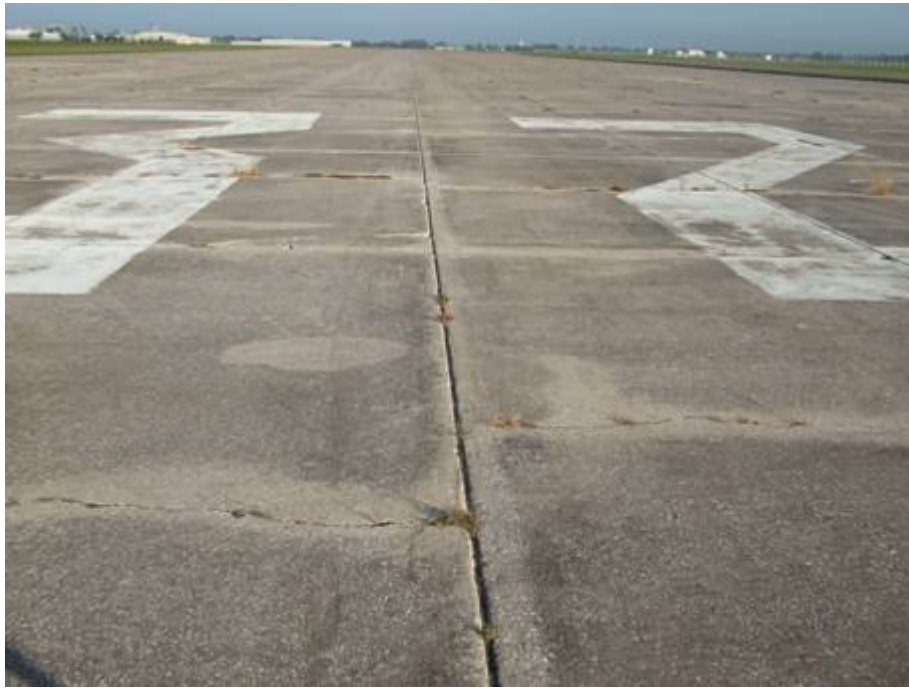
RW 14-32 Section 6205 SU 101: Low Severity Linear Cracking,
High Severity Joint Seal Damage (September 17, 2007)

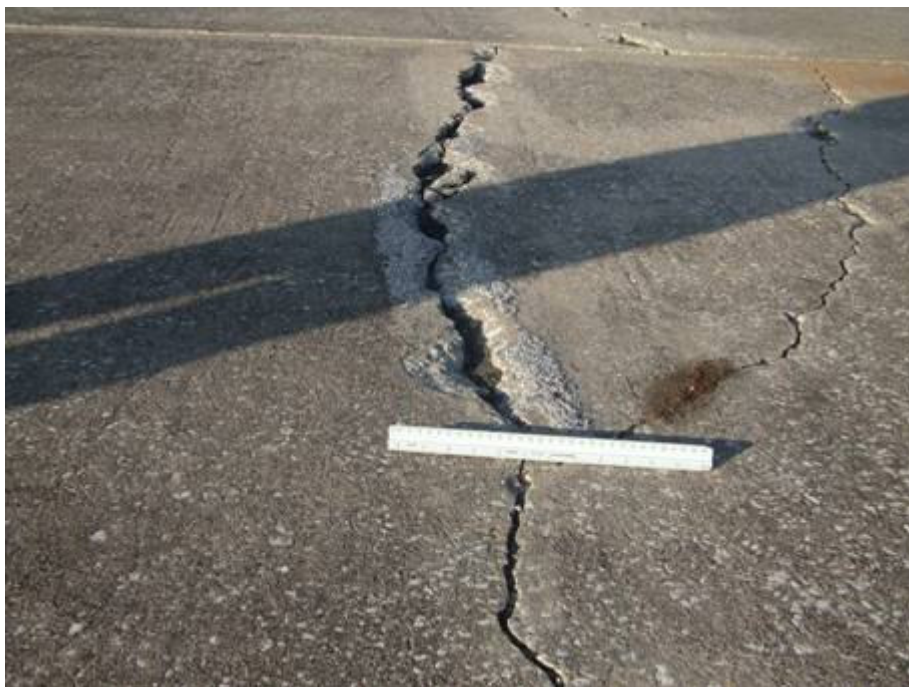
RW 14-32 Section 6205 SU 101: High Severity Linear Cracking (September 17, 2007)

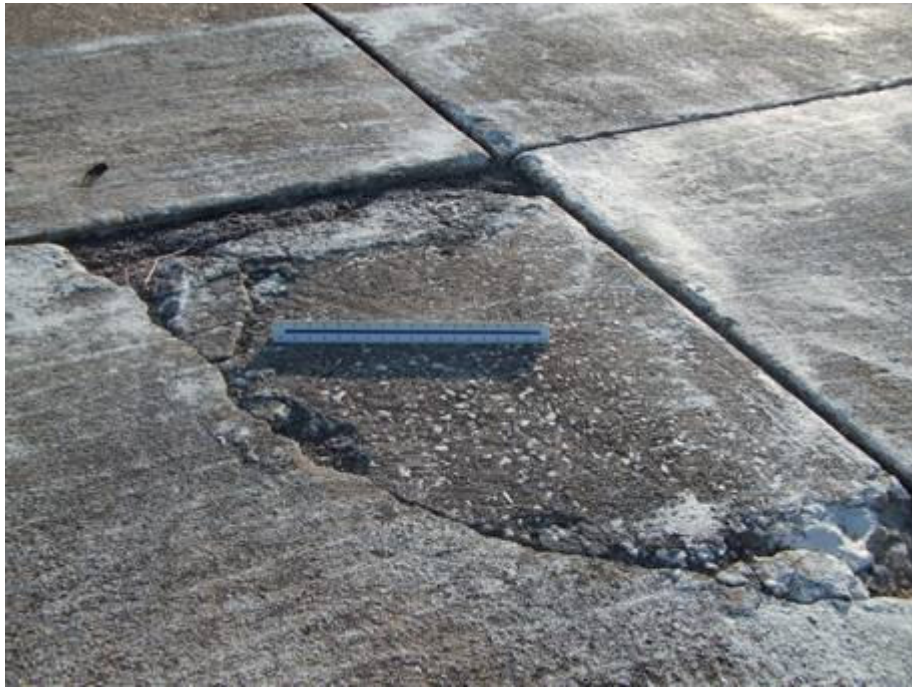
RW 14-32 Section 6205 SU 101: High Severity Corner Break (September 17, 2007)

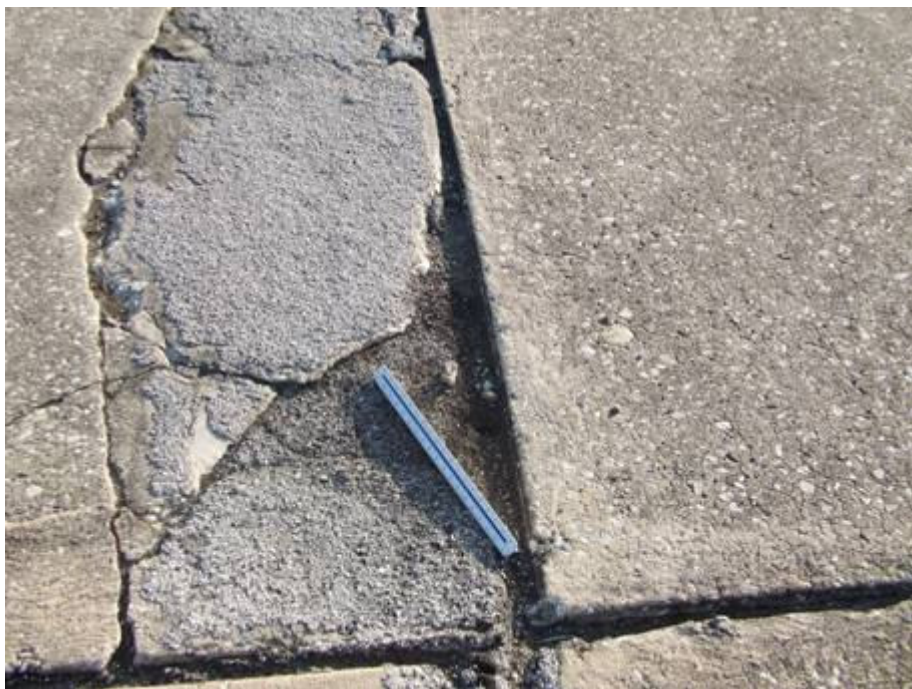
RW 14-32 Section 6205 SU 101: High Severity Corner Spall (September 17, 2007)

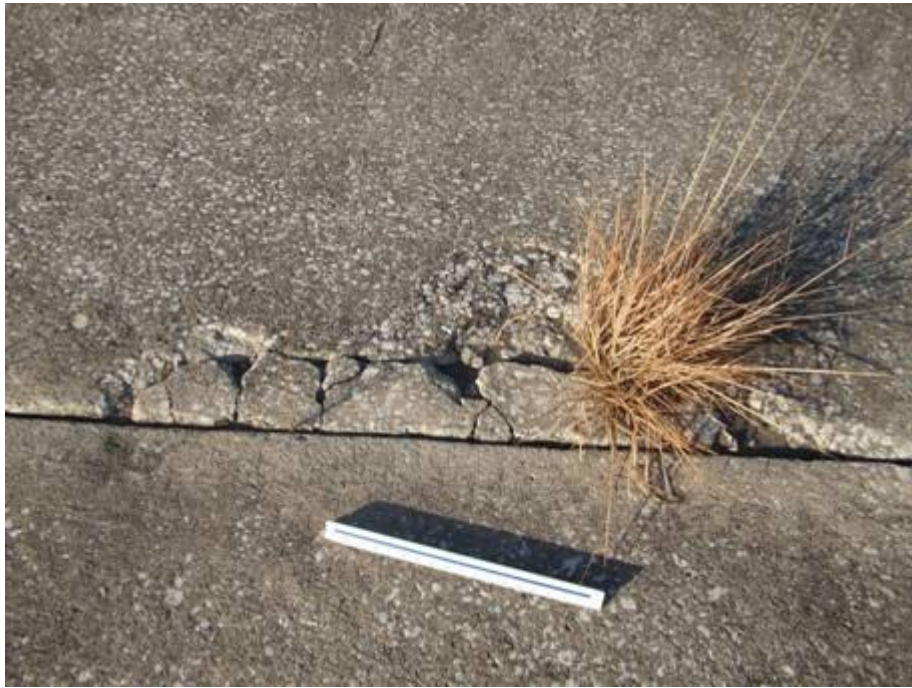
RW 14-32 Section 6205 SU 105: High Severity Joint Spall (September 17, 2007)

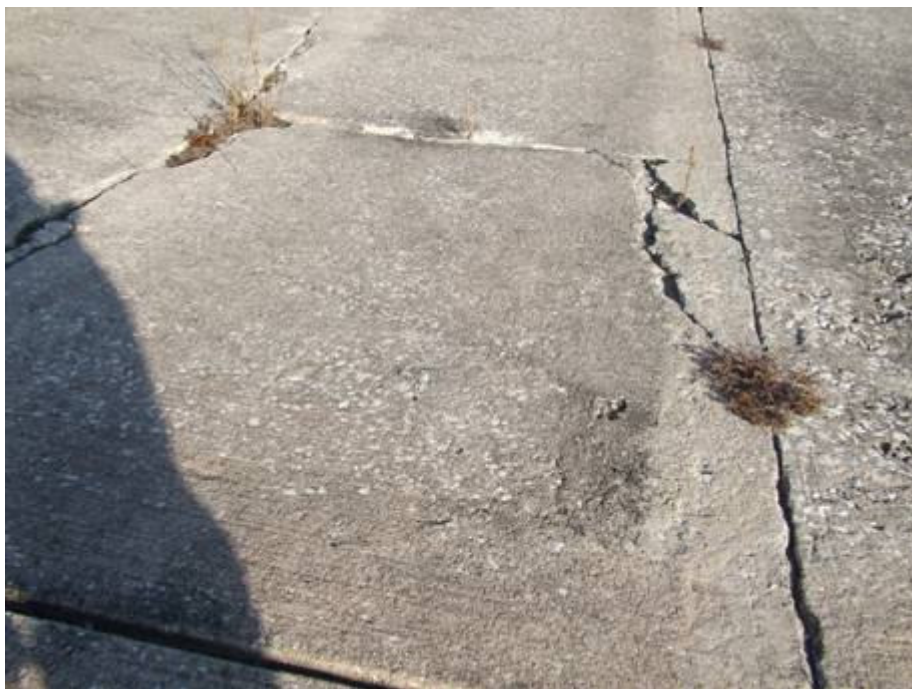
RW 14-32 Section 6205 SU 121: High Severity Shattered Slab (September 17, 2007)

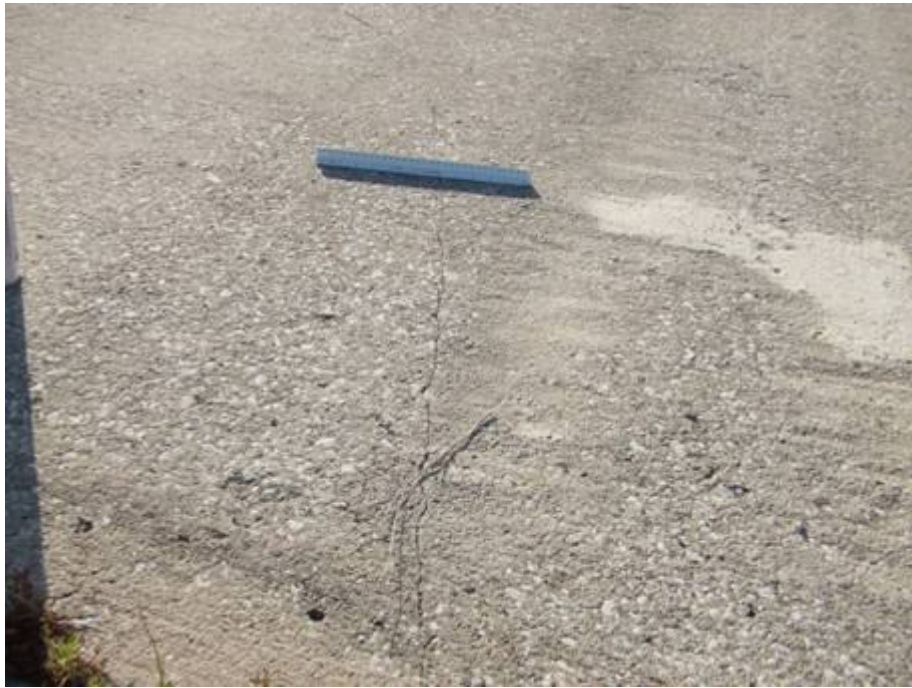
RW 14-32 Section 6205 SU 128: Shrinkage Cracking (Sept. 17, 2007)

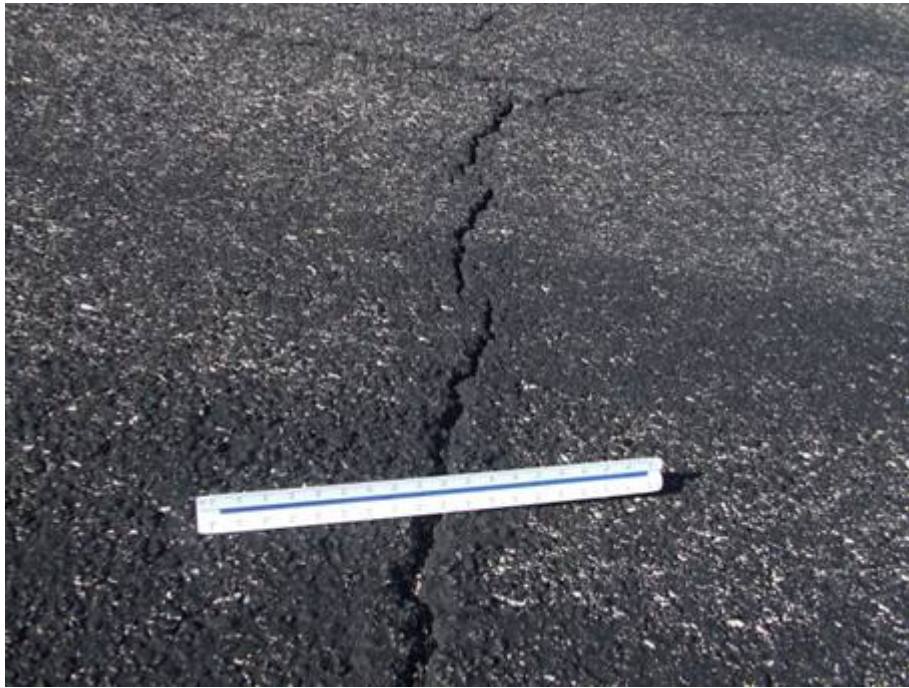
RW 14-32 Section 6210 SU 159: Medium Severity L/T Cracking (September 17, 2007)

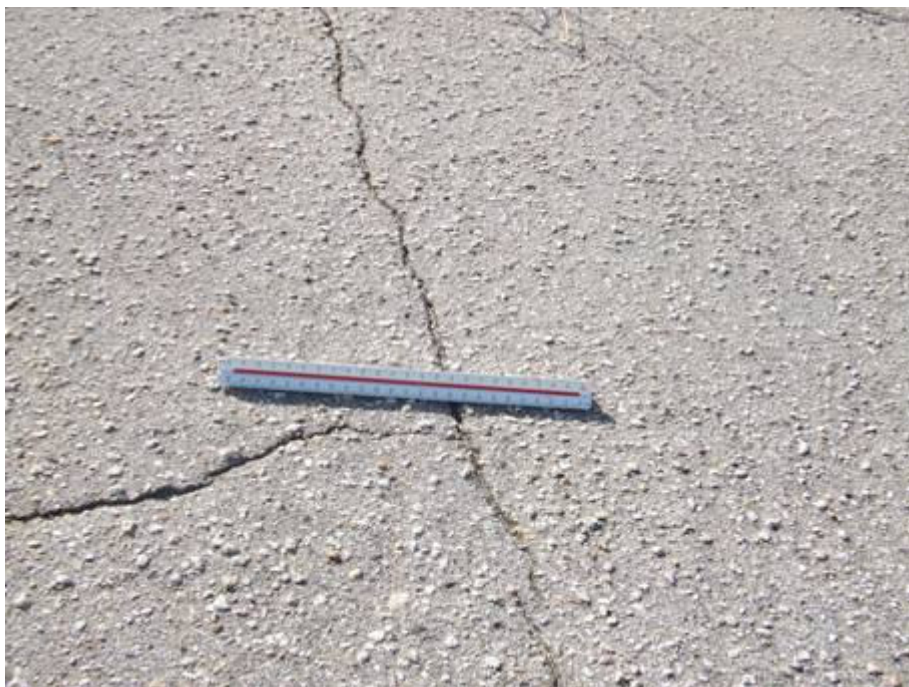
RW 14-32 Section 6215 SU 198: Medium Severity L/T Cracking,
Low Severity Weathering (September 17, 2007)

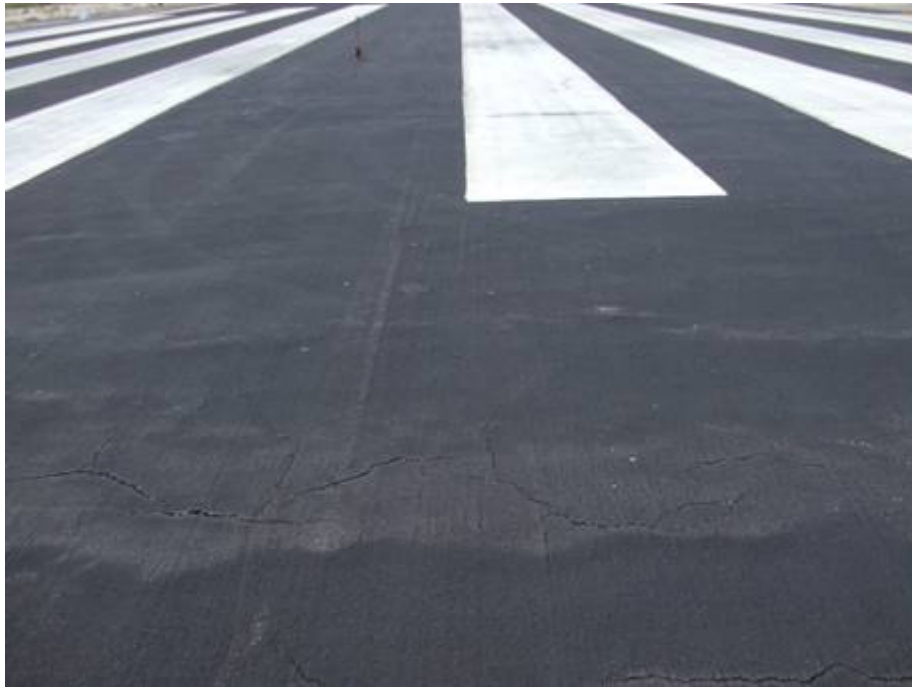
RW 18-36 Section 6105 SU 203: Low Severity Block Cracking (September 17, 2007)

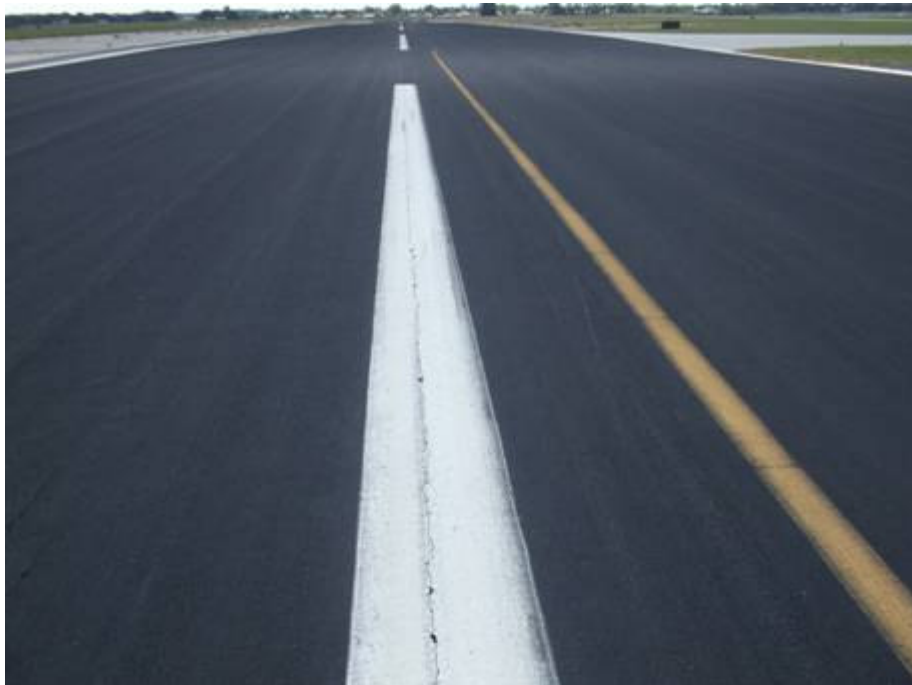
RW 18-36 Section 6105 SU 138: Low Severity L/T Cracking (September 17, 2007)

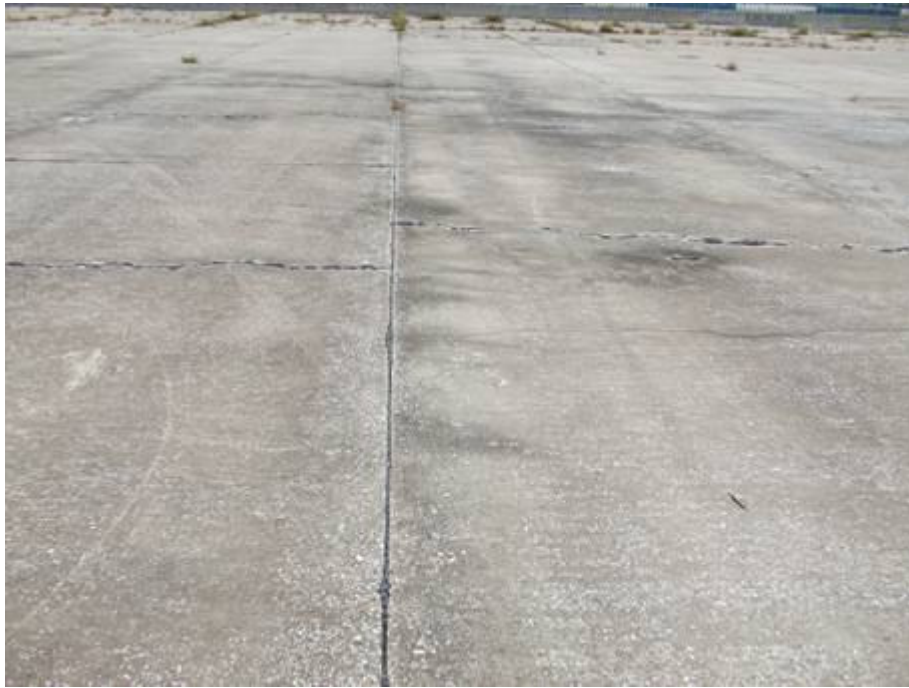
AP W Section 4105 SU 302: Low Severity Joint Seal Damage (September 17, 2007)

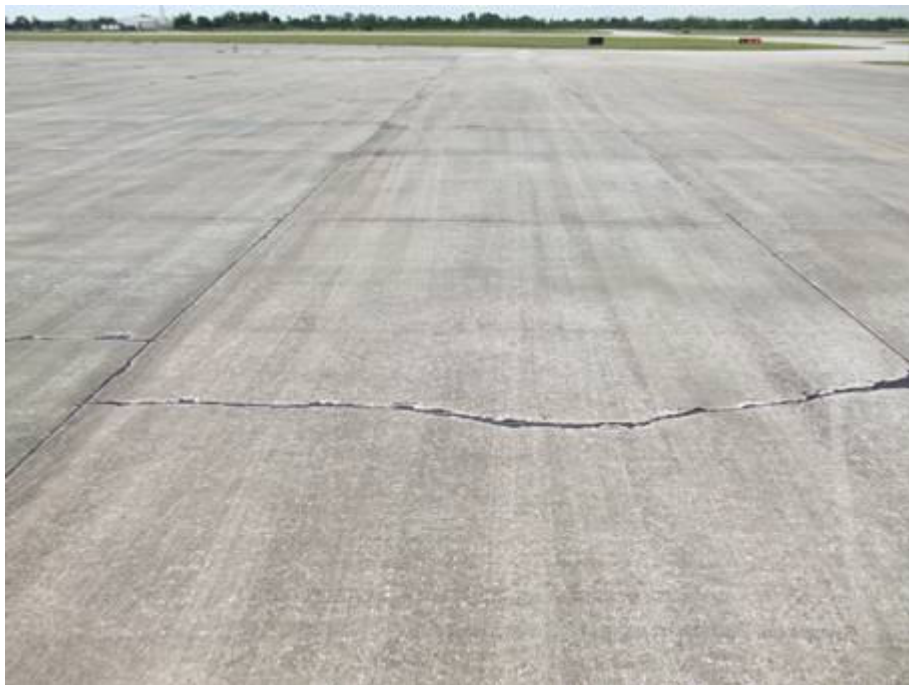
AP W Section 4105 SU 302: Medium Severity Linear Cracking (September 17, 2007)
