**STATE OF FLORIDA
DEPARTMENT OF TRANSPORTATION
AVIATION OFFICE**

**Statewide Airfield Pavement Management Program
Sebastian Municipal Airport
(General Aviation)
Sebastian, Florida
(District 4)**

January 31, 2008

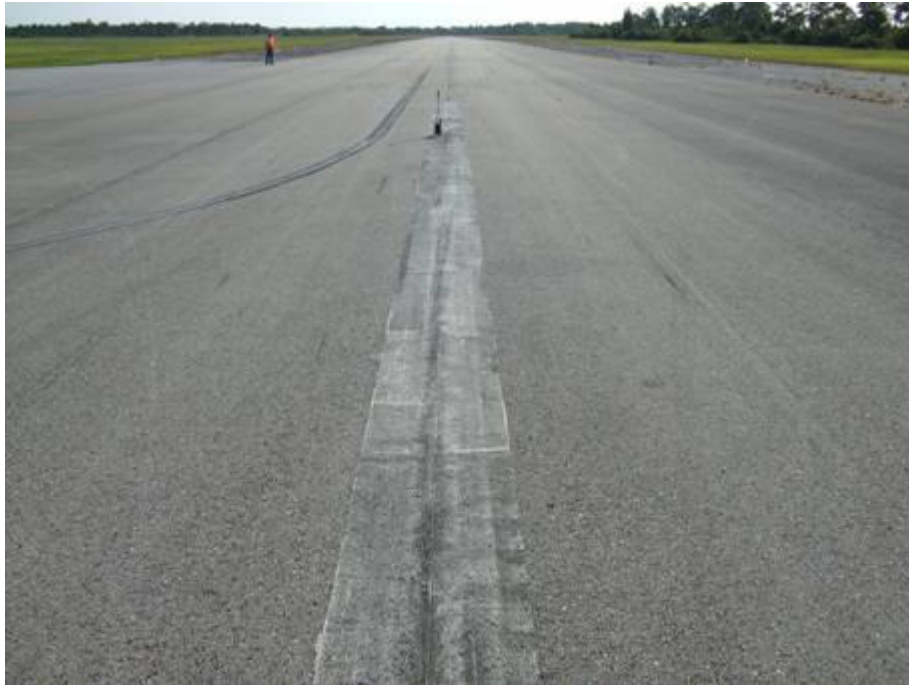
RW 4-22 Section 6205 SU 303: Section Overview (July 9, 2007)

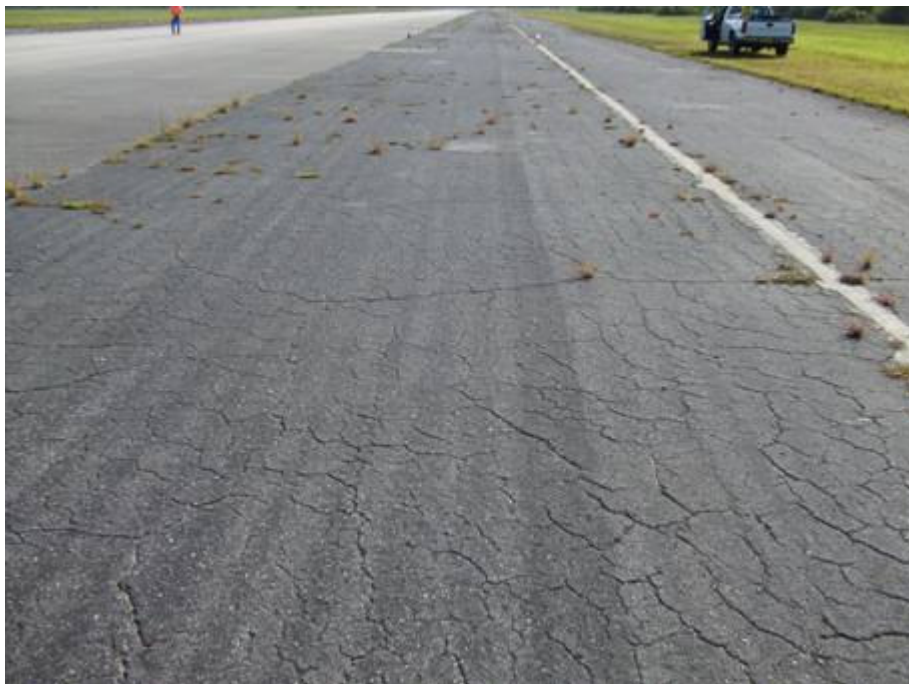
RW 4-22 Section 6210 SU 504: Medium Severity Block Cracking (July 9, 2007)

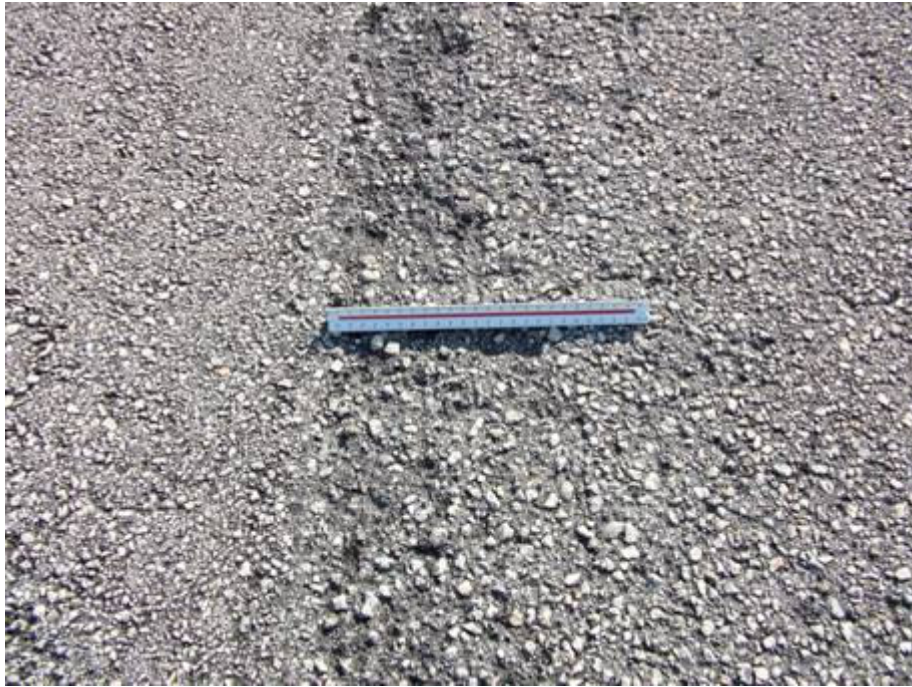
RW 4-22 Section 6205 SU 314: Medium Severity Weathering (July 9, 2007)

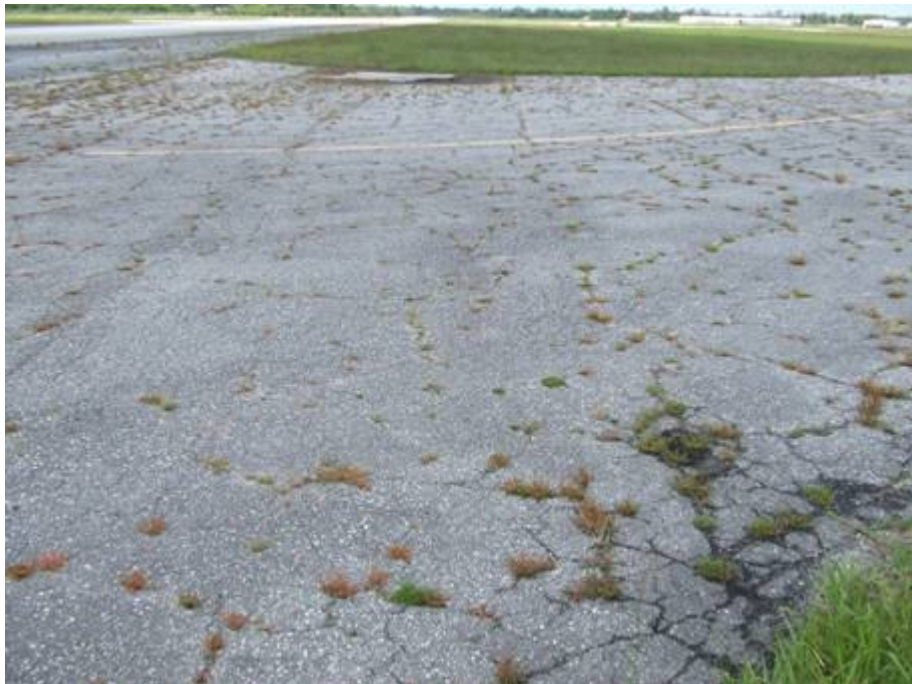
TW 3 Section 306 SU 101: Medium Severity Block Cracking (July 9, 2007)

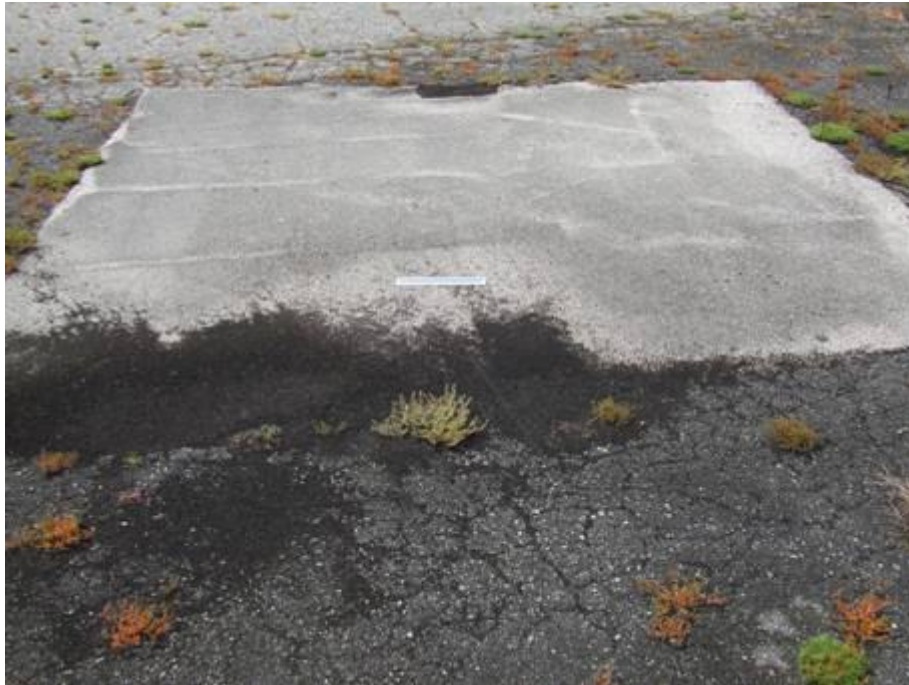
TW 3 Section 306 SU 101: Low Severity Patch (July 9, 2007)

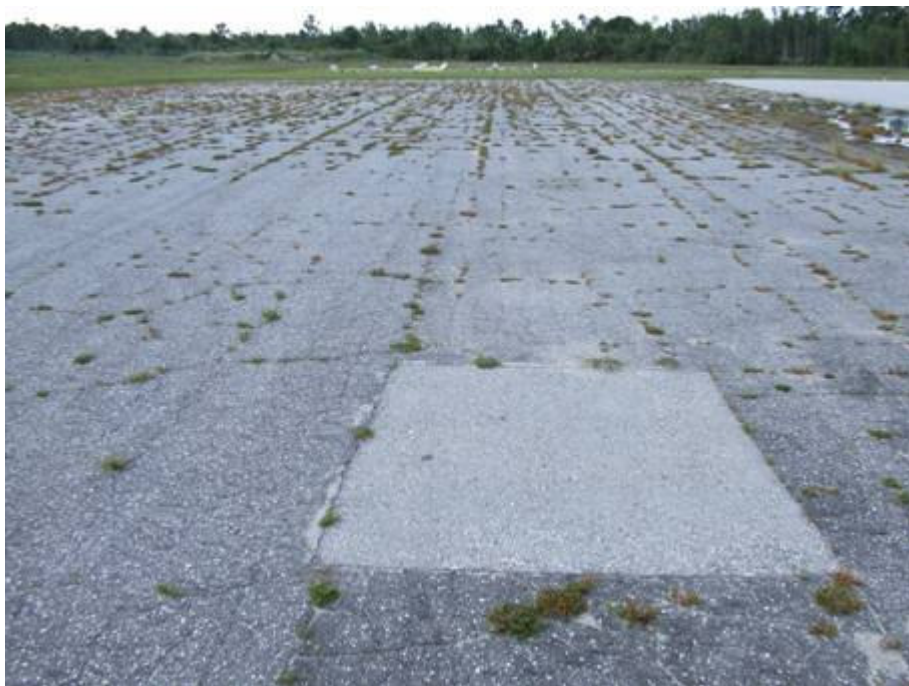
TW 4 Section 410 SU 435: Medium Severity Block Cracking (July 9, 2007)

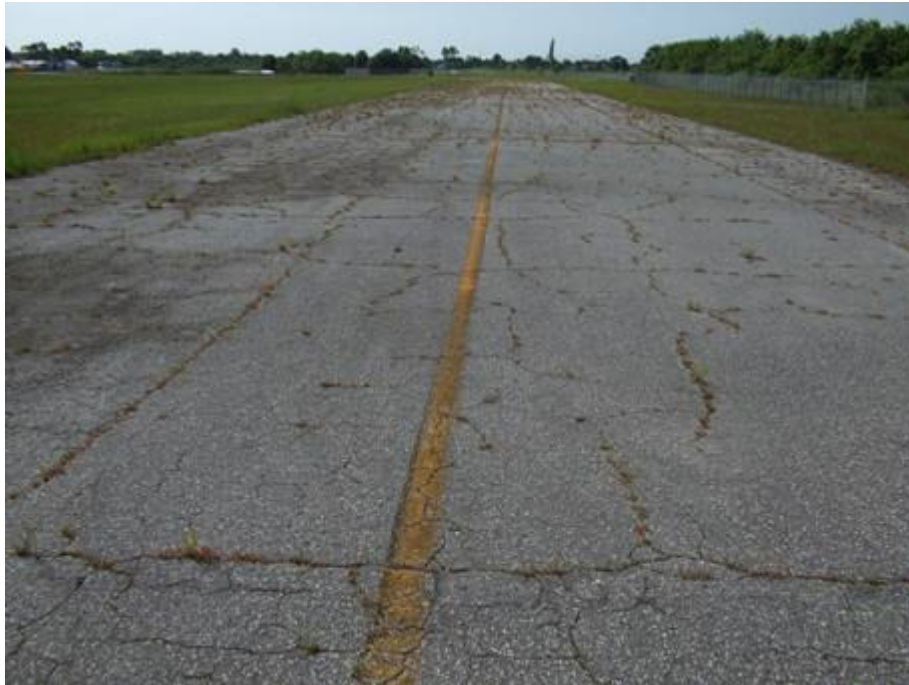
TW 2 Section 205 SU 200: Medium Severity Block Cracking (July 9, 2007)
