**STATE OF FLORIDA
DEPARTMENT OF TRANSPORTATION
AVIATION OFFICE**

**Statewide Airfield Pavement Management Program
Homestead General Aviation Airport
(General Aviation)
Homestead, Florida
(District 6)**

February 8, 2008

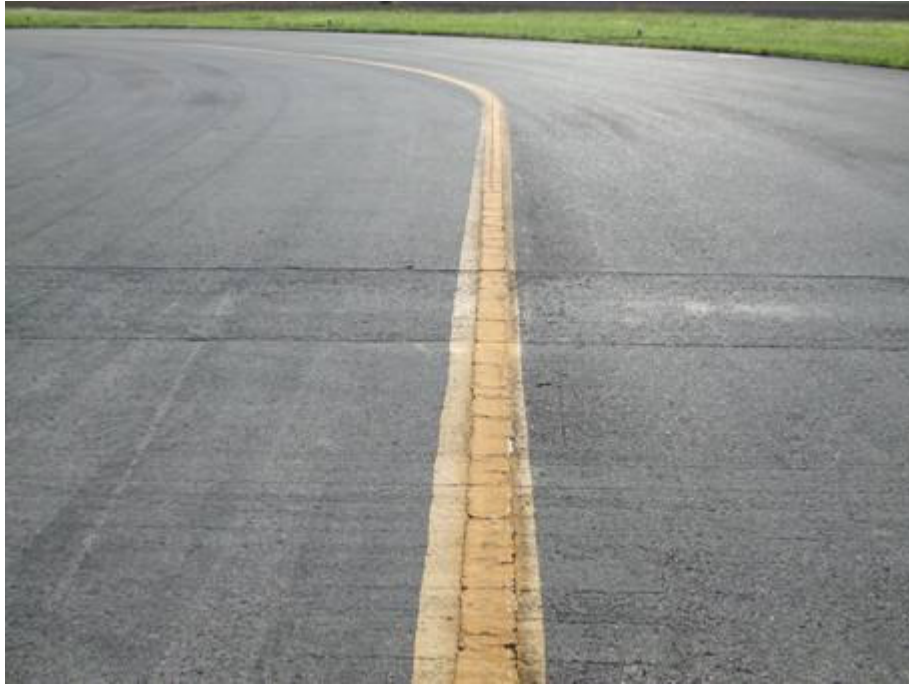
TW E Section 110 SU 202: Low Severity Patching (September 17, 2007)

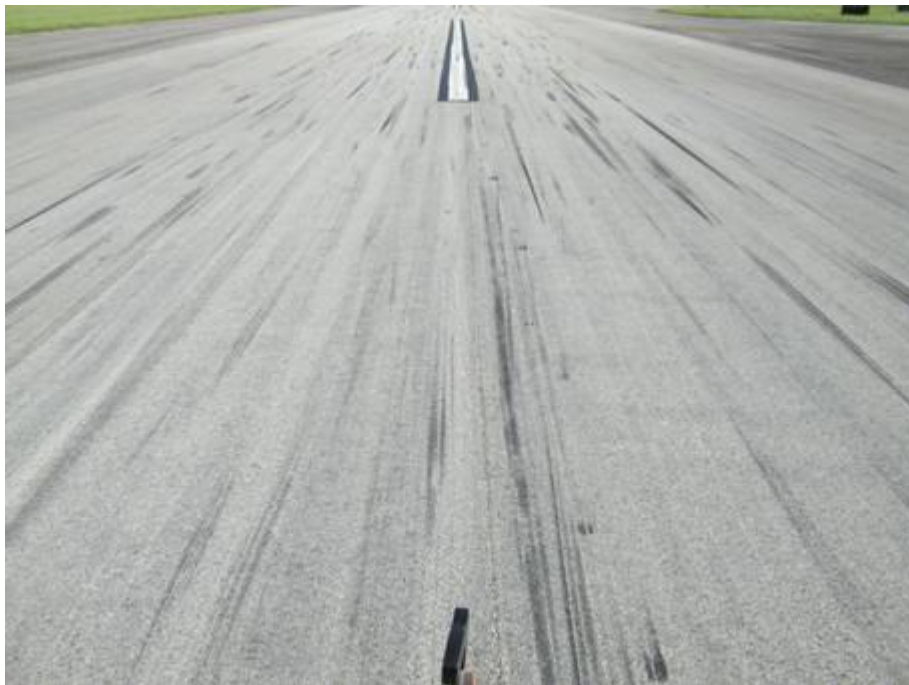
RW 18-36 Section 6110 SU 305: Section Overview (September 17, 2007)

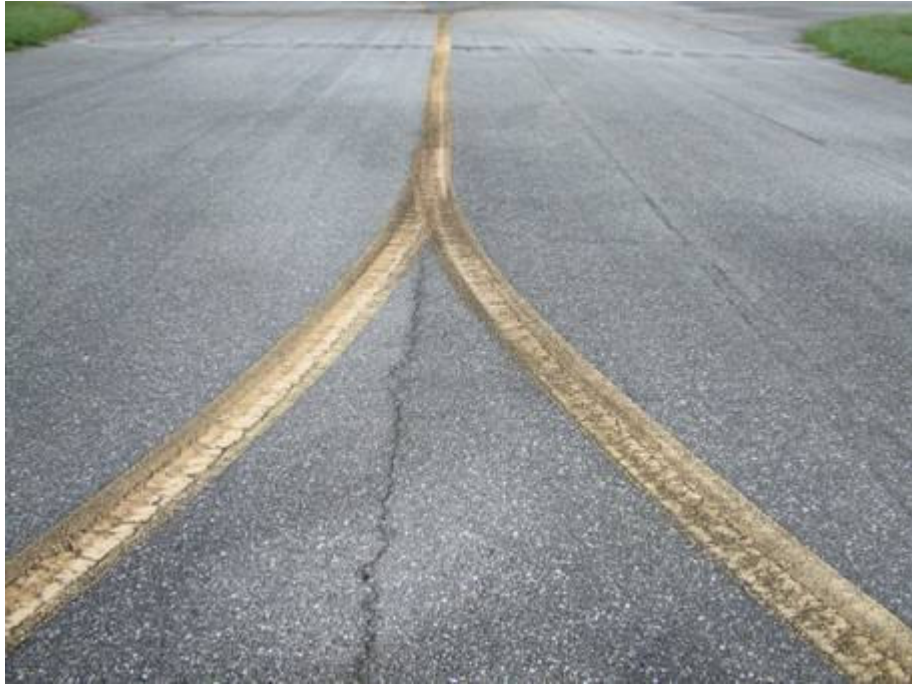
TW E Section 140 SU 401: Low Severity L/T Cracking (September 17, 2007)

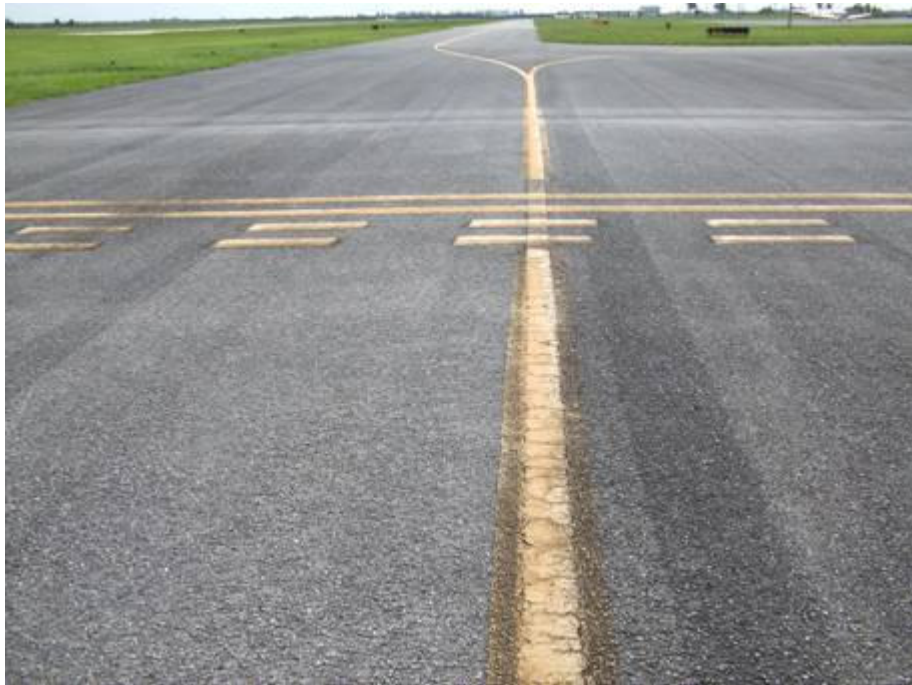
TW E Section 160 SU 601: Section Overview (September 17, 2007)

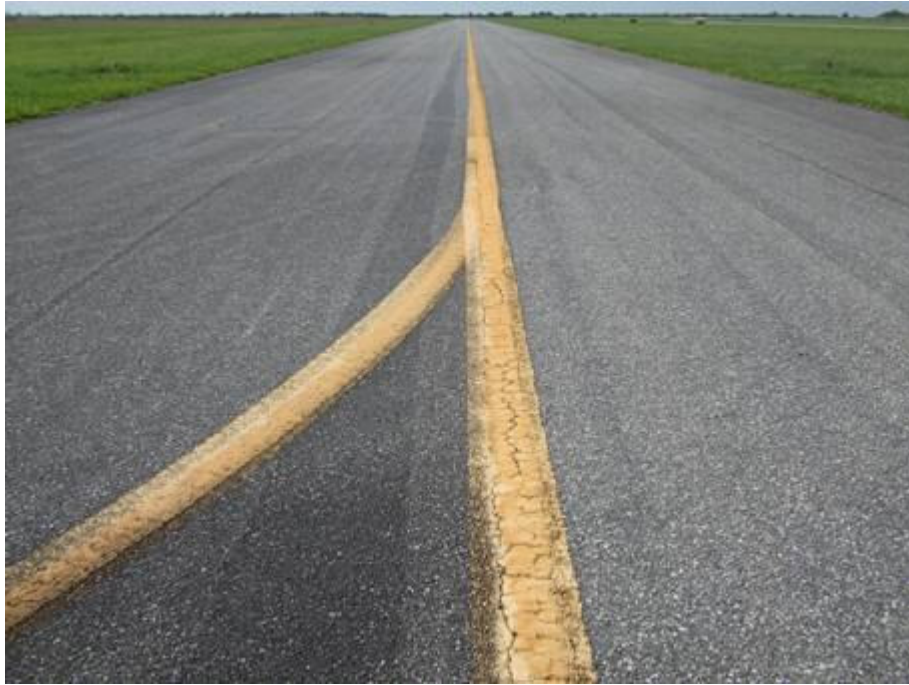
TW E Section 105 SU 132: Section Overview (September 17, 2007)

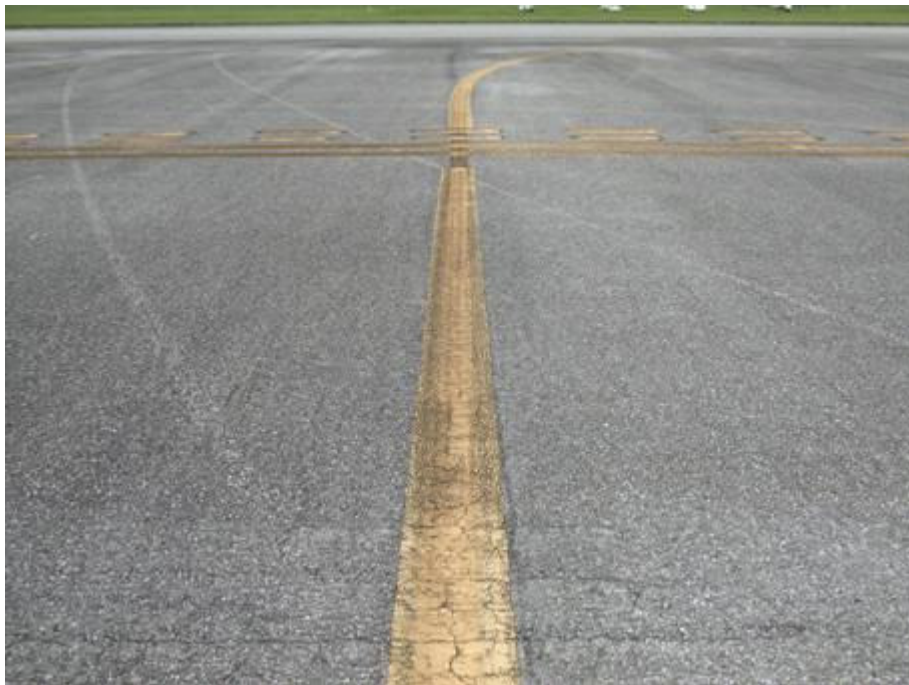
TW E Section 120 SU 201 Section Overview (September 17, 2007)

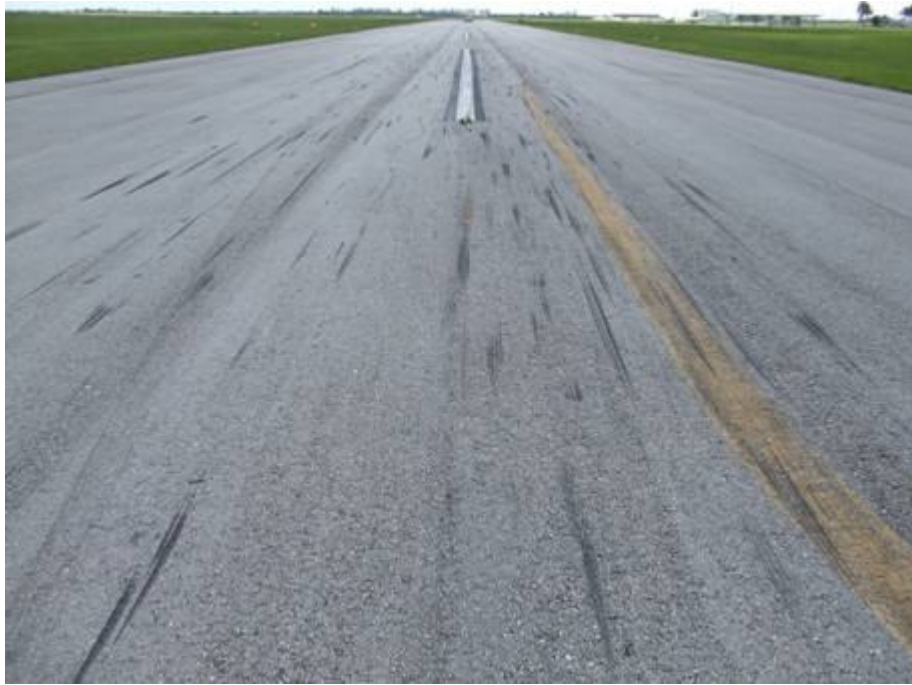
RW 9-27 Section 6205 SU 102: Section Overview (September 17, 2007)

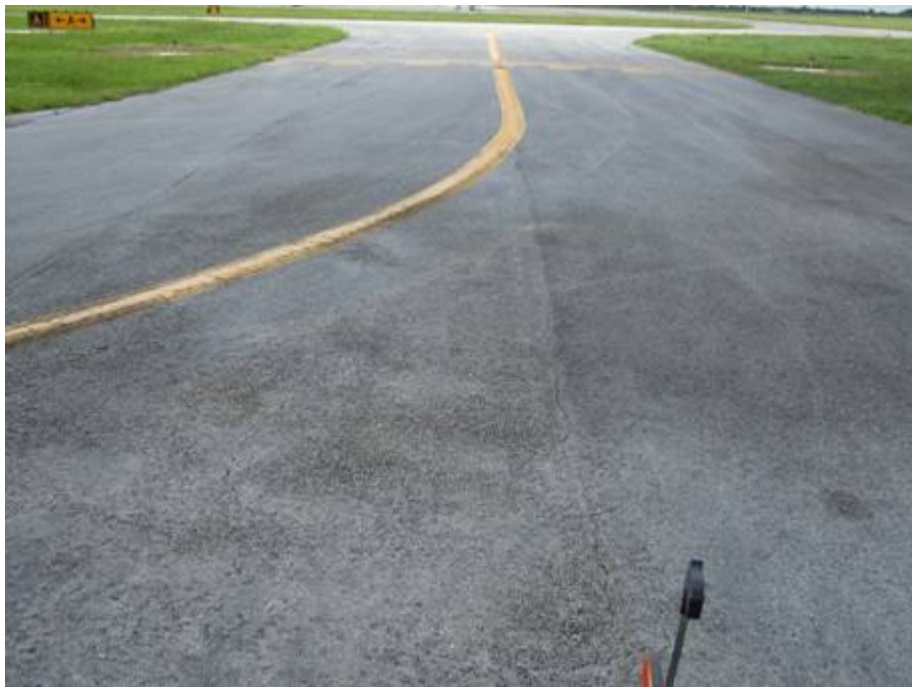
TW N Section 280 SU 300: Low Severity L/T Cracking (September 17, 2007)

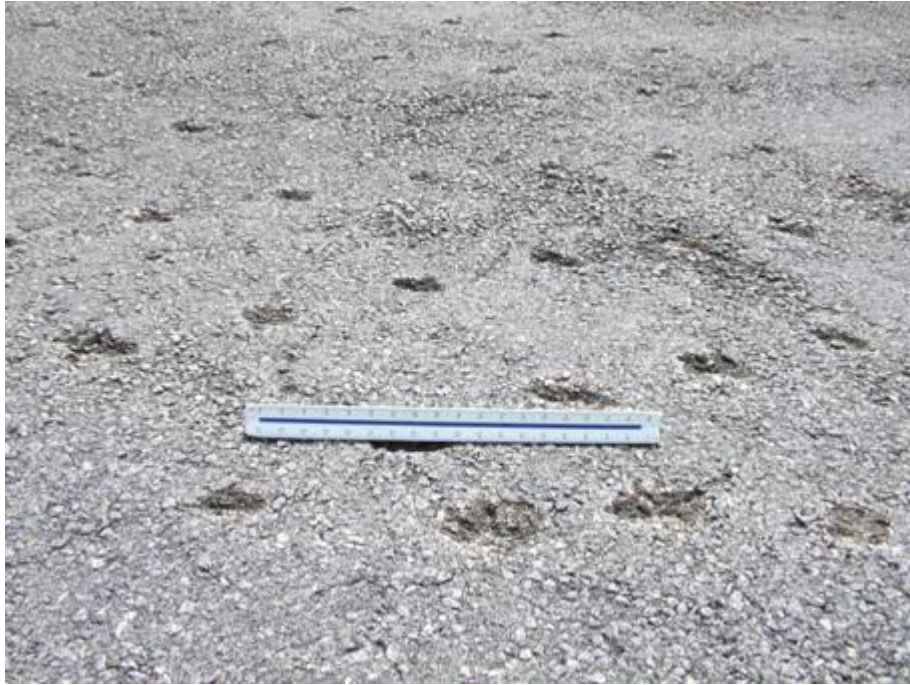
TW N Section 280 SU 300: Medium Severity Weathering (September 17, 2007)

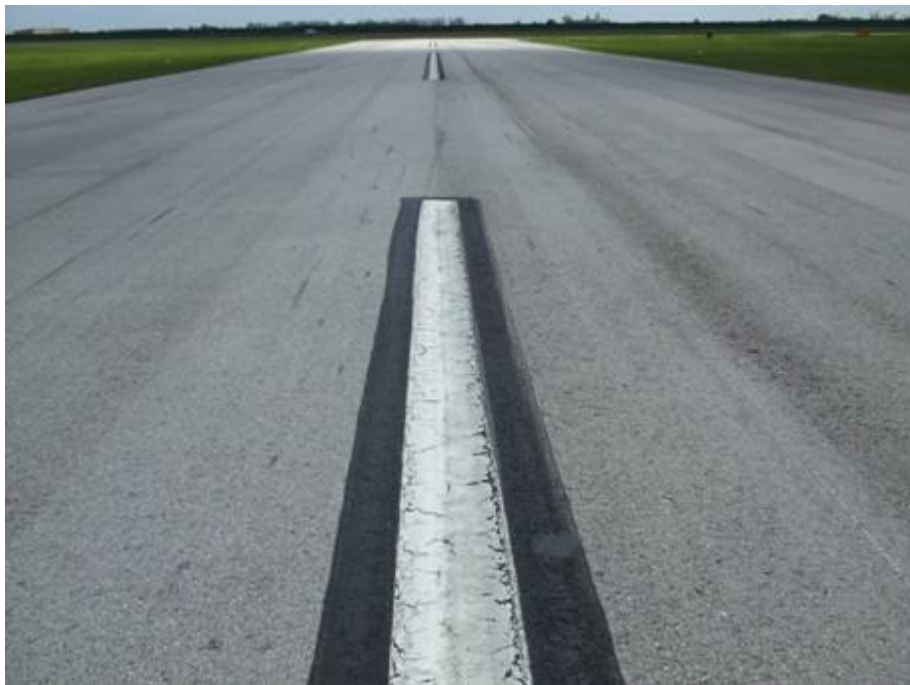
RW 9-27 Section 6205 SU 149: Section Overview (September 17, 2007)

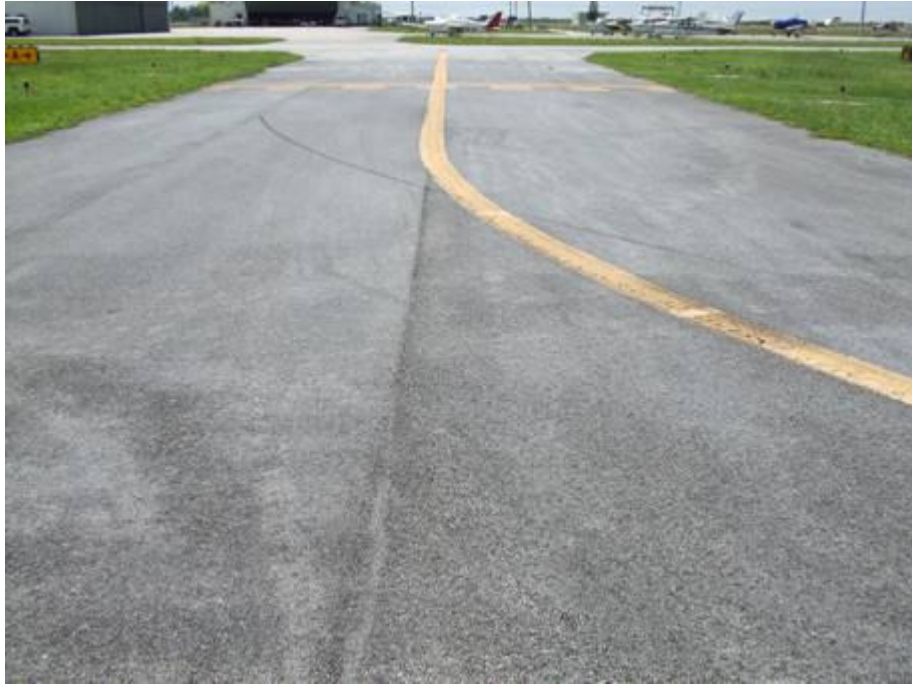
TW N Section 250 SU 301: Low Severity L/T Cracking (September 17, 2007)

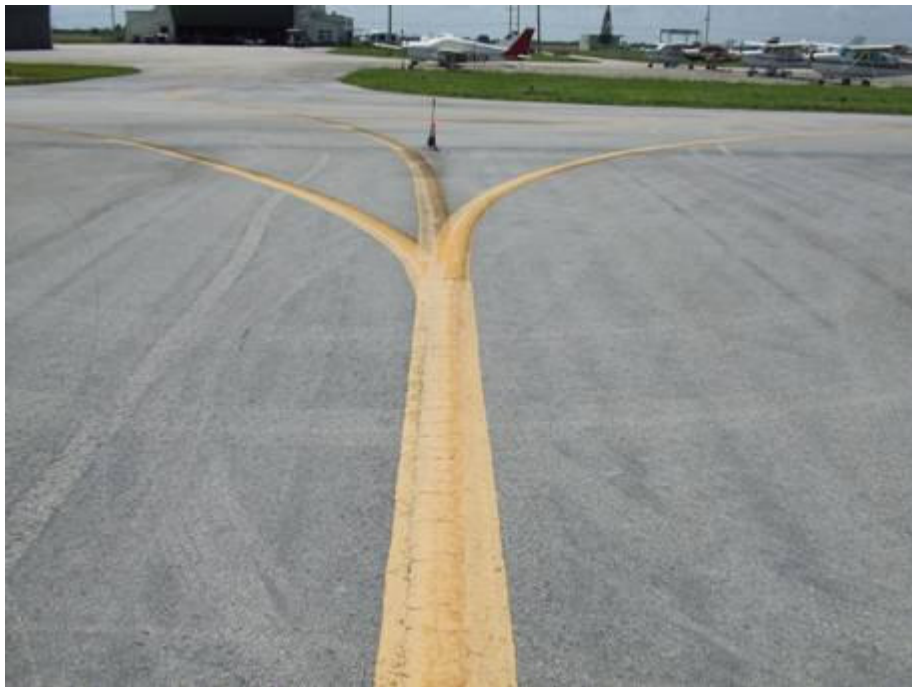
TW N Section 255 SU 300: Section Overview (September 17, 2007)

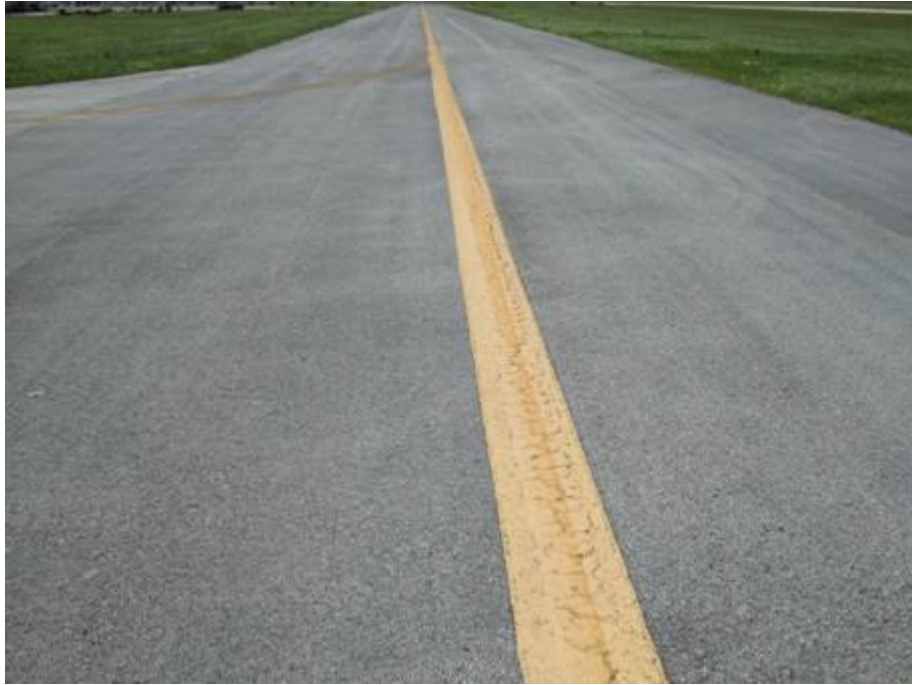
TW N Section 215 SU 129: Section Overview (September 17, 2007)

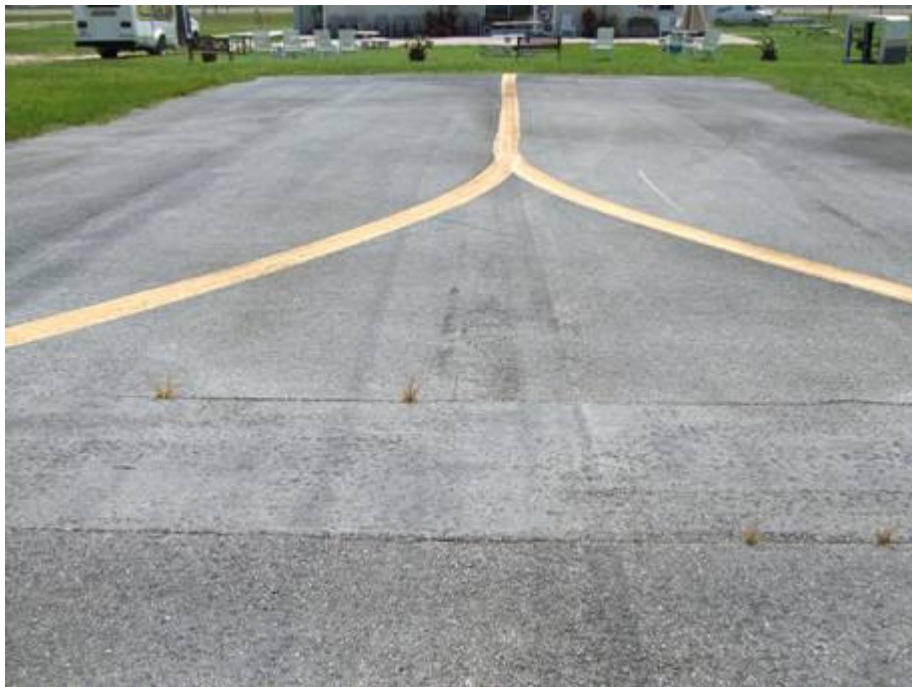
TW N Section 295 SU 500: Low Severity Patching (September 17, 2007)

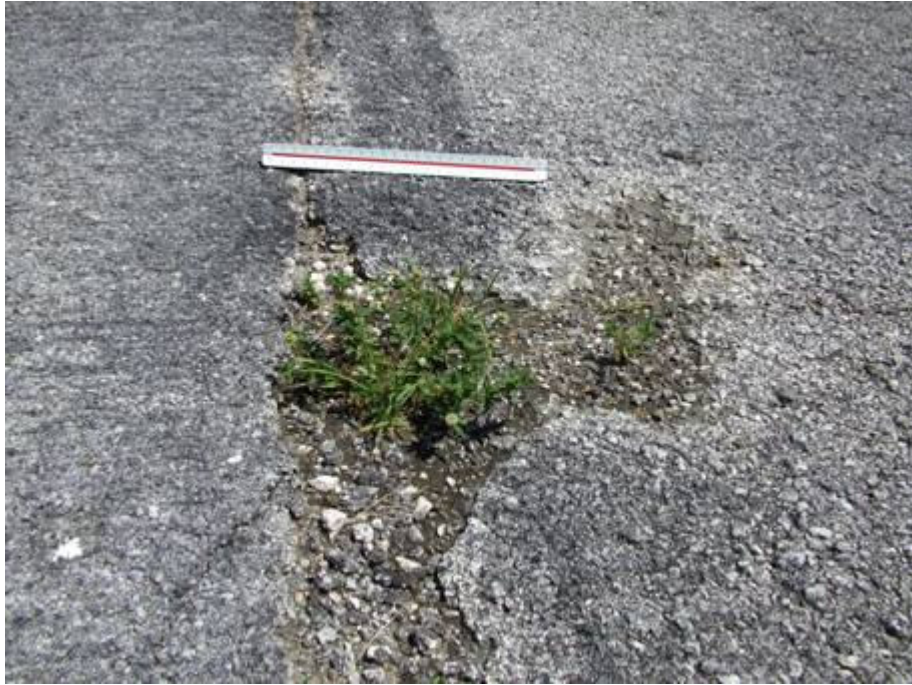
TW N Section 295 SU 500: High Severity Weathering (September 17, 2007)

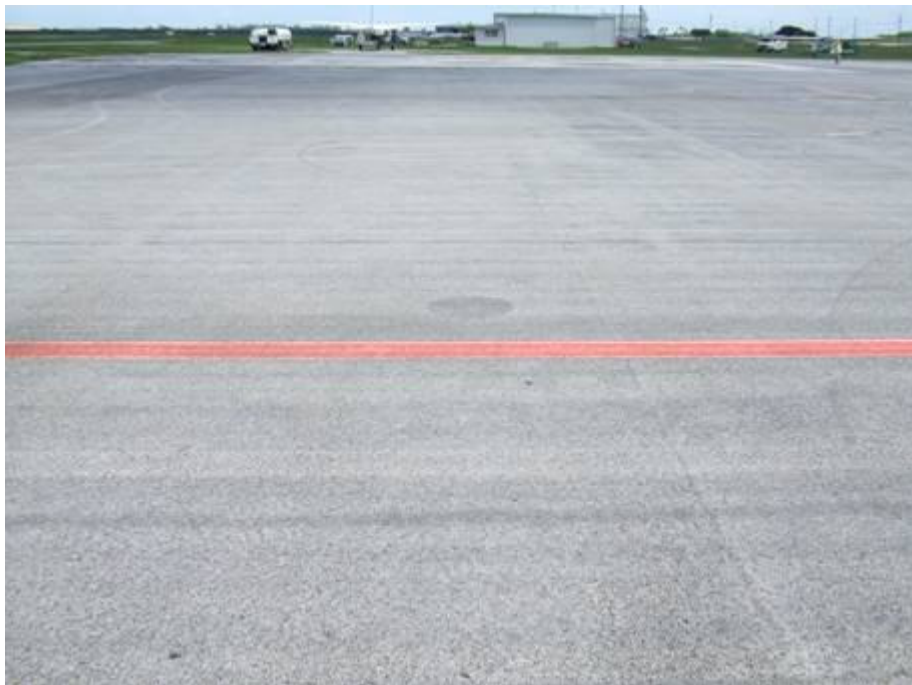
AP N Section 4205 SU 202: Section Overview (September 17, 2007)

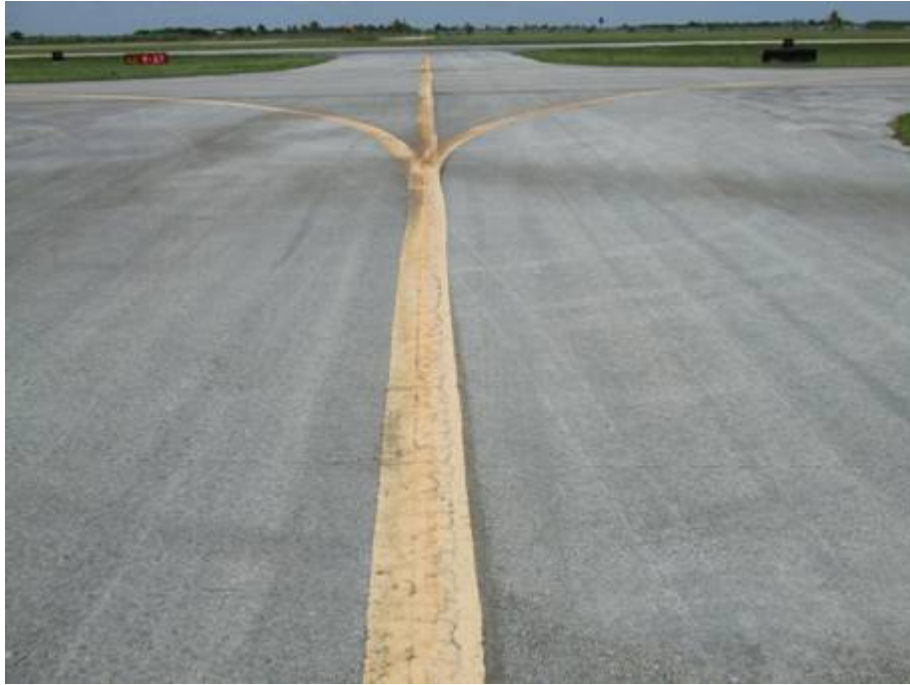
TW N Section 280 SU 300: Section Overview (September 17, 2007)

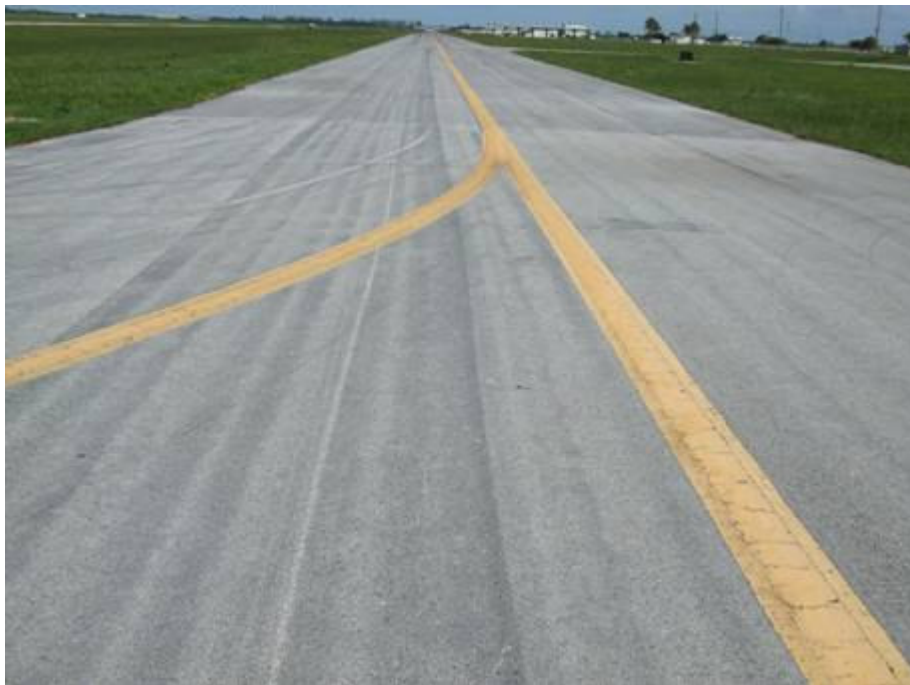
TW N Section 210 SU 104: Section Overview (September 17, 2007)
