**STATE OF FLORIDA  
DEPARTMENT OF TRANSPORTATION  
AVIATION OFFICE**

**Statewide Airfield Pavement  
Management Program**

**AirGlades Airport– 2IS  
(General Aviation)  
Clewiston, Florida  
(District 1)**

**May 2011**

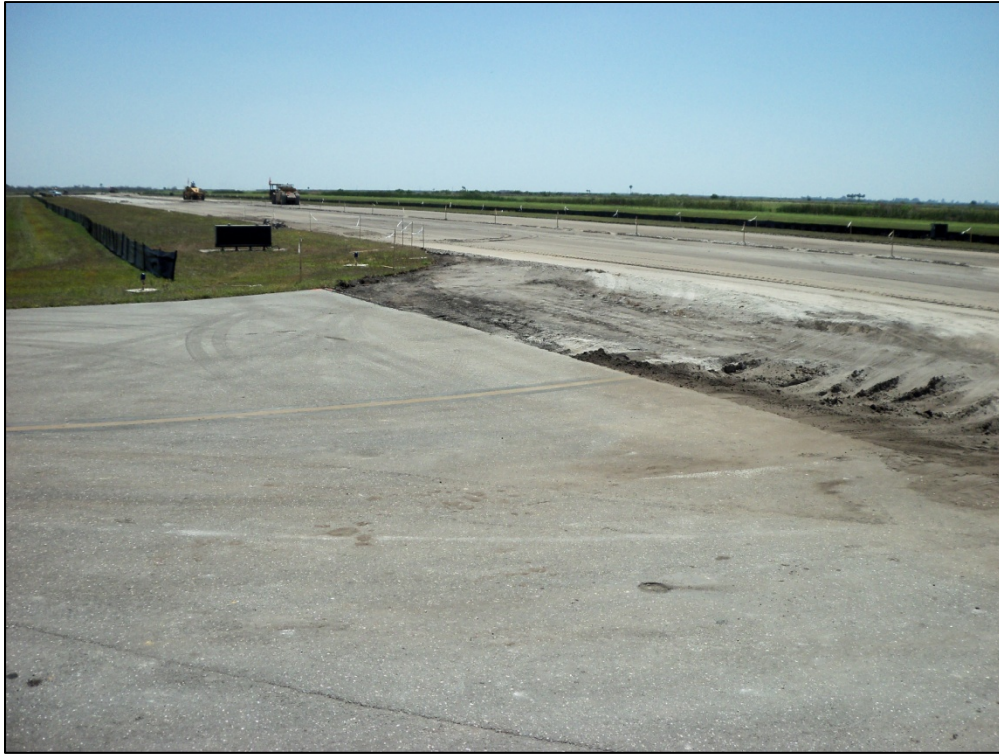
Taxiway Connector A2, Section 210, Sample Unit 100 – Low severity (48) Longitudinal and Transverse Cracking, (49) Oil Spillage, low severity (52) Weathering and Raveling

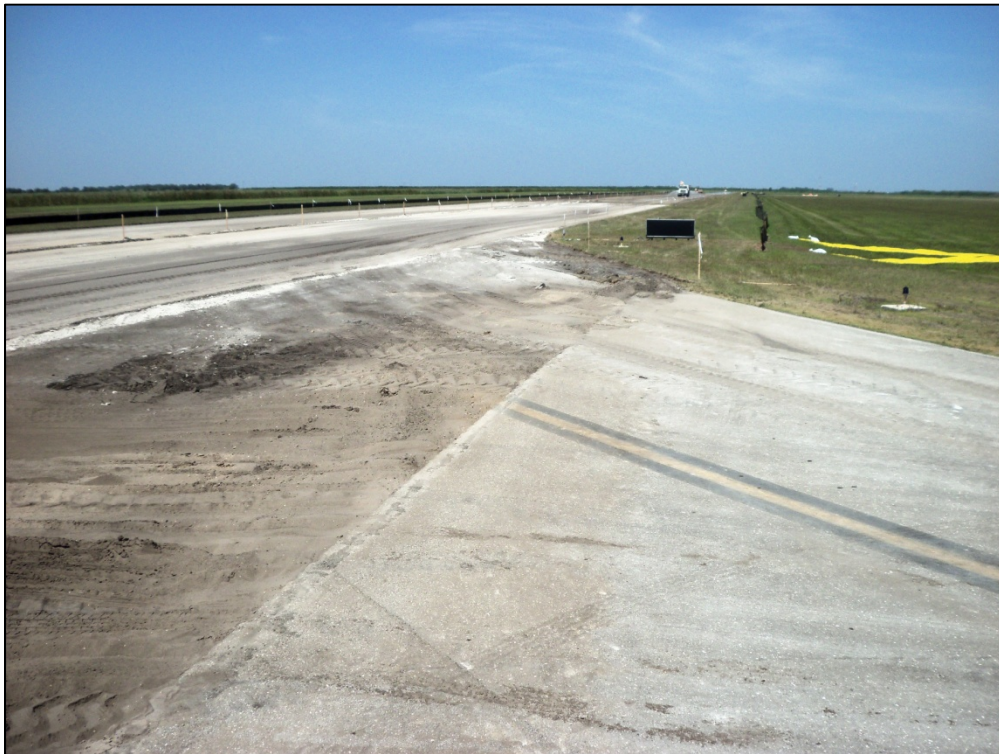
Taxiway Connector A2, Section 210, Sample Unit 100 – Low severity (48) Longitudinal and Transverse Cracking, (49) Oil Spillage, low severity (52) Weathering and Raveling

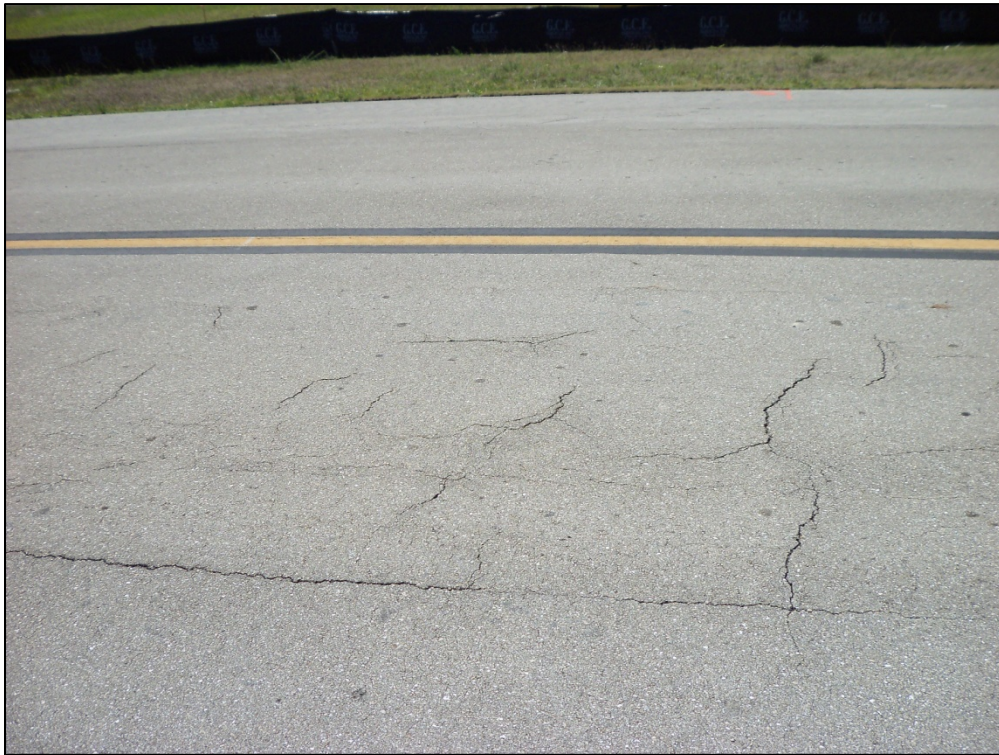
Taxiway Alpha, Section 120, Sample Unit 119 – Low severity (43) Block Cracking, low and medium severity (48) Longitudinal and Transverse Cracking, low severity (52) Weathering and Raveling

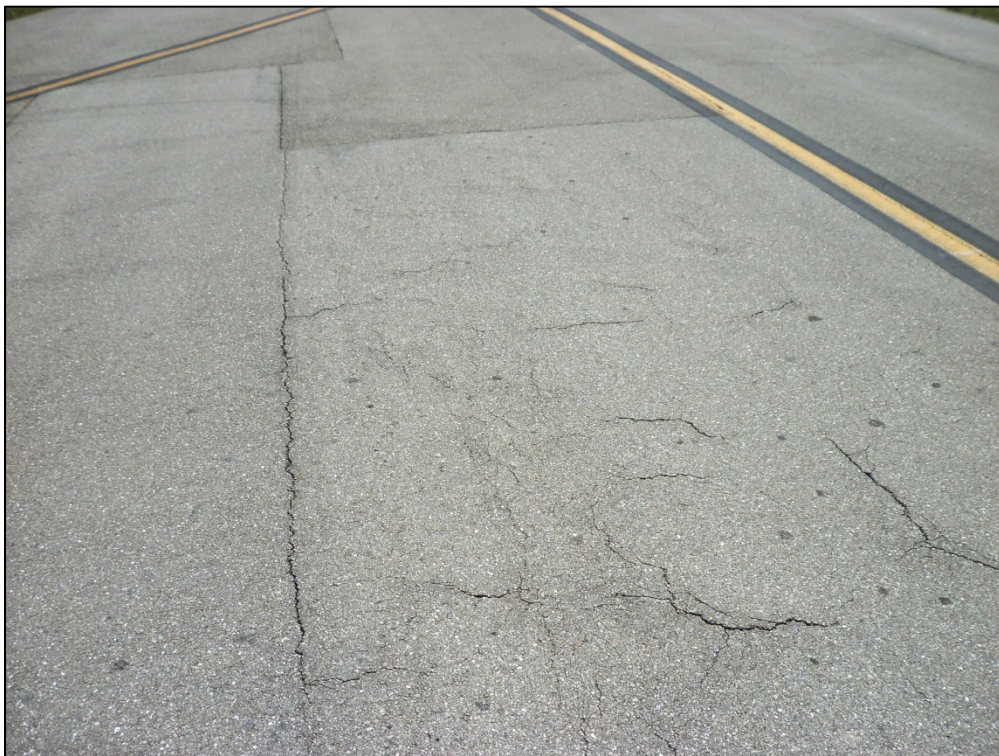
Taxiway Alpha, Section 120, Sample Unit 119 – Low severity (43) Block Cracking, low and medium severity (48) Longitudinal and Transverse Cracking, low severity (52) Weathering and Raveling

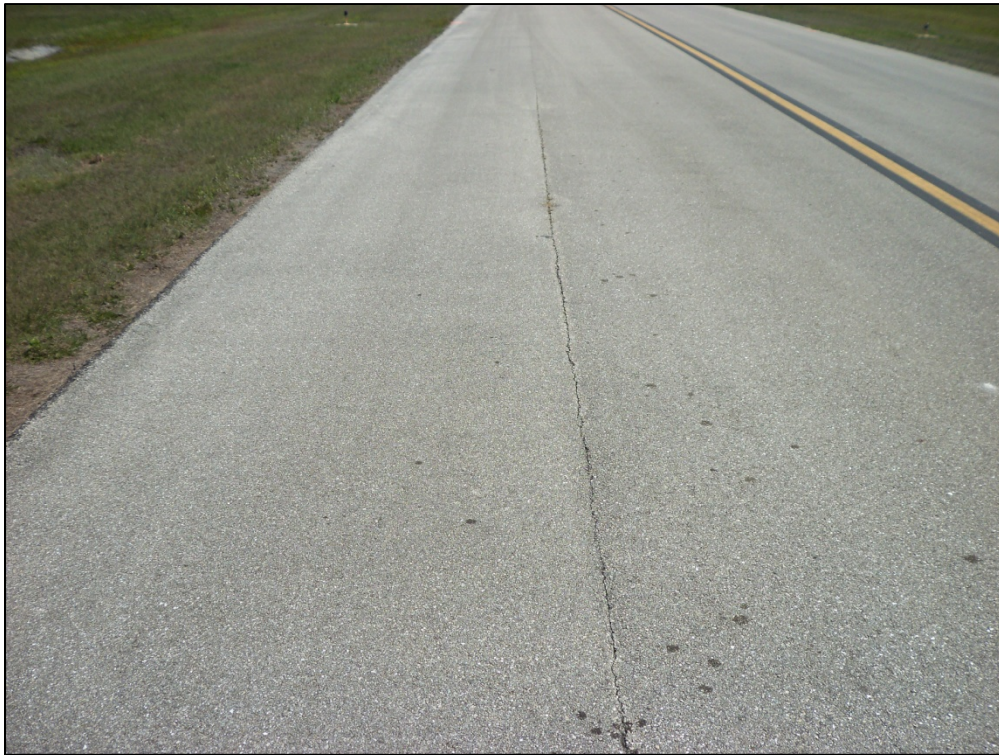
Taxiway Connector A1, Section 105, Sample Unit 102 – Low severity (48) Longitudinal and Transverse Cracking, low severity (52) Weathering and Raveling

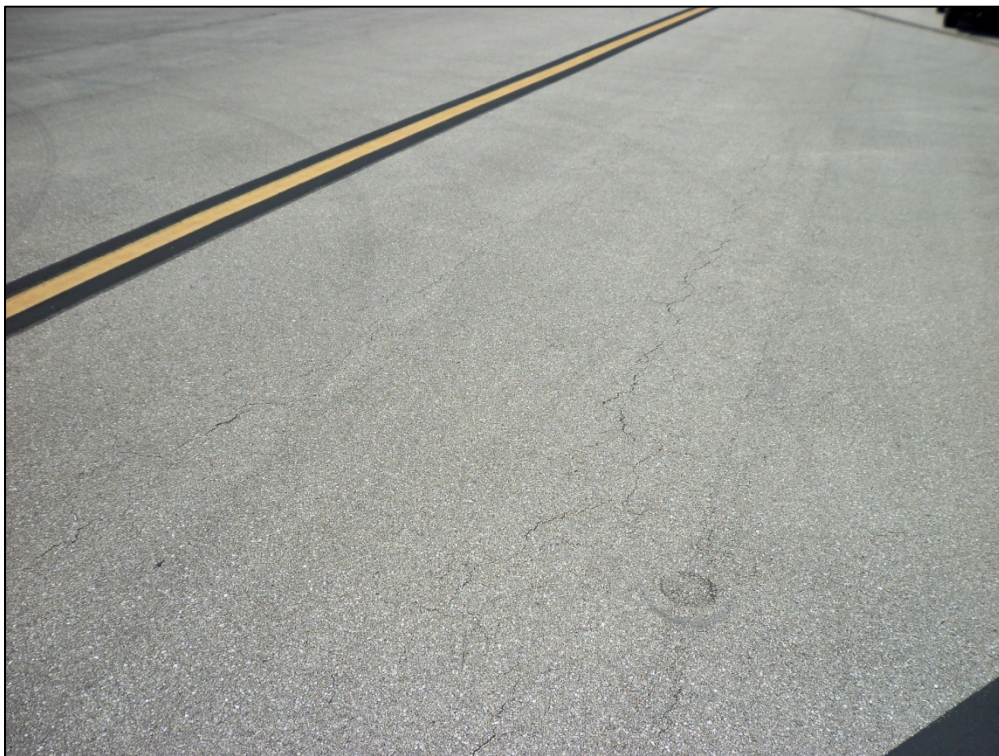
Taxiway Alpha, Section 103, Sample Unit 121 – Low severity (48) Longitudinal and Transverse Cracking, low severity (52) Weathering and Raveling, low severity (56) Swelling

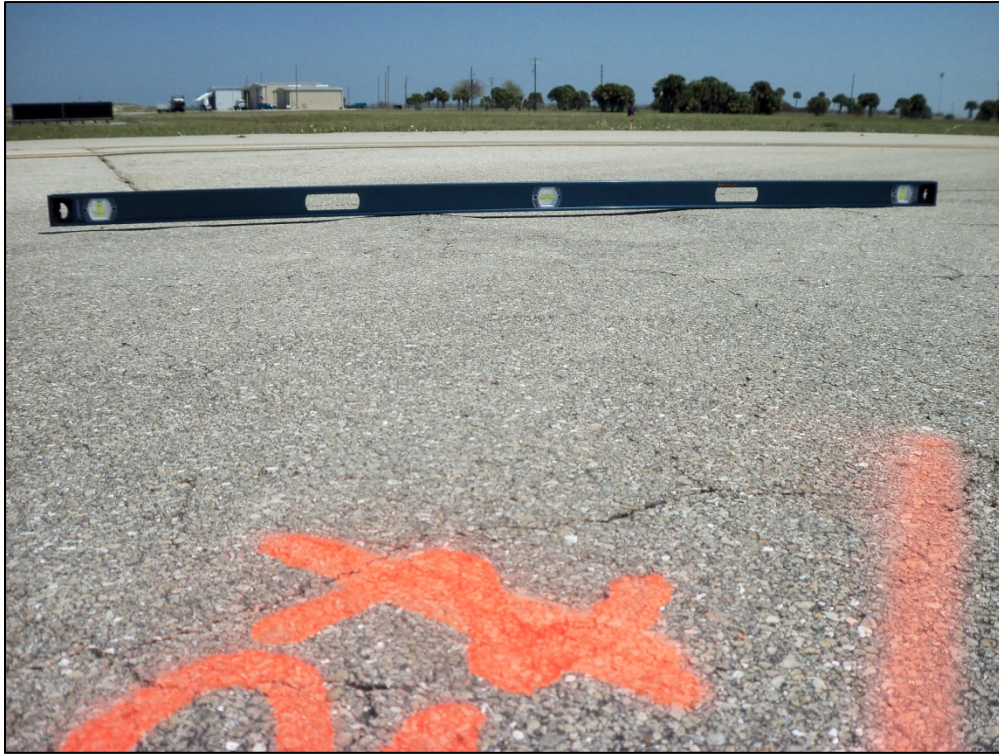
Taxiway Alpha, Section 103, Sample Unit 121 – Low severity (48) Longitudinal and Transverse Cracking, low severity (52) Weathering and Raveling, low severity (56) Swelling

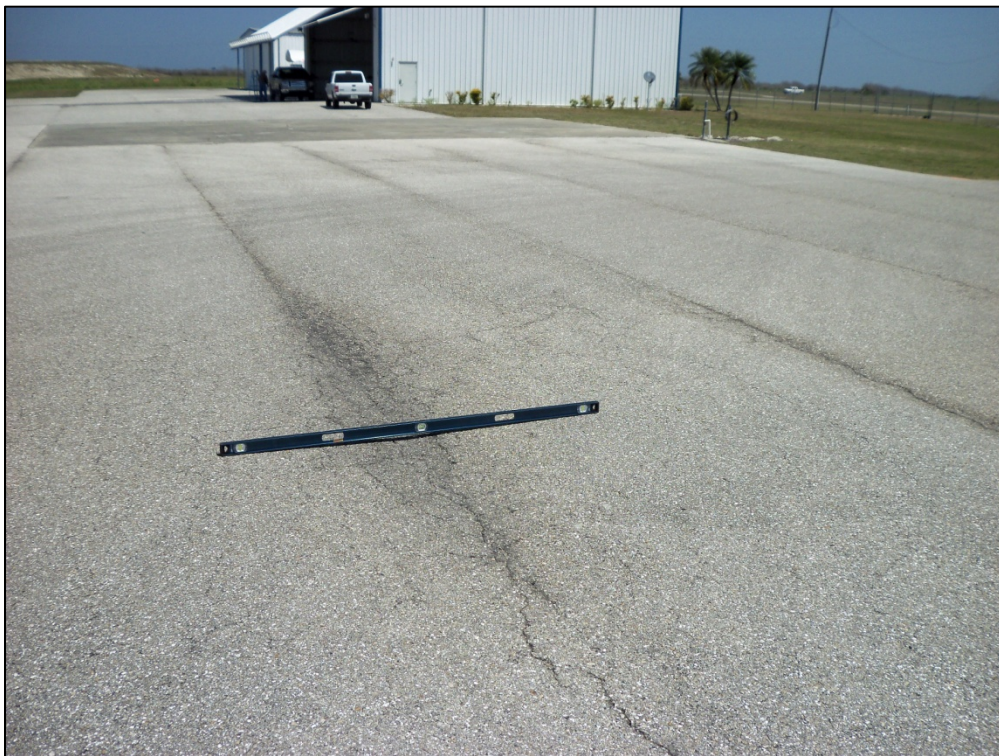
Apron NW, Section 4405, Sample Unit 305 – Low severity (43) Block Cracking, medium severity (45) Depression, low and medium severity (48) Longitudinal and Transverse Cracking, low and medium severity (52) Weathering and Raveling

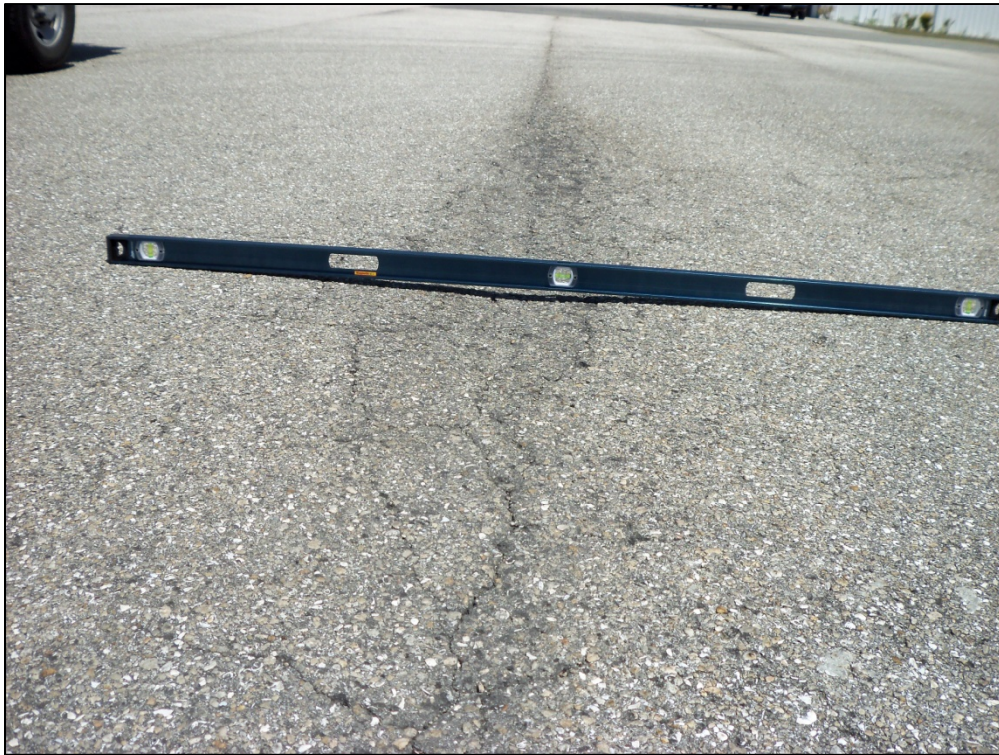
Apron NW, Section 4405, Sample Unit 305 – Low severity (43) Block Cracking, medium severity (45) Depression, low and medium severity (48) Longitudinal and Transverse Cracking, low and medium severity (52) Weathering and Raveling

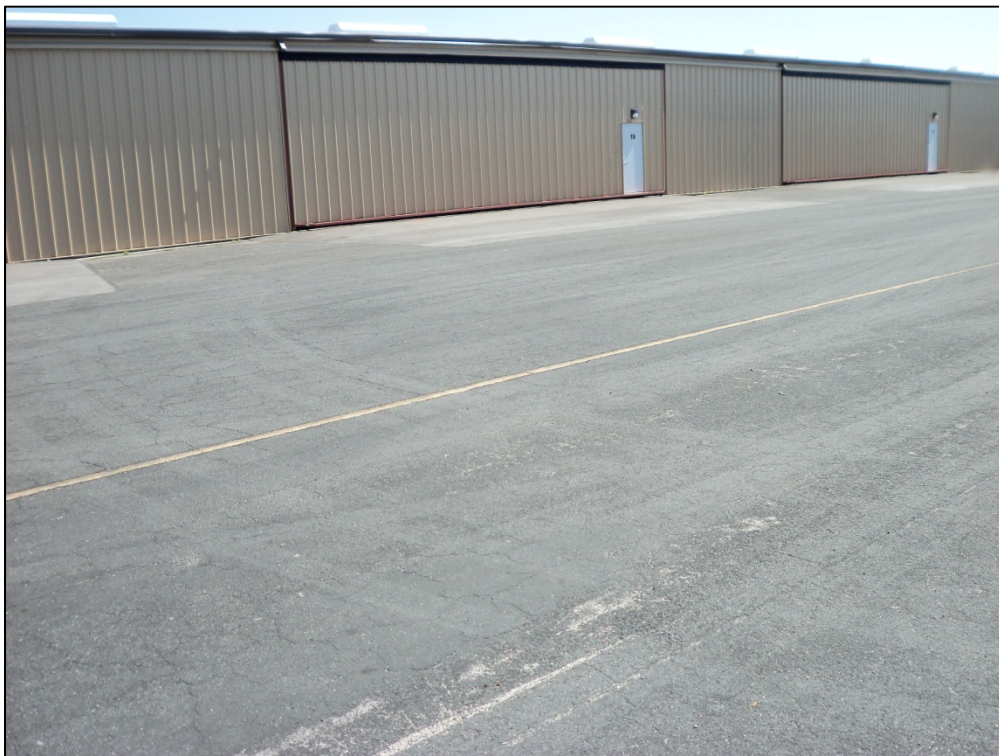
Apron, Section 4105, Sample Unit 402 – Low severity (50) Patch, low and medium severity (52) Weathering and Raveling

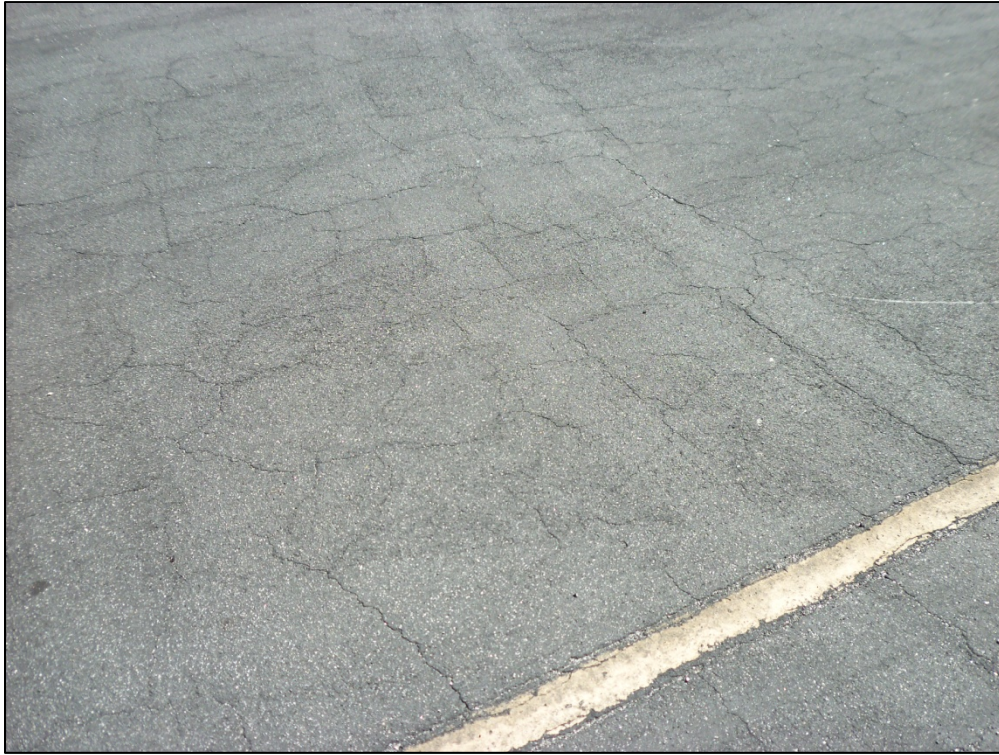
Apron, Section 4105, Sample Unit 402 – Low severity (50) Patch, low and medium severity (52) Weathering and Raveling

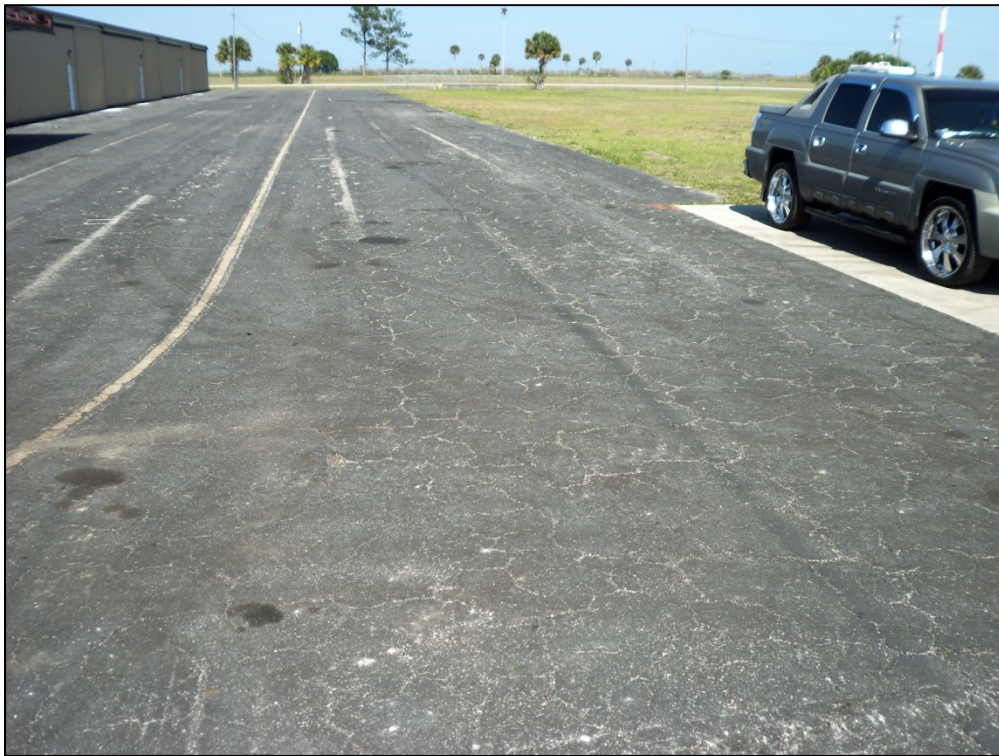
Apron, Section 4105, Sample Unit 150 – Low severity (43) Block Cracking, (49) Oil Spillage, low and medium severity (52) Weathering and Raveling

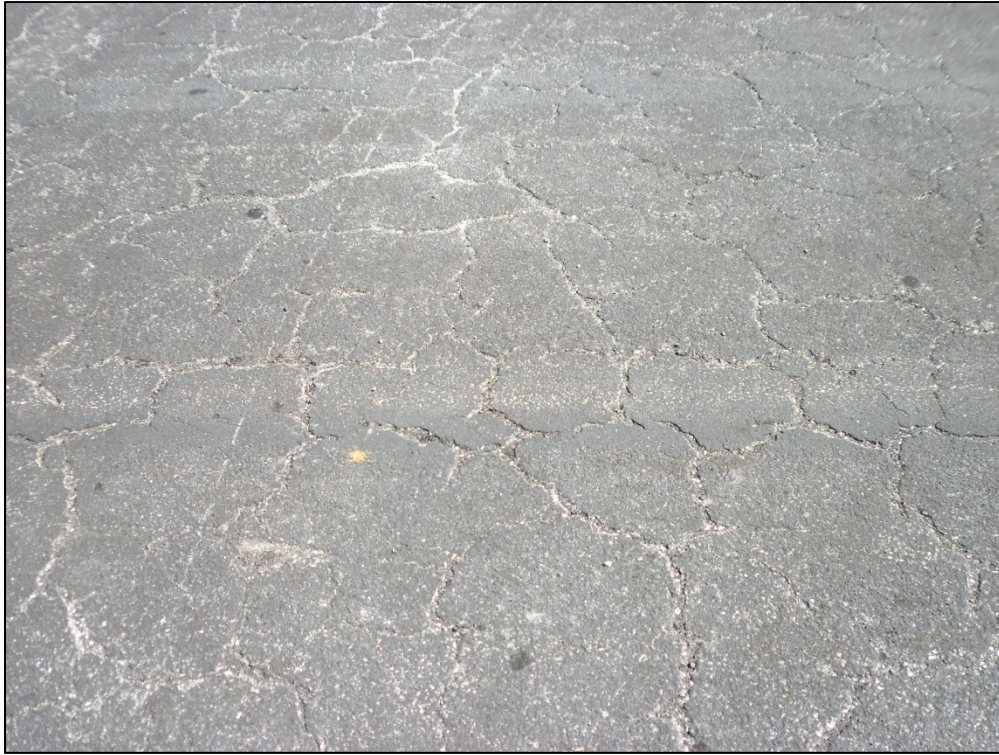
Apron, Section 4105, Sample Unit 150 – Low severity (43) Block Cracking, (49) Oil Spillage, low and medium severity (52) Weathering and Raveling

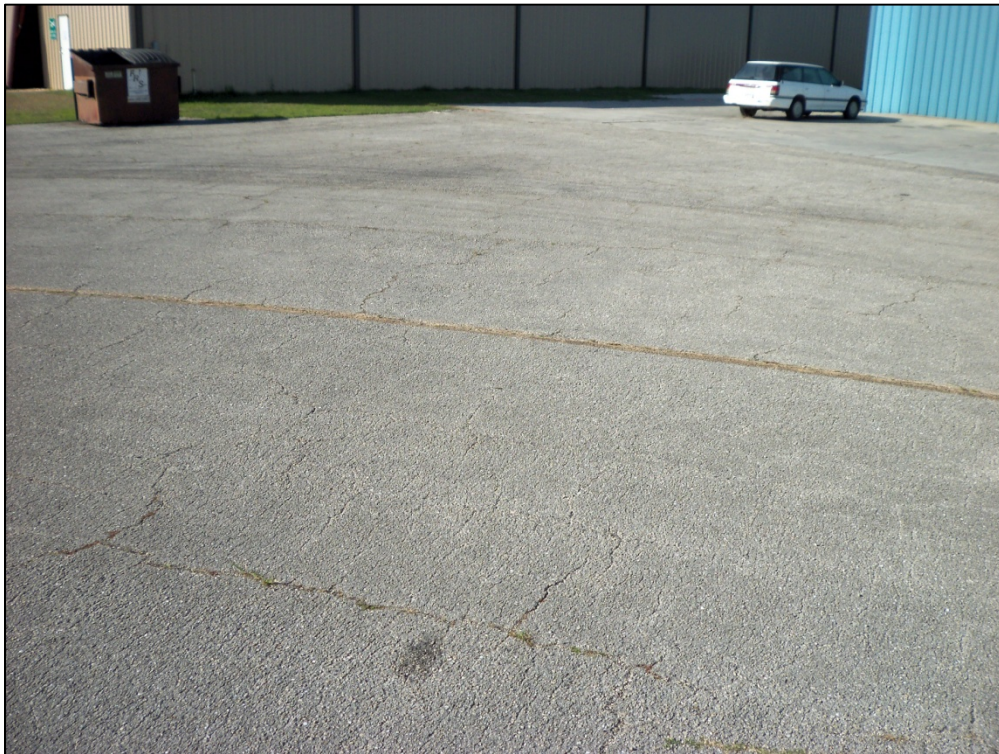
Apron, Section 405, Sample Unit 103 – Low and medium severity (43) Block Cracking, medium and high severity (52) Weathering and Raveling

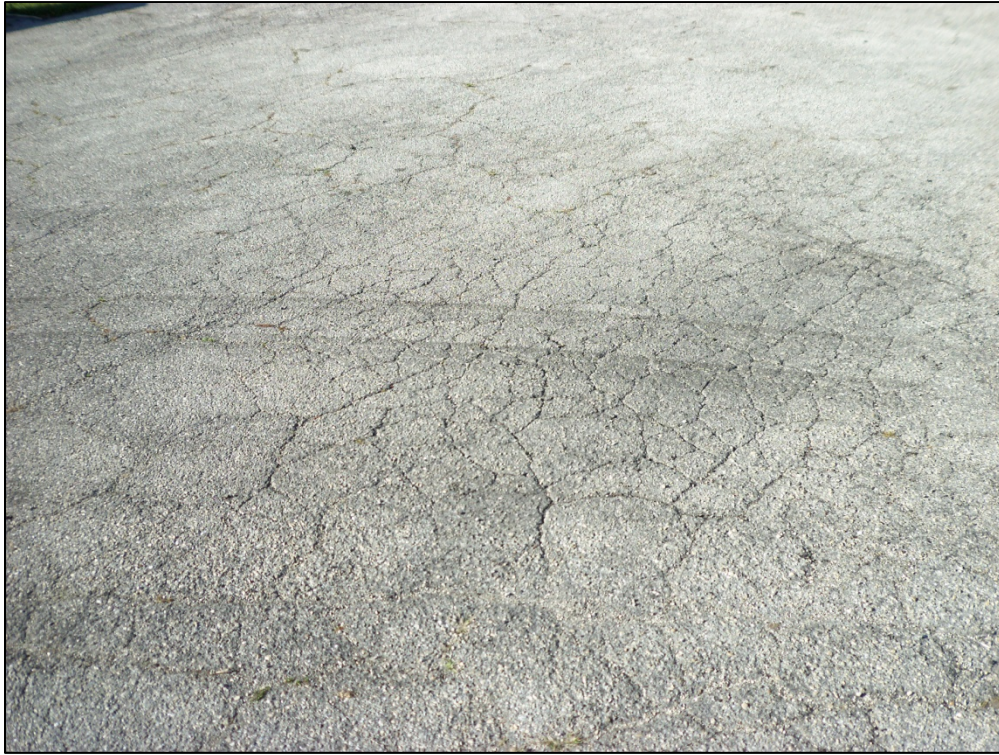
Apron, Section 405, Sample Unit 103 – Low and medium severity (43) Block Cracking, medium and high severity (52) Weathering and Raveling

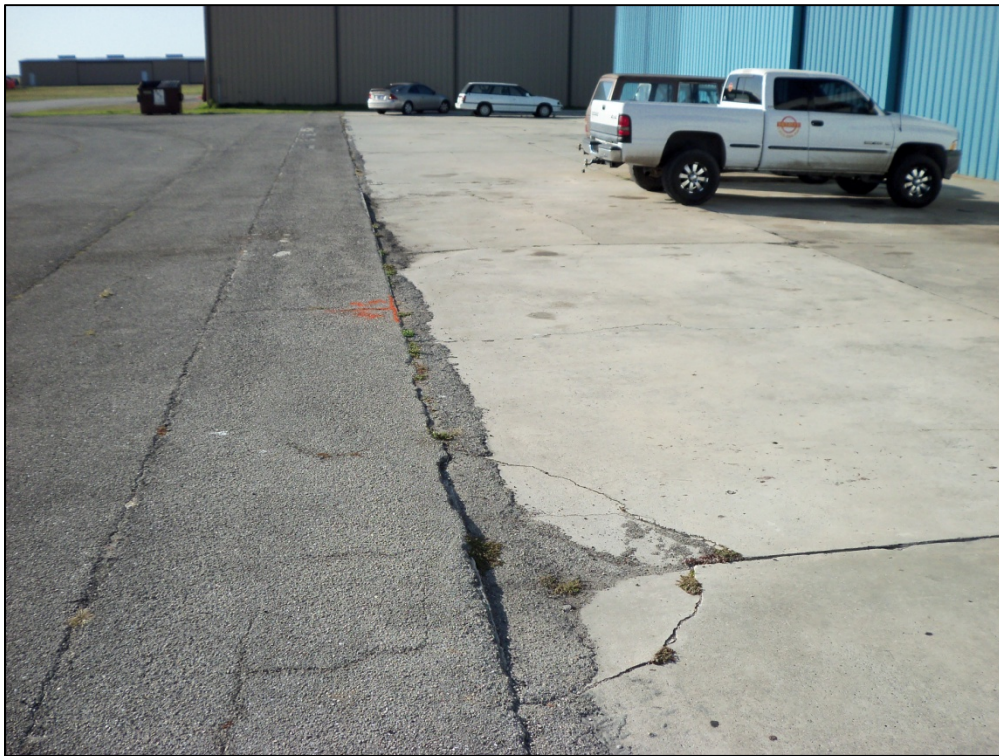
Apron, Section 4205, Sample Unit 100 – Low and medium severity (62) Corner Break, (63) LTD Cracking, (65) Joint Seal Damage, (70) Sealing/Map Cracking, (72) Shattered Slabs, (73) Shrinkage Cracks, (74) Joint Spalling, (75) Corner Spalling
