**STATE OF FLORIDA
DEPARTMENT OF TRANSPORTATION
AVIATION OFFICE**

**Statewide Airfield Pavement
Management Program**

**Apalachicola Regional Airport– AAF
(General Aviation)
Apalachicola, Florida
(District 3)**

May 2011

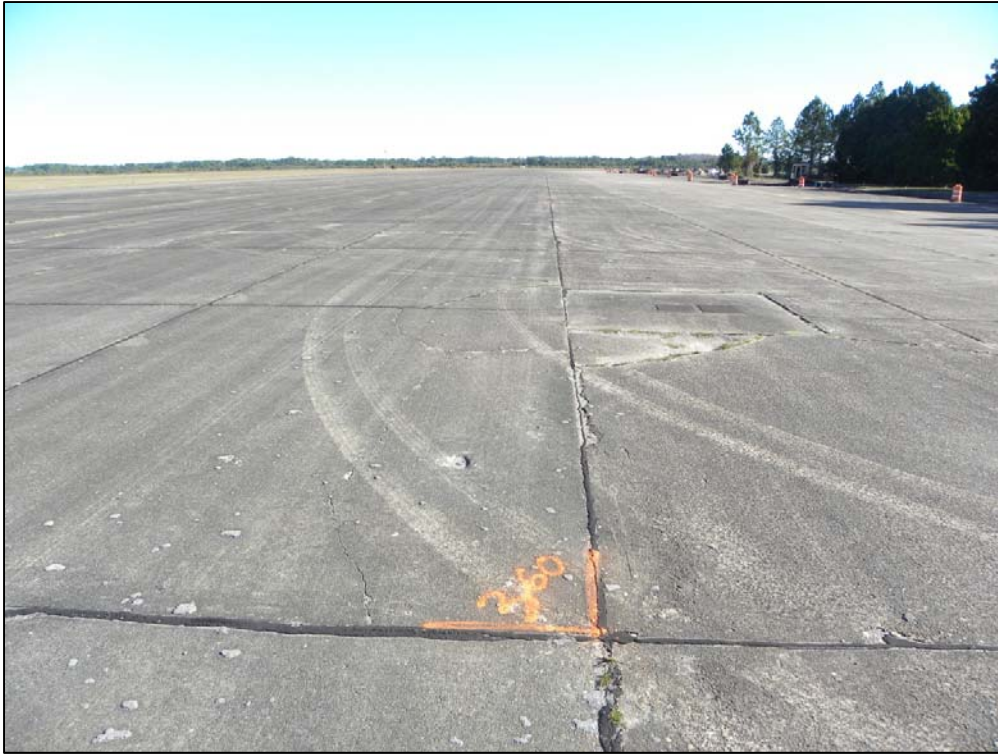
Apron, Section 4105, Sample Unit 360 – High severity (62) Corner Break, high severity (63) Longitudinal/Transverse/Diagonal Cracking, medium severity (65) Joint Seal Damage, low, medium and high severity (74) Joint Spalling, medium severity (75) Corner Spalling

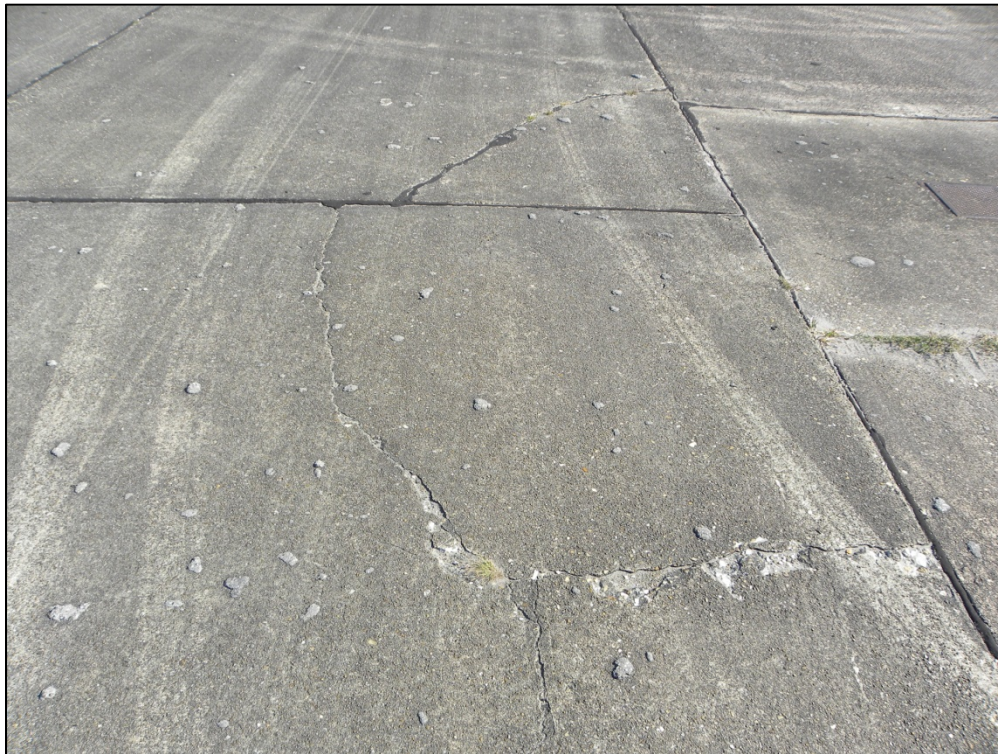
Apron, Section 4105, Sample Unit 360 – High severity (62) Corner Break, high severity (63) Longitudinal/Transverse/Diagonal Cracking, medium severity (65) Joint Seal Damage, low, medium and high severity (74) Joint Spalling, medium severity (75) Corner Spalling

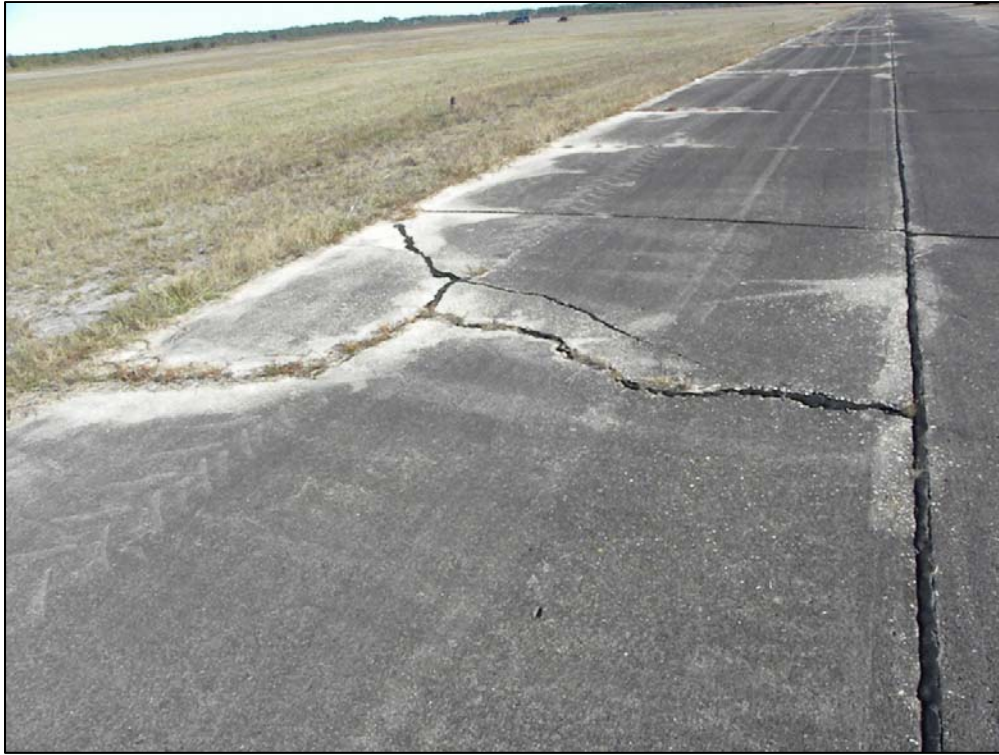
Apron, Section 4105, Sample Unit 166 – Medium and high severity (63) Longitudinal/Transverse/Diagonal Cracking, medium severity (65) Joint Seal Damage, low severity (66) Patching, high severity (72) Shattered Slab, (73) Shrinkage Cracking, medium severity (74) Joint Spalling, low severity (75) Corner Spalling

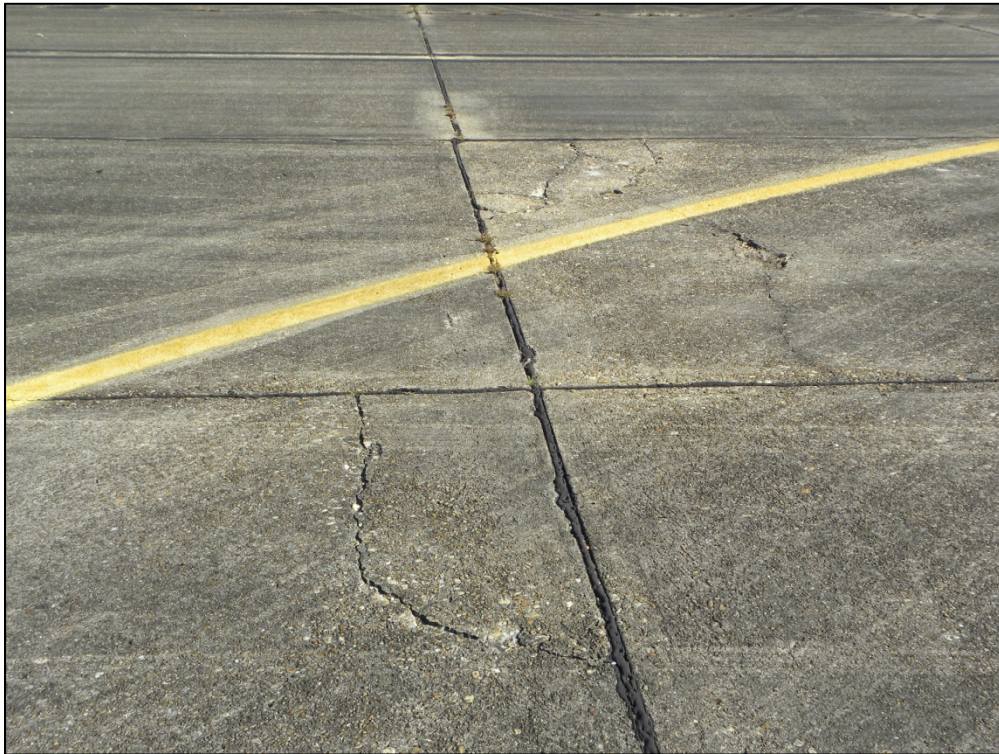
Apron, Section 4105, Sample Unit 214 – Medium and high severity (62) Corner Break, medium and high severity (63) Longitudinal/Transverse/Diagonal Cracking, medium severity (65) Joint Seal Damage, (68) Popouts, low severity (74) Joint Spalling

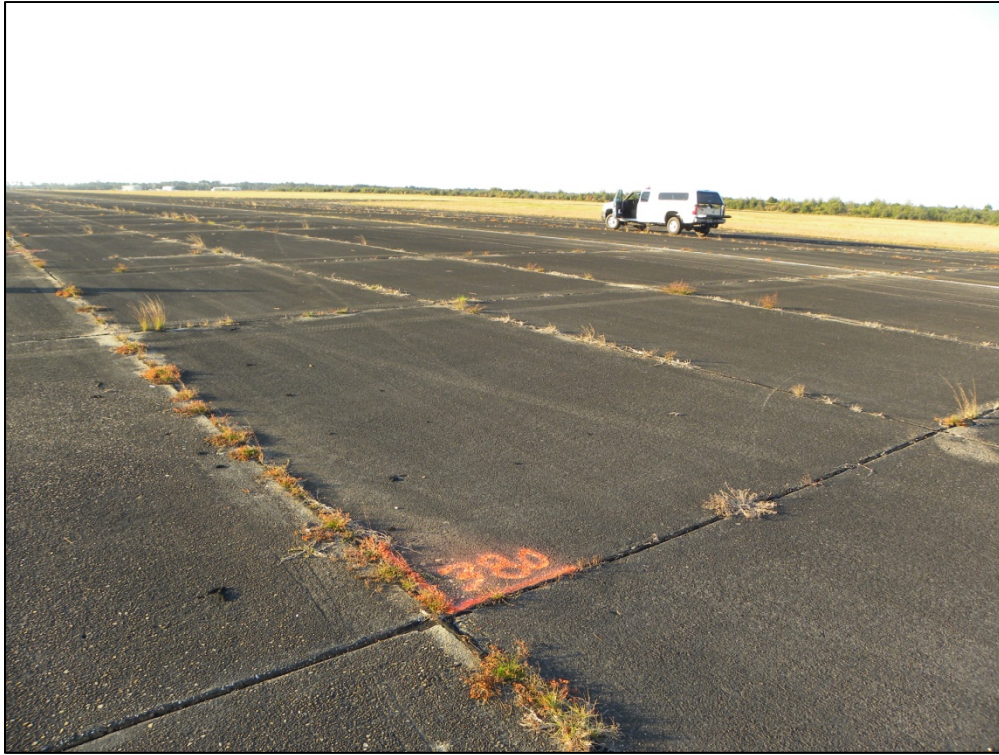
Runway 18-36, Section 6305, Sample Unit 380 – High severity (63) Longitudinal/Transverse/Diagonal Cracking, medium severity (65) Joint Seal Damage, low severity (66) Patching, low severity (74) Joint Spalling, low severity (75) Corner Spalling

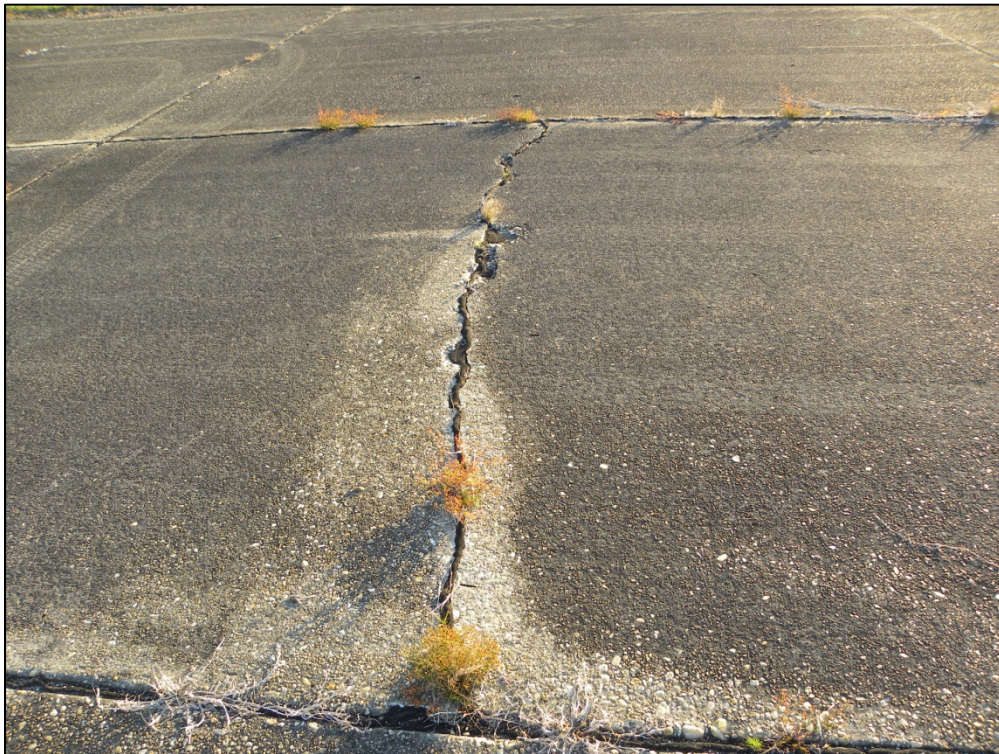
Runway 18-36, Section 6305, Sample Unit 380 – High severity (63) Longitudinal/Transverse/Diagonal Cracking, medium severity (65) Joint Seal Damage, low severity (66) Patching, low severity (74) Joint Spalling, low severity (75) Corner Spalling

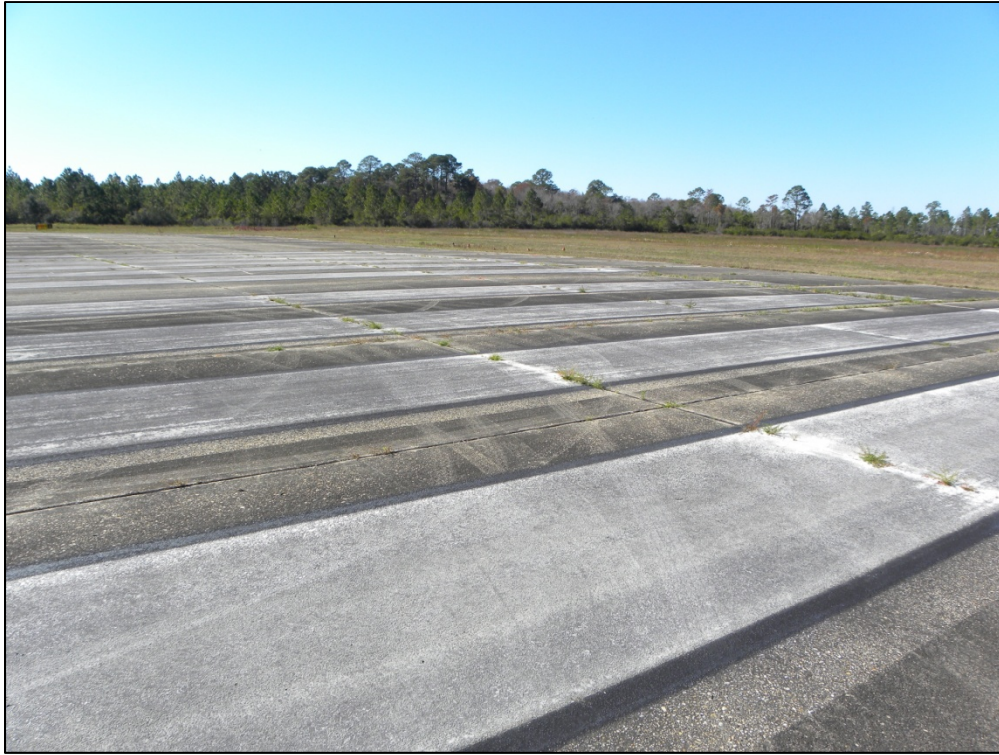
Runway 13-31, Section 6105, Sample Unit 384 – Low, medium and high severity (63) Longitudinal/Transverse/Diagonal Cracking, medium severity (65) Joint Seal Damage, low and medium severity (74) Joint Spalling

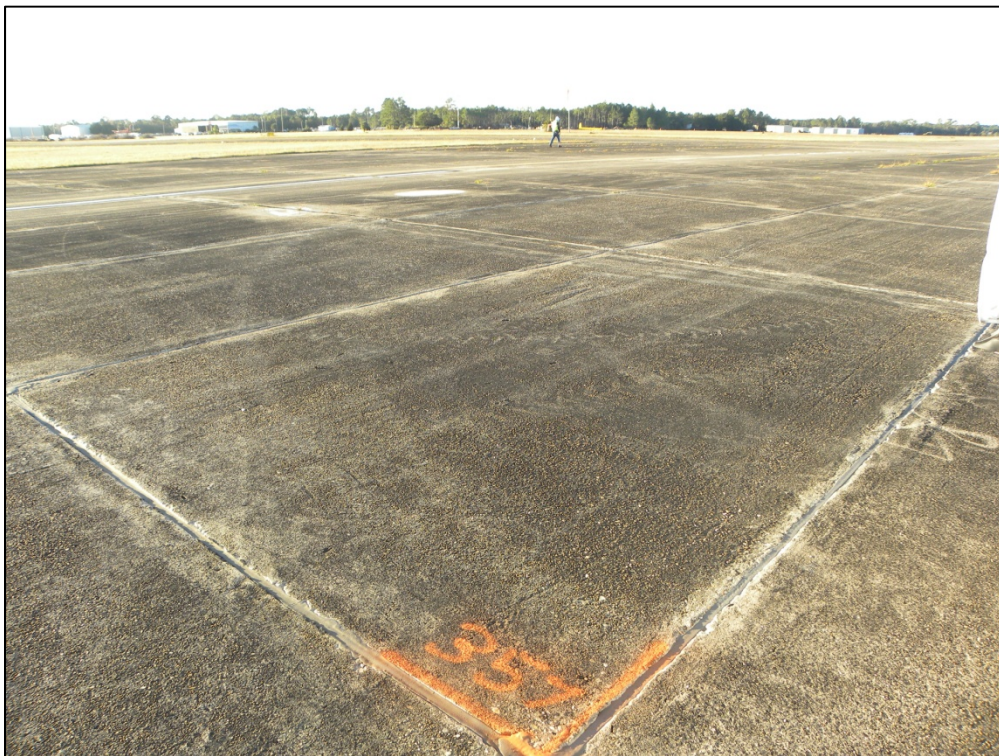
Runway 6-24, Section 6205, Sample Unit 357 – High severity (63) Longitudinal/Transverse/Diagonal Cracking, low severity (65) Joint Seal Damage, low severity (74) Joint Spalling, low severity (75) Corner Spalling

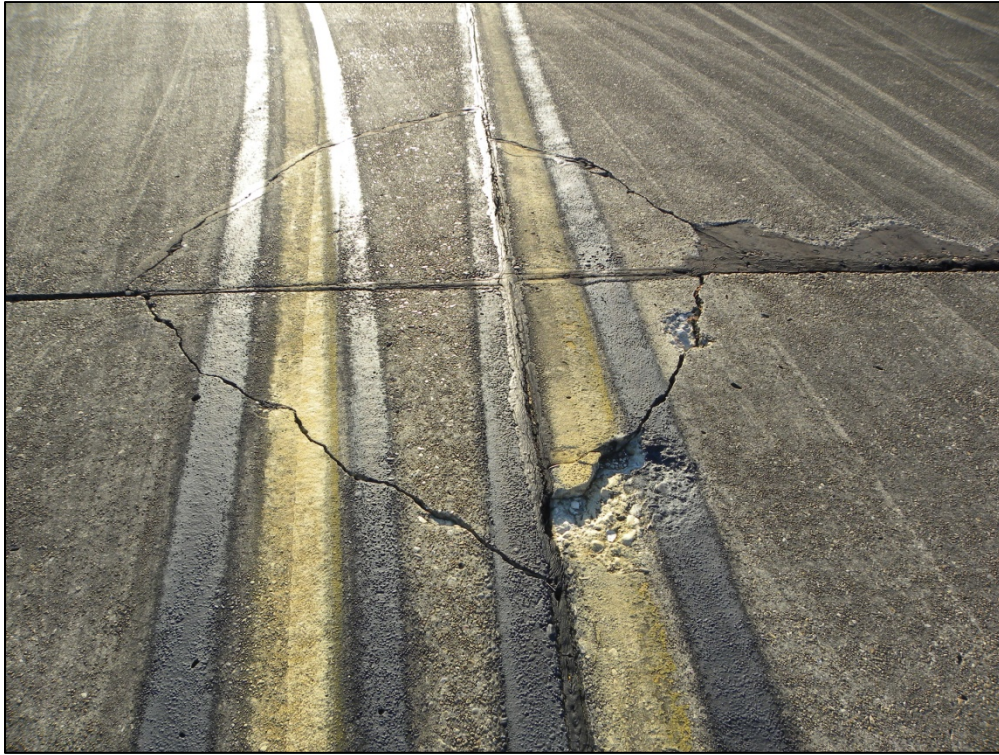
Taxiway A4, Section 230, Sample Unit 103 – High severity (62) Corner Break, high severity (63) Longitudinal/Transverse/Diagonal Cracking, low severity (65) Joint Seal Damage, low, medium and high severity (74) Joint Spalling, medium severity (75) Corner Spalling

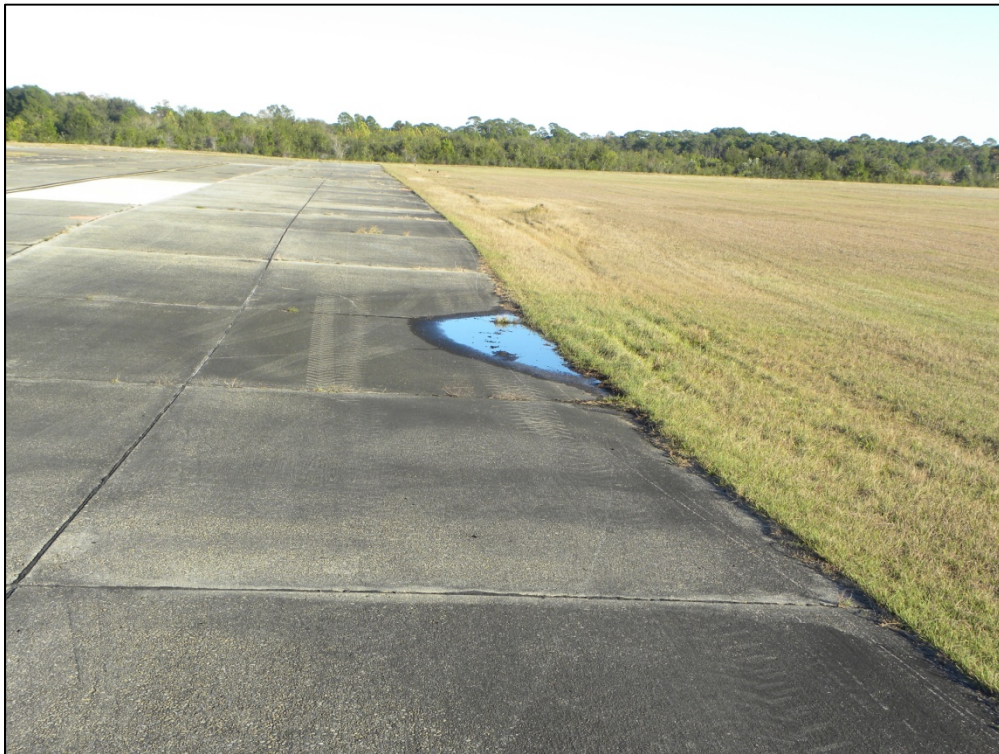
Taxiway A5, Section 210, Sample Unit 202 – Medium severity (65) Joint Seal Damage, high severity (71) Settlement or Faulting, medium severity (75) Corner Spalling

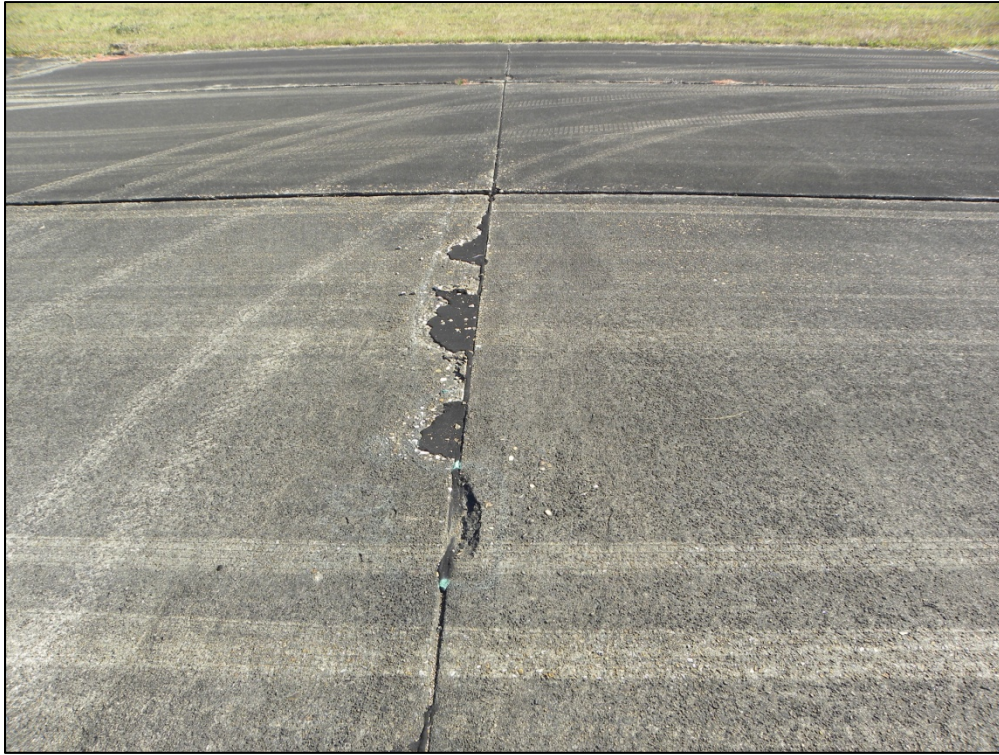
Taxiway Charlie, Section 105, Sample Unit 119 – Medium and high severity (65) Joint Seal Damage, low and high severity (74) Joint Spalling, medium severity (75) Corner Spalling

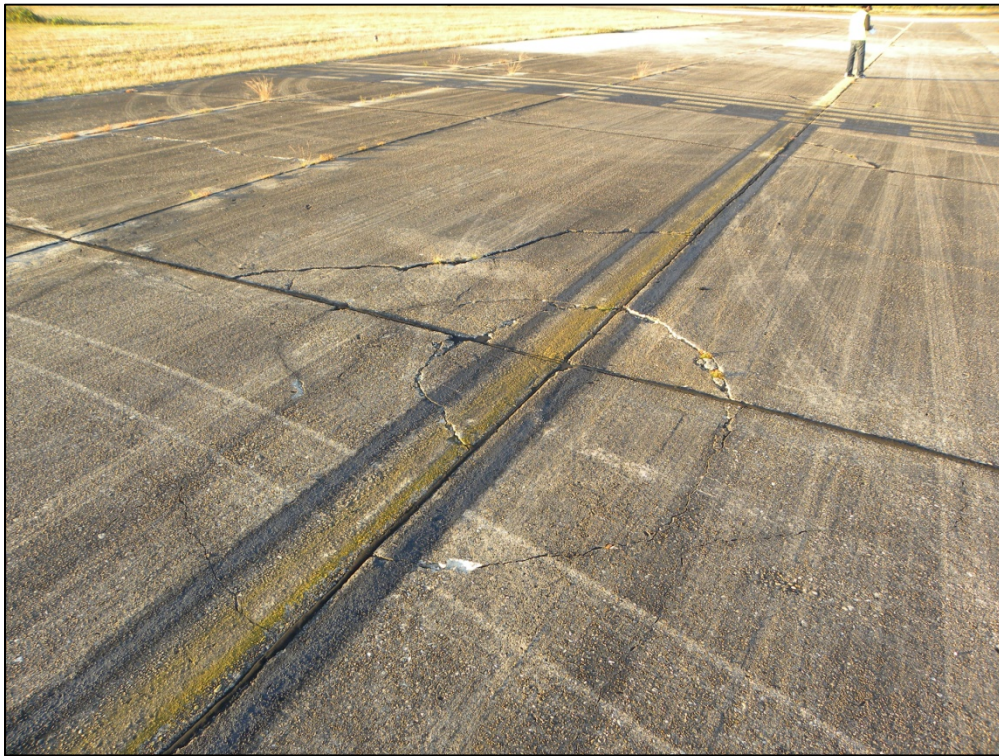
Taxiway B5, Section 335, Sample Unit 103 – Medium and high severity (62) Corner Spalling, low, medium and high severity (63) Longitudinal/Transverse/Diagonal Cracking, low severity (65) Joint Seal Damage, low severity (67) Patching, low and high severity (74) Joint Spalling
