**STATE OF FLORIDA  
DEPARTMENT OF TRANSPORTATION  
AVIATION OFFICE**

**Statewide Airfield Pavement  
Management Program**

**Arcadia Municipal Airport– X06  
(General Aviation)  
Arcadia, Florida  
(District 1)**

**May 2011**

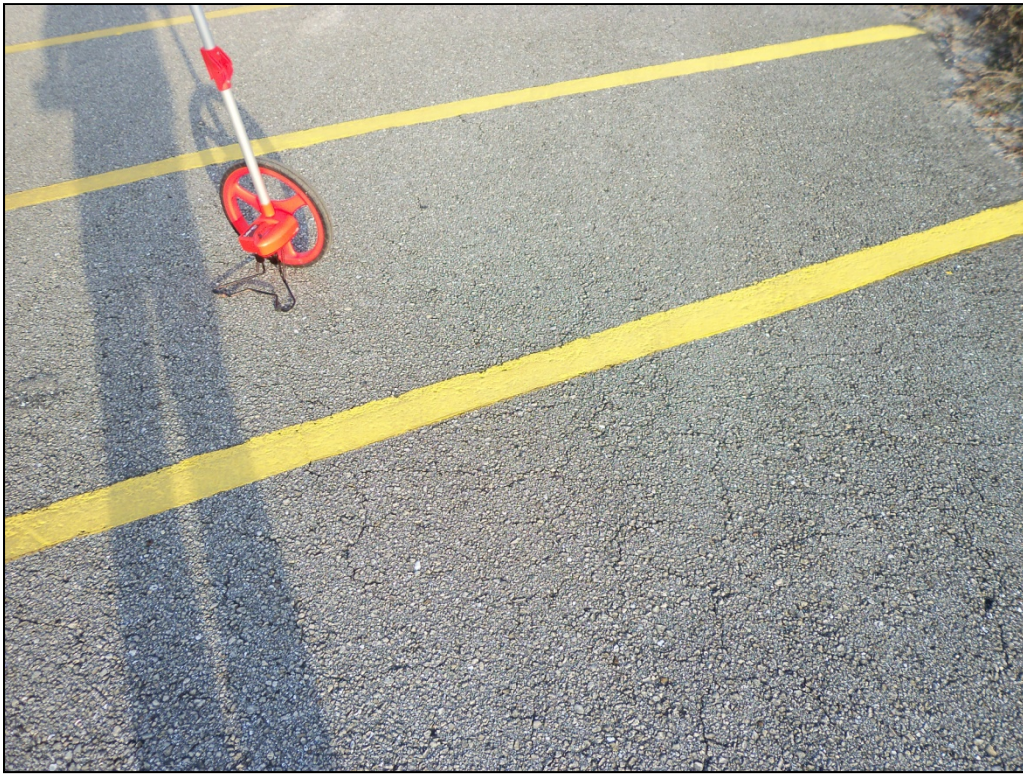
Apron, Section 4105, Sample Unit 100 – Low severity (52) Weathering and Raveling, low severity (48) Longitudinal and Transverse Cracking, and low severity (43) Block Cracking.

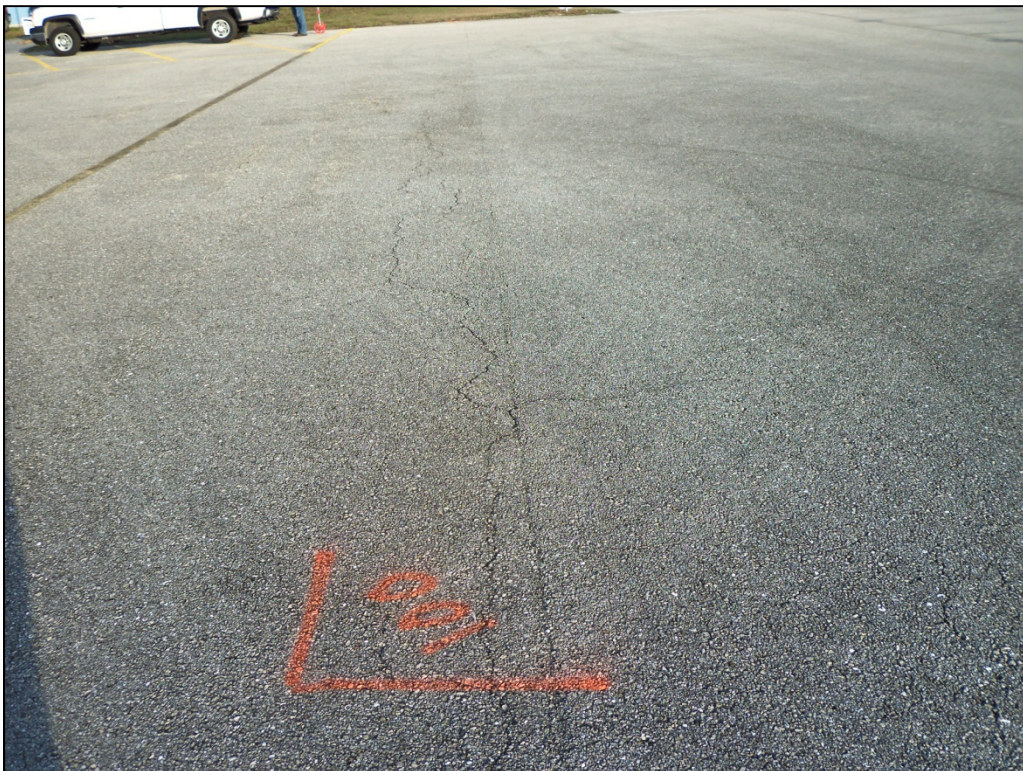
Apron, Section 4105, Sample Unit 100 – Low severity (52) Weathering and Raveling, low severity (48) Longitudinal and Transverse Cracking, and low severity (43) Block Cracking.

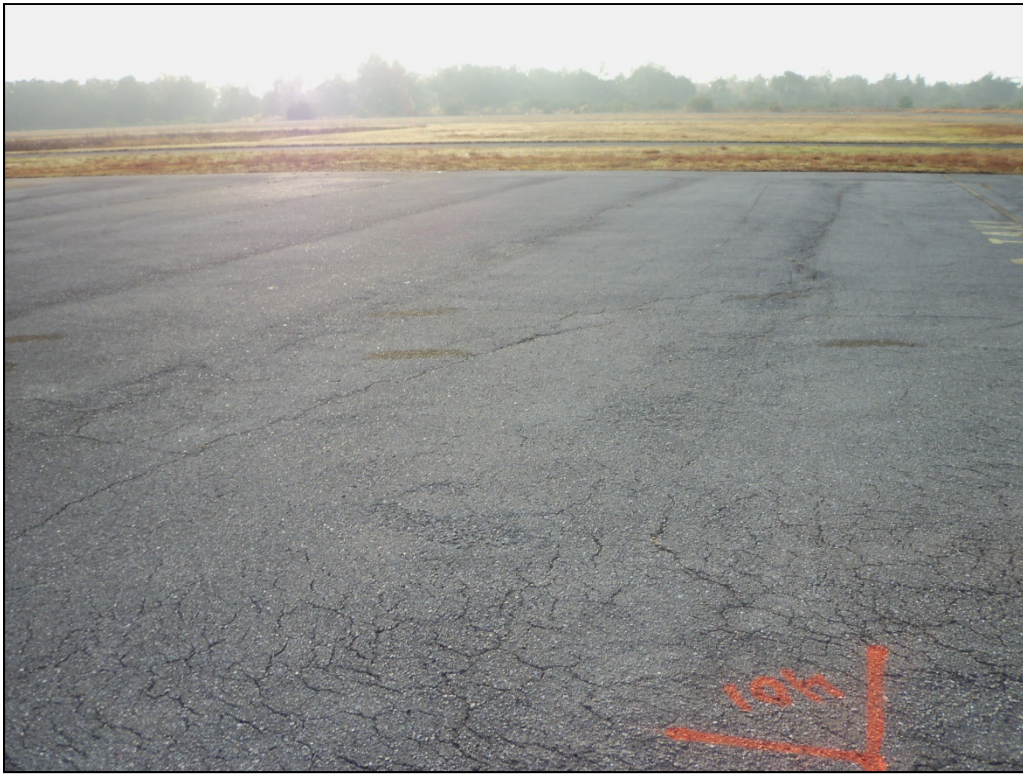
Apron, Section 4110, Sample Unit 401 – Low severity (52) Weathering and Raveling and low severity (43) Block Cracking.

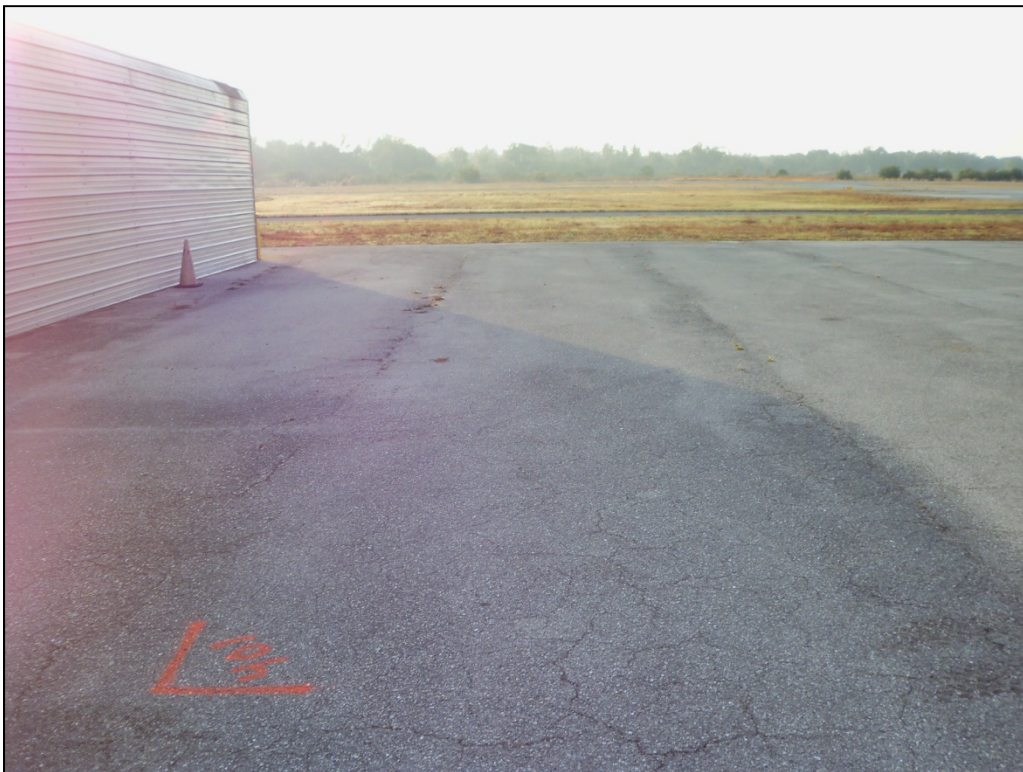
Apron, Section 4110, Sample Unit 401 – Low severity (52) Weathering and Raveling and low severity (43) Block Cracking.

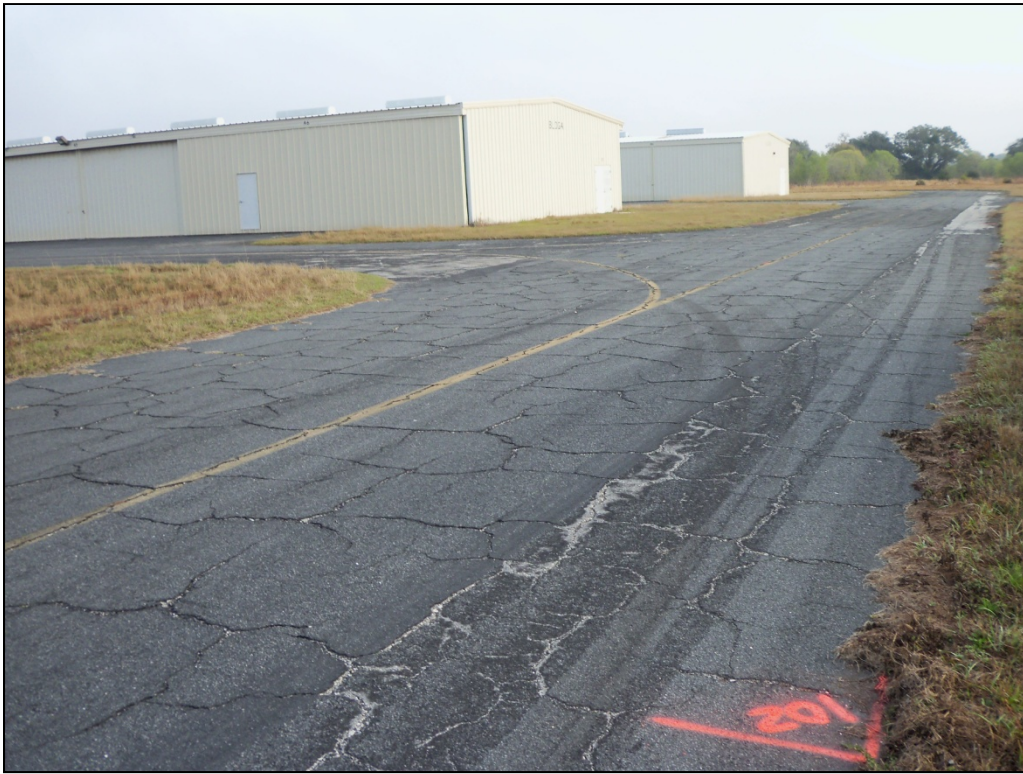
The taxiway access to the hangars exhibited medium to high severity block cracking, longitudinal/transverse cracking, and weathering/raveling. It appears that the pavement sections have been seal coated in the past to retard the degradation of the pavement. However the curling of the pavement around the cracks has attributed to rideability issues. The condition analysis has resulted in a PCI of 31 with a condition rating of ‘Very Poor’ of which is below both the FDOT and FAA recommended minimum PCI values.

Taxiway Access to Hangars, Section 230, Sample Unit 102 – Medium severity (43) Block Cracking and medium severity (52) Weathering and Raveling.

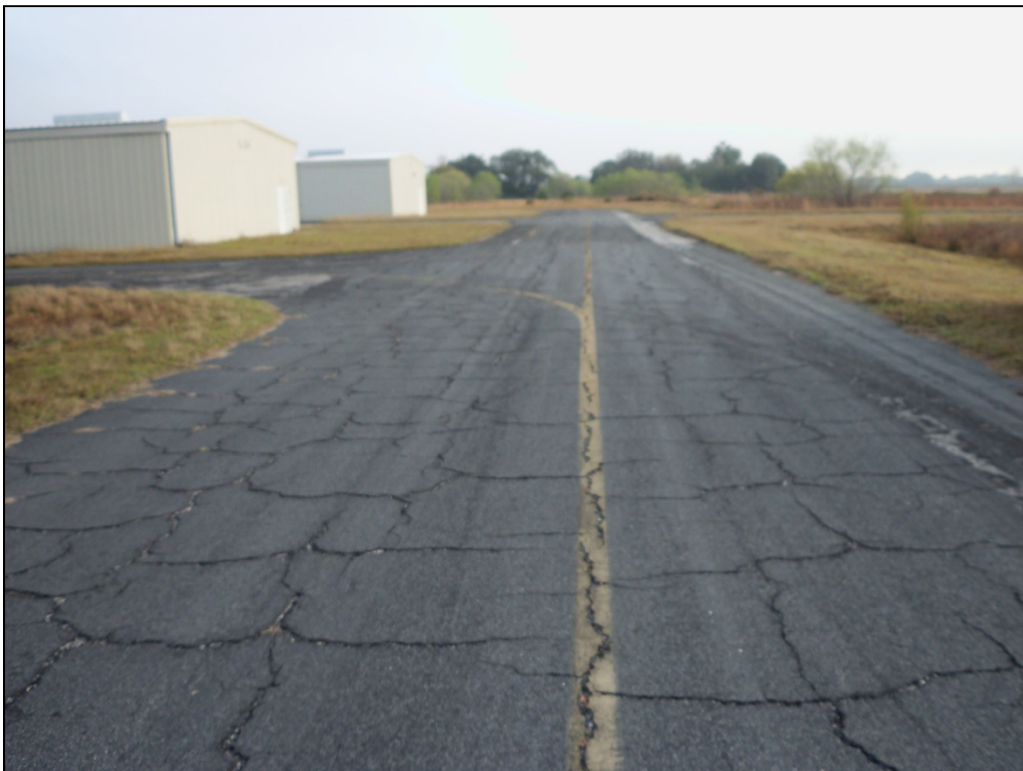
Taxiway Access to Hangars, Section 230, Sample Unit 102 – Medium severity (43) Block Cracking and medium severity (52) Weathering and Raveling.

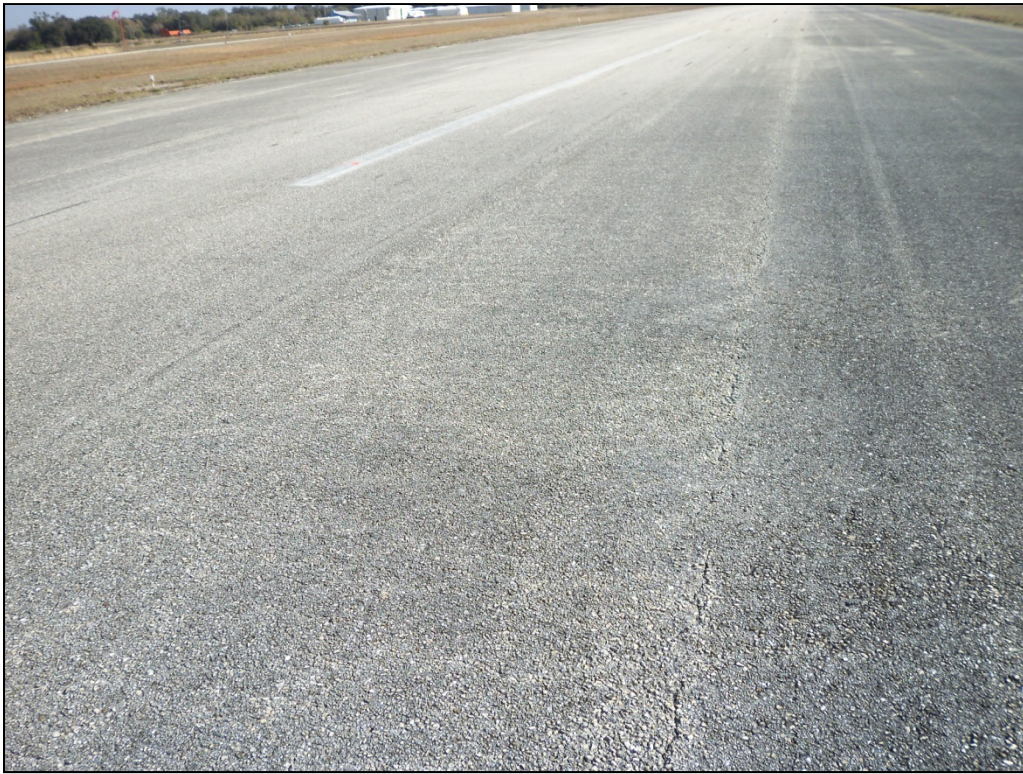
Runway 5-23 showed common distresses of weathering and raveling, longitudinal cracking, and occasional block cracking. The taxiway to the hangars and the hanger access pavement suffered medium to high severity block cracking with weathering and raveling. The pavements’ dark color is evidence of past seal coat applications in spite of degrading block cracking distresses. The condition analysis of the runway resulted in a PCI of 58 with a condition rating of ‘Fair’. Runway 5-23’s PCI of 58 is below both the FAA and FDOT recommended minimum PCI values.

Runway 5-23, Section 6105, Sample Unit 106 – Low severity (48) Longitudinal and Transverse Cracking, medium and high severity (52) Weathering and Raveling, and low severity (43) Block Cracking.

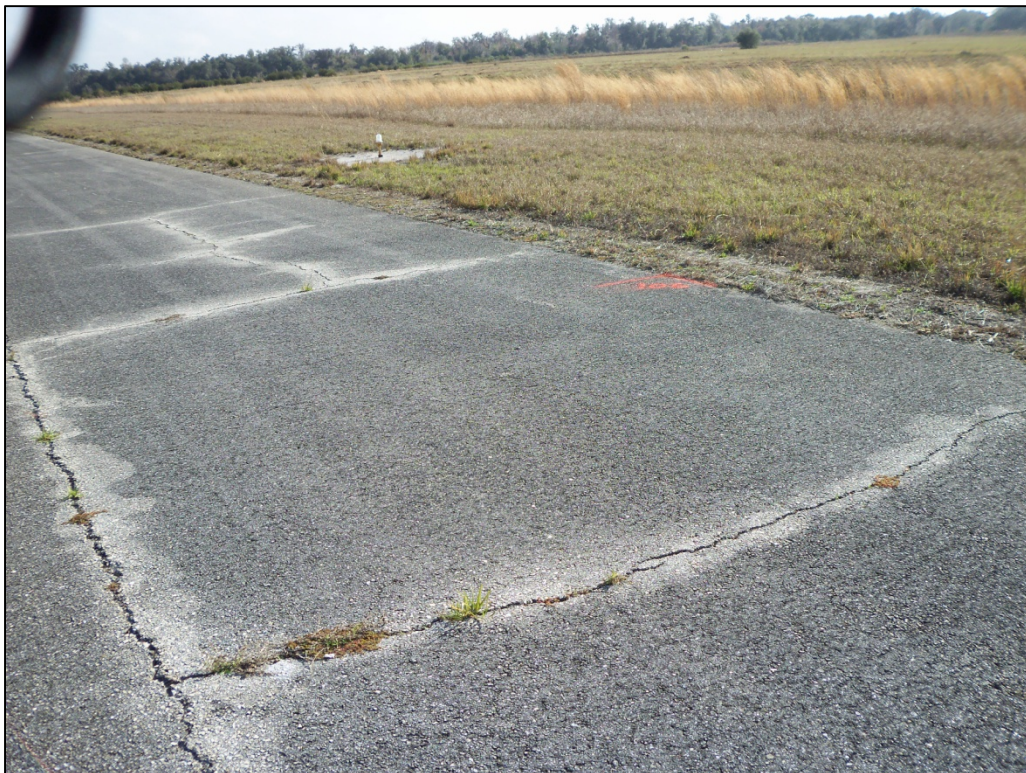
Runway 5-23, Section 6105, Sample Unit 106 – Medium severity (48) Longitudinal and Transverse Cracking, medium and high severity (52) Weathering and Raveling, and low severity (43) Block Cracking.
