**STATE OF FLORIDA
DEPARTMENT OF TRANSPORTATION
AVIATION OFFICE**

**Statewide Airfield Pavement
Management Program**

**Avon Park Executive Airport– AVO
(General Aviation)
Avon Park, Florida
(District 1)**

May 2011

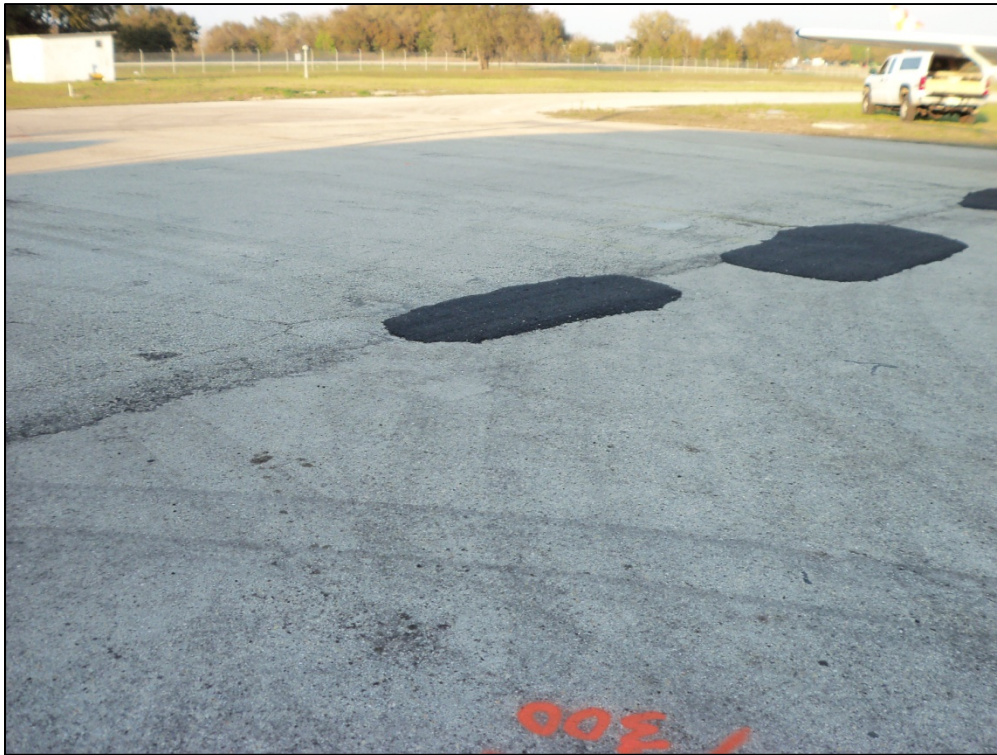
Apron, Section 4205, Sample Unit 300 – Low severity (43) Block Cracking, low severity (50) Patch, low and medium severity (52) Weathering and Raveling

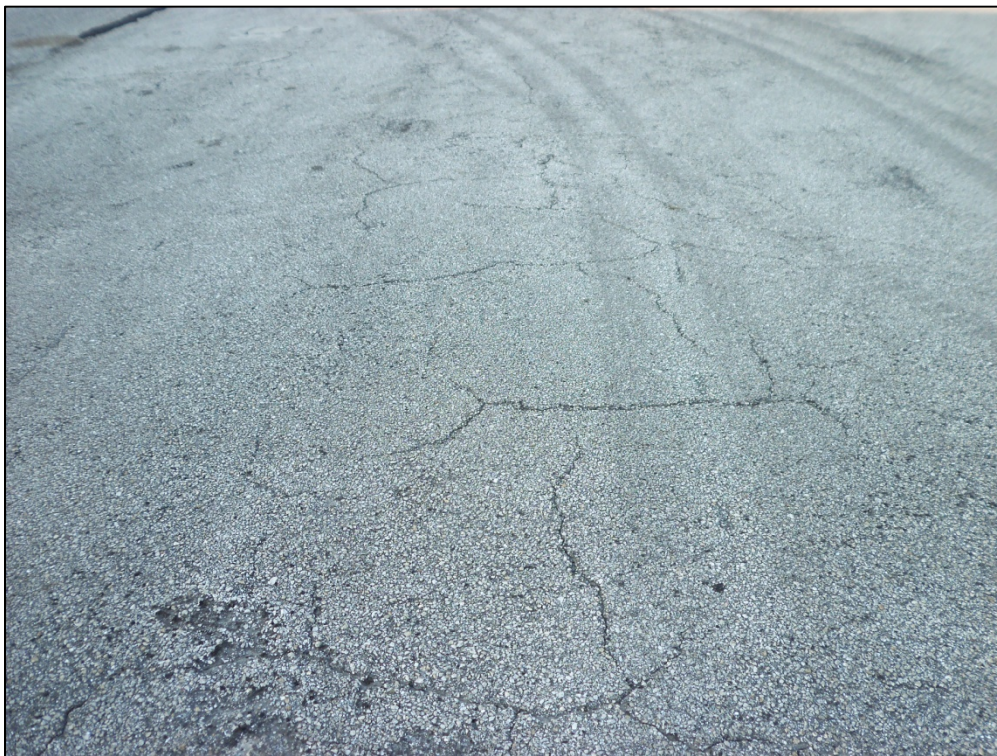
Apron, Section 4205, Sample Unit 300 – Low severity (43) Block Cracking, low severity (50) Patch, low and medium severity (52) Weathering and Raveling

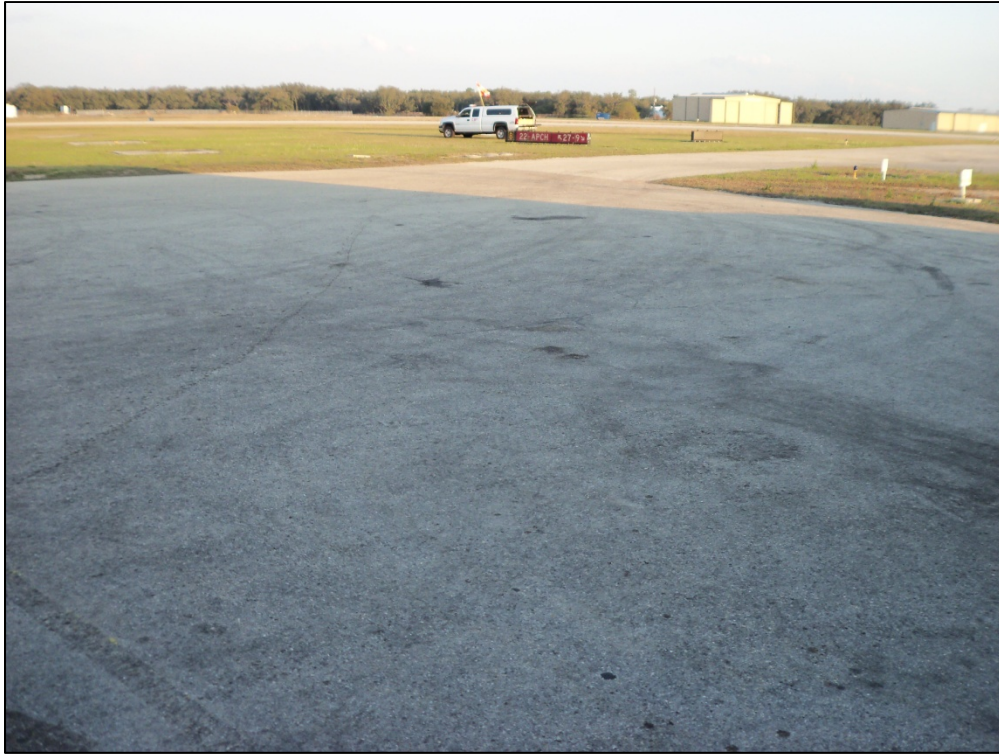
Apron, Section 4210, Sample Unit 102 – Low severity (43) Block Cracking, low severity (48) Longitudinal and Transverse Cracking, medium severity (52) Weathering and Raveling

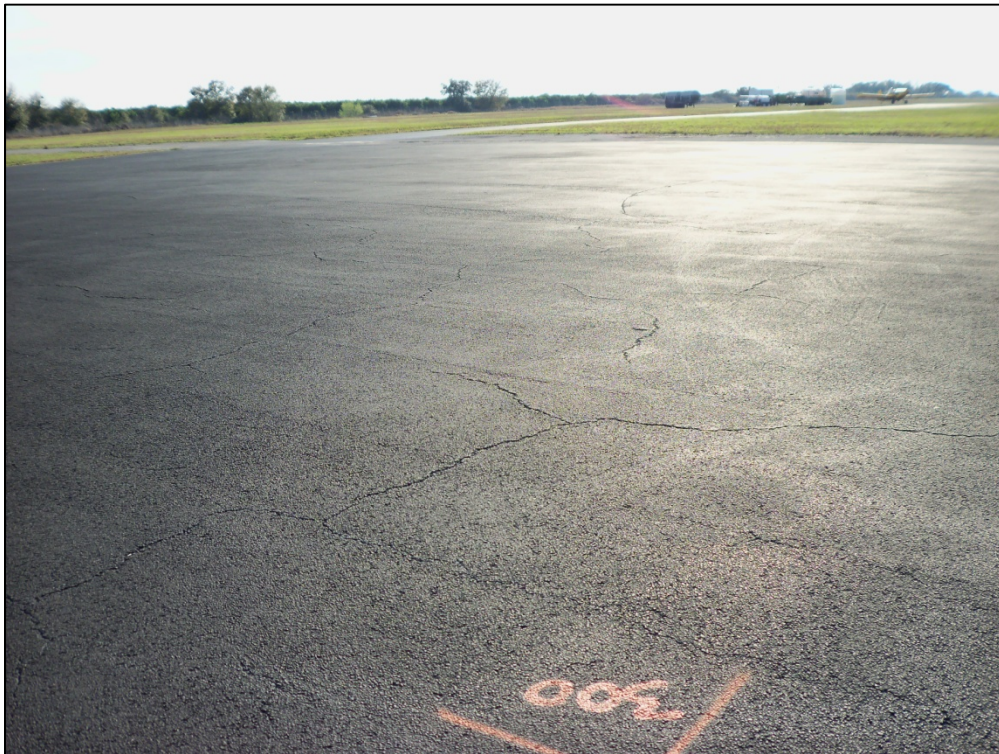
Apron, Section 4405, Sample Unit 300 – Low severity (43) Block Cracking, low severity (50) Patch, low severity (52) Weathering and Raveling

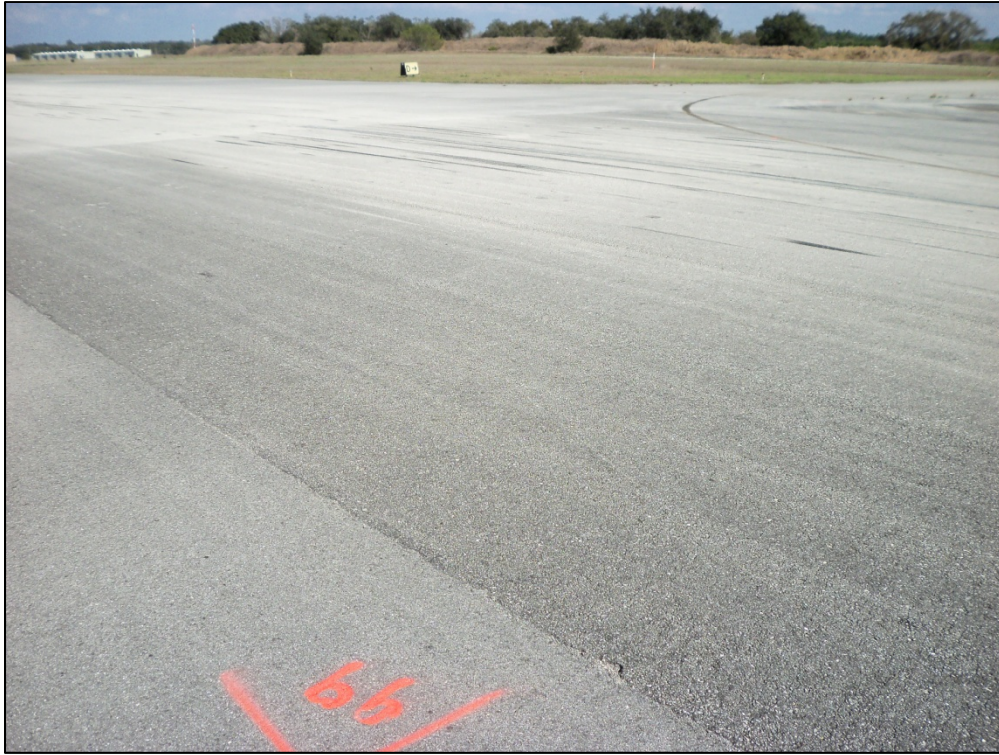
Runway 5-23 exhibited low and medium severity weathering and raveling in addition to longitudinal cracks primarily located along the paving joints. This is a common distress due to the pavement being weakest at the joint locations. Isolated instances of low severity block cracking distresses were also observed along the runway pavement section.

Runway 5-23, Section 6102, Sample Unit 99 – Low severity (48) Longitudinal and Transverse Cracking, low and medium severity (52) Weathering and Raveling

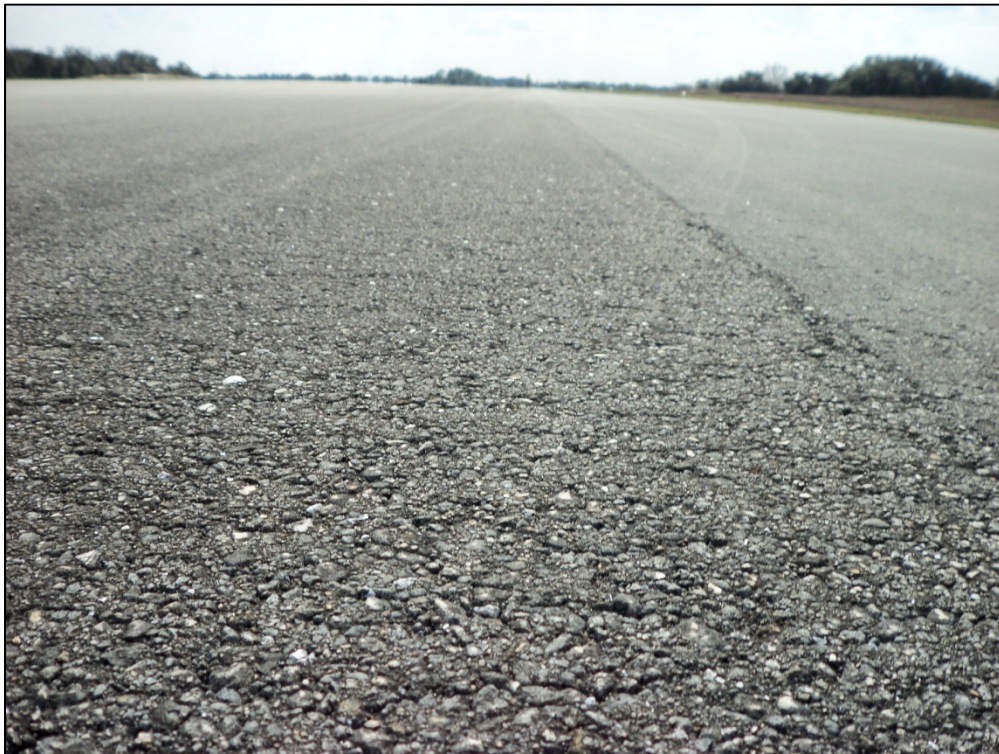
Runway 5-23, Section 6102, Sample Unit 99 – Low severity (48) Longitudinal and Transverse Cracking, low and medium severity (52) Weathering and Raveling

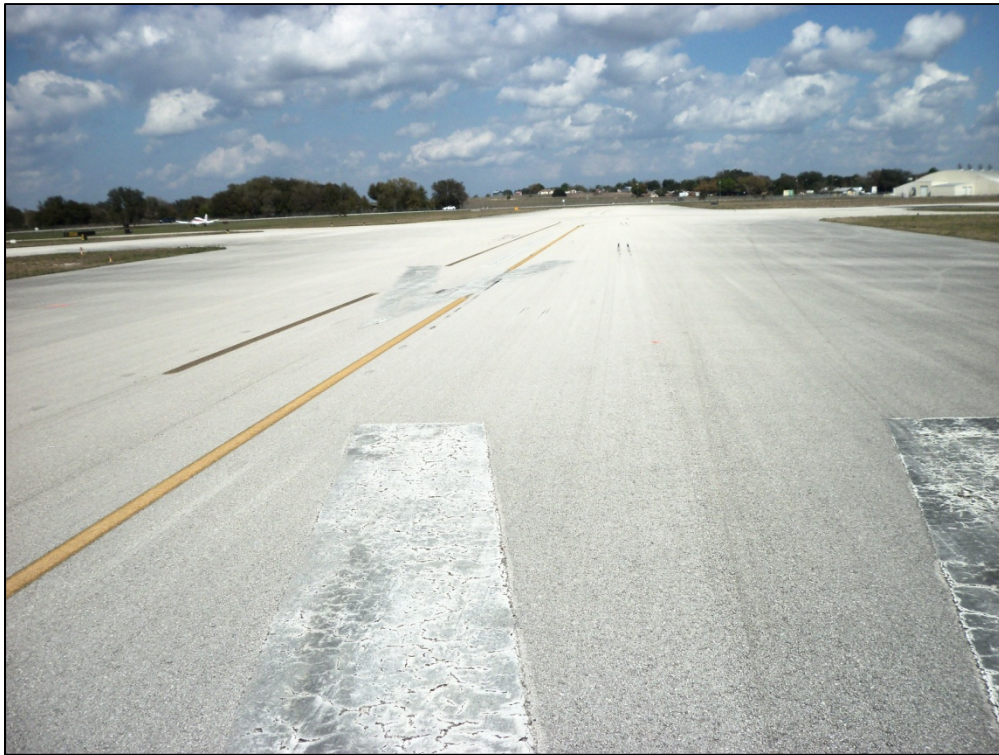
Runway 5-23, Section 6110, Sample Unit 158 – Low severity (48) Longitudinal and Transverse Cracking, low and medium severity (52) Weathering and Raveling

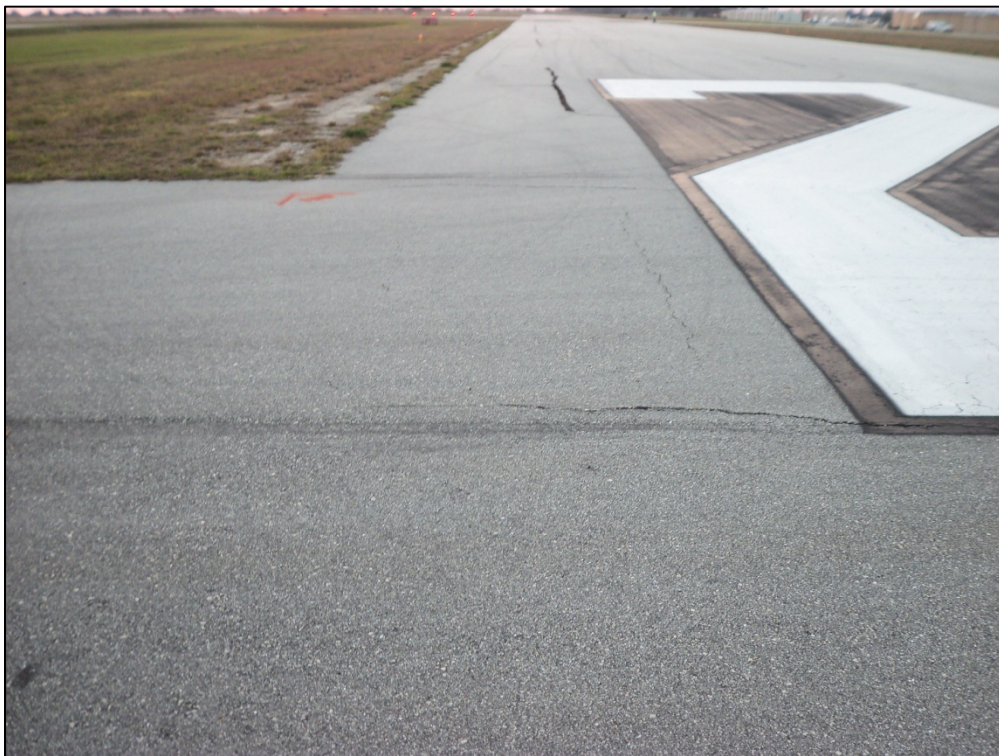
Runway 10-28 exhibited very similar distress characteristics to RW 5-23, with low and medium severity weathering and raveling in addition to longitudinal cracks primarily located along the paving joints.

Runway 10-28, Section 6220, Sample Unit 100 – Low severity (48) Longitudinal and Transverse Cracking, low severity (52) Weathering and Raveling

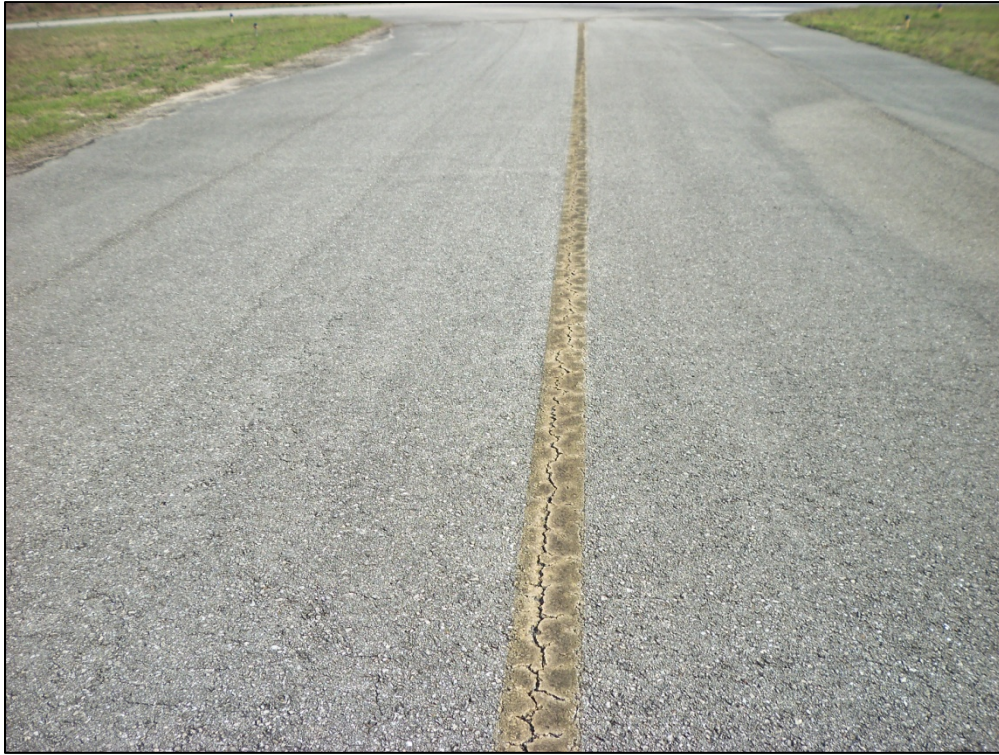
Taxiway Connector Delta, Section 415, Sample Unit 101 – Low severity (43) Block Cracking, low severity (48) Longitudinal and Transverse Cracking, low severity (52) Weathering and Raveling

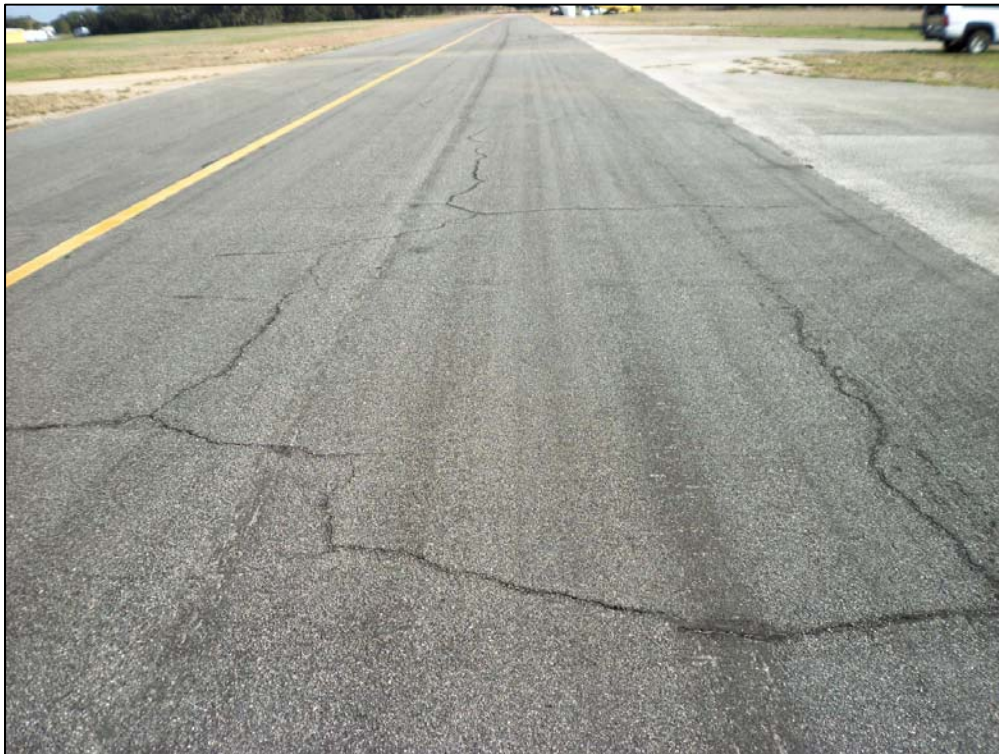
Taxiway Alpha, Section 115, Sample Unit 105 – Low severity (43) Block Cracking, low severity (48) Longitudinal and Transverse Cracking, low severity (52) Weathering and Raveling

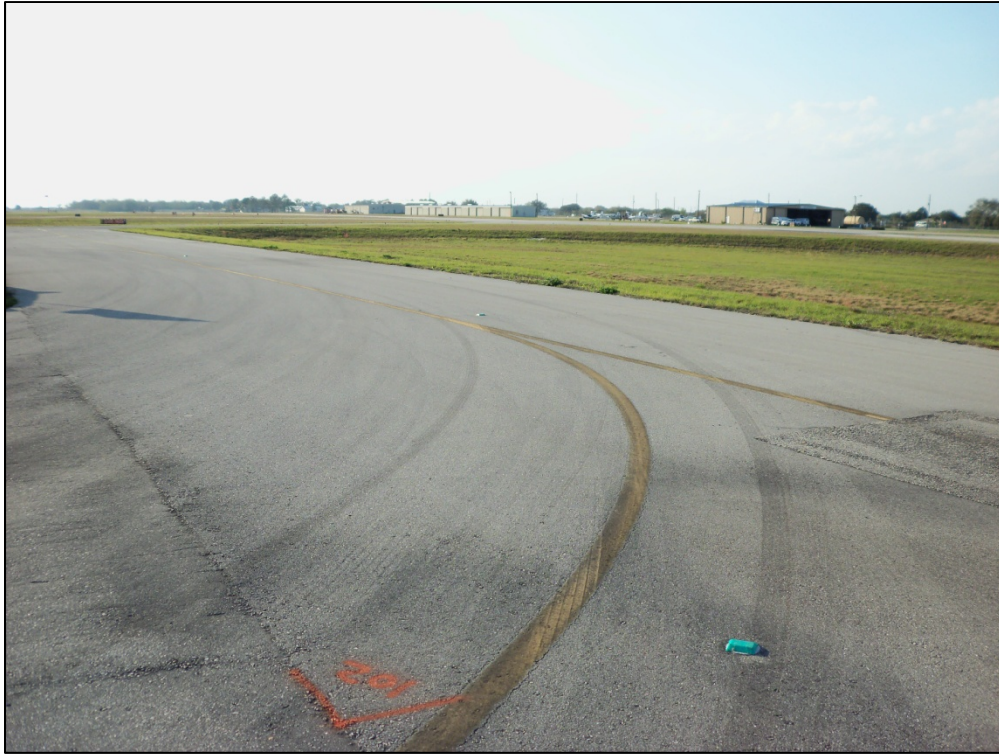
Taxiway 605, Section 605, Sample Unit 102 – Low severity (48) Longitudinal and Transverse Cracking, low severity (50) Patch, low severity (52) Weathering and Raveling

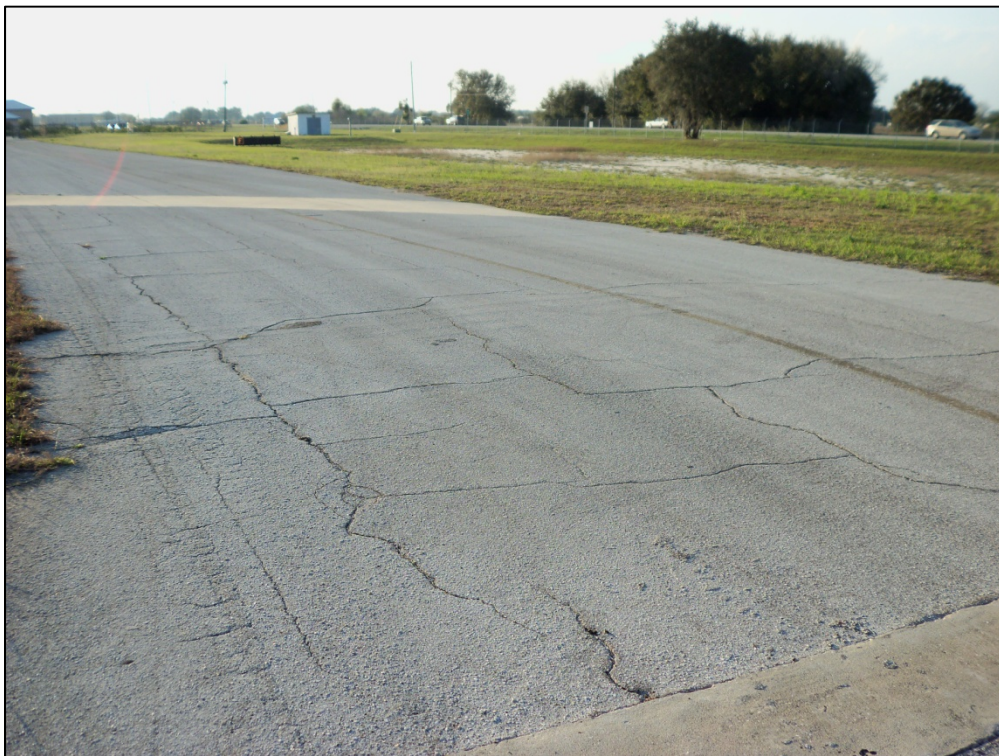
Taxiway Delta, Section 405, Sample Unit 101 – Medium severity (43) Block Cracking, low severity (50) Patch, low severity (52) Weathering and Raveling

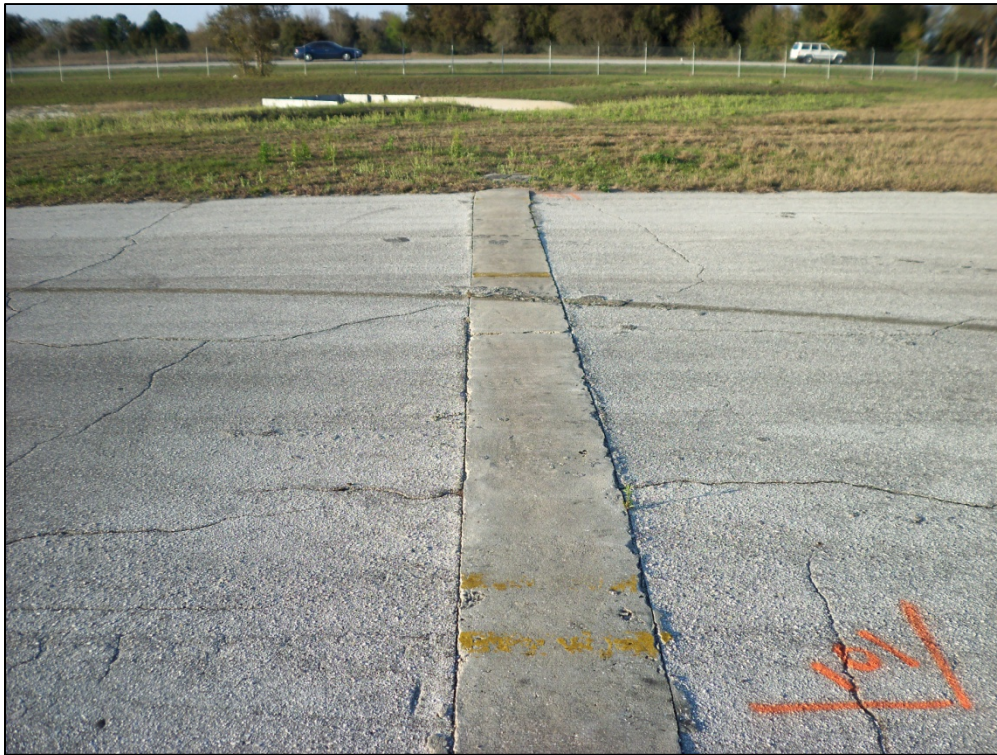
Taxiway Delta, Section 405, Sample Unit 101 – Medium severity (43) Block Cracking, low severity (50) Patch, low severity (52) Weathering and Raveling

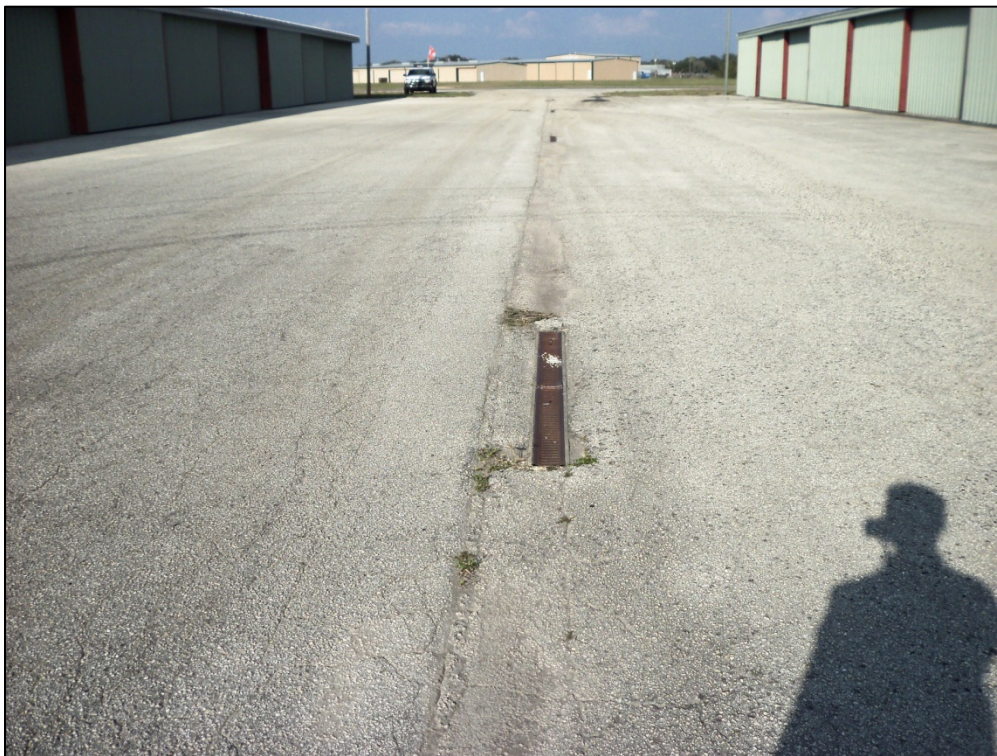
T-Hangar, Section 4305, Sample Unit 301 – Low severity Block Cracking, low severity (48) Longitudinal and Transverse Cracking, low severity (50) Patch, low and medium severity (52) Weathering and Raveling

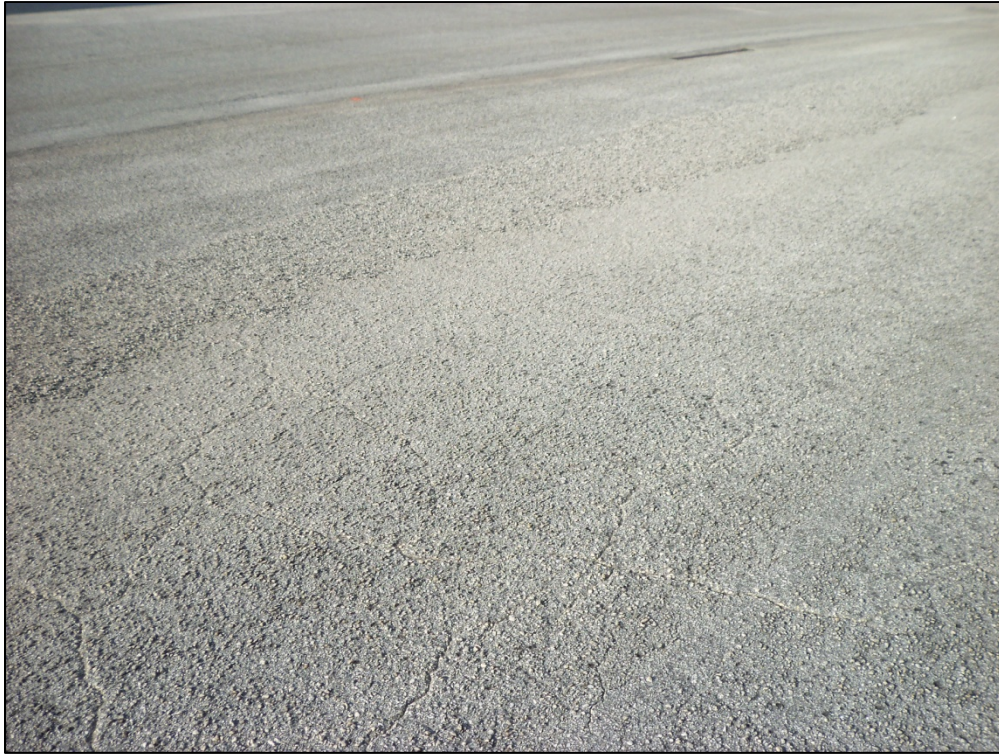
T-Hangar, Section 4305, Sample Unit 301 – Low severity Block Cracking, low severity (48) Longitudinal and Transverse Cracking, low severity (50) Patch, low and medium severity (52) Weathering and Raveling

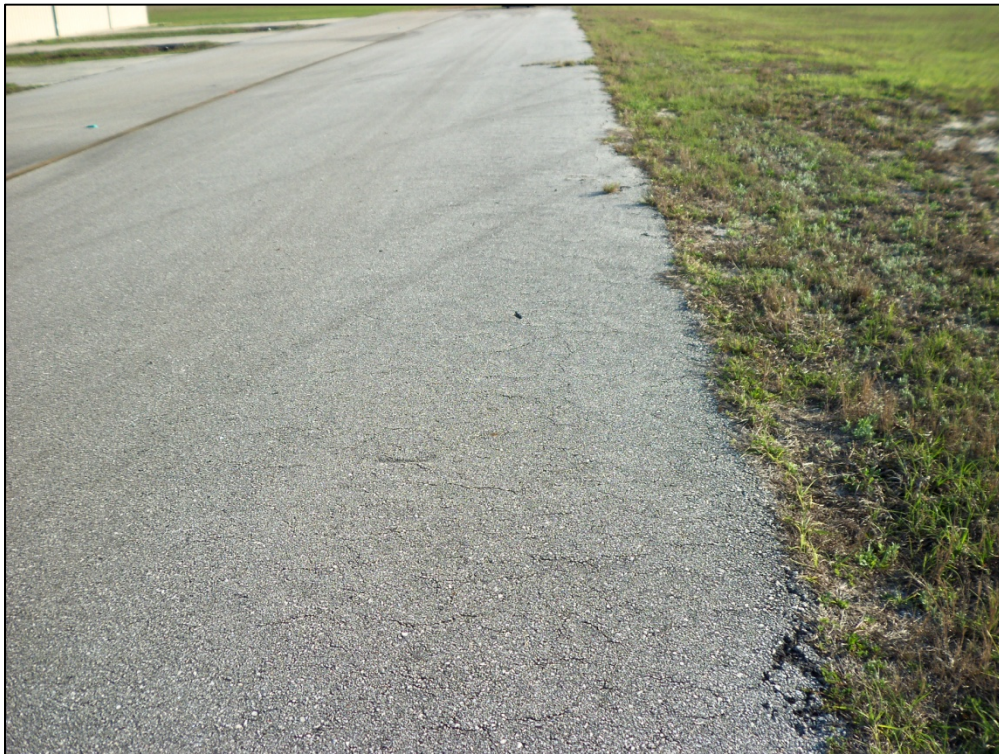
T-Hangar, Section 705, Sample Unit 402 – Low severity (43) Block Cracking, low severity (48) Longitudinal and Transverse Cracking, medium severity (50) Patch, low severity (52) Weathering and Raveling
