**STATE OF FLORIDA
DEPARTMENT OF TRANSPORTATION
AVIATION OFFICE**

**Statewide Airfield Pavement
Management Program**

**Belle Glade State Municipal Airport– X10
(General Aviation)
Belle Glade, Florida
(District 4)**

May 2011

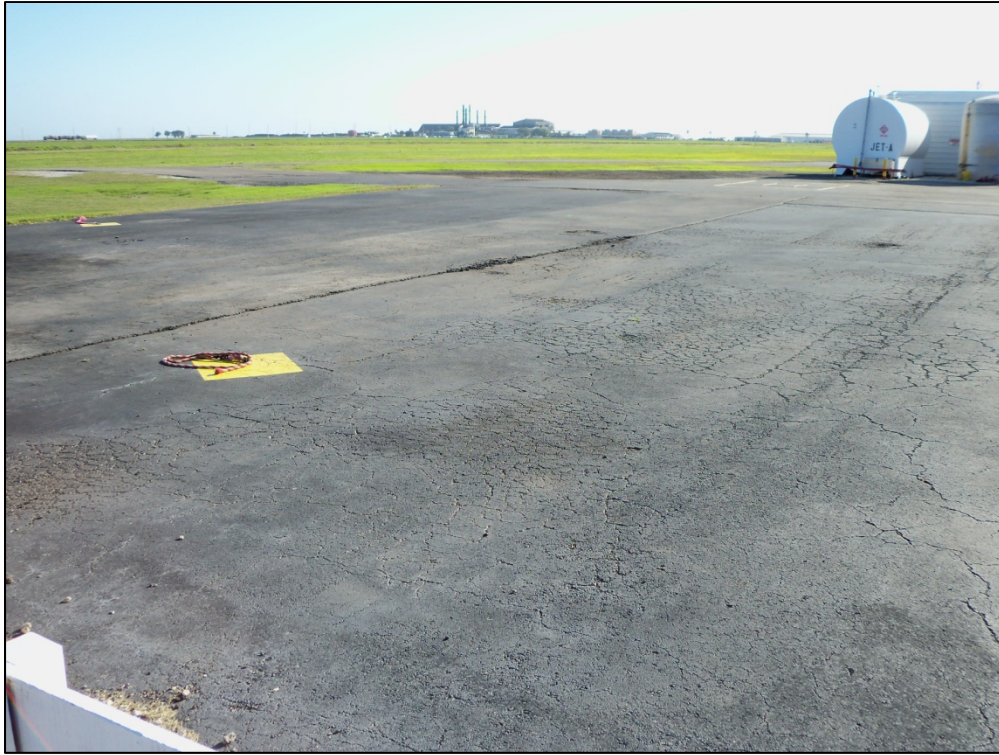
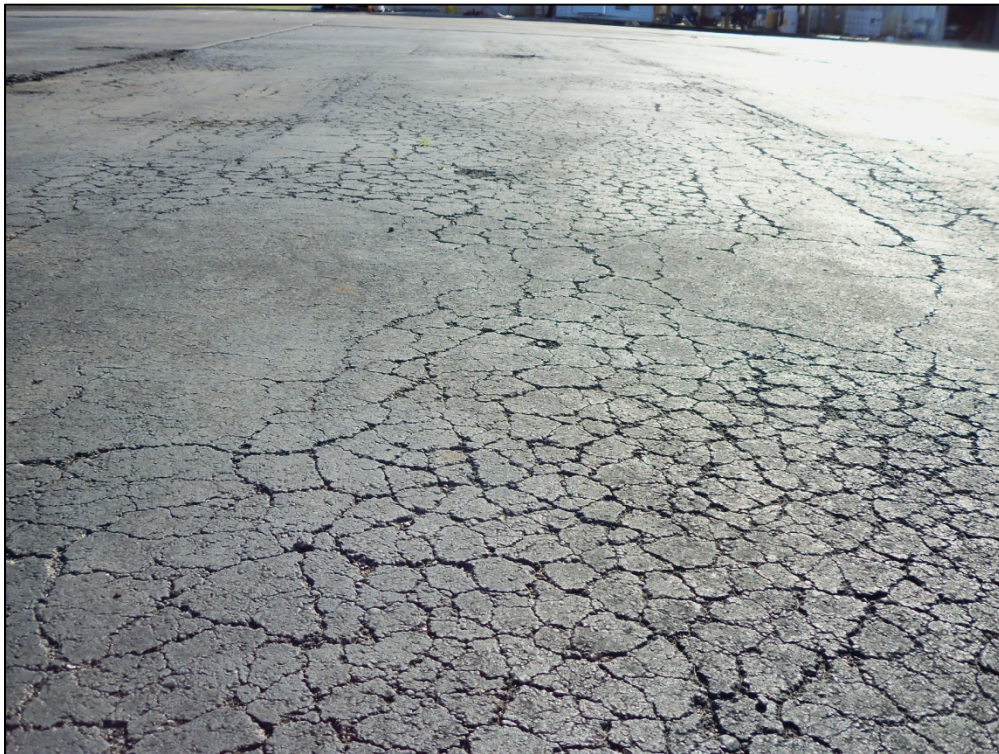
Apron, Section 4110, Sample Unit 100 – Medium severity (43) Block Cracking, low severity (48) Longitudinal and Transverse Cracking, (49) Oil Spillage, low and medium severity (52) Weathering and Raveling

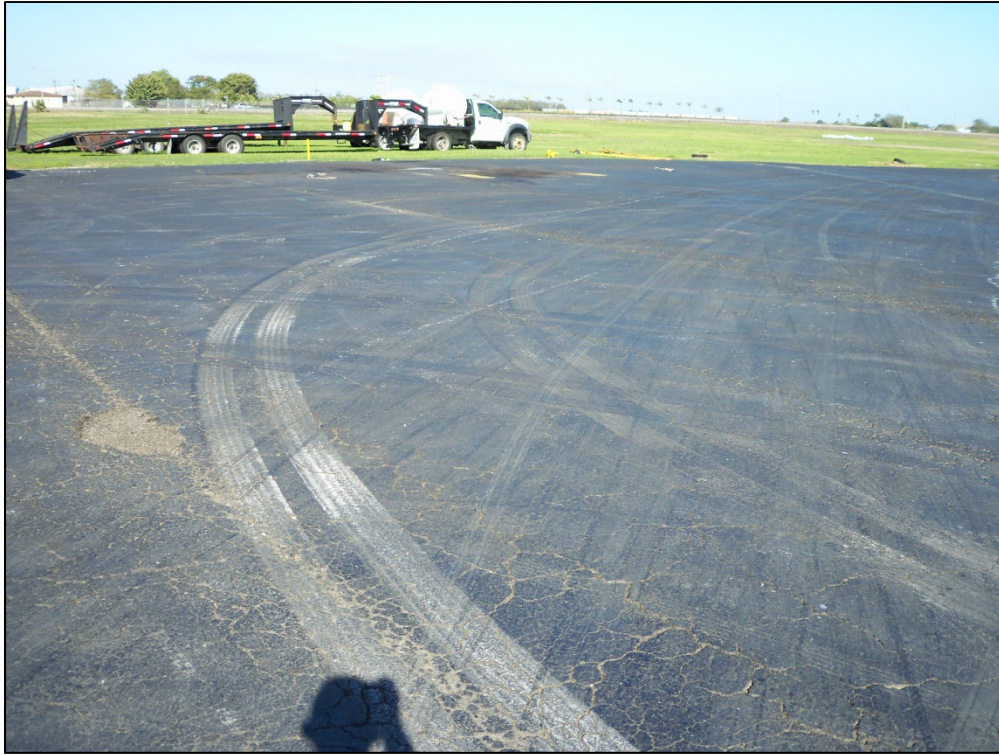
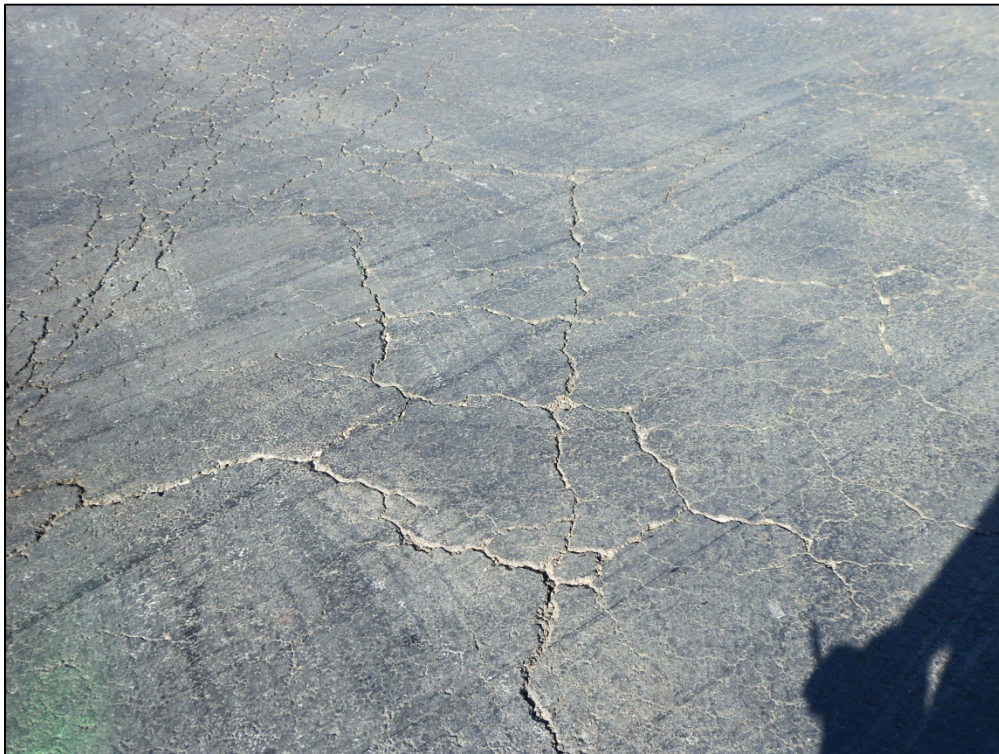
Apron, Section 4105, Sample Unit 200 – Low and medium severity (43) Block Cracking, low severity (48) Longitudinal and Transverse Cracking, (49) Oil Spillage, high severity (52) Weathering and Raveling

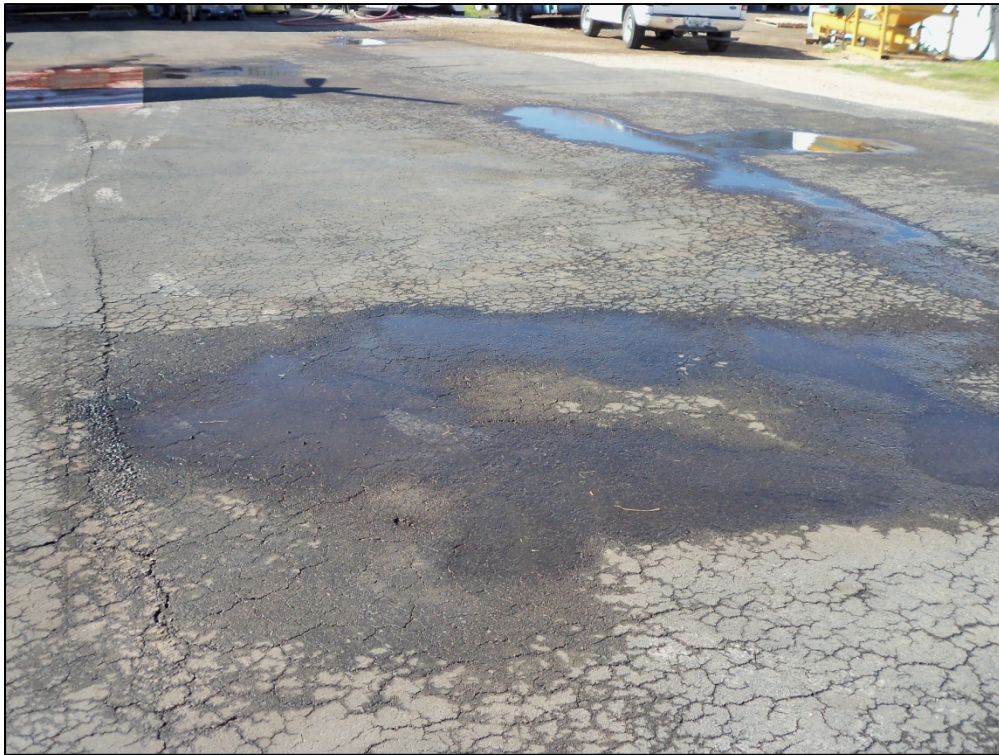
Apron, Section 4115, Sample Unit 100 – Low severity (43) Block Cracking, low severity (45) Depression, low severity (52) Weathering and Raveling

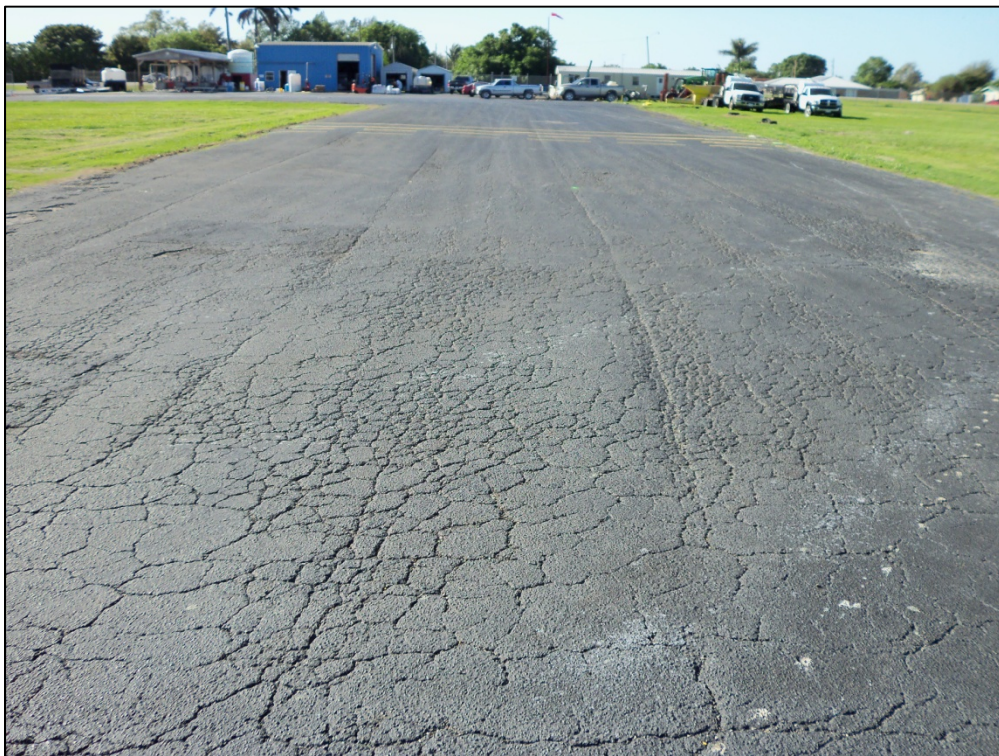
Taxiway, Section 105, Sample Unit 100 – Medium severity (43) Block Cracking, medium and high severity (52) Weathering and Raveling

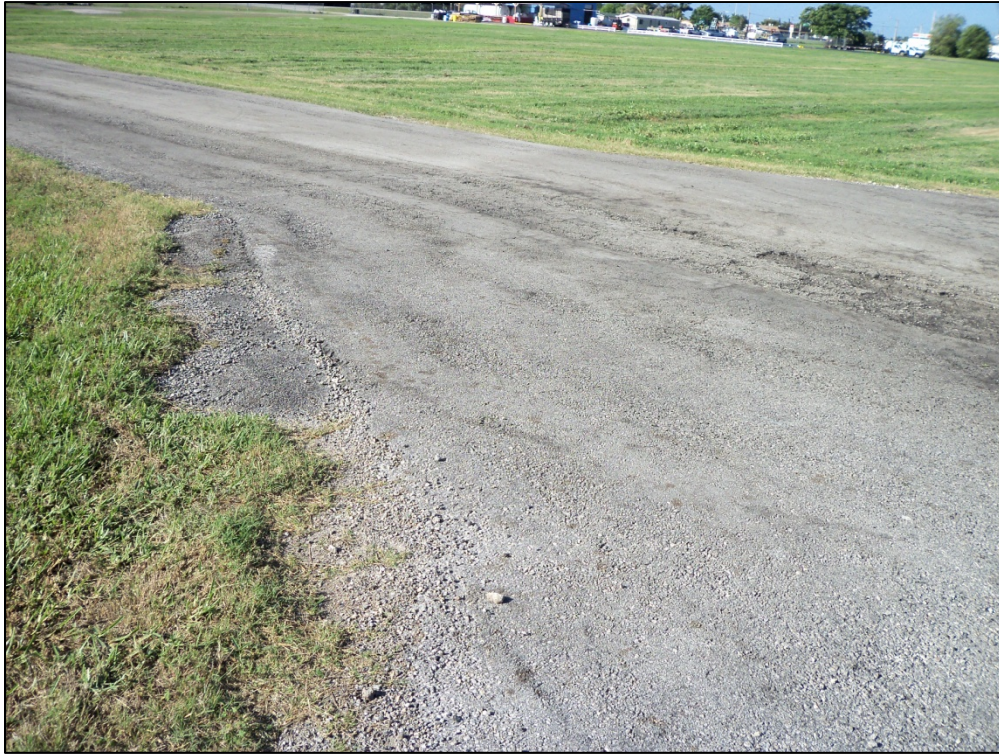
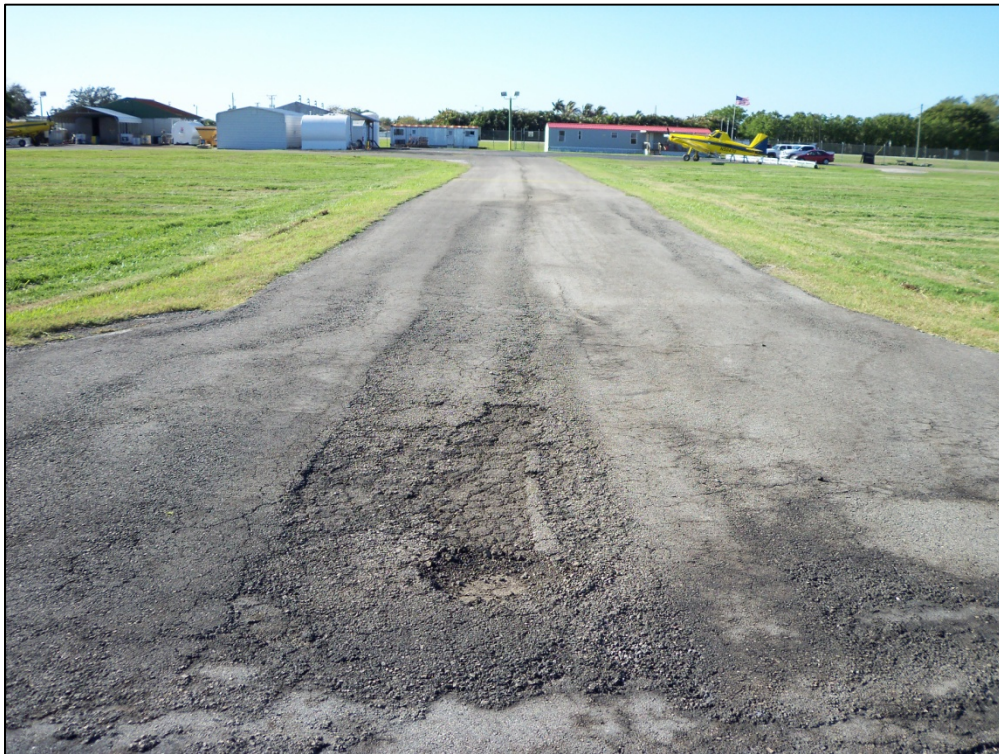
Taxiway, Section 115, Sample Unit 100 – Low severity (43) Block Cracking, low severity (48) Longitudinal and Transverse Cracking, low and high severity (52) Weathering and Raveling

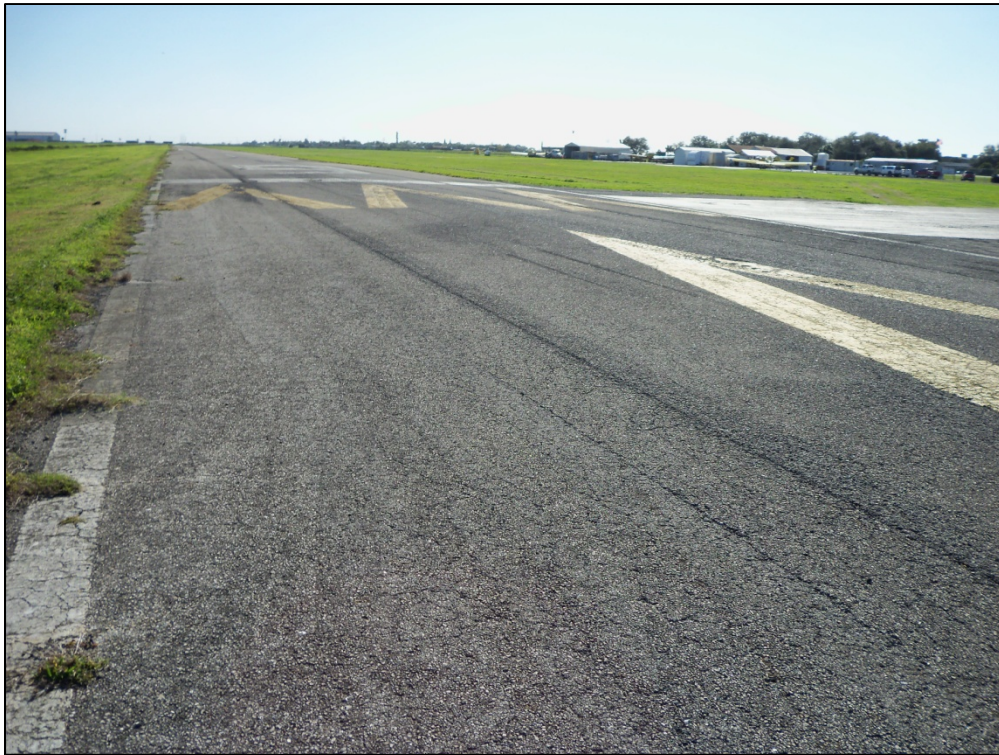
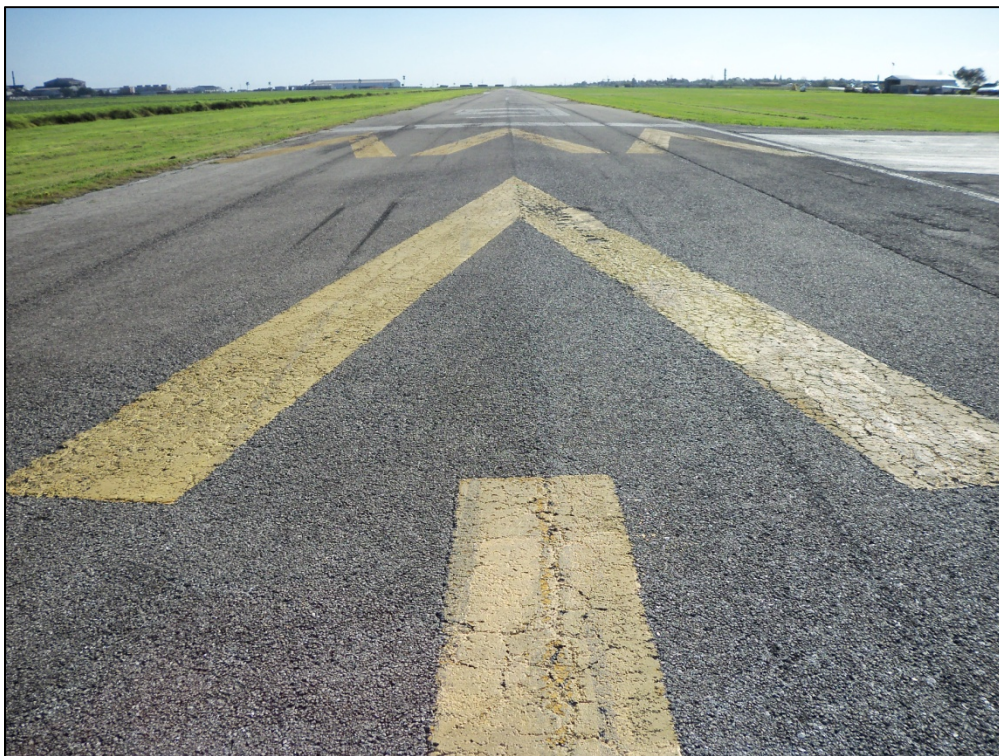
Runway 9-27, Section 6105, Sample Unit 101 – Low severity (43) Block Cracking, low, medium and high severity (52) Weathering and Raveling

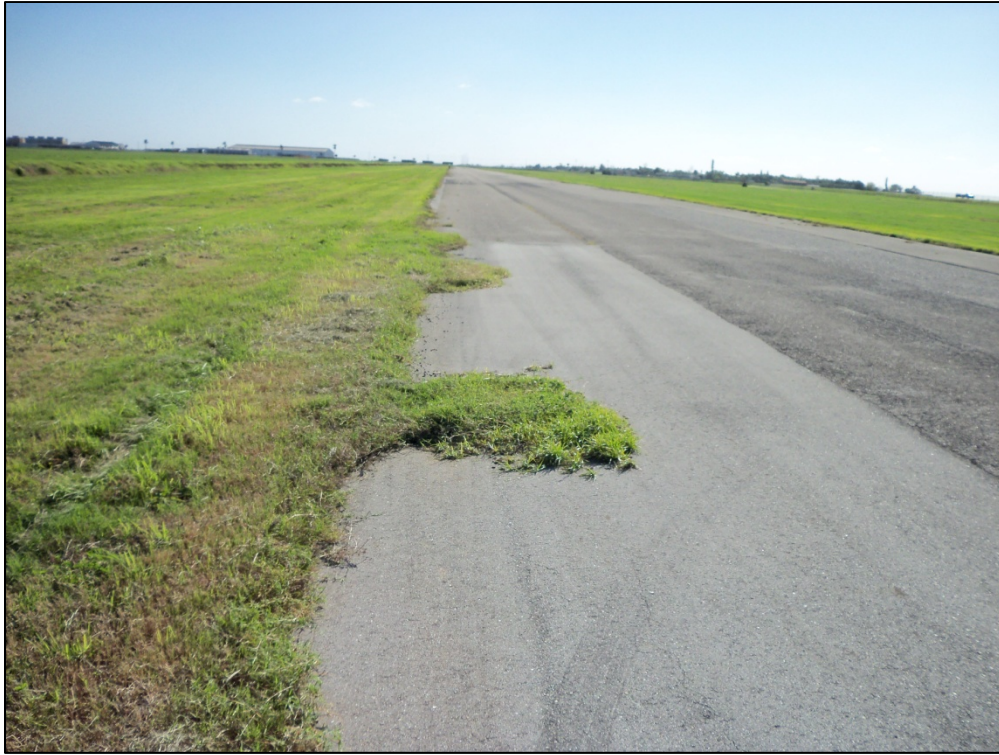
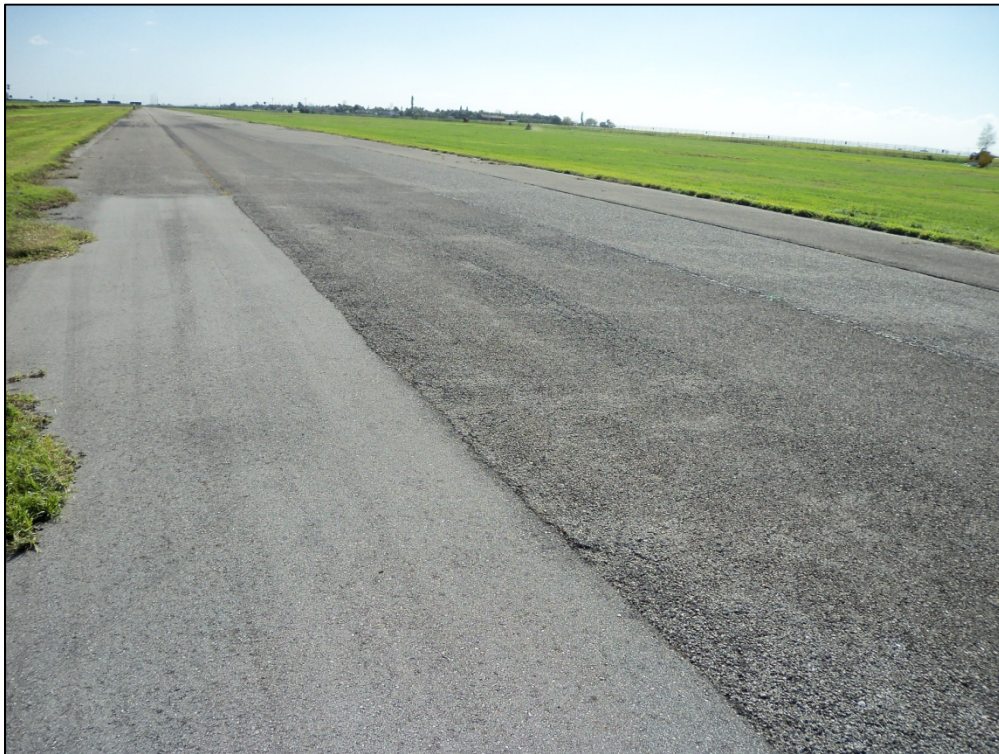
Runway 9-27, Section 6105, Sample Unit 109 – Low severity (48) Longitudinal and Transverse Cracking, low, medium and high severity (52) Weathering and Raveling
