**STATE OF FLORIDA
DEPARTMENT OF TRANSPORTATION
AVIATION OFFICE**

**Statewide Airfield Pavement
Management Program**

**Bob Sikes Airport– CEW
(General Aviation)
Eglin AFB, Florida
(District 3)**

May 2011

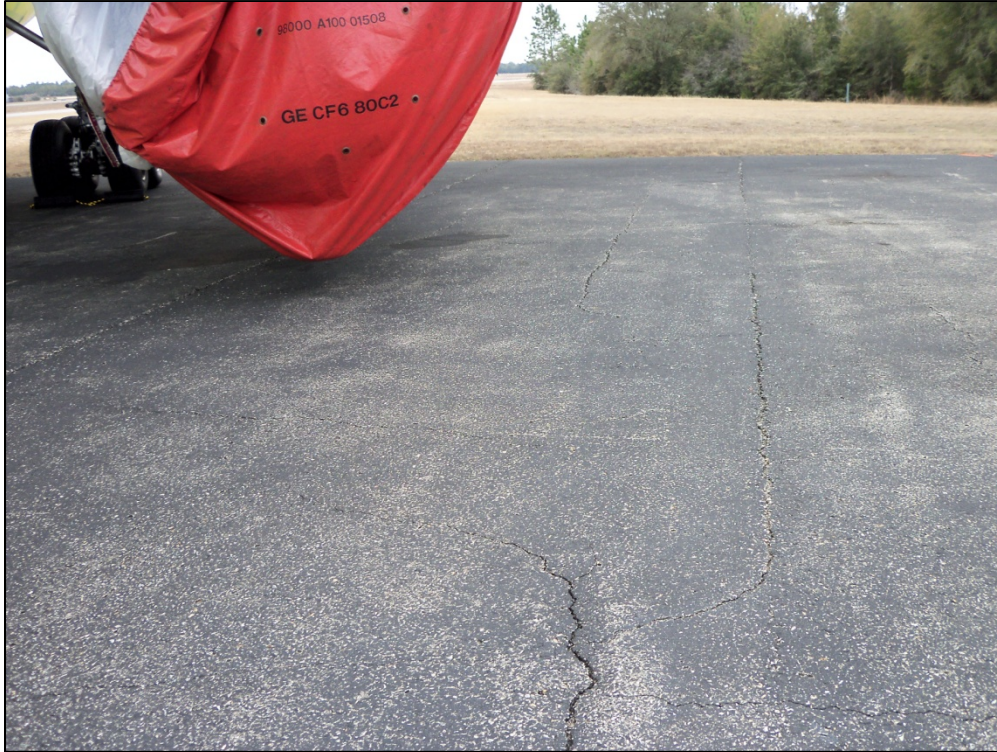
Apron, Section 4115, Sample Unit 200 – Medium severity (43) Block Cracking, high severity (48) Longitudinal and Transverse Cracking, (49) Oil Spillage, medium severity (52) Weathering and Raveling

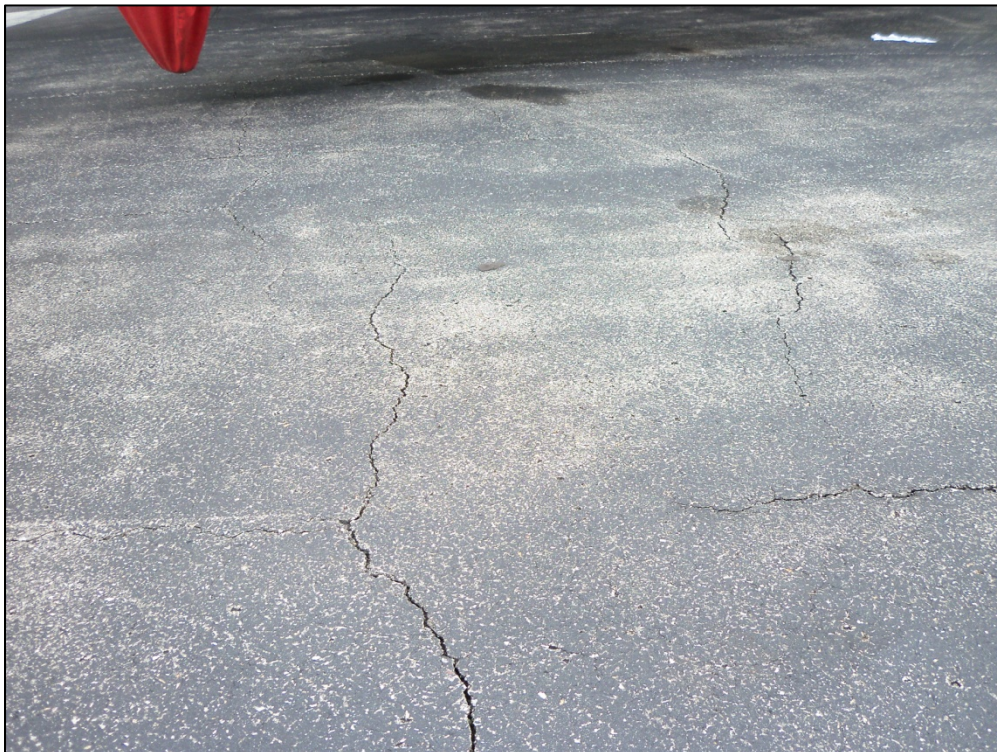
Apron, Section 4115, Sample Unit 200 – Medium severity (43) Block Cracking, high severity (48) Longitudinal and Transverse Cracking, (49) Oil Spillage, medium severity (52) Weathering and Raveling

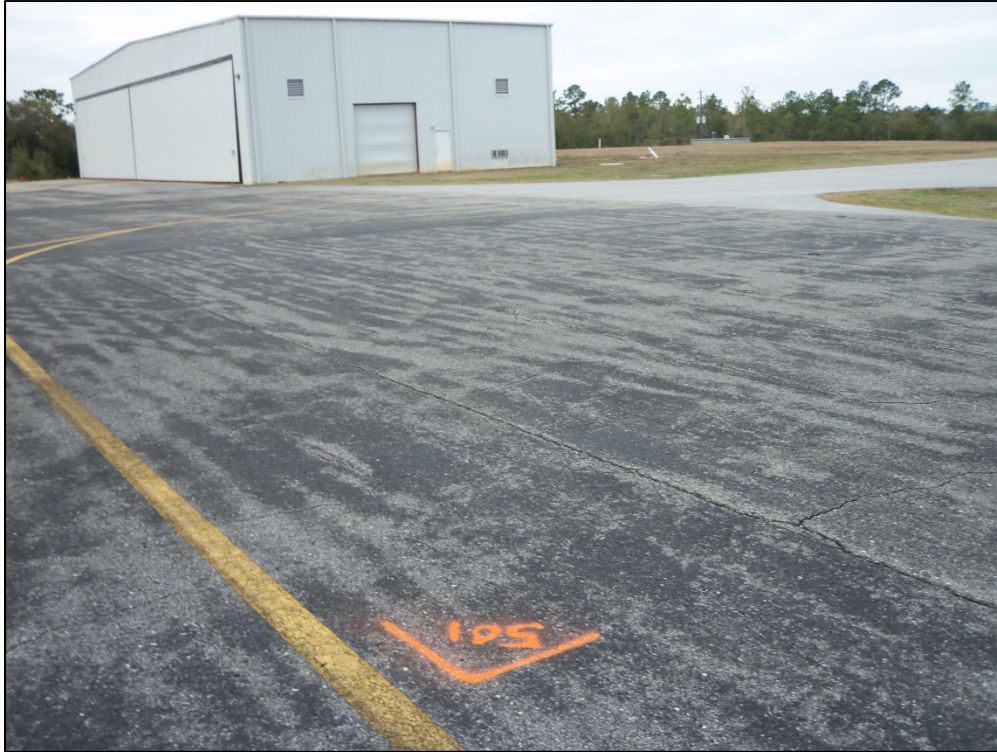
Apron, Section 4110, Sample Unit 501 – Medium severity (43) Block Cracking, low severity (48) Longitudinal and Transverse Cracking, medium severity (52) Weathering and Raveling

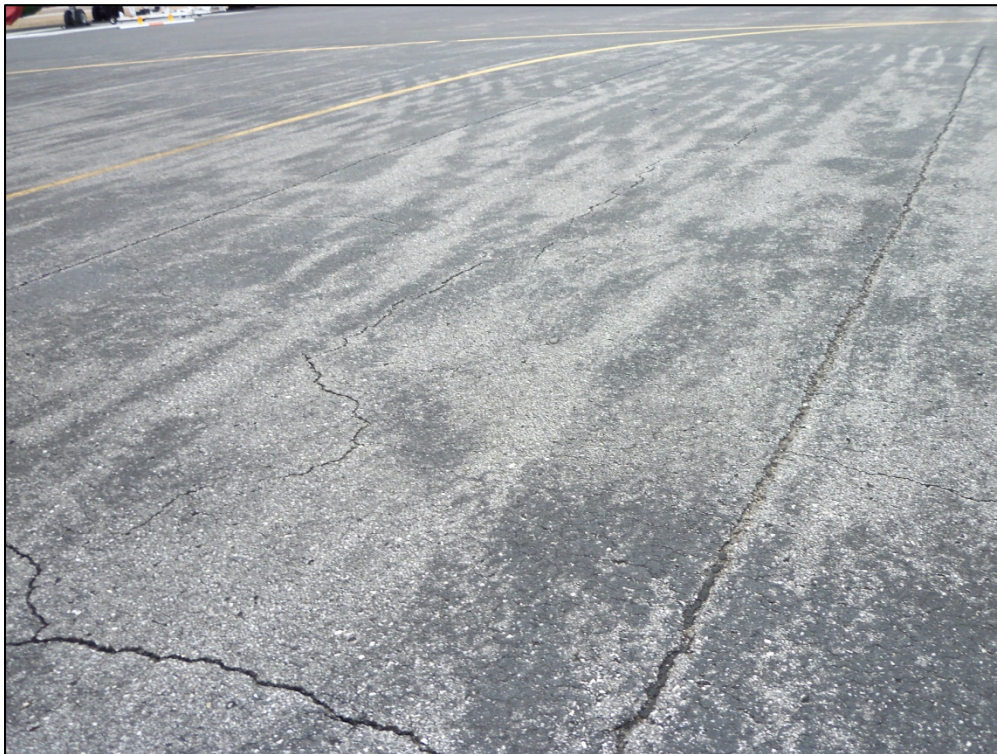
Apron, Section 4110, Sample Unit 501 – Medium severity (43) Block Cracking, low severity (48) Longitudinal and Transverse Cracking, medium severity (52) Weathering and Raveling

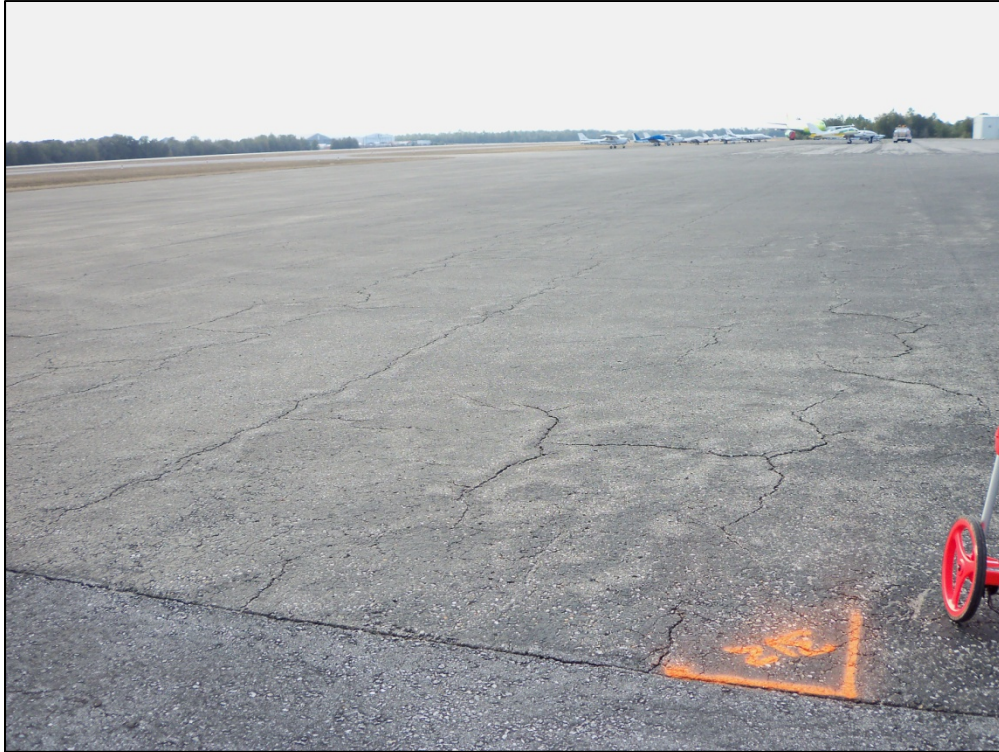
Apron, Section 4115, Sample Unit 312 – Medium severity (43) Block Cracking, medium severity (52) Weathering and Raveling

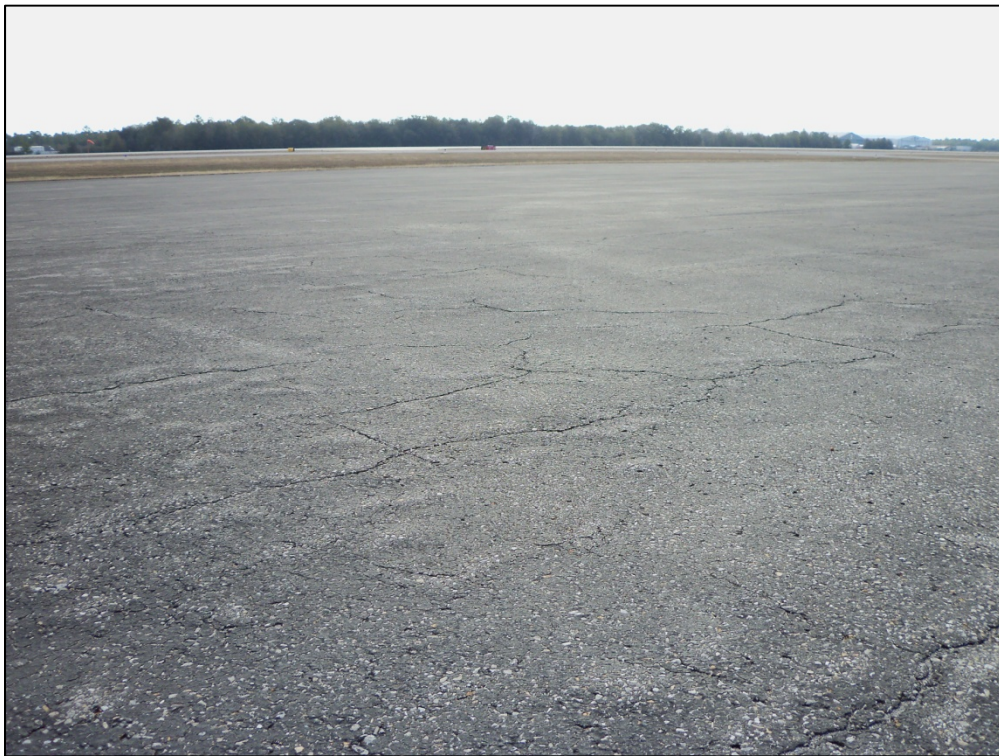
Apron, Section 4115, Sample Unit 312 – Medium severity (43) Block Cracking, medium severity (52) Weathering and Raveling

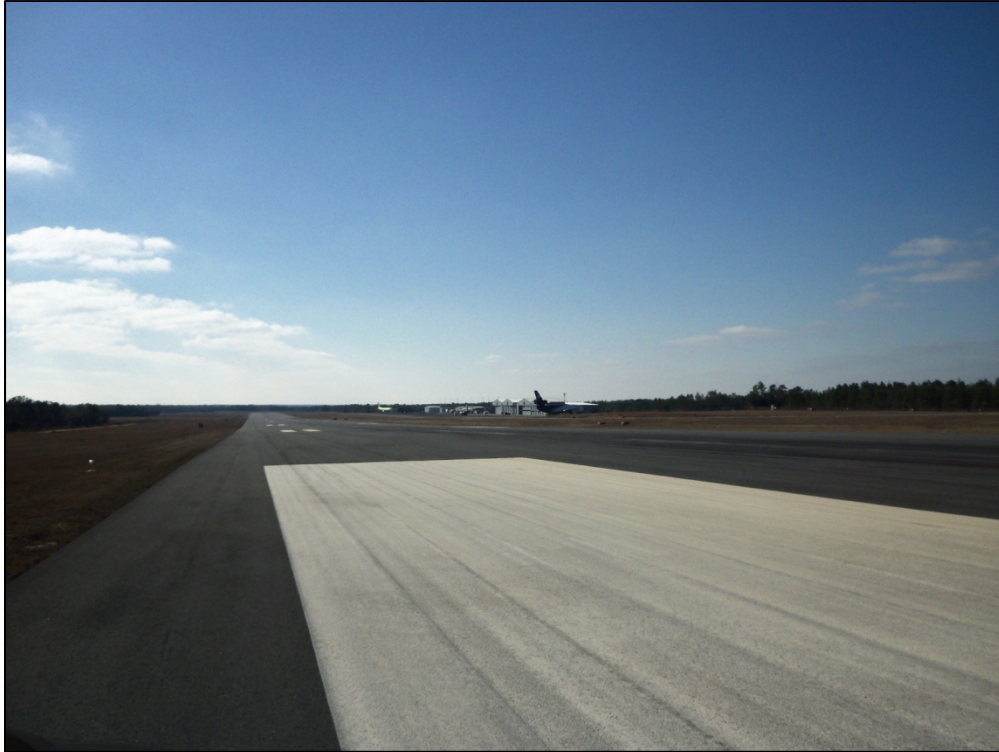
Runway 17-35, Section 6125, Sample Unit 404 – No distresses observed

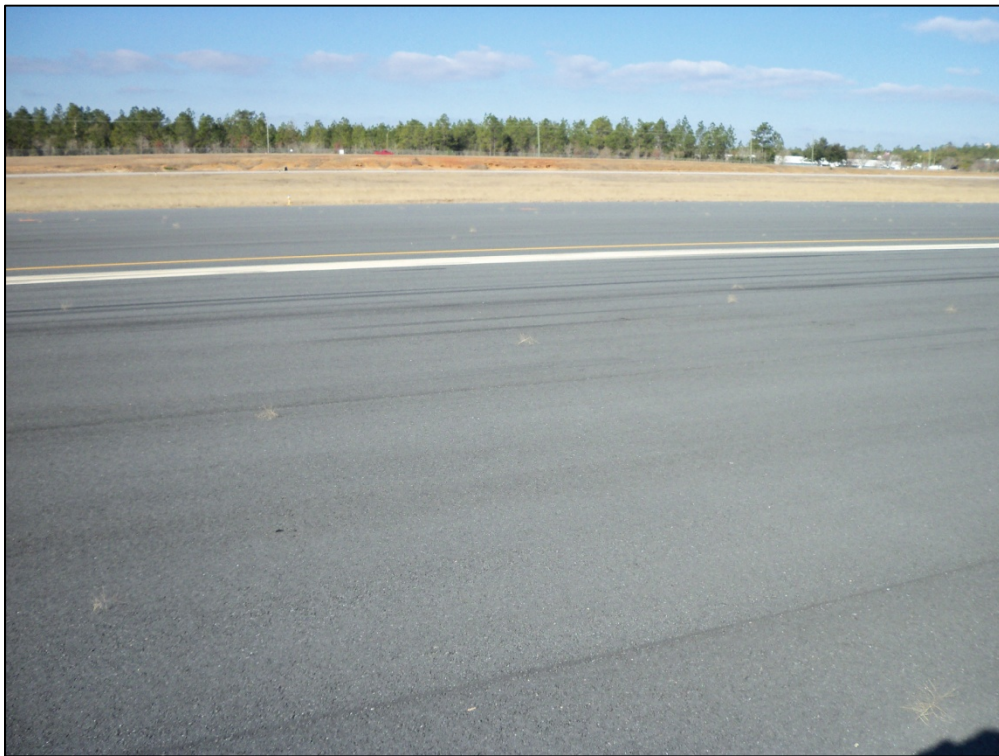
Runway 17-35, Section 6125, Sample Unit 404 – No distresses observed

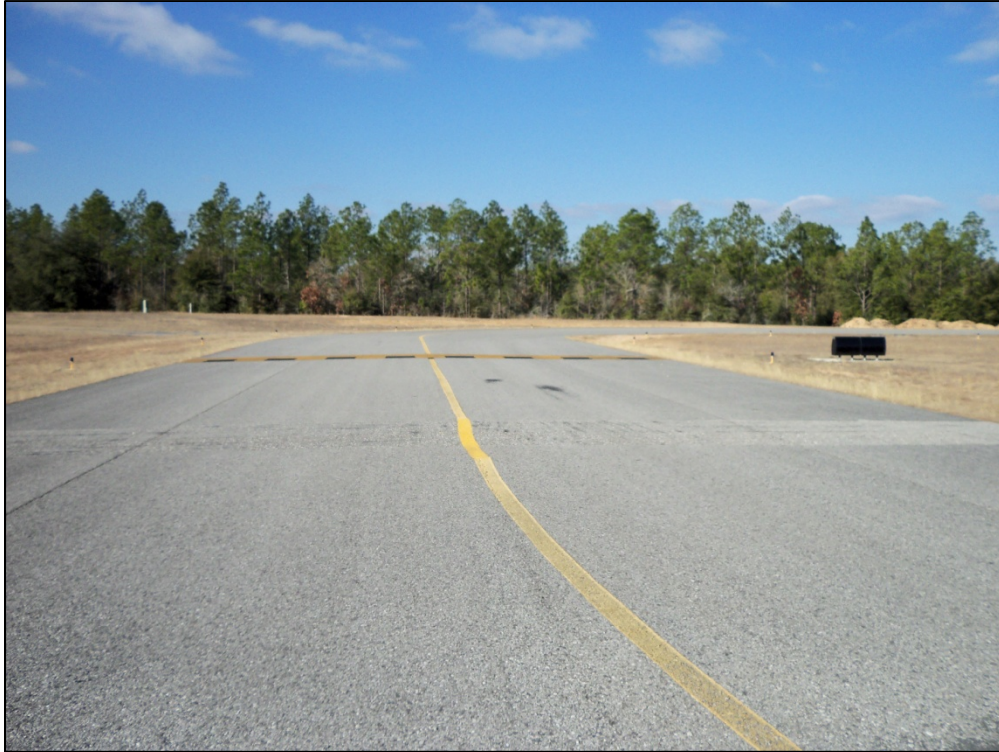
Taxiway, Section 105, Sample Unit 101 – Medium severity (43) Block Cracking, medium severity (52) Weathering and Raveling

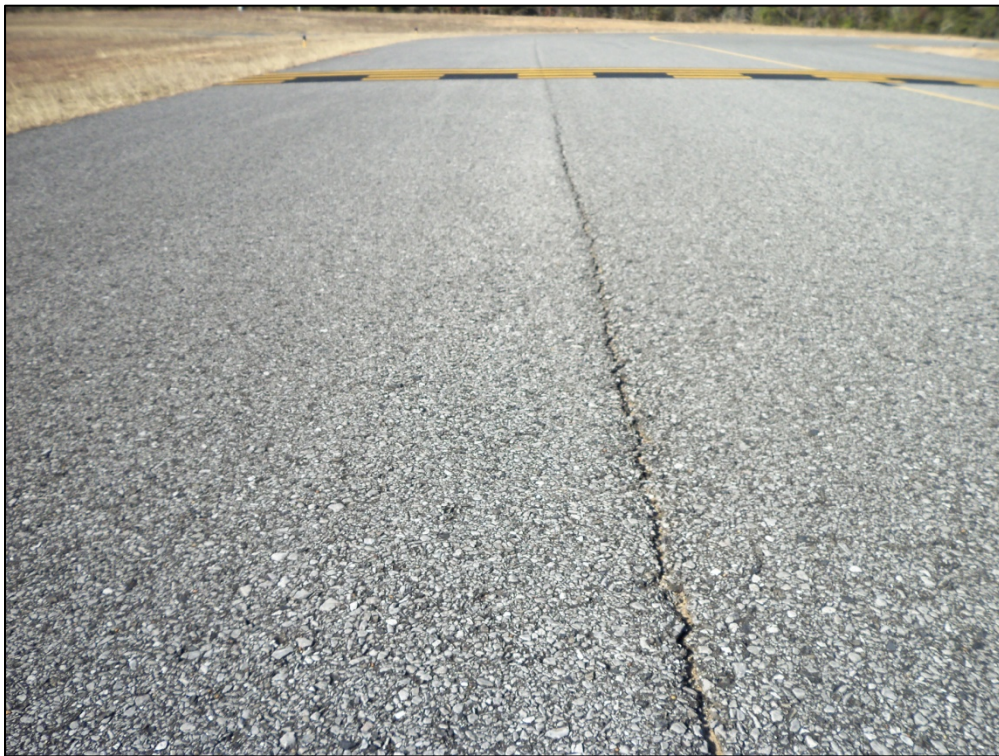
Taxiway, Section 105, Sample Unit 101 – Medium severity (43) Block Cracking, medium severity (52) Weathering and Raveling

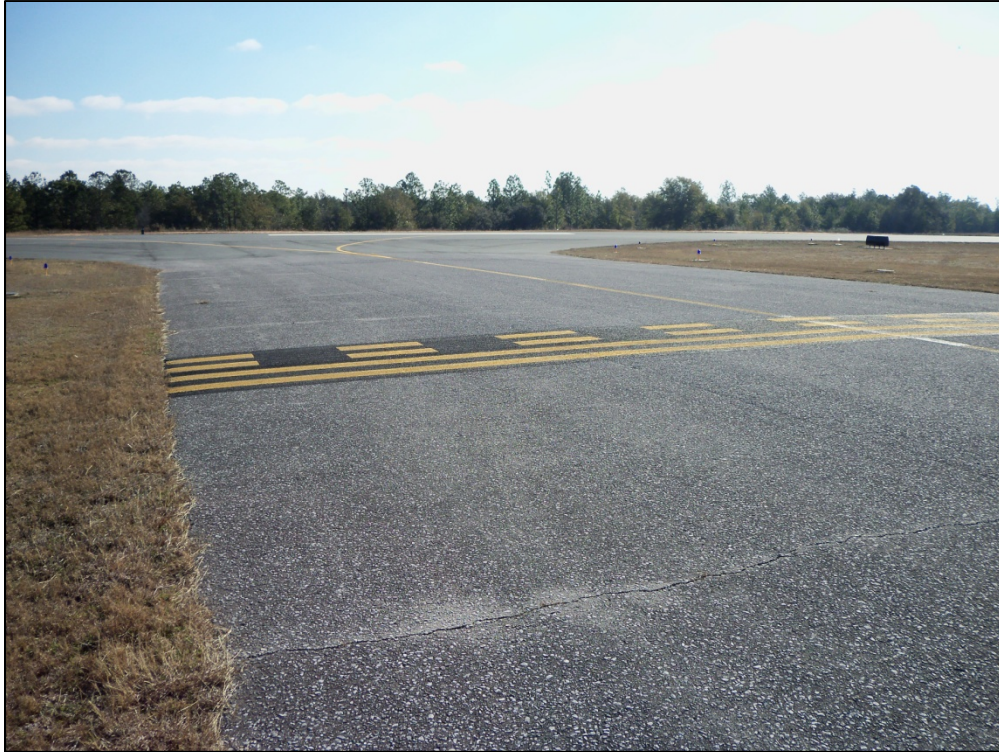
Taxiway A4, Section 110, Sample Unit 153 – Low severity (43) Block Cracking, low severity (48) Longitudinal and Transverse Cracking, low severity (52) Weathering and Raveling

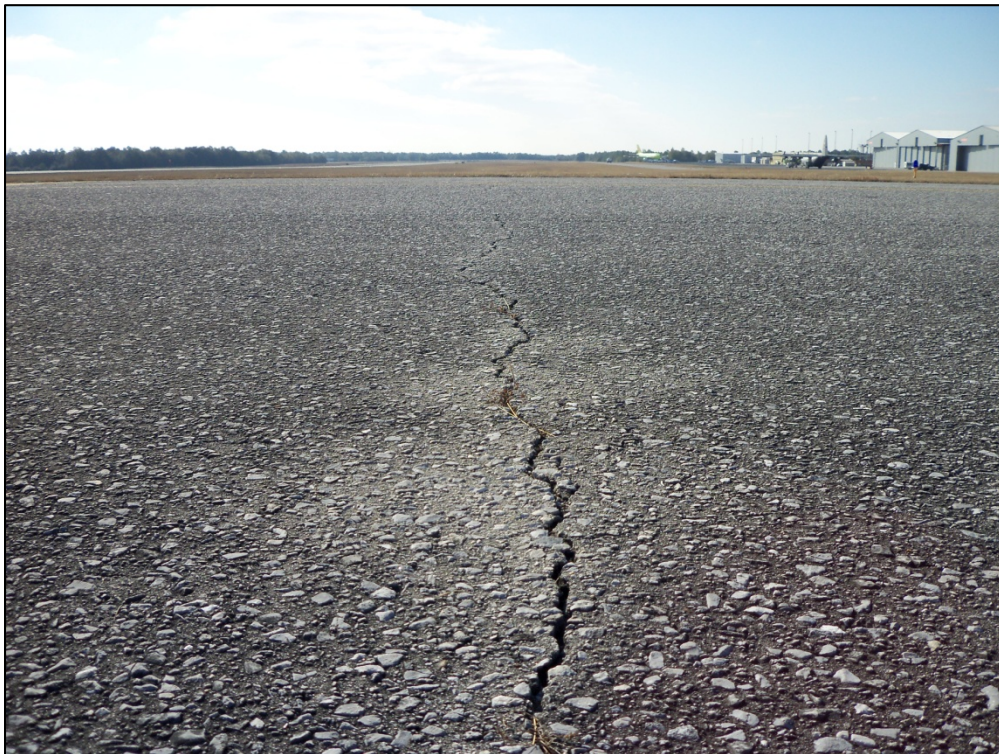
Taxiway A4, Section 110, Sample Unit 153 – Low severity (43) Block Cracking, low severity (48) Longitudinal and Transverse Cracking, low severity (52) Weathering and Raveling
