**STATE OF FLORIDA
DEPARTMENT OF TRANSPORTATION
AVIATION OFFICE**

**Statewide Airfield Pavement
Management Program**

**Carrabelle-Thompson Airport – X13
(General Aviation)
Carrabelle, Florida
(District 3)**

May 2011

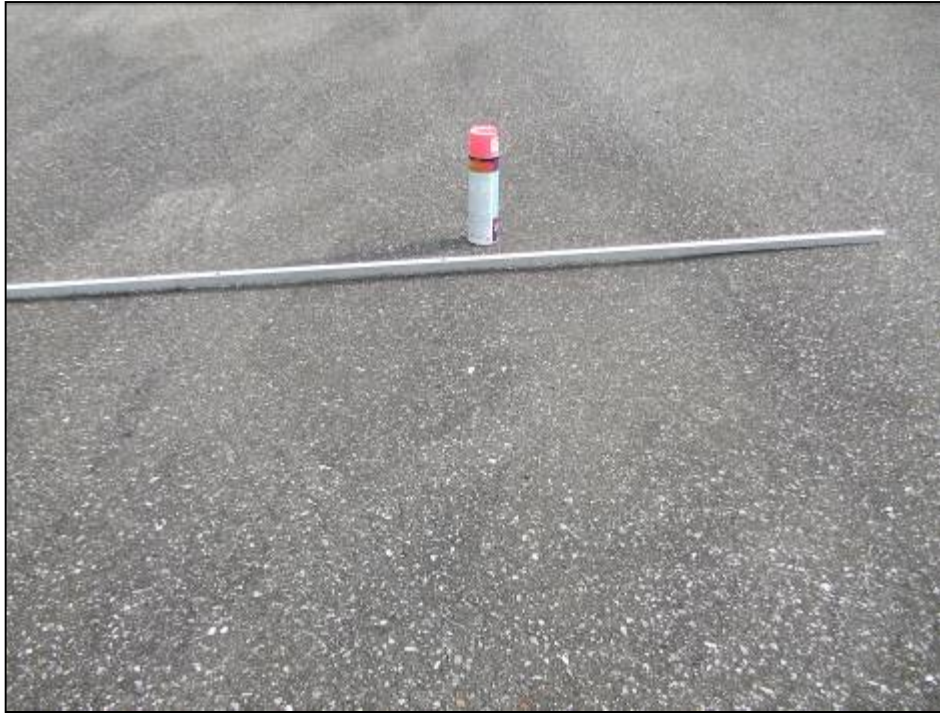
Apron Section 4105, Sample Unit 100 – Low severity (45) Depression, low severity (48) Longitudinal and Transverse Cracking, low severity (52) Weathering and Raveling, low severity (56) Swelling.

The immediate M&R needs, or needs that have been programmed to be completed in the first year of the 10-year M&R plan based on an unlimited budget at Carrabelle-Thompson Airport, include: Apron Section 4105 and Taxiway A Section 105. The primary distresses exhibited by these pavements include raveling and longitudinal / transverse cracking. The apron area was also observed to contain localized areas of deformation in the form of both swelling and depression. Based on the inspection data, the areas require reconstruction and mill and overlay. The immediate needs are summarized in Table IV below.

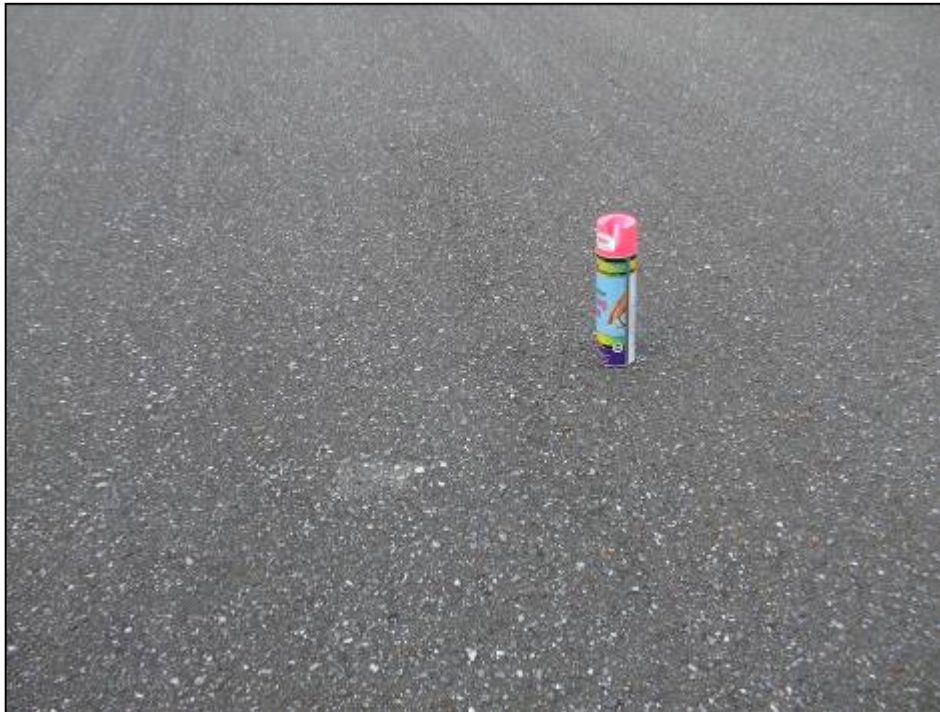
Runway 5-23 Section 6105, Sample Unit 175 – Low and medium severity (48) Longitudinal and Transverse Cracking, low severity (52) Weathering and Raveling.

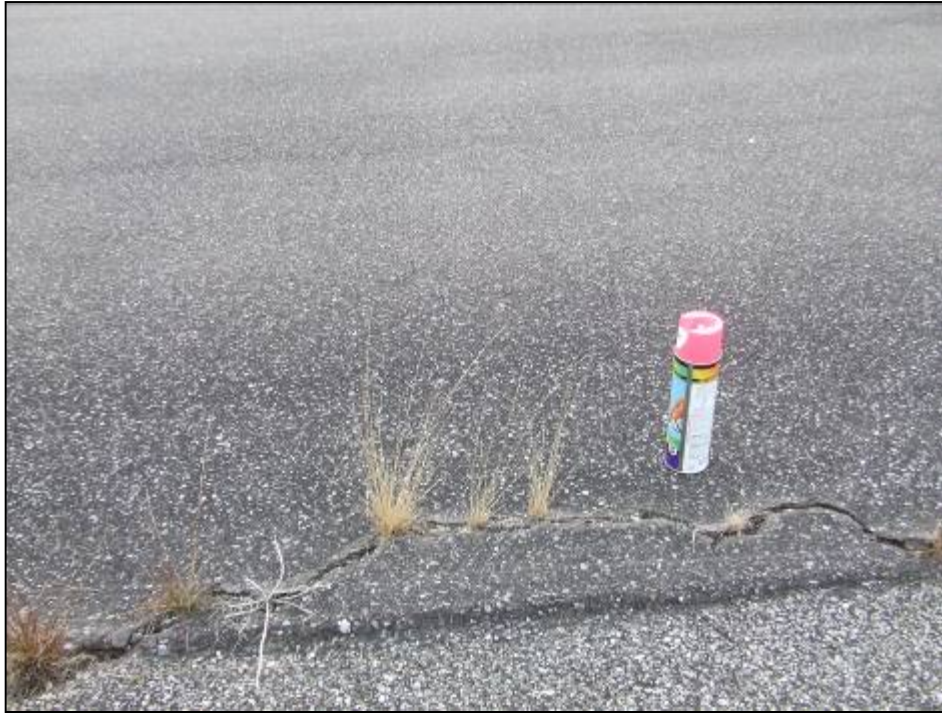
Runway 5-23 Section 6105, Sample Unit 175 – Low and medium severity (48) Longitudinal and Transverse Cracking, low severity (52) Weathering and Raveling.

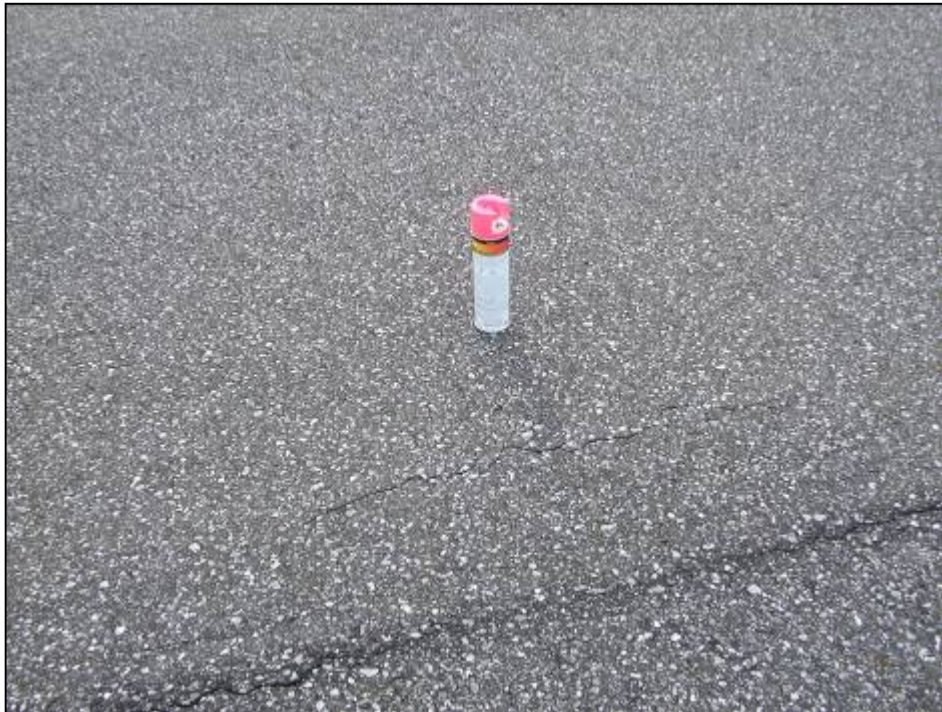
Runway 5-23 Section 6105, Sample Unit 139 – Low and medium severity (48) Longitudinal and Transverse Cracking, low severity (52) Weathering and Raveling, low severity (56) Swelling.

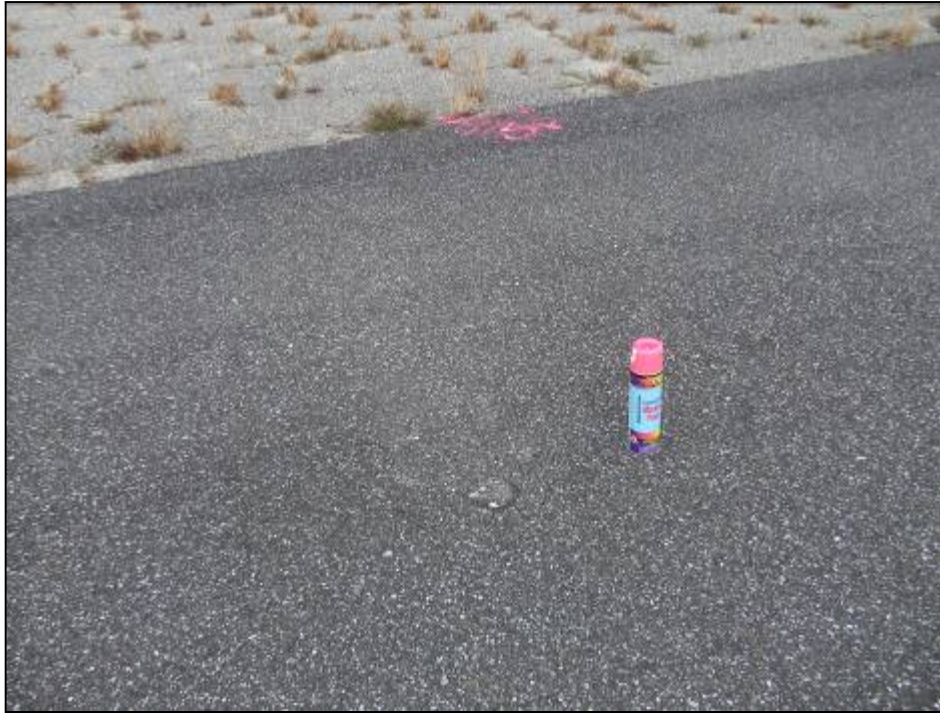
Runway 5-23 Section 6105, Sample Unit 115 – Low and medium severity (48) Longitudinal and Transverse Cracking, low severity (50) Patching, low severity (52) Weathering and Raveling.

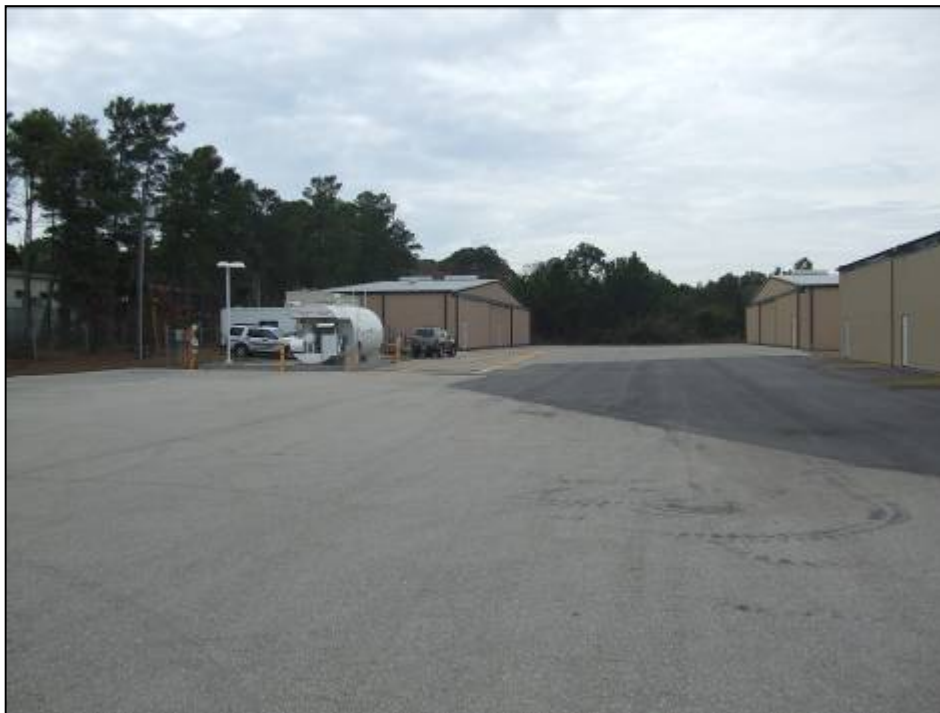
Apron Section 4115, Sample Unit 201 – Low severity (48) Longitudinal and Transverse Cracking, low severity (49) Oil Spillage, low severity (50) Patching.
