**STATE OF FLORIDA
DEPARTMENT OF TRANSPORTATION
AVIATION OFFICE**

**Statewide Airfield Pavement
Management Program**

**Clearwater Airpark– CLW
(Regional Reliever)
Clearwater, Florida
(District 7)**

January 2012

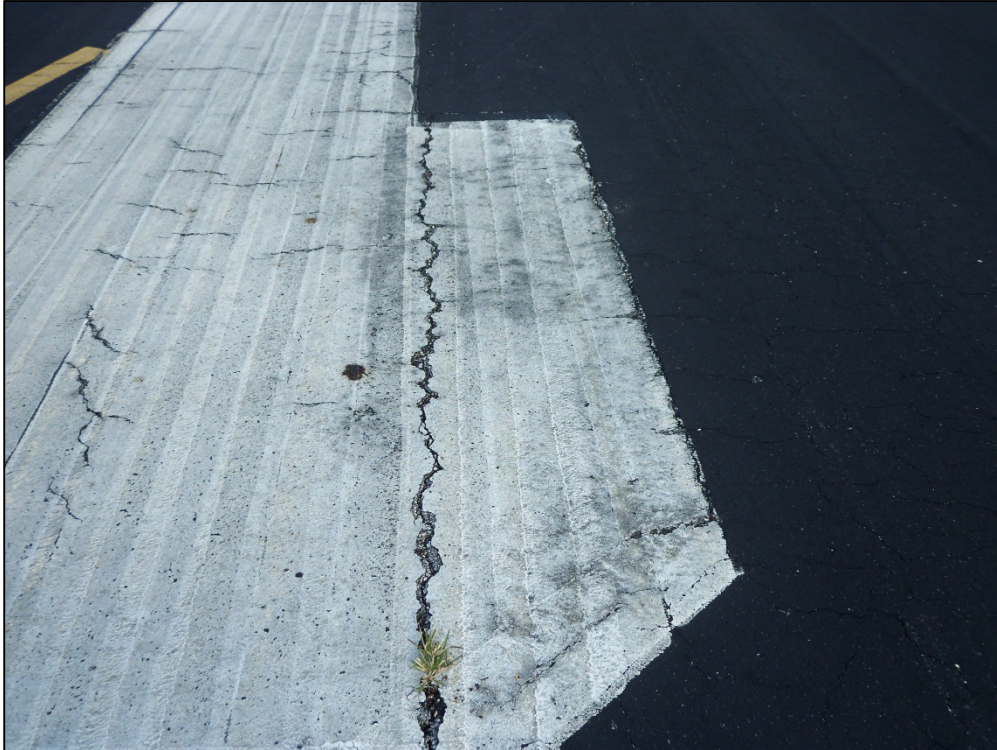
The asphalt pavement on Runway 16-34 exhibited low and medium severity longitudinal/transverse cracking, low and medium severity weathering/raveling, low severity patching, low severity block cracking and low severity swelling. These are climate, age related distresses. Runway 16-34 has a PCI range of 53-69, which is considered below critical.

Runway 16-34, Section 6110, Sample Unit 158 – Low severity (48) Longitudinal and Transverse Cracking, (52) Weathering and Raveling

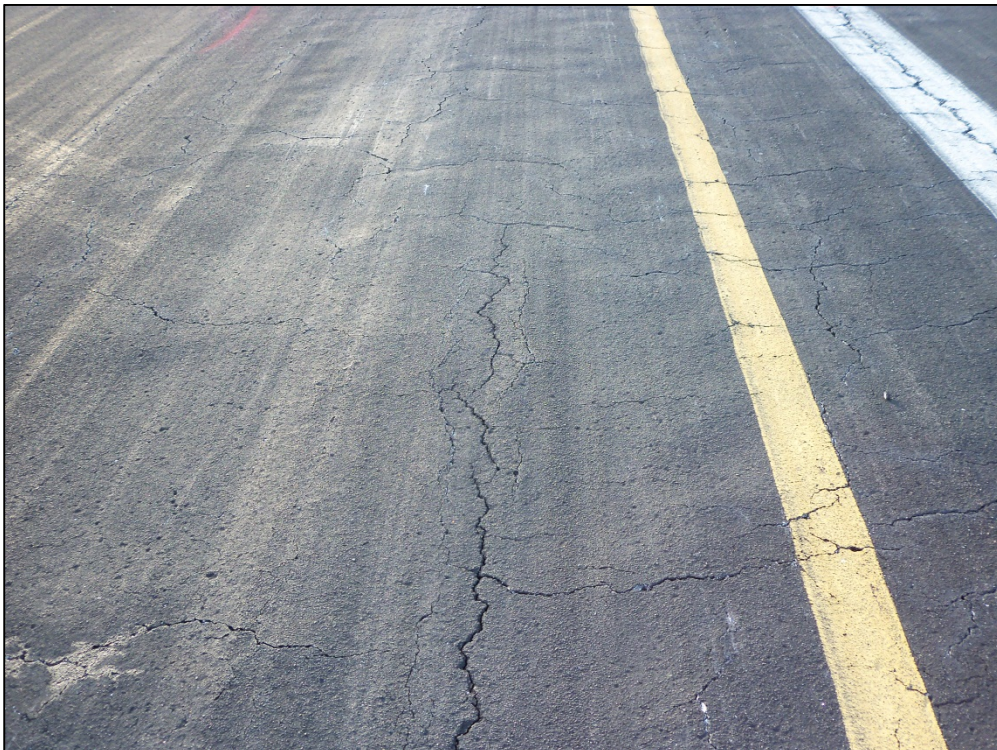
Runway 16-34, Section 6110, Sample Unit 155 – Low severity (43) Block Cracking, (48) Longitudinal and Transverse Cracking

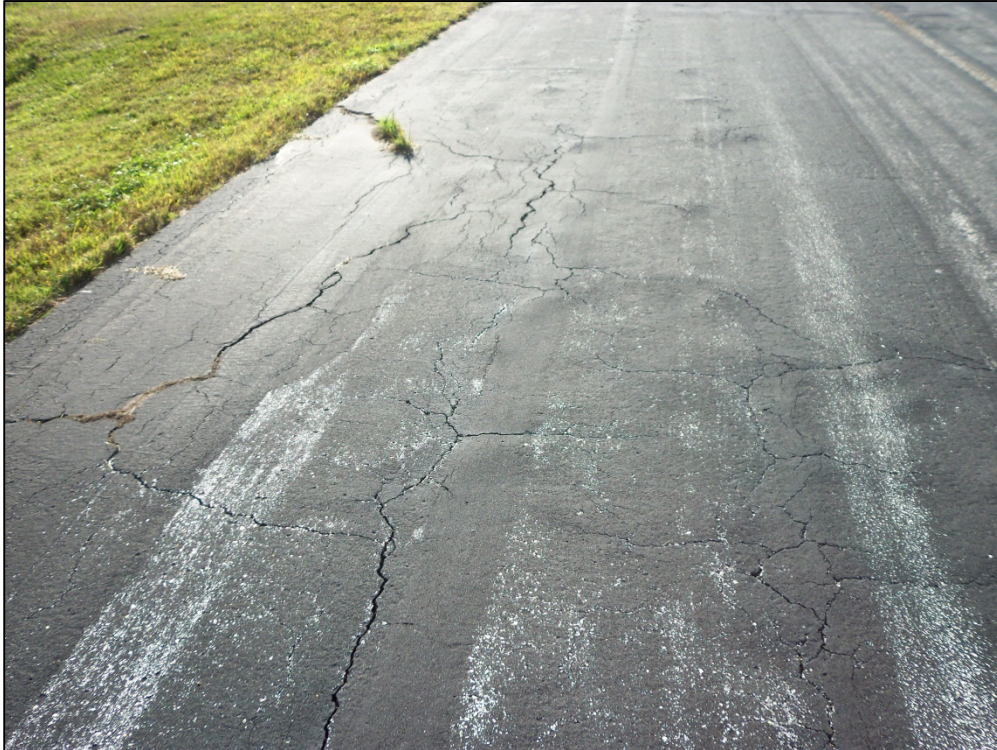
Taxiway A pavements exhibited medium severity patching, low severity swelling, low severity block cracking, low and high severity longitudinal/transverse cracking, low and medium severity weathering and raveling. These are climate and age related distresses. Taxiway Alpha has a PCI range of 53-69, which is considered below critical.

Taxiway Alpha, Section 105, Sample Unit 114 – Low severity (43) Block Cracking, High severity (48) Longitudinal and Transverse Cracking, Low severity (52) Raveling and Weathering

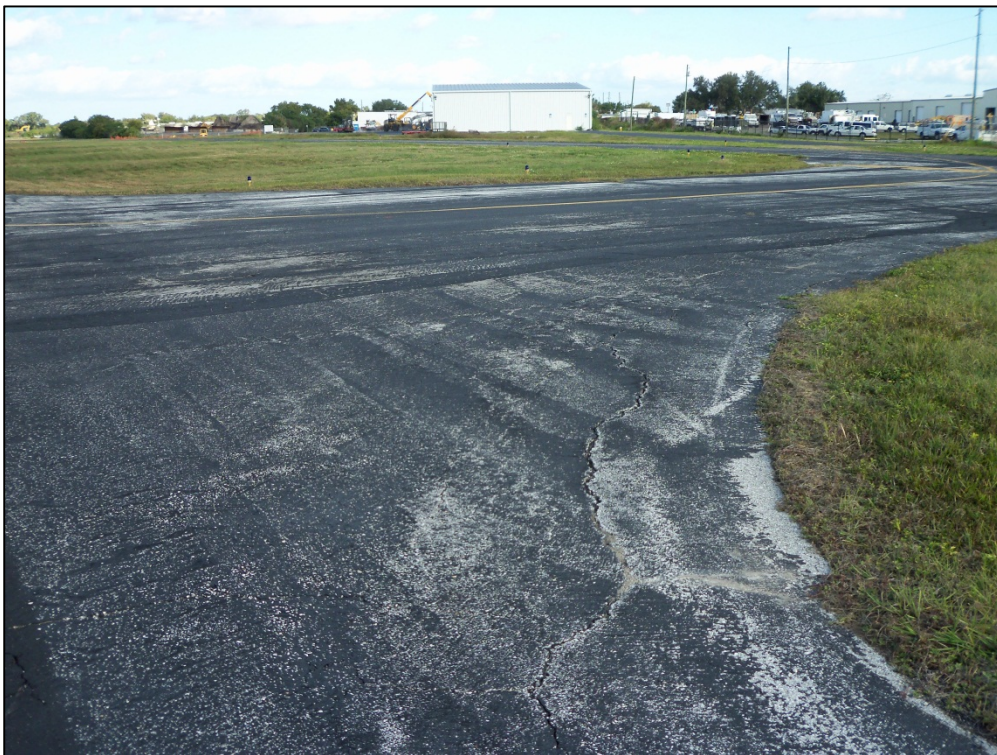
Taxiway A-3, A-2 and Center Apron pavements exhibited low and medium severity longitudinal/transverse cracking, low severity block cracking and low and medium severity weathering/raveling. These are climate and age related distresses. These areas are in Very Poor condition. The Apron at T-Hangars 1 and the Run-up Apron at Runway 34 exhibited similar distresses and are in Poor condition.

Taxiway Connector A-2, Section 120, Sample Unit 200 – Medium severity (48) Longitudinal and Transverse Cracking, (52) Raveling and Weathering

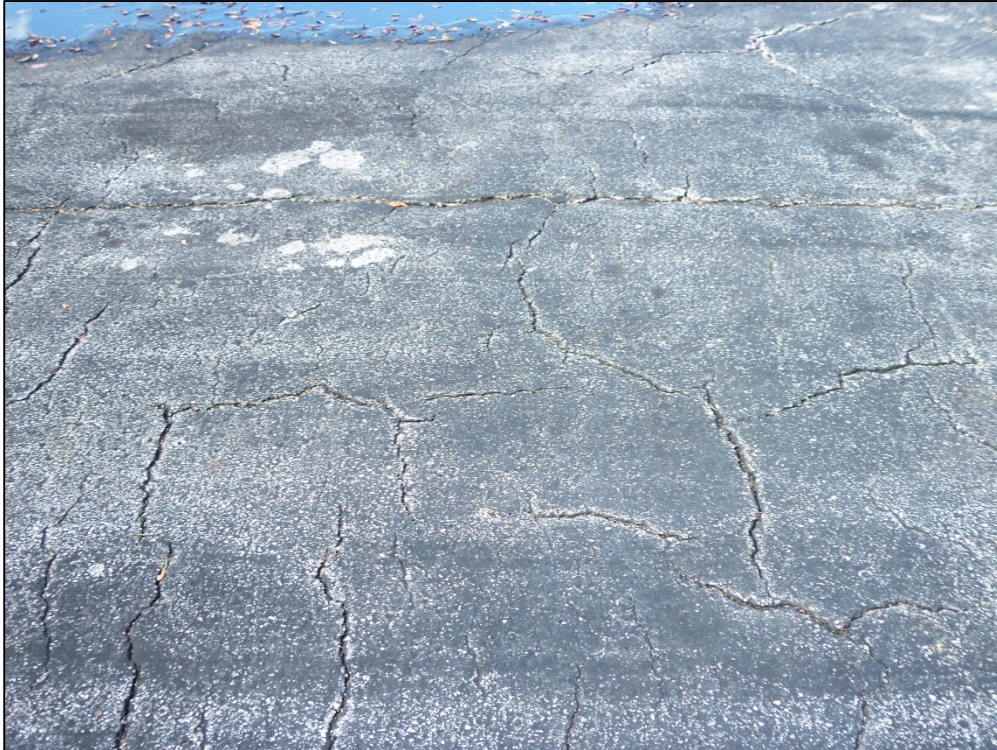
Apron Center, Section 4405, Sample Unit 200 – Medium severity (43) Block Cracking, Low severity (52) Raveling and Weathering

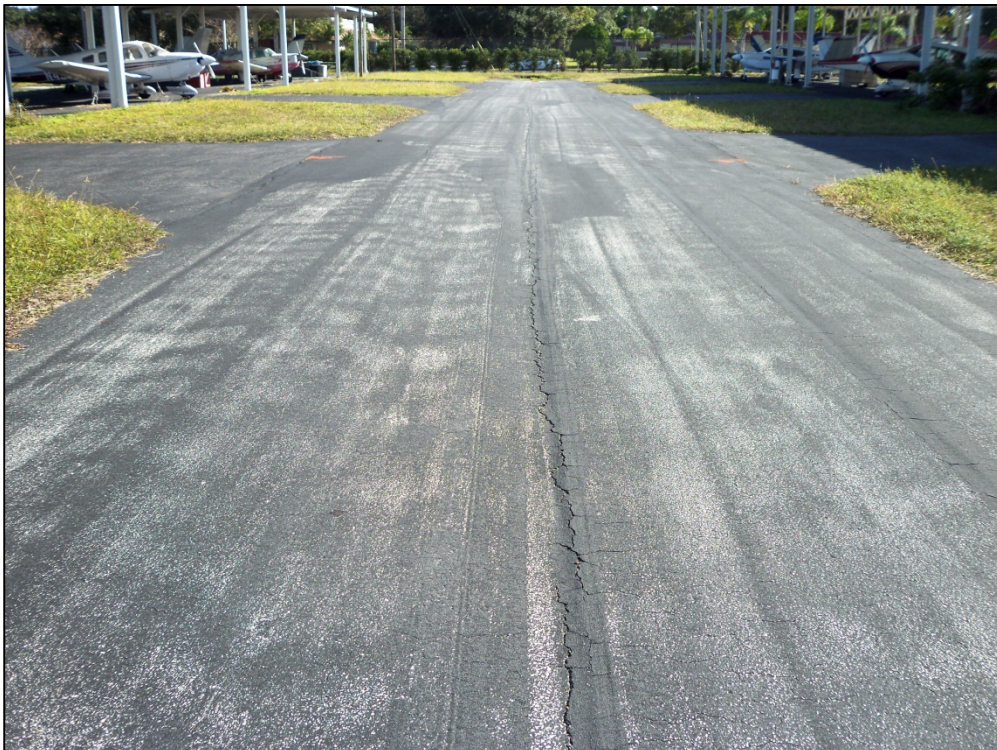
Apron T-Hangar, Section 4105, Sample Unit 201 – Low severity (48) Longitudinal and Transverse Cracking, (52) Raveling and Weathering
