**STATE OF FLORIDA  
DEPARTMENT OF TRANSPORTATION  
AVIATION OFFICE**

**Statewide Airfield Pavement  
Management Program**

**Crystal River Airport –CGC  
(General Aviation)  
Crystal River, Florida  
(District 7)**

**May 2011**

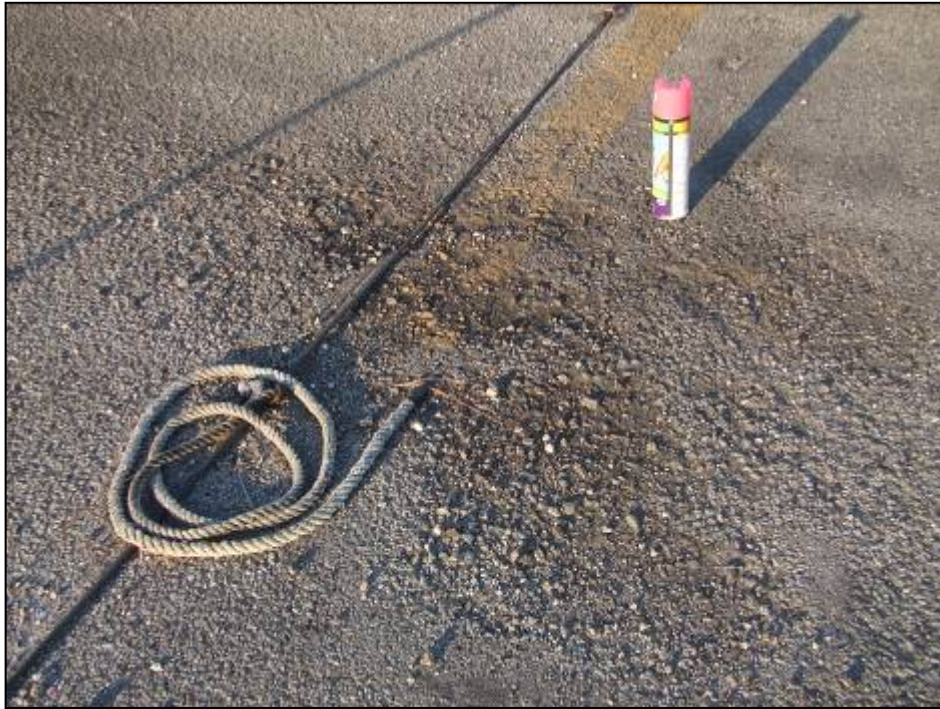
Main Apron, Section 4110, Sample Unit 198 – Low severity (45) Depression; low severity (49) Oil Spillage; low severity (50) Patching; low, medium and high severity (52) Weathering and Raveling.

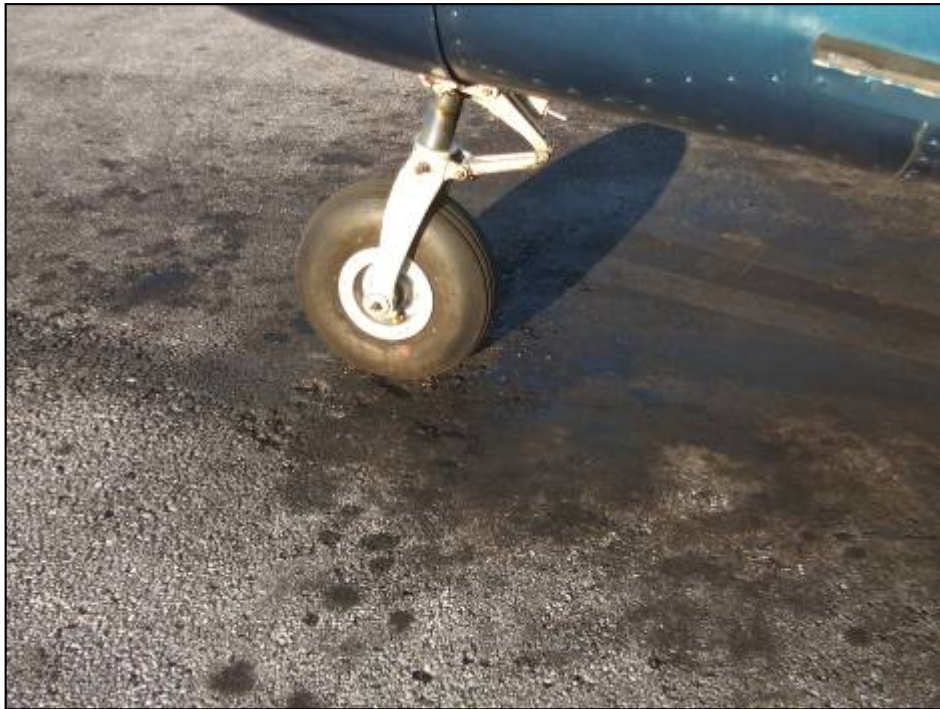
Main Apron, Section 4110, Sample Unit 198 – Low severity (45) Depression; low severity (49) Oil Spillage; low severity (50) Patching; low, medium and high severity (52) Weathering and Raveling.

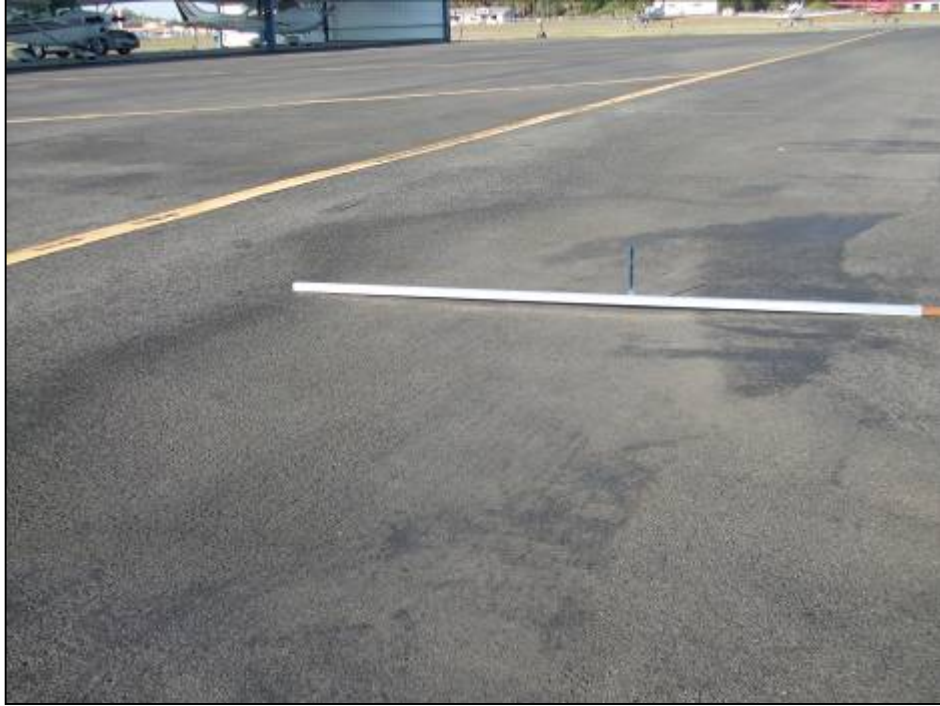
Main Apron, Section 4110, Sample Unit 198 – Low severity (45) Depression; low severity (49) Oil Spillage; low severity (50) Patching; low, medium and high severity (52) Weathering and Raveling.

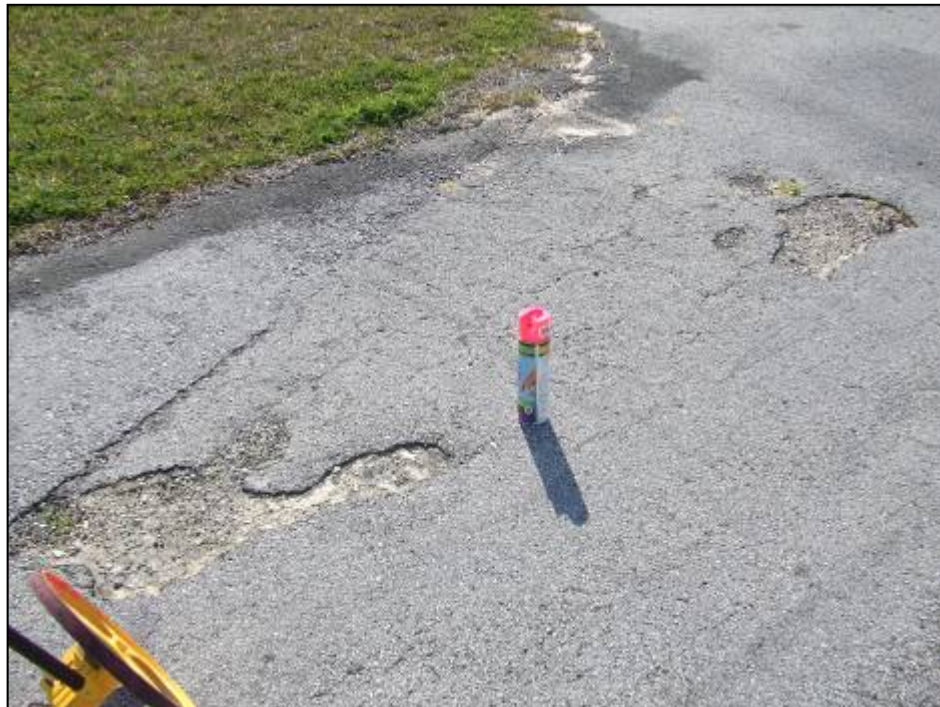
Connector Taxiway to AP exhibited low to high severity weathering and raveling, and medium severity patching. Low severity depression, swelling, and longitudinal and transversal cracking distresses were also observed. Parallel Taxiway to RW 9-27 was in good condition with small areas exhibiting low severity weathering and raveling. Additional low severity distresses such as longitudinal and transversal cracking, patching and swelling were observed.

Connector Taxiway to AP, Section 205, Sample Unit 103 – Low severity (45) Depression, low severity (48) Longitudinal and Transverse Cracking, medium severity (50) Patching, medium and high severity (52) Weathering and Raveling.

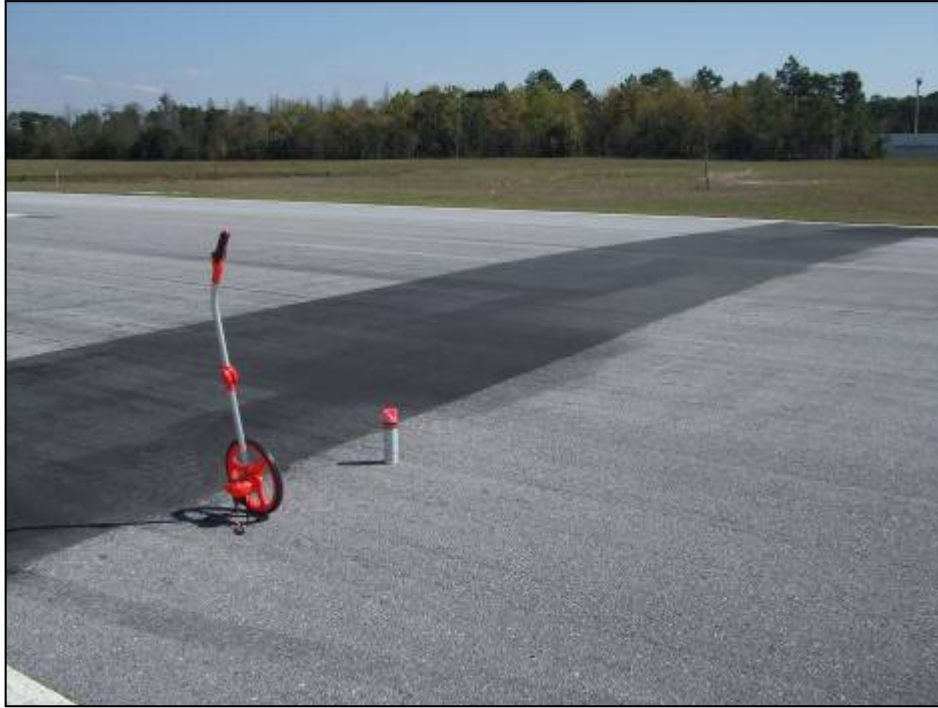
The asphalt concrete pavement of runway 9-27 exhibited low to medium severity weathering and raveling, and low severity longitudinal and transversal cracking, in addition to low severity distresses such as: swelling, and patching.

Runway 9-27, Section 6105, Sample Unit 146 – Low severity (48) Longitudinal and Transverse Cracking, low severity (50) Patching, low and medium severity (52) Weathering and Raveling.

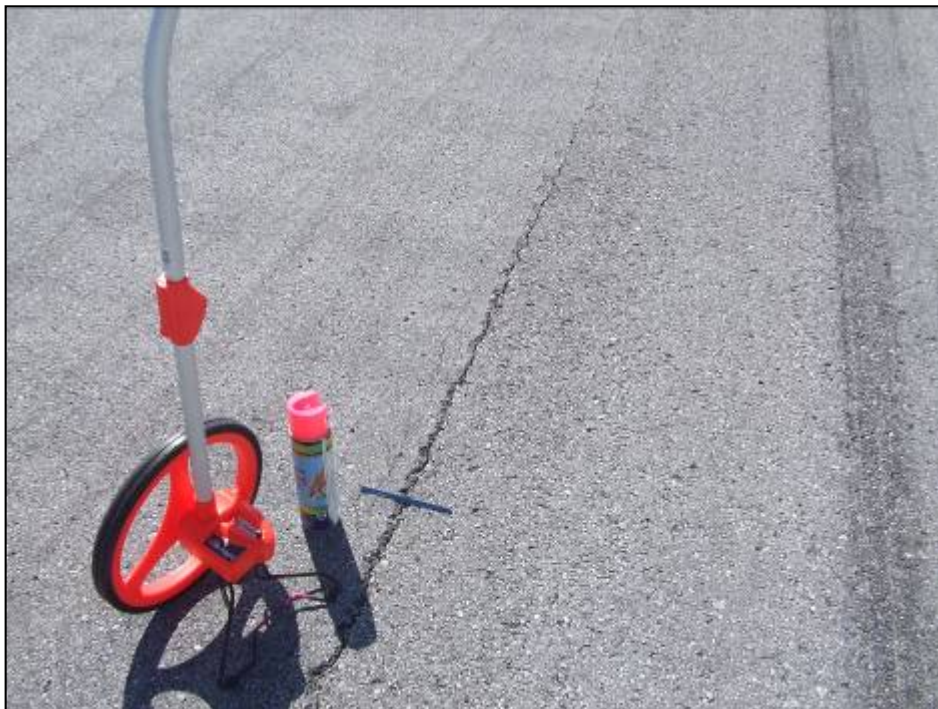
Runway 9-27, Section 6110, Sample Unit 161 –Low severity (48) Longitudinal and Transverse Cracking, low and medium severity (52) Weathering and Raveling.
