**STATE OF FLORIDA
DEPARTMENT OF TRANSPORTATION
AVIATION OFFICE**

**Statewide Airfield Pavement
Management Program**

**Dade-Collier Training and Transition Airport– TNT
(General Aviation)
Miami, Florida
(District 6)**

May 2012

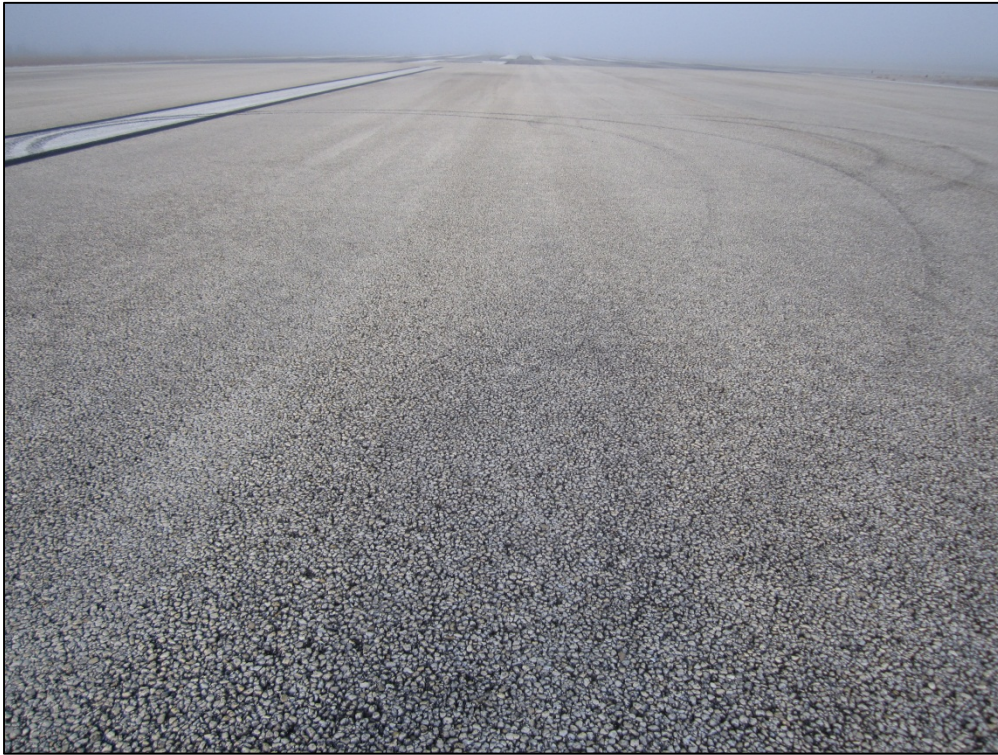
Runway 9-27, Section 6105, Sample Unit 304 – Low severity (52) Weathering and Raveling

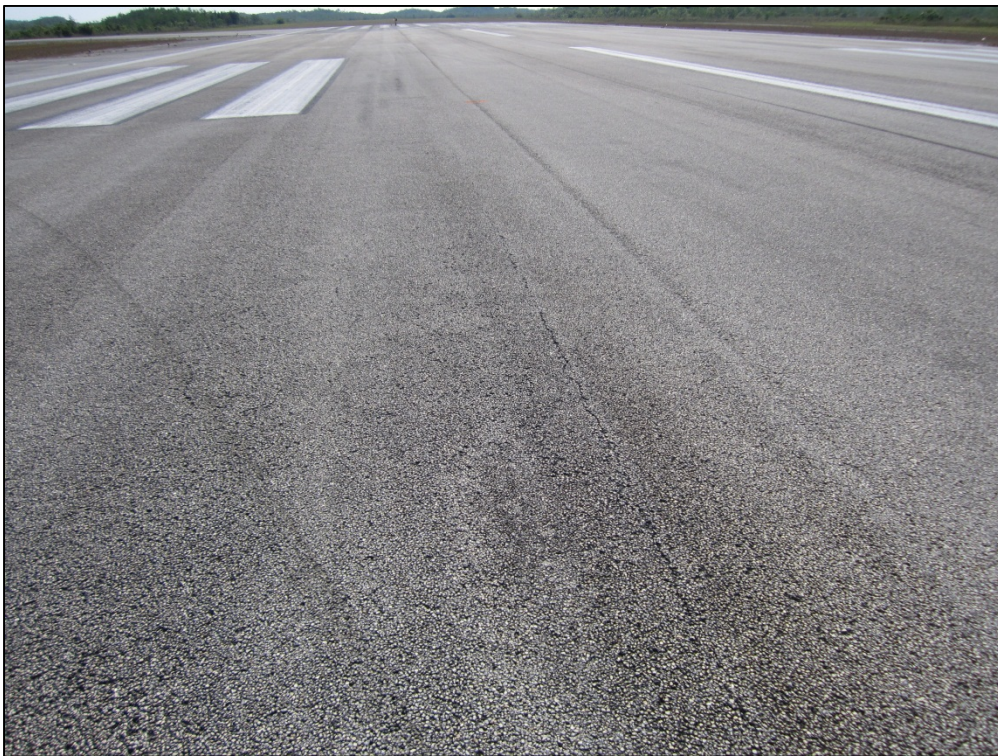
Runway 9-27 is surfaced with asphalt concrete and exhibited low to medium severity weathering and raveling; low severity longitudinal and transverse cracking; and low severity swelling. Runway 9-27 has an average PCI of 70 with a condition rating of Fair. It is currently above the FAA minimum PCI level, although it is below the FDOT minimum PCI level.

Runway 9-27, Section 6110, Sample Unit 198 – Low to medium severity (52) Weathering and Raveling; low severity (48) Longitudinal and Transverse Cracking; low severity (56) Swelling

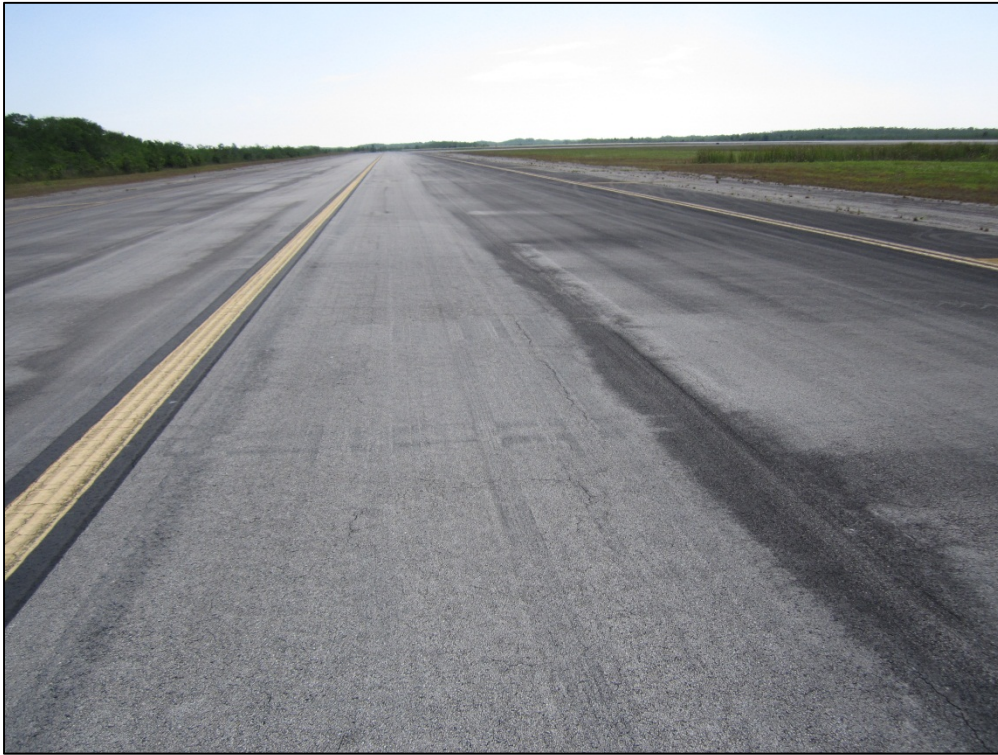
The taxiways are all surfaced with asphalt concrete pavement and exhibited similar distresses. Weathering and raveling and longitudinal and transverse cracking were found on all taxiway pavements and typically were low severity, although medium severity weathering and raveling was present throughout Taxiway A-1. Low severity swelling was found on the majority of the taxiways, and low severity block cracking was found in isolated areas. One isolated area of rutting was recorded on Taxiway Alpha.

Taxiway Alpha, Section 105, Sample Unit 237 – Low severity (52) Weathering and Raveling; low severity (48) Longitudinal and Transverse Cracking; low severity (56) Swelling; low severity (53) Rutting

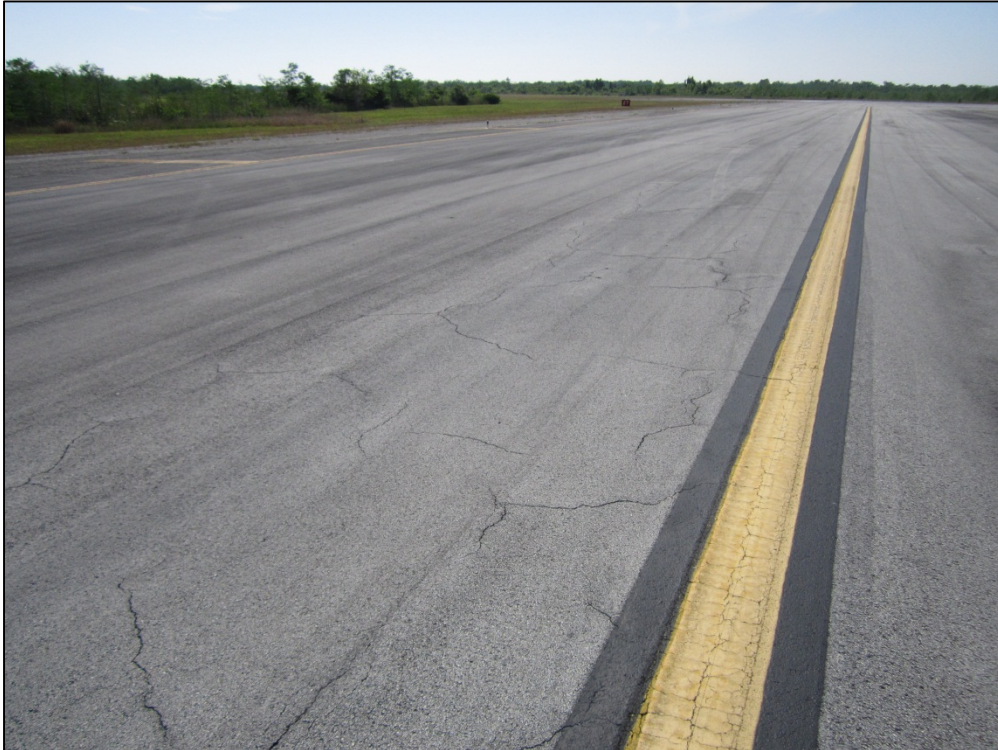
Taxiway Alpha, Section 180, Sample Unit 111 – Low severity (52) Weathering and Raveling; low severity (48) Longitudinal and Transverse Cracking; low severity (56) Swelling

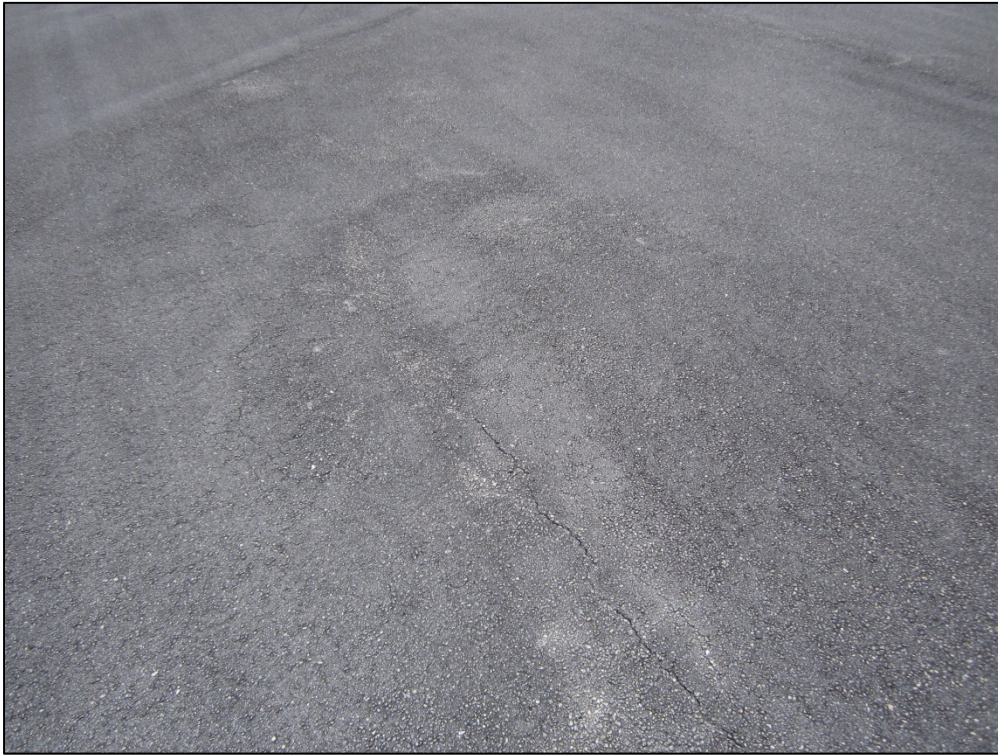
Taxiway A-4, Section 150, Sample Unit 417 – Low severity (52) Weathering and Raveling; low severity (48) Longitudinal and Transverse Cracking; low severity (56) Swelling

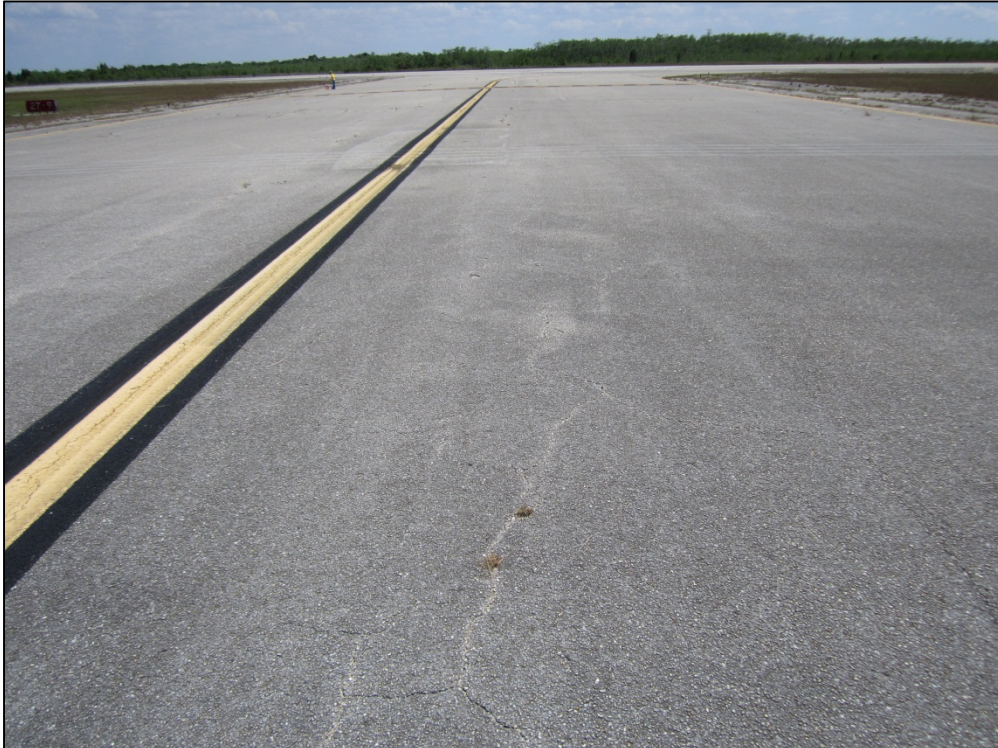
Taxiway A-6, Section 170, Sample Unit 608 – Low severity (52) Weathering and Raveling; low severity (48) Longitudinal and Transverse Cracking

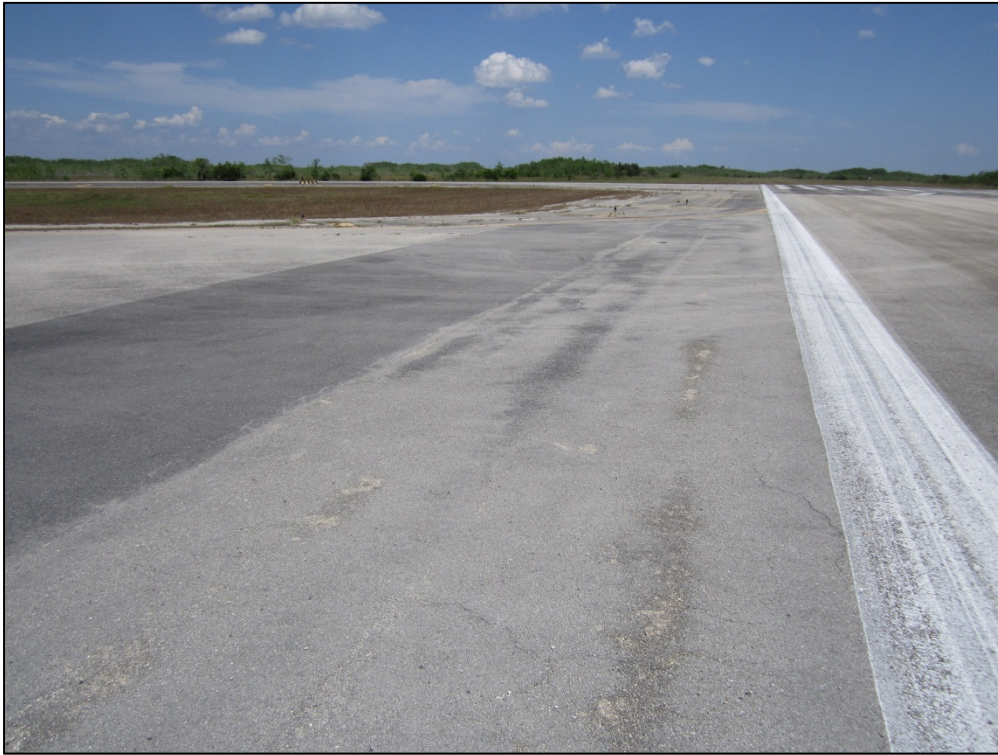
Taxiway A-6, Section 176, Sample Unit 600 – Low severity (52) Weathering and Raveling; low severity (48) Longitudinal and Transverse Cracking; low severity (56) Swelling
