**STATE OF FLORIDA  
DEPARTMENT OF TRANSPORTATION  
AVIATION OFFICE**

**Statewide Airfield Pavement  
Management Program**

**DeFuniak Springs Municipal Airport– 54J  
(General Aviation)  
DeFuniak Springs, Florida  
(District 3)**

**May 2011**

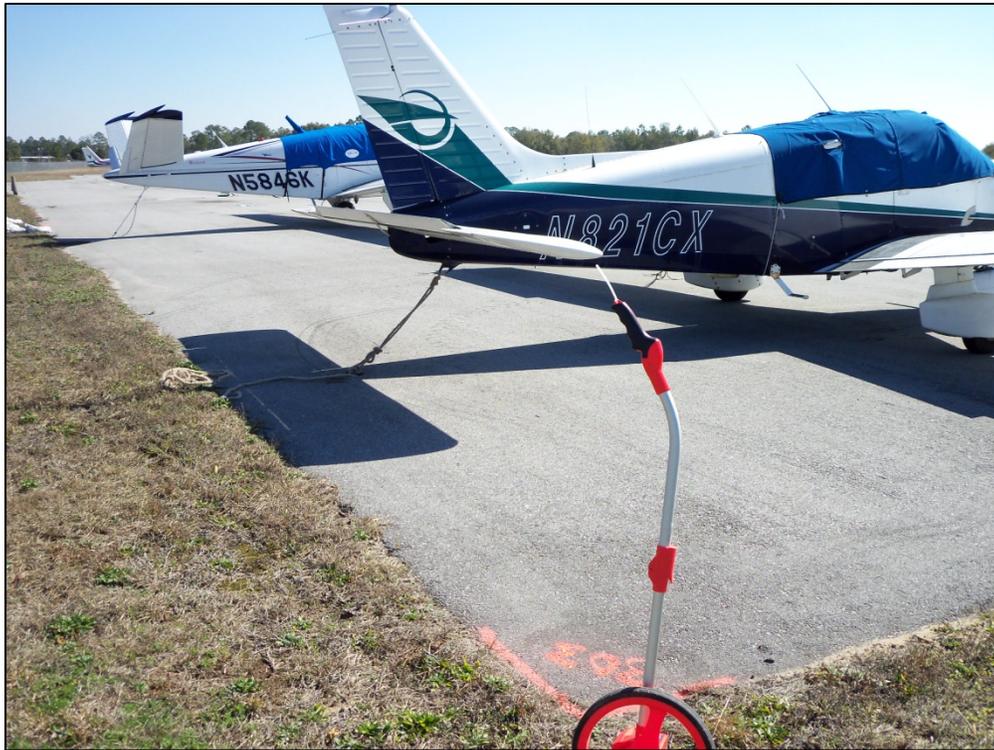
Apron, Section 4110, Sample Unit 303 – Low severity (52) Weathering and Raveling

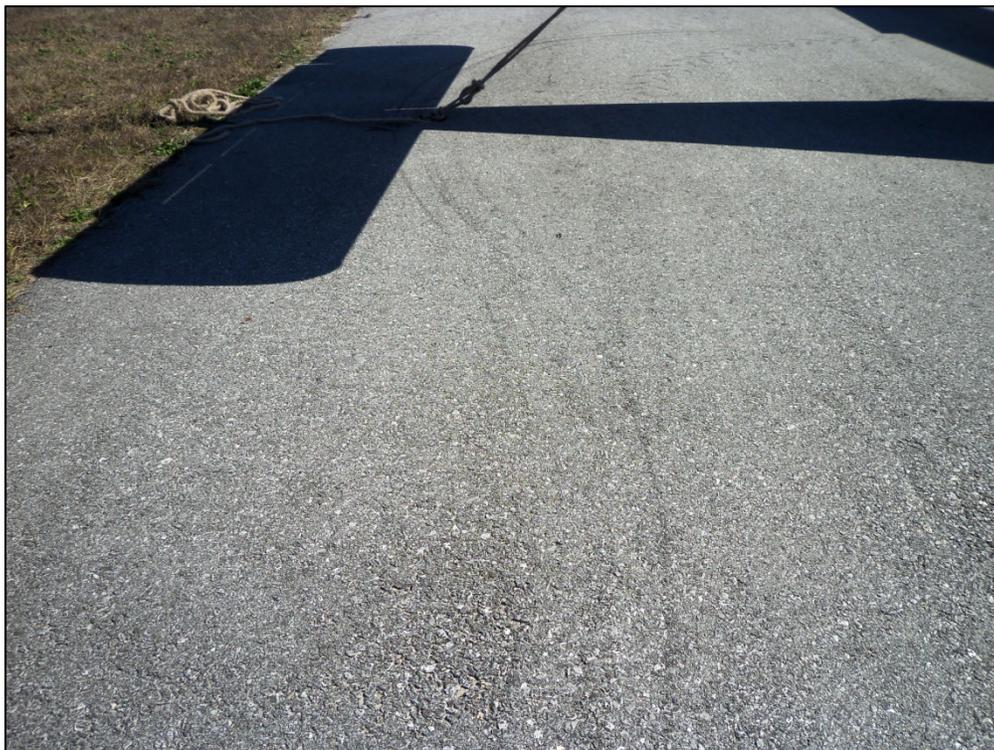
Apron, Section 4110, Sample Unit 303 – Low severity (52) Weathering and Raveling

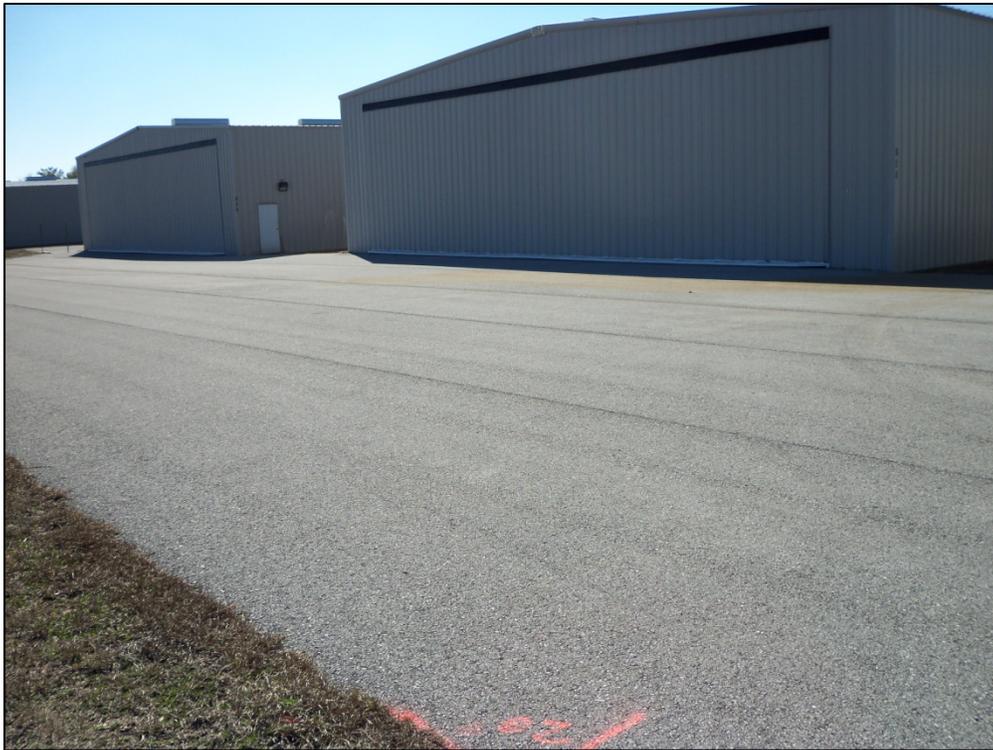
Apron, Section 4310, Sample Unit 208 – Low severity (48) Longitudinal and Transverse Cracking, low severity (52) Weathering and Raveling

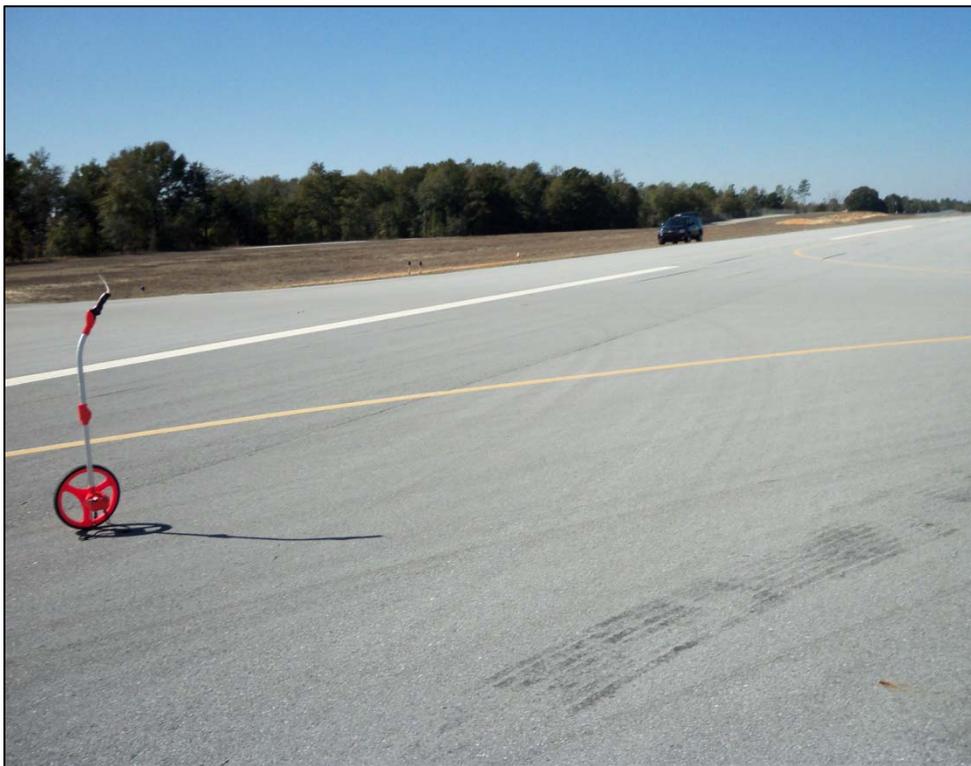
Runway 9-27, Section 6110, Sample Unit 112 – No distresses observed

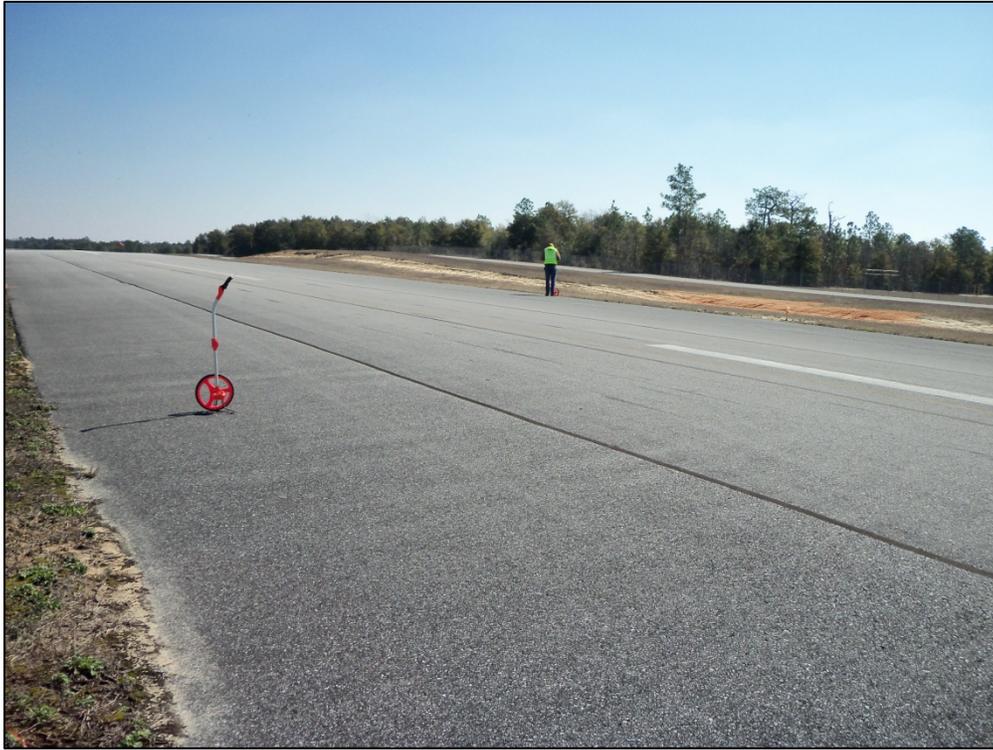
Runway 9-27, Section 6120, Sample Unit 95 – Low severity (48) Longitudinal and Transverse Cracking, low severity (52) Weathering and Raveling

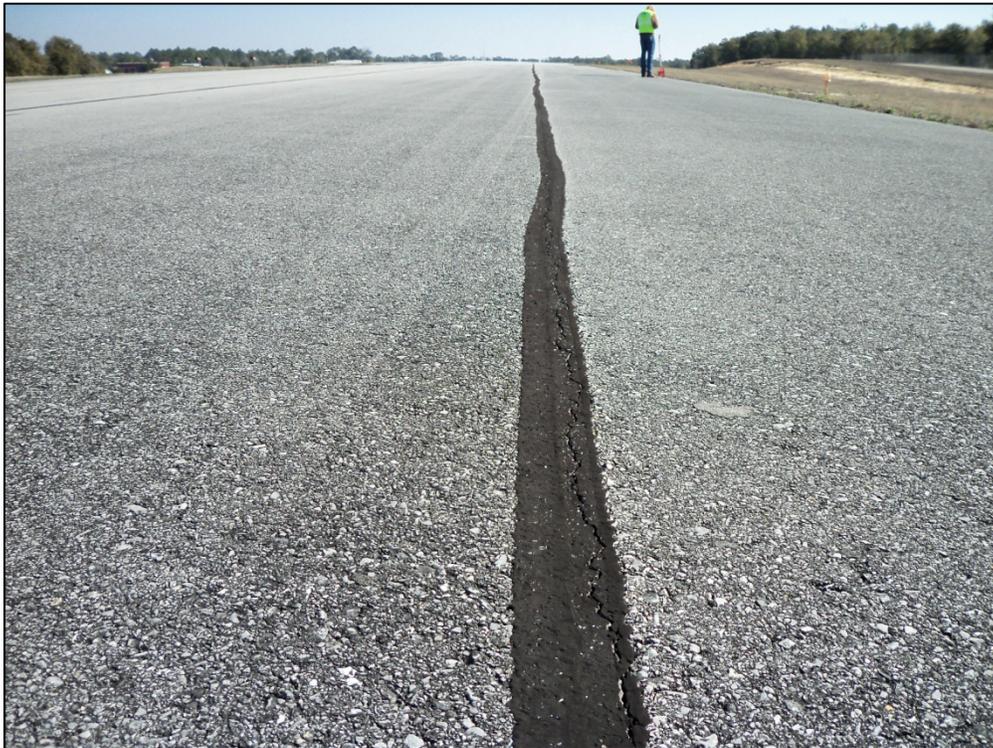
Runway 9-27, Section 6120, Sample Unit 95 – Low severity (48) Longitudinal and Transverse Cracking, low severity (52) Weathering and Raveling

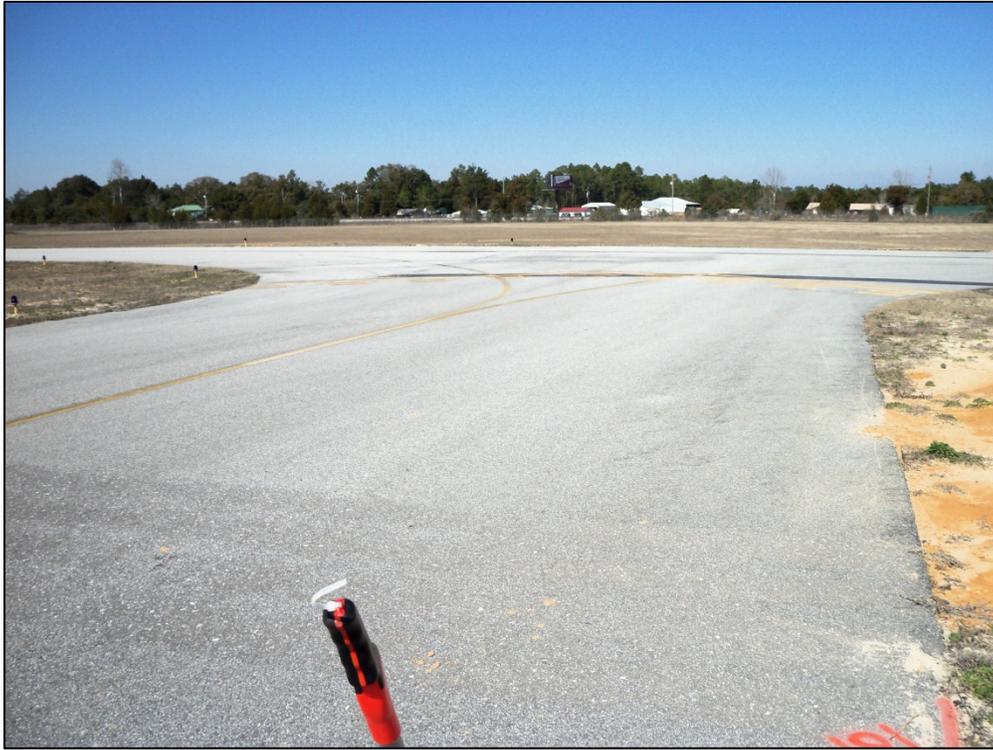
Taxiway Connector RW 9, Section 605, Sample Unit 101 – Low severity (48) Longitudinal and Transverse Cracking, low severity (52) Weathering and Raveling

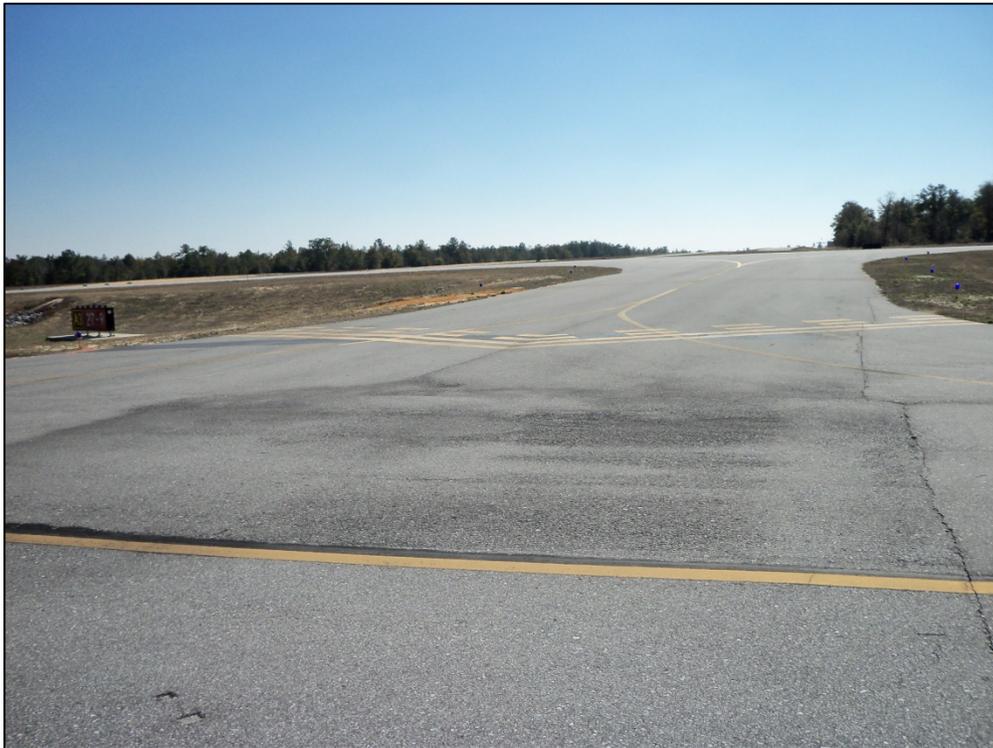
Taxiway Connector RW 9, Section 605, Sample Unit 101 – Low severity (48) Longitudinal and Transverse Cracking, low severity (52) Weathering and Raveling

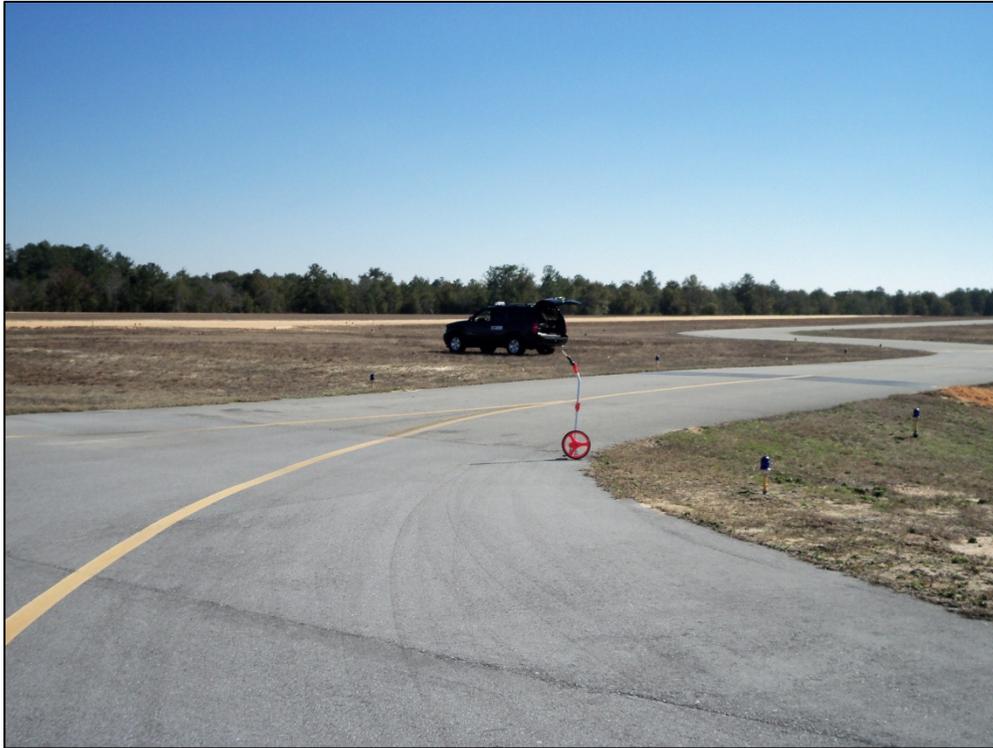
Taxiway Sierra, Section 710, Sample Unit 116 – Low severity (48) Longitudinal and Transverse Cracking, low and medium severity (52) Weathering and Raveling

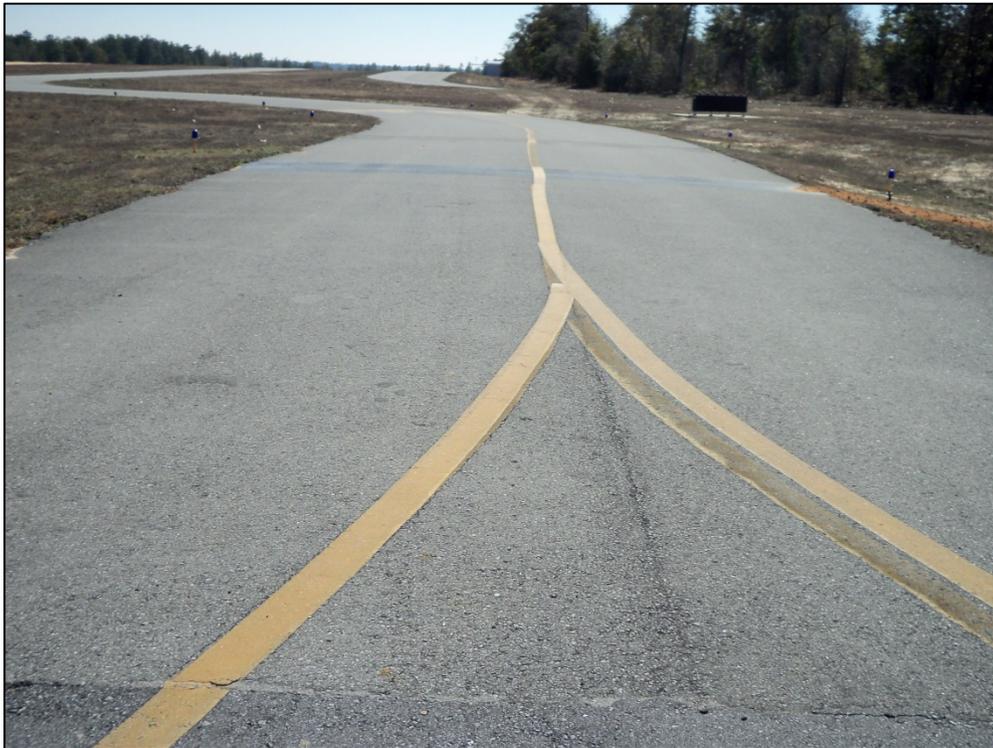
Taxiway Sierra, Section 710, Sample Unit 116 – Low severity (48) Longitudinal and Transverse Cracking, low and medium severity (52) Weathering and Raveling
