**STATE OF FLORIDA
DEPARTMENT OF TRANSPORTATION
AVIATION OFFICE**

**Statewide Airfield Pavement
Management Program**

**Everglades Airpark– X01
(General Aviation)
Everglades City, Florida
(District 1)**

May 2011

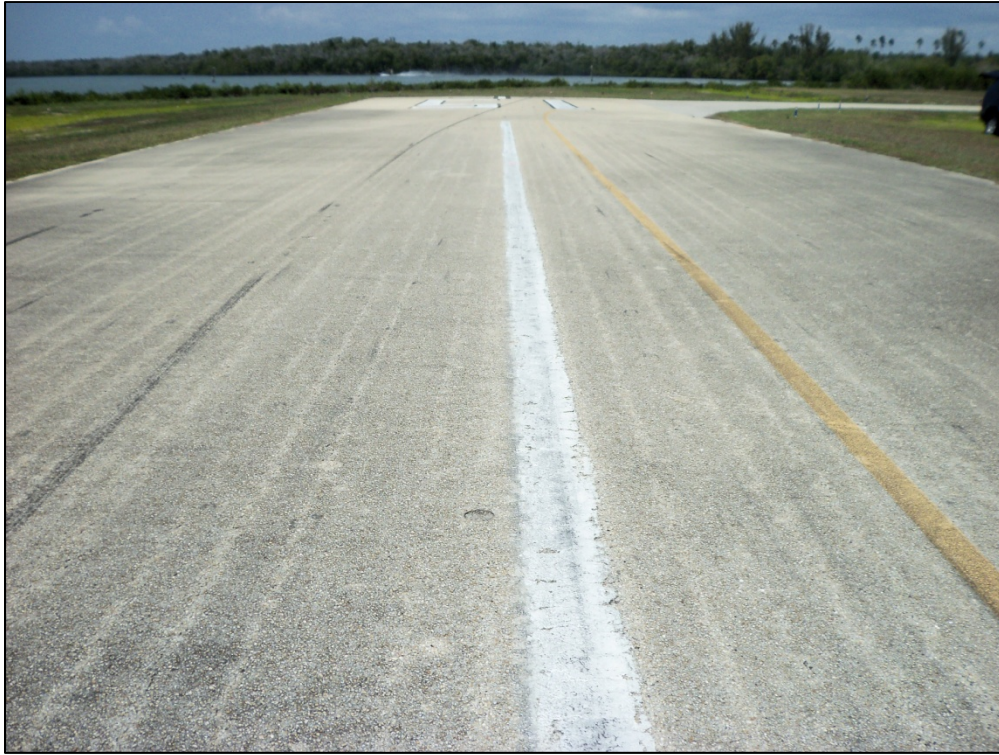
Runway 15-33, Section 6105, Sample Unit 101 – Low severity (48) Longitudinal and Transverse Cracking, low and medium severity (52) Weathering and Raveling

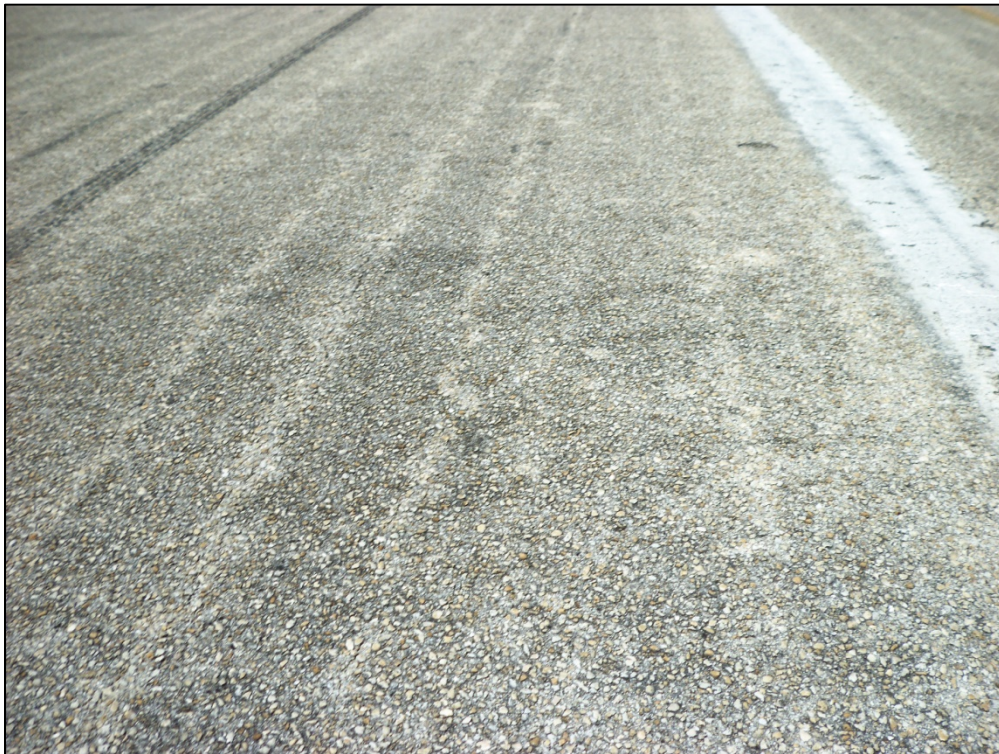
Runway 15-33, Section 6105, Sample Unit 101 – Low severity (48) Longitudinal and Transverse Cracking, low and medium severity (52) Weathering and Raveling

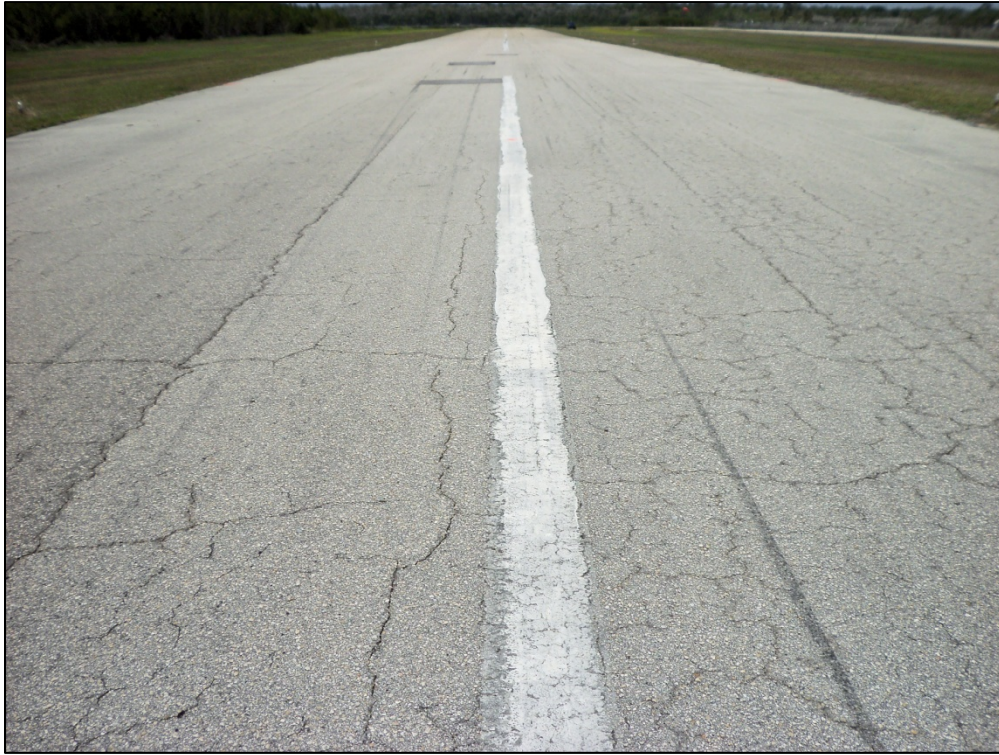
Runway 15-33, Section 6110, Sample Unit 109 – Medium severity (43) Block Cracking, low severity (45) Depression, medium severity (50) Patch, low and medium severity (52) Weathering and Raveling

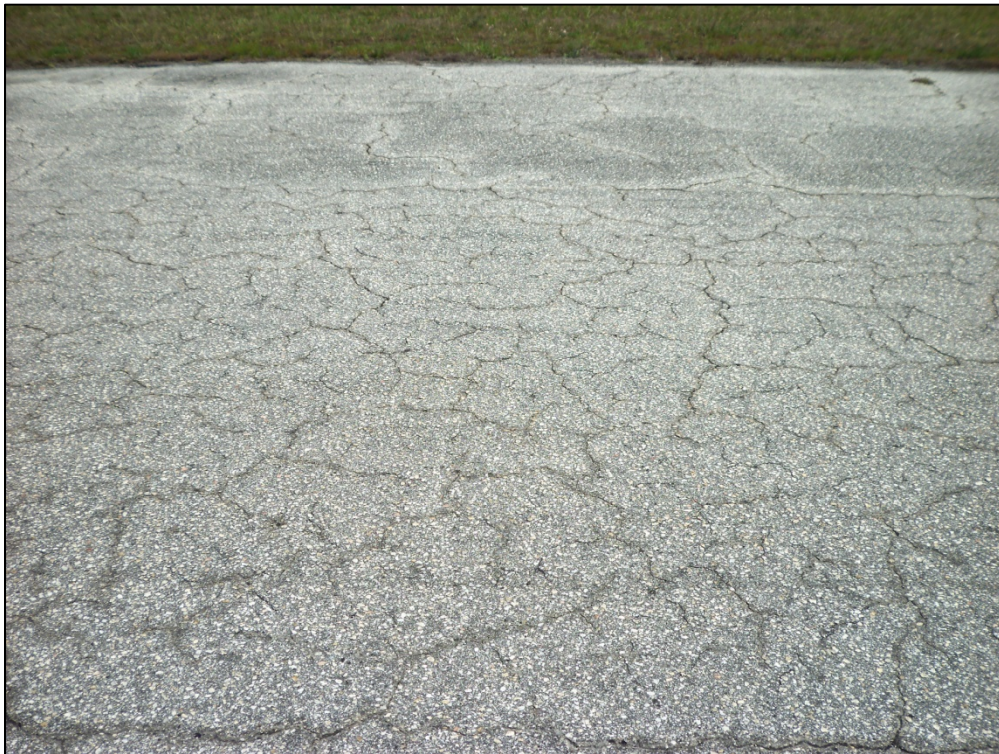
Runway 15-33, Section 6110, Sample Unit 109 – Medium severity (43) Block Cracking, low severity (45) Depression, medium severity (50) Patch, low and medium severity (52) Weathering and Raveling

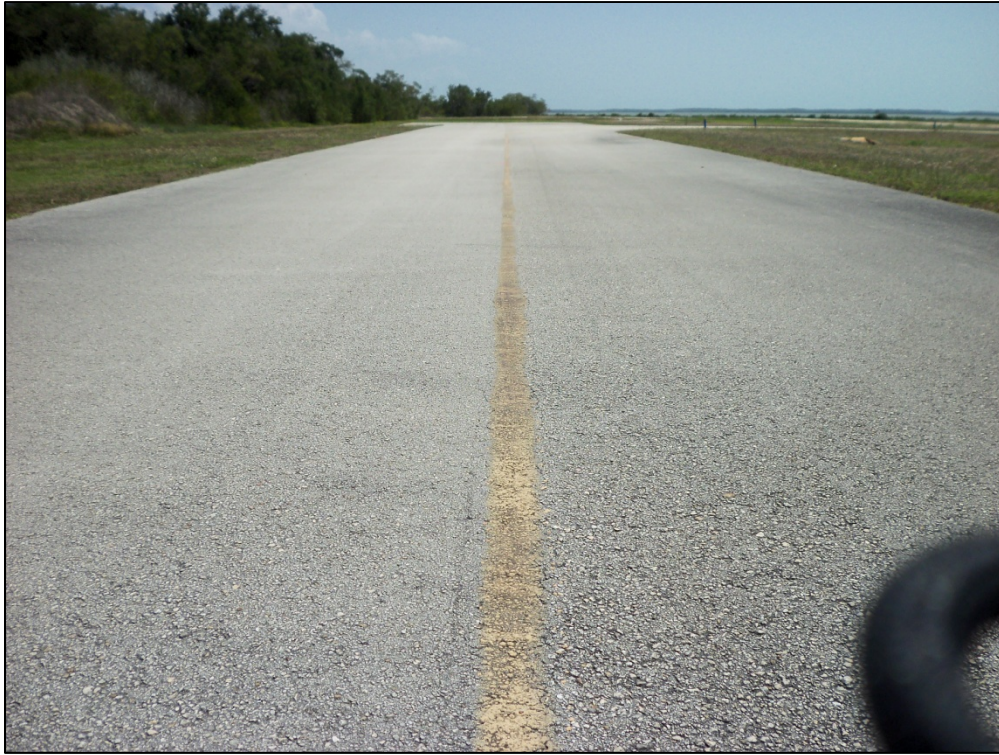
Taxiway Alpha, Section 105, Sample Unit 103 – Low severity (52) Weathering and Raveling

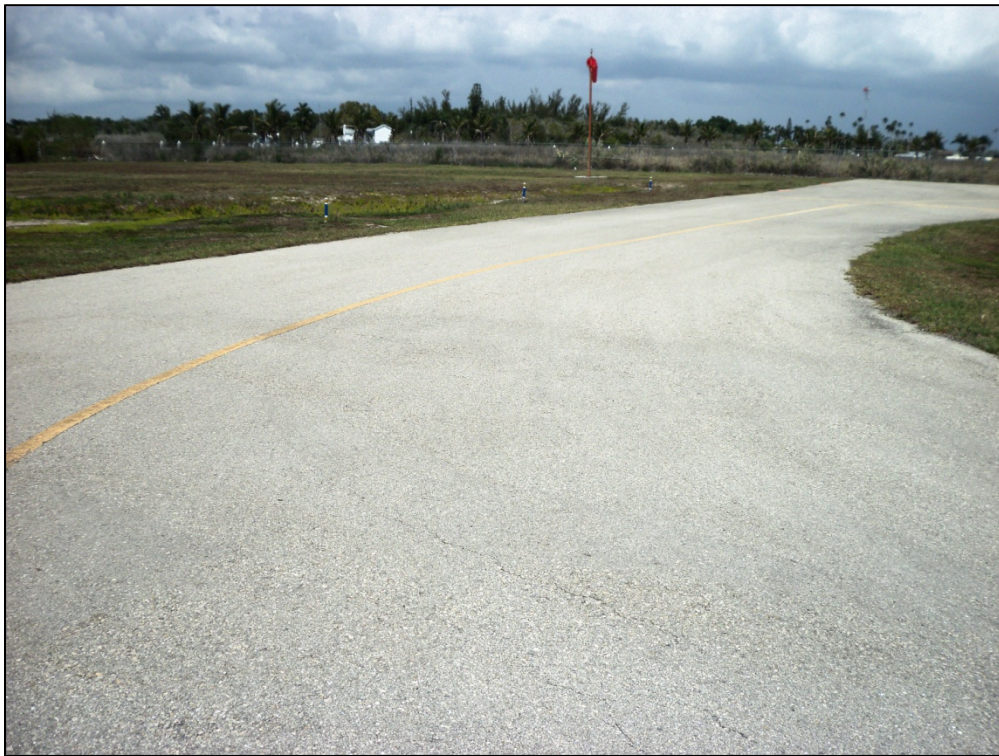
Taxiway Connector, Section 115, Sample Unit 214 – Low severity (48) Longitudinal and Transverse Cracking, low severity (52) Weathering and Raveling
