**STATE OF FLORIDA
DEPARTMENT OF TRANSPORTATION
AVIATION OFFICE**

**Statewide Airfield Pavement
Management Program**

**Flagler County–XFL
(General Aviation)
Flagler, Florida
(District 5)**

June 2012

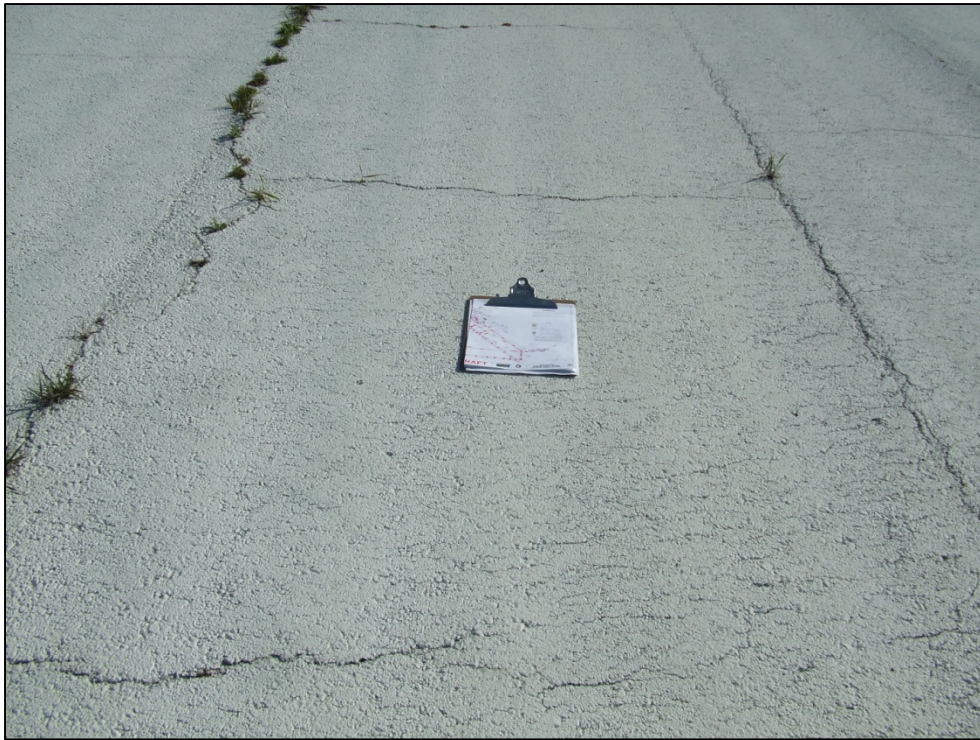
11-29. The pavement on Runway 6-24 exhibited low to high severity weathering and raveling, low severity swelling, low severity patching, along with low to medium severity longitudinal and transverse cracking. These distresses are mostly attributed to the climate and age of the pavement.

Runway 6-24, Section 6205, Sample Unit 177 – Low to medium severity (48) Longitudinal and Transverse Cracking and low severity (52) Weathering and Raveling.

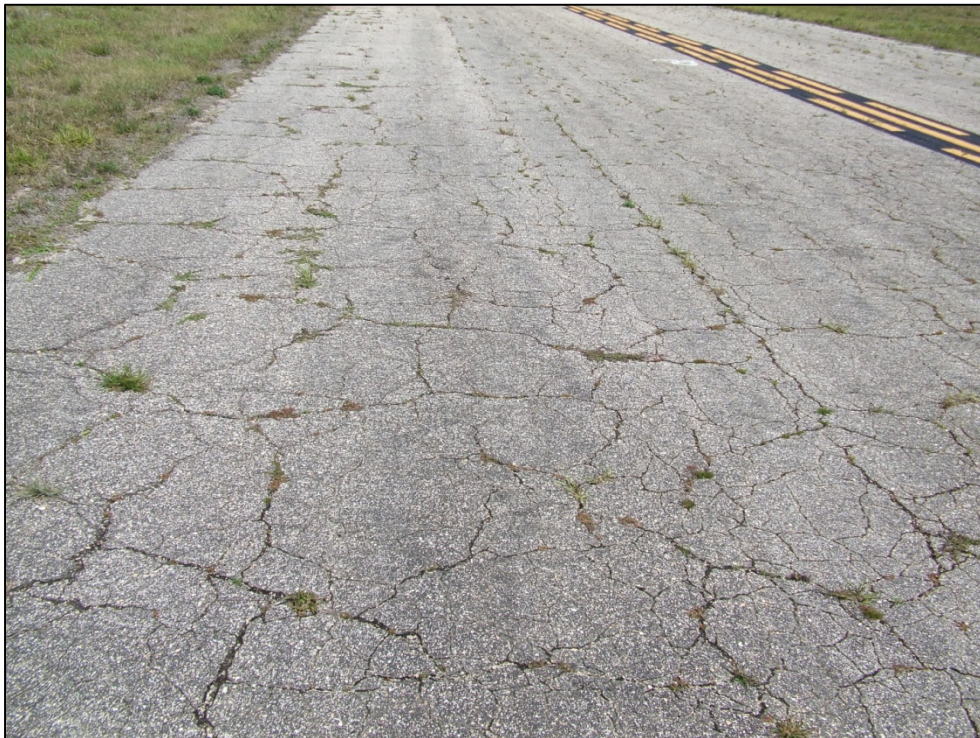
Taxiway Delta, Section 405, Sample Unit 103 – Medium to high severity (43) Block cracking and medium severity (52) Weathering / Raveling.

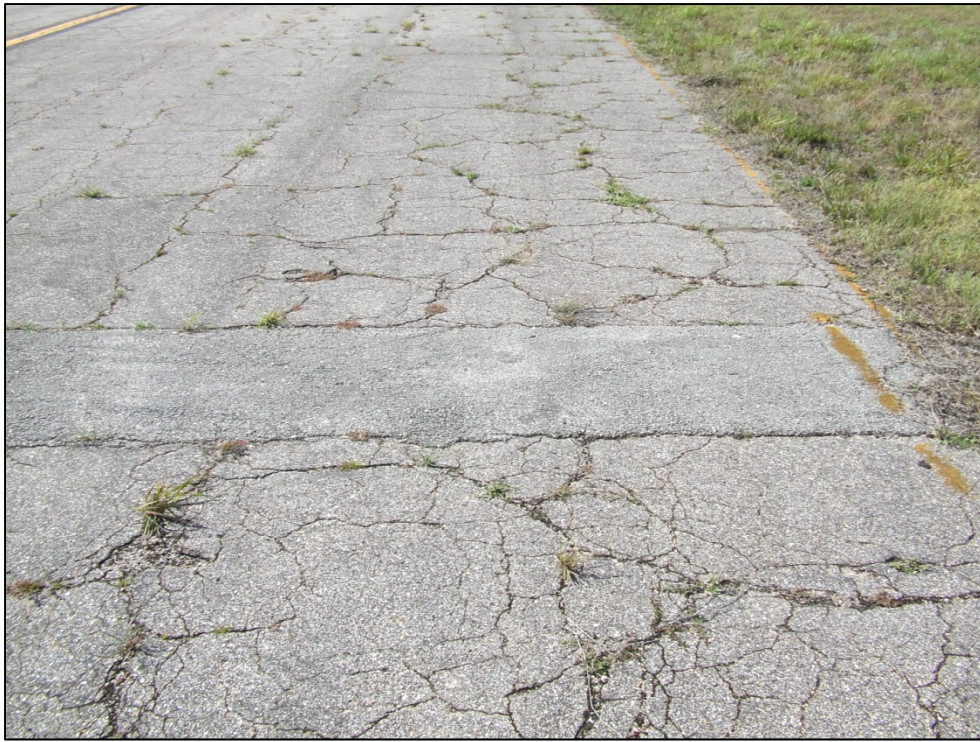
Taxiway Delta, Section 405, Sample Unit 101 – Low severity (41) Alligator Cracking, low to medium severity (43) Block cracking, low severity (50) Patching, and low to medium severity (52) Weathering and Raveling.

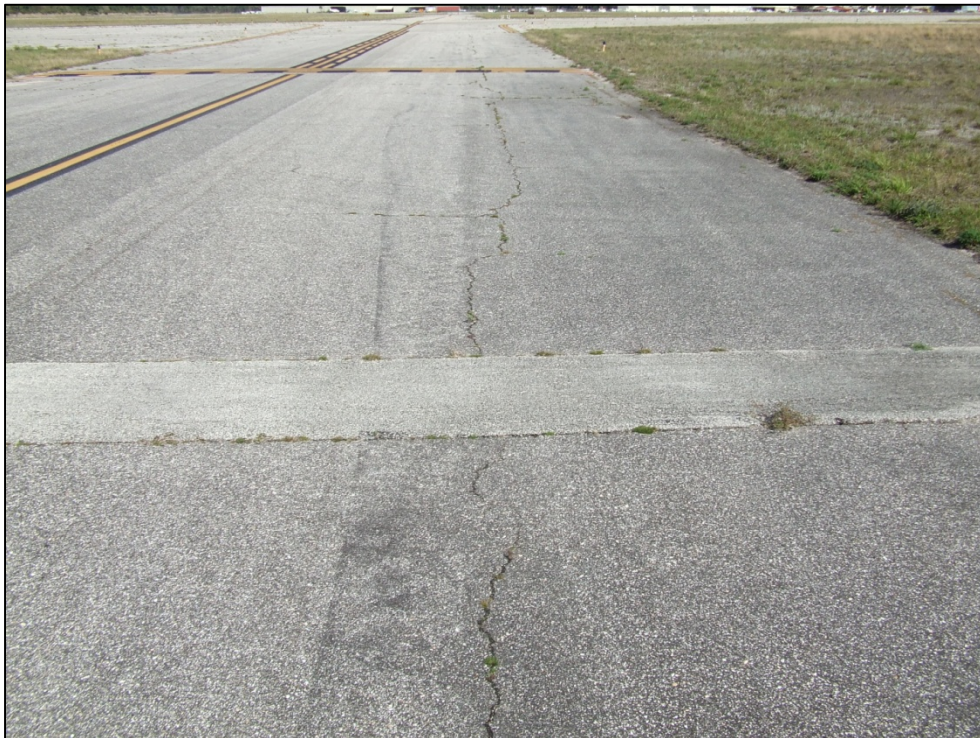
Taxiway Alpha exhibited broad pavement condition indices ranging from 39-80. Taxiway Charlie exhibited pavement condition indices ranging from 44-68. Taxiways Alpha and Charlie pavements exhibited low to medium severity longitudinal and transverse cracking, low to medium severity block cracking, low to medium severity weathering and raveling, low severity swelling, low to high severity depression, and low to medium severity patching. Bravo exhibited a pavement condition index of 68. Taxiway Bravo exhibited extensive low to medium severity weathering and raveling, low severity longitudinal and transverse cracking, and low severity swelling. Taxiway Delta exhibited pavement condition indices ranging from 19-68. Taxiway Echo exhibited broad pavement condition indices ranging from 11-69, while Taxiway Foxtrot exhibited a pavement condition index of 42. Taxiways Delta, Echo, and Foxtrot exhibited the worst conditions, with evidence of low severity alligator cracking, low to high severity longitudinal and transverse cracking, low to high severity block cracking, low to medium severity weathering and raveling, low to medium severity swelling, low to medium severity depression, and low to medium severity patching. These are climate, age, subgrade, and load related distresses.

Taxiway Charlie, Section 310, Sample Unit 101 – Low to medium severity (48) Longitudinal and Transverse Cracking; medium severity (50) patching, low severity (52) Weathering and Raveling.

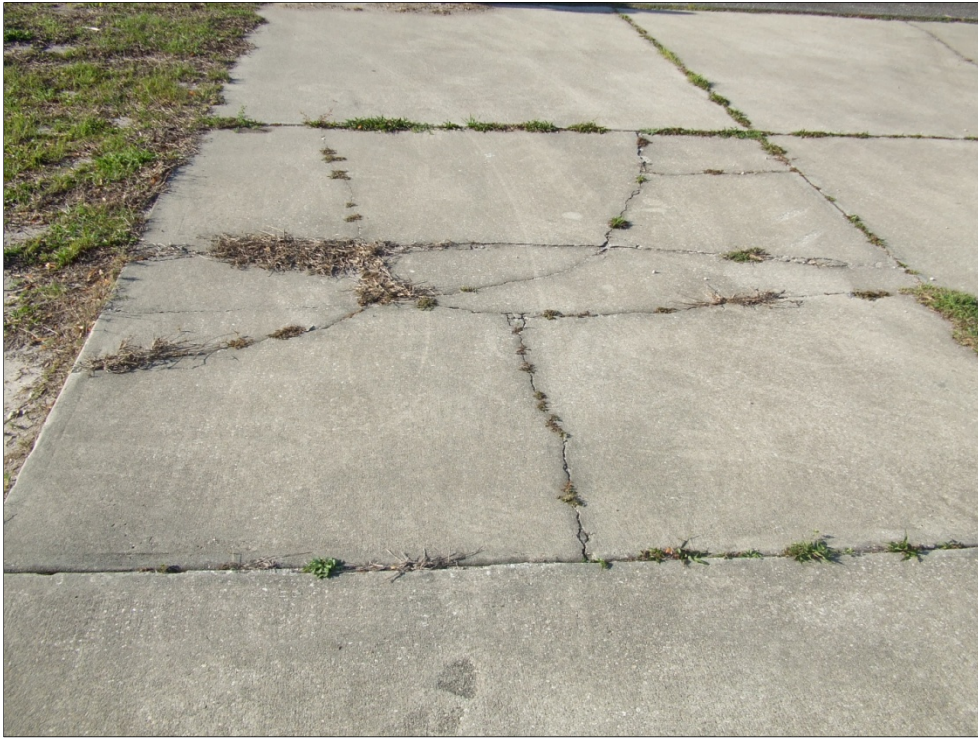
Apron, Section 4130, Sample Unit 101 – High severity (65) Joint Seal Damage and high severity (72) Shattered Slab.

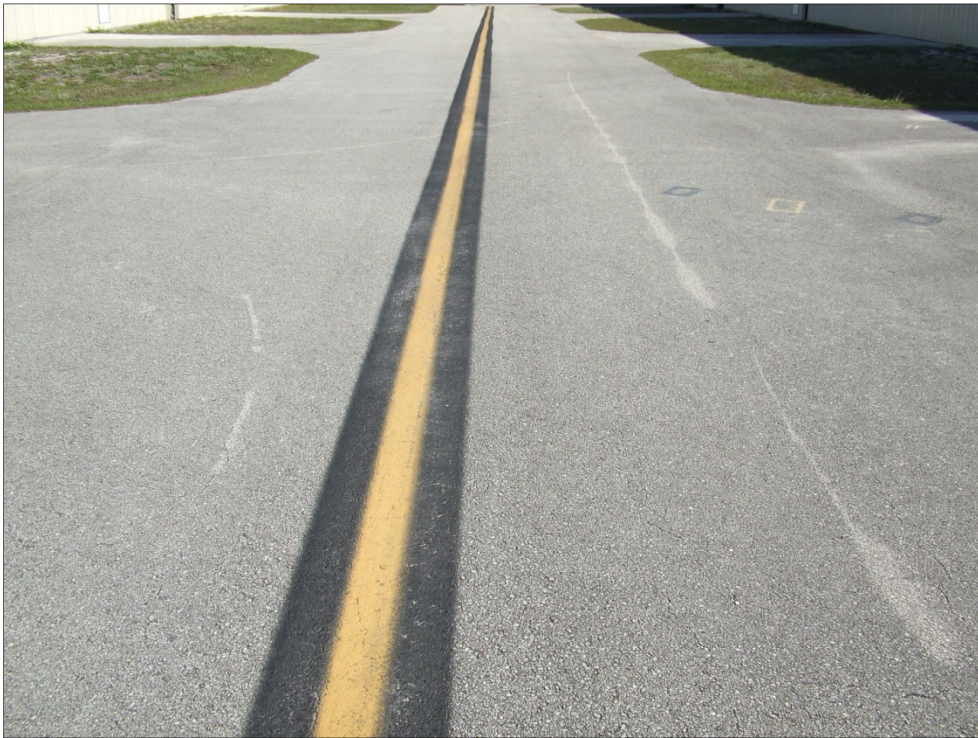
Apron T-Hangar, Section 4310, Sample Unit 302 – Low severity (52) Weathering and Raveling.
