**STATE OF FLORIDA  
DEPARTMENT OF TRANSPORTATION  
AVIATION OFFICE**

**Statewide Airfield Pavement  
Management Program**

**Herlong Airport–HEG  
(Regional Reliever)  
Jacksonville, Florida  
(District 2)**

**June 2012**

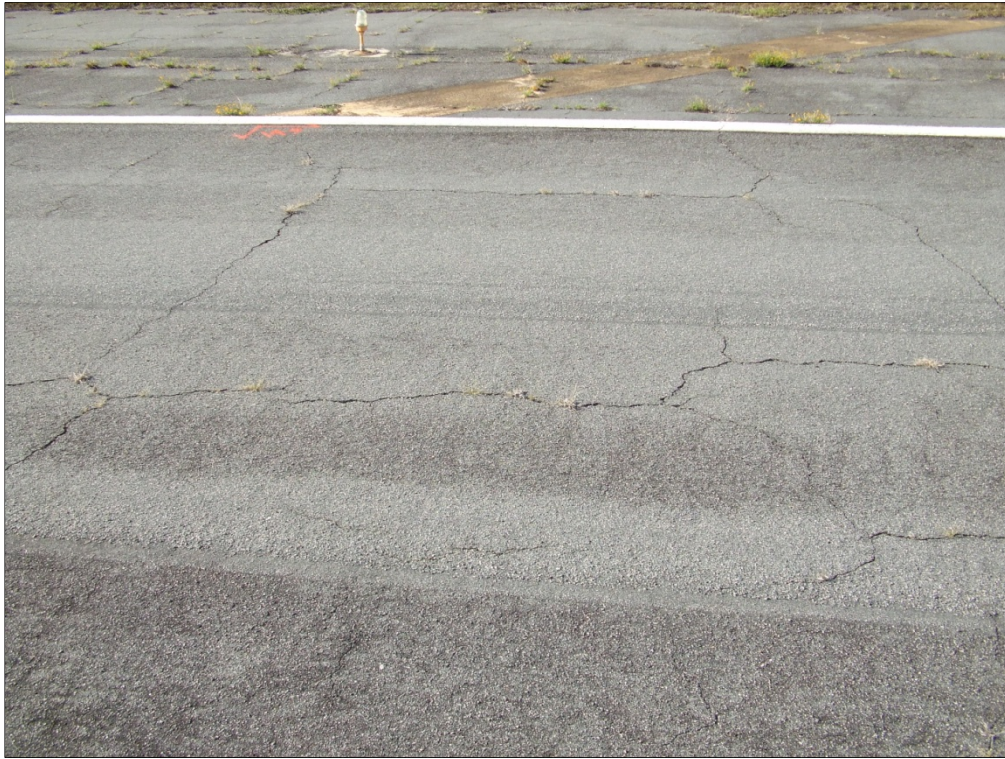
Runway 11-29, Section 6205, Sample Unit 149 – Low severity (43) Block Cracking, and low to medium severity (52) Weathering and Raveling.

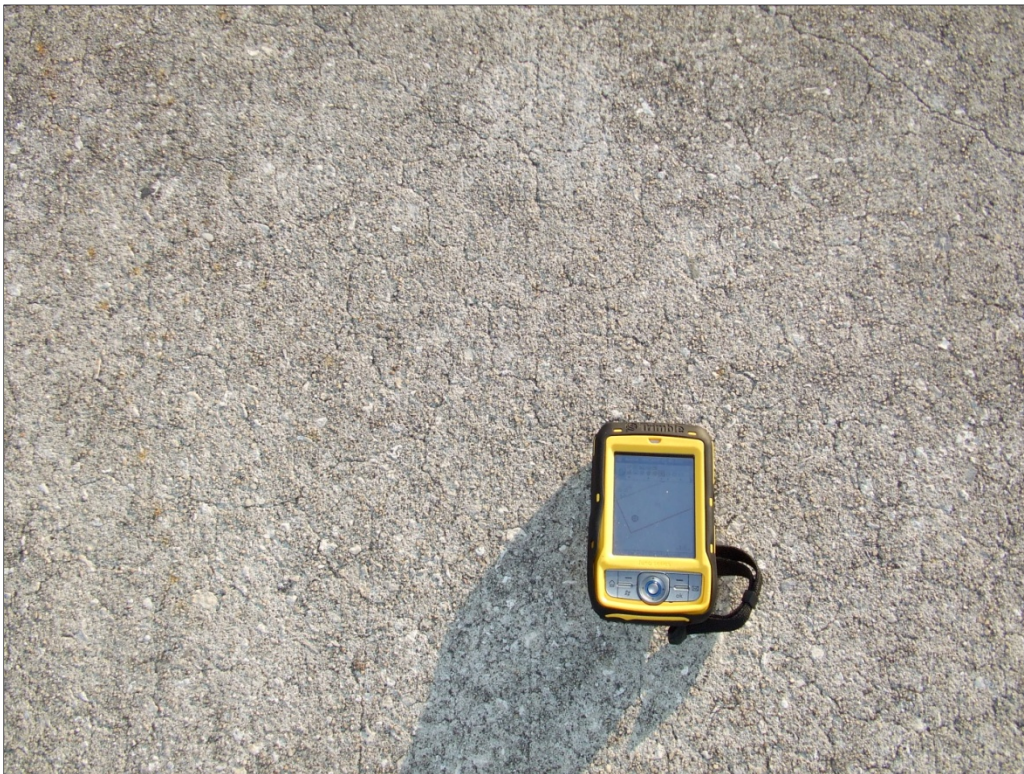
Northeast Apron, Section 4410, Sample Unit 201 –Low severity (70) Scaling.

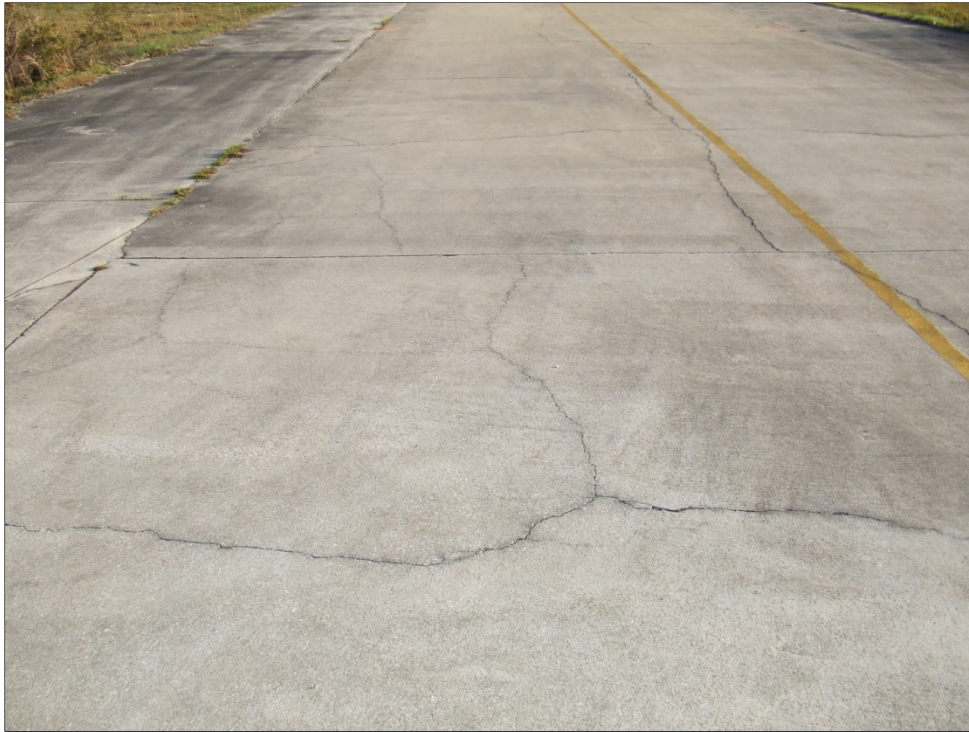
Taxiway to Northeast Apron, Section 1105, Sample Unit 500 – Low severity (63) Linear Cracking, low severity (65) Joint Seal Damage, medium severity (74) Joint Spalling, and low severity (72) Shattered Slab.

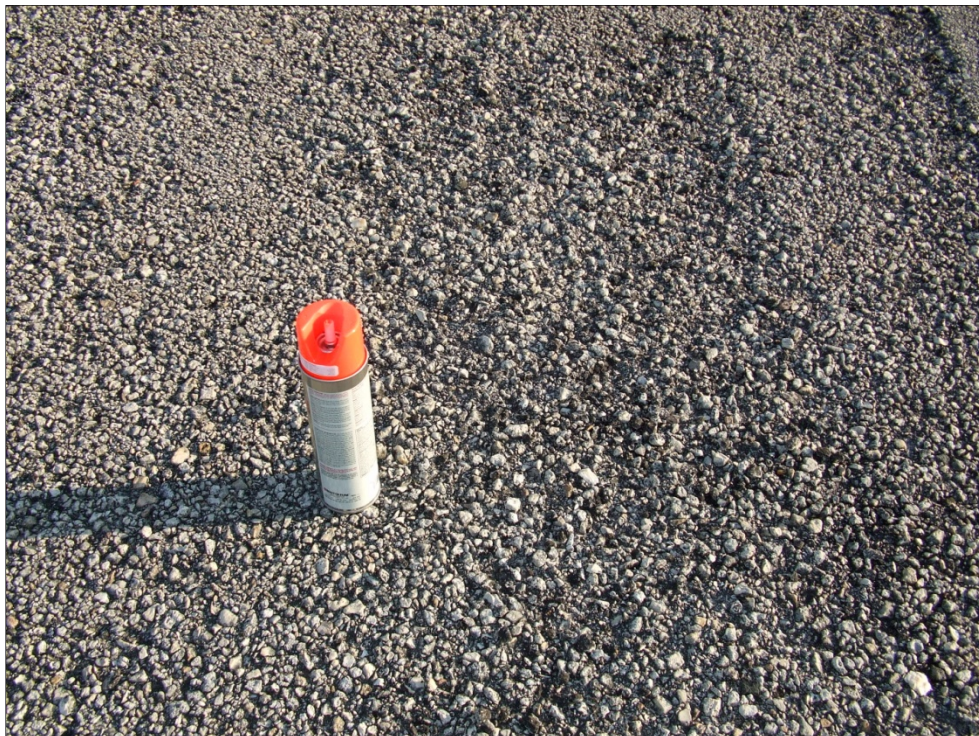
Run Up Apron on RWs 7, 25, Section 5110, Sample Unit 100 – High severity (52) Weathering and Raveling.

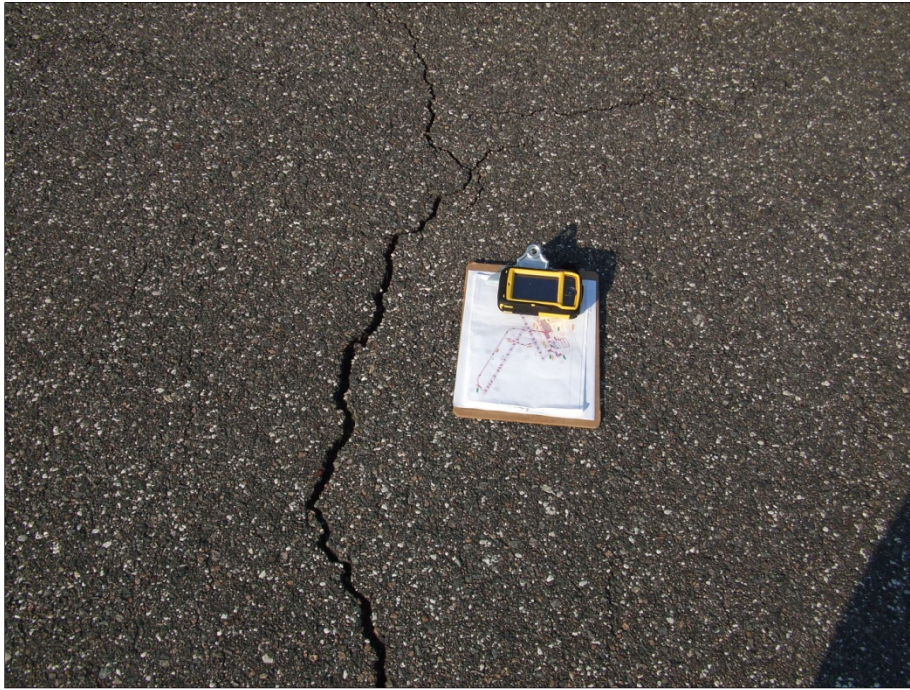
Taxiway T-Hangars, Section 920, Sample Unit 101 – Medium severity (48) Longitudinal / Transverse Cracking and low severity (52) Weathering and Raveling.

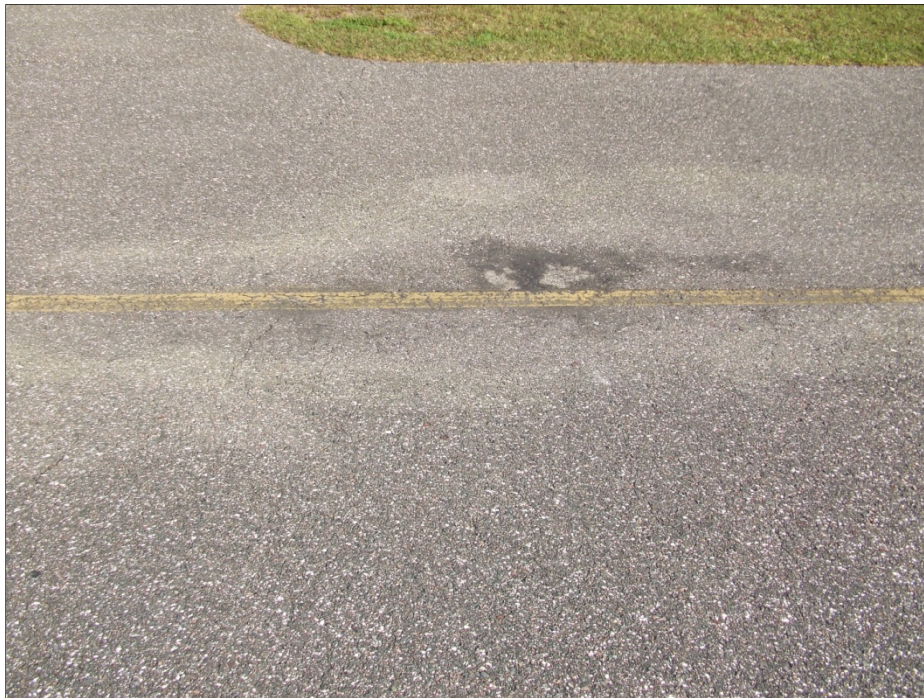
Taxiway T-Hangars, Section 925, Sample Unit 200 – Low severity (45) Depression and low severity (52) Weathering and Raveling

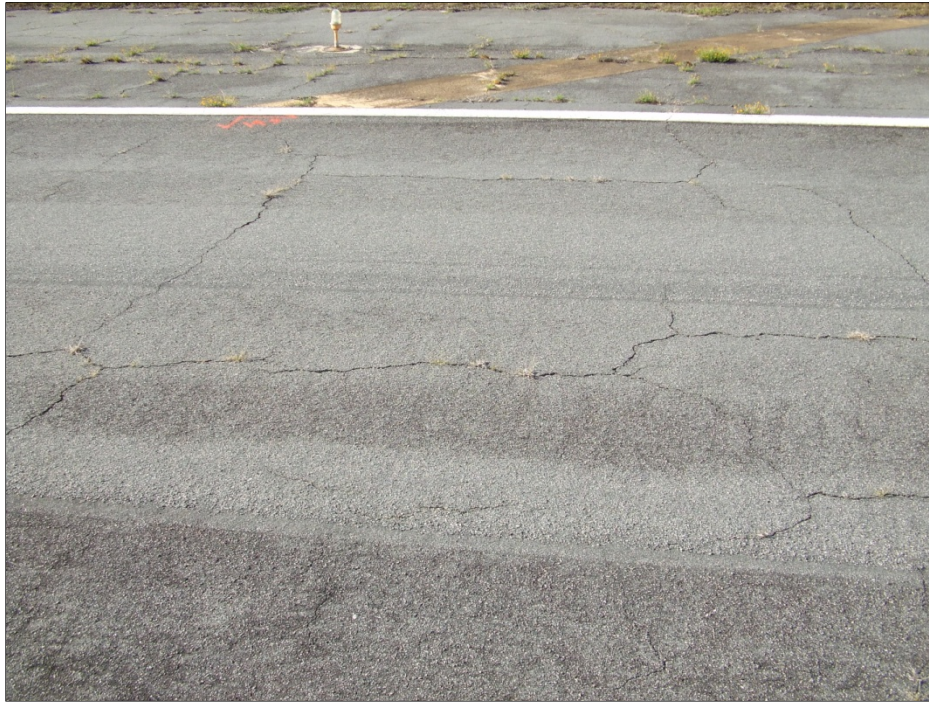
Runway 11-29, Section 6205, Sample Unit 149 – Low severity (43) Block Cracking and low severity (52) Weathering and Raveling

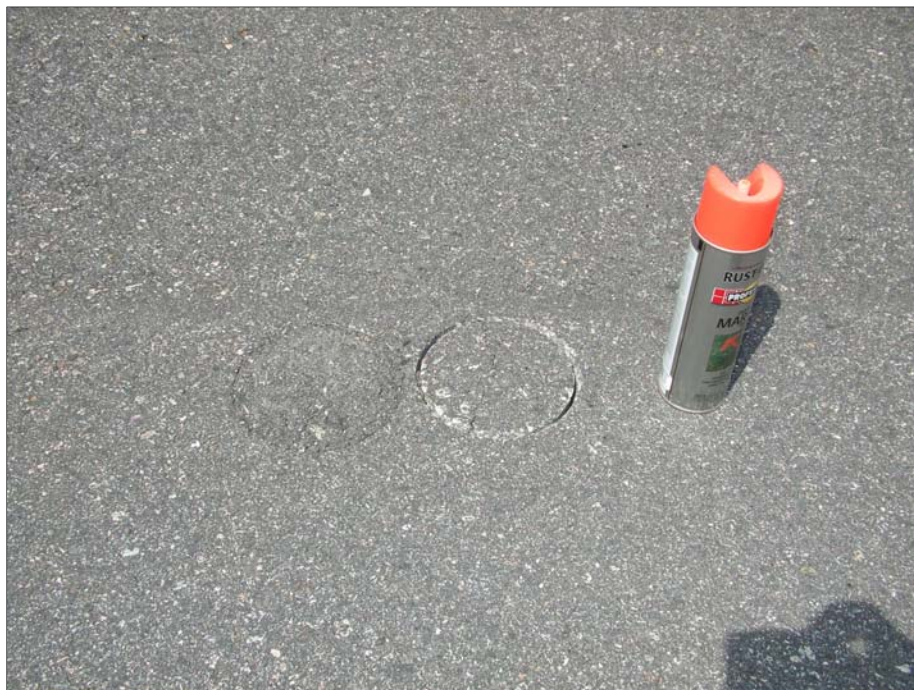
Runway 7-25, Section 6105, Sample Unit 106 – Low severity (50) Patching
