**STATE OF FLORIDA
DEPARTMENT OF TRANSPORTATION
AVIATION OFFICE**

**Statewide Airfield Pavement
Management Program**

**Hernando County – BKV
(General Aviation)
Brookeville, Florida
(District 7)**

May 2011

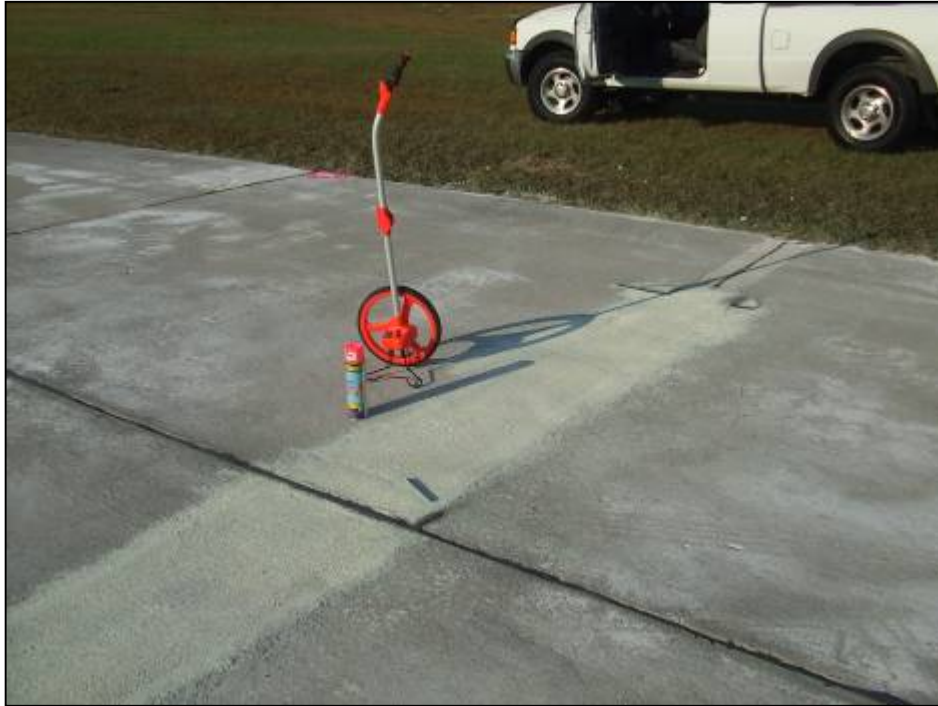
Taxiway Alpha, Section 140, Sample Unit 906 – Low severity (63) Linear Cracking, low severity (65) Joint Seal Damage, low severity (66) Small Patch, low severity (67) Large Patch, low severity (70) Scaling.

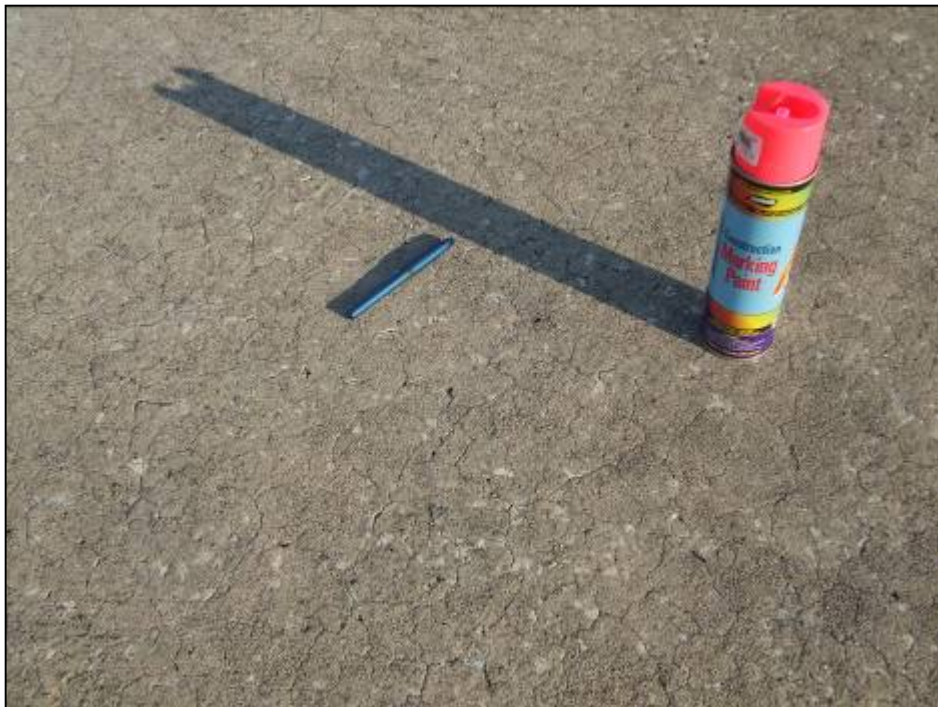
Taxiway Alpha, Section 140, Sample Unit 906 – Low severity (63) Linear Cracking, low severity (65) Joint Seal Damage, low severity (66) Small Patch, low severity (67) Large Patch, low severity (70) Scaling.

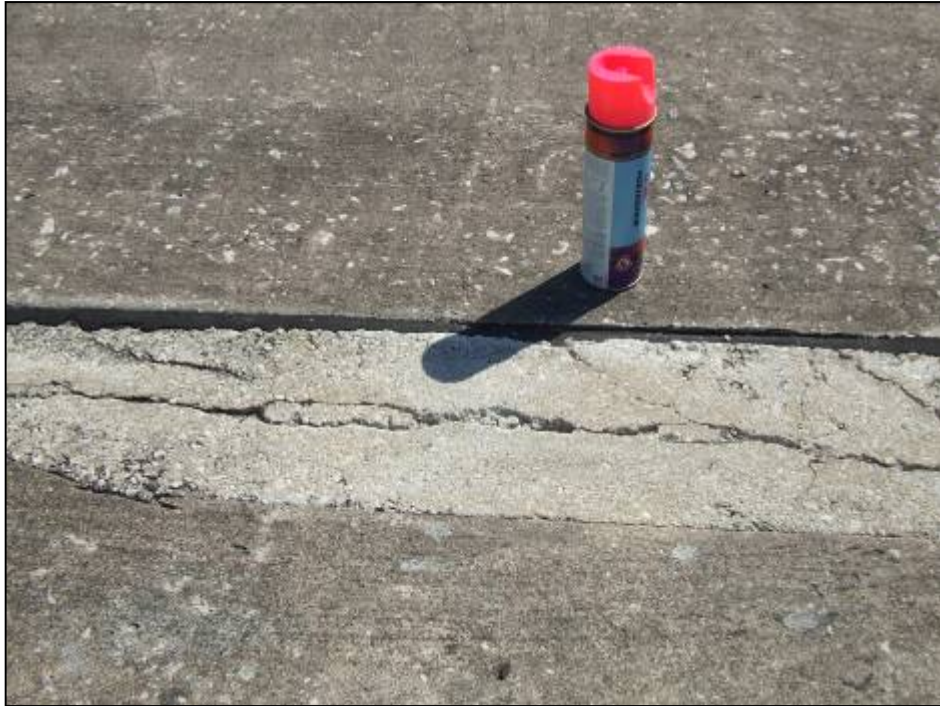
Taxiway Alpha, Section 105, Sample Unit 121 – Low severity (65) Joint Seal Damage, low and medium severity (66) Small Patch, low severity (70) Scaling, low severity (73) Shrinkage Cracking.

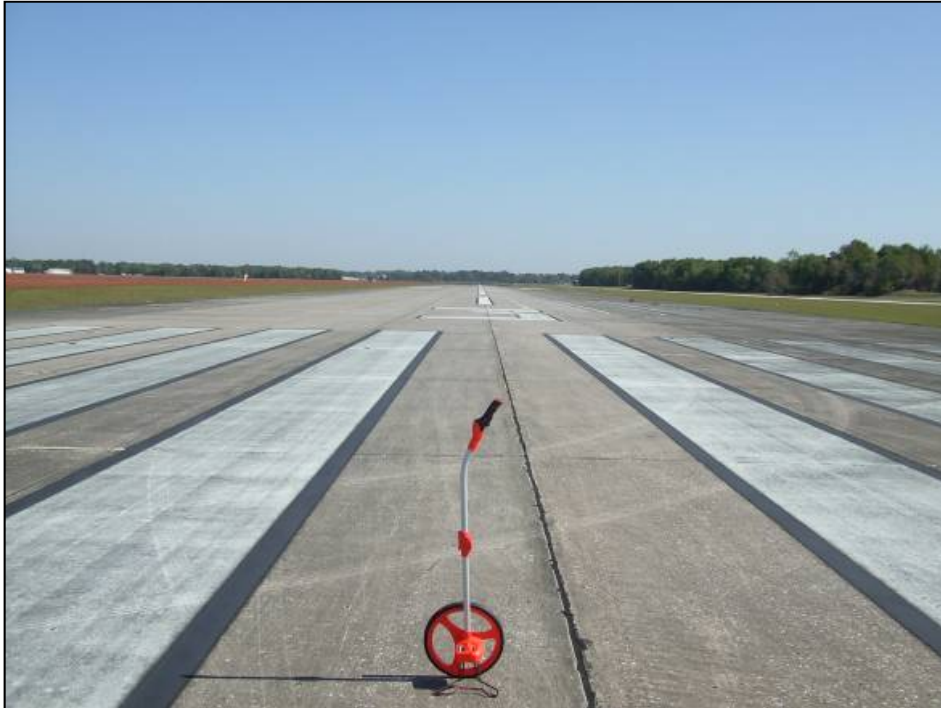
Runway 3-21, Section 6210, Sample Unit 301 – Low and medium severity (63) Linear Cracking, low severity (65) Joint Seal Damage, low and medium severity (66) Small Patch, low severity (70) Scaling, low severity (74) Joint Spalling.

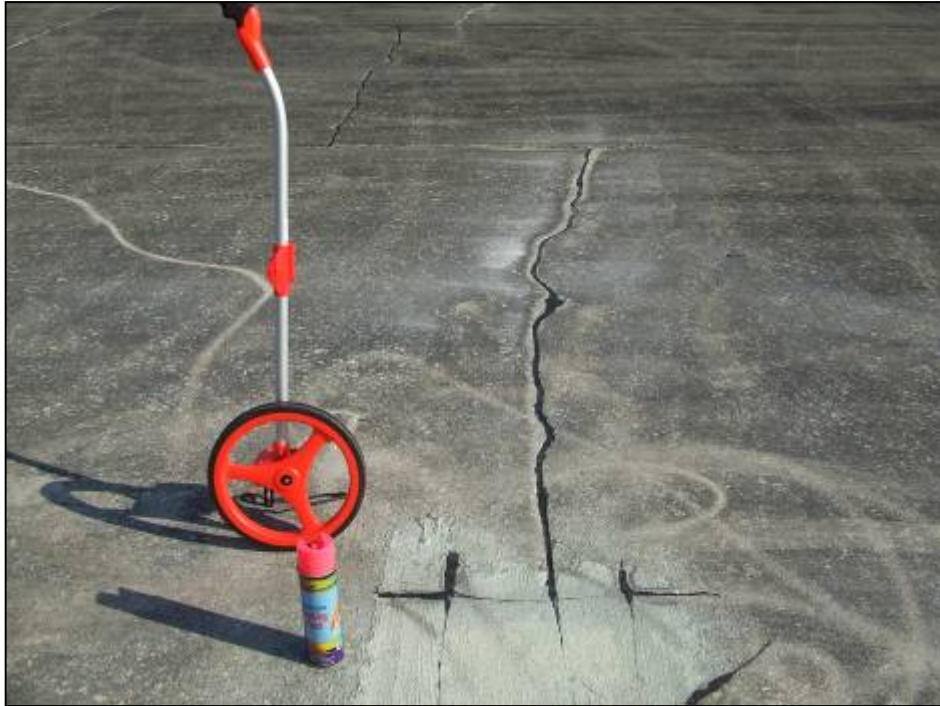
Runway 9-27, Section 6110, Sample Unit 306 – Low severity (63) Linear Cracking, low severity (65) Joint Seal Damage, low severity (66) Small Patch, low severity (70) Scaling.

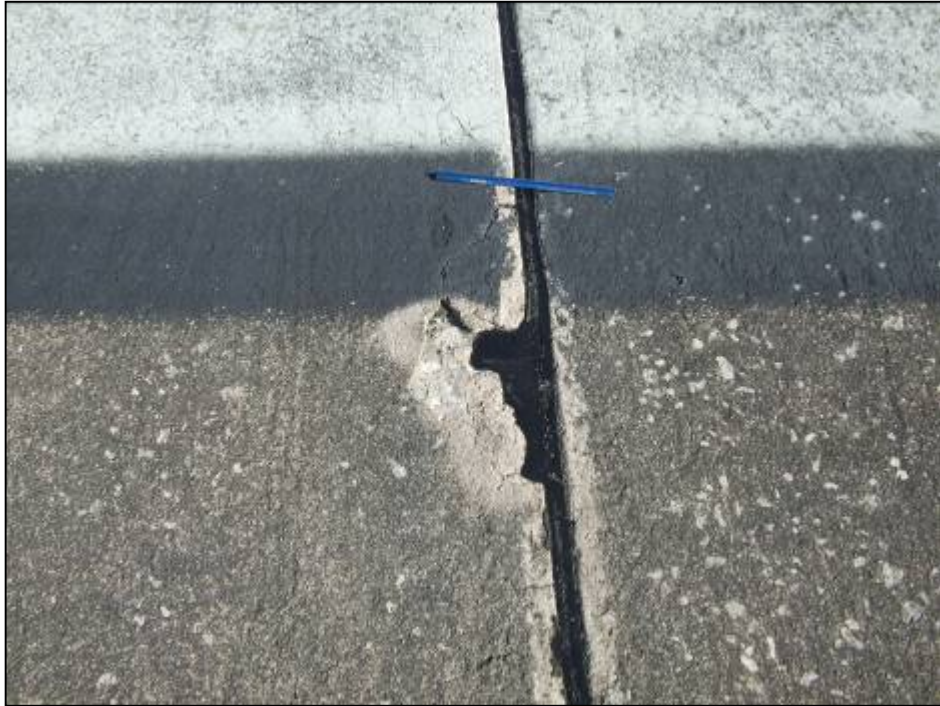
Runway 9-27, Section 6105, Sample Unit 520 – Low and medium severity (63) Linear Cracking, low severity (65) Joint Seal Damage, low severity (66) Small Patch, low severity (67) Large Patch, low severity (70) Scaling.
