**STATE OF FLORIDA
DEPARTMENT OF TRANSPORTATION
AVIATION OFFICE**

**Statewide Airfield Pavement
Management Program**

**Homestead General Aviation Airport– X51
(General Aviation)
Miami, Florida
(District 6)**

May 2012

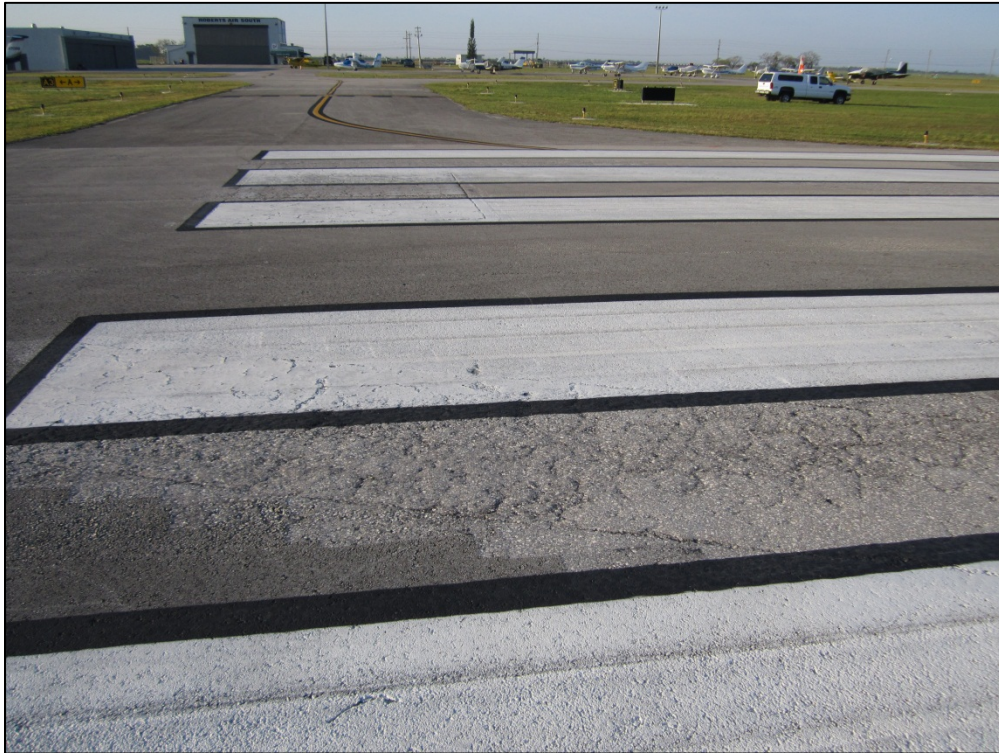
Runway 10-28, Section 6205, Sample Unit 159 – Low severity (48) Longitudinal and Transverse Cracking, low and medium severity (52) Weathering and Raveling

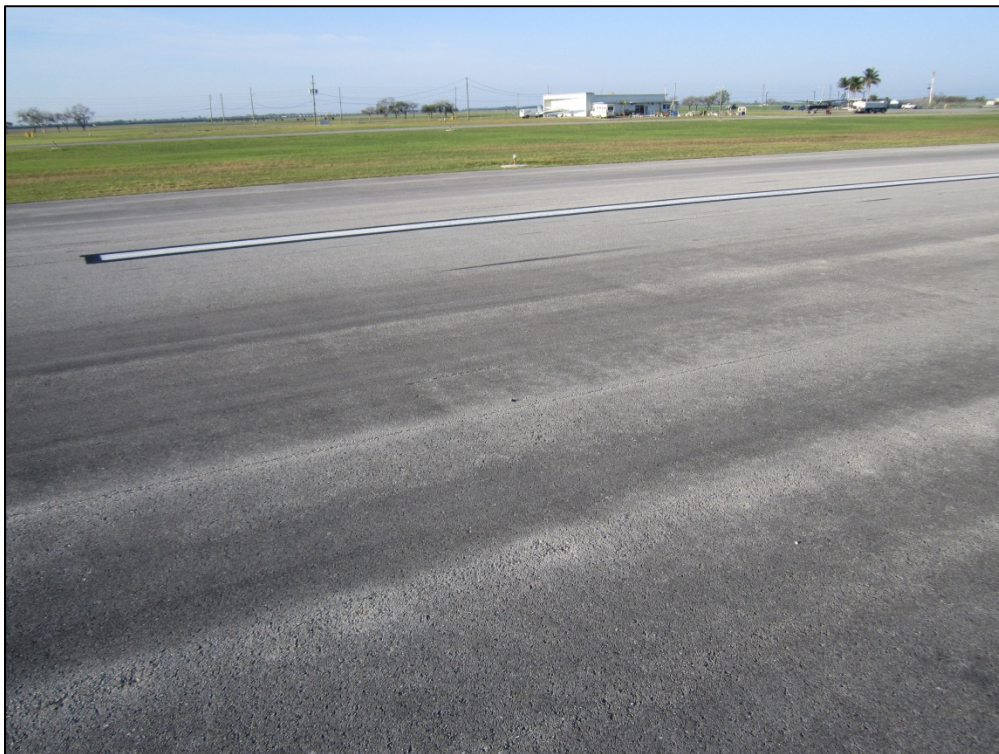
Runway 10-28, Section 6205, Sample Unit 149 – Low severity (48) Longitudinal and Transverse Cracking, low severity (52) Weathering and Raveling

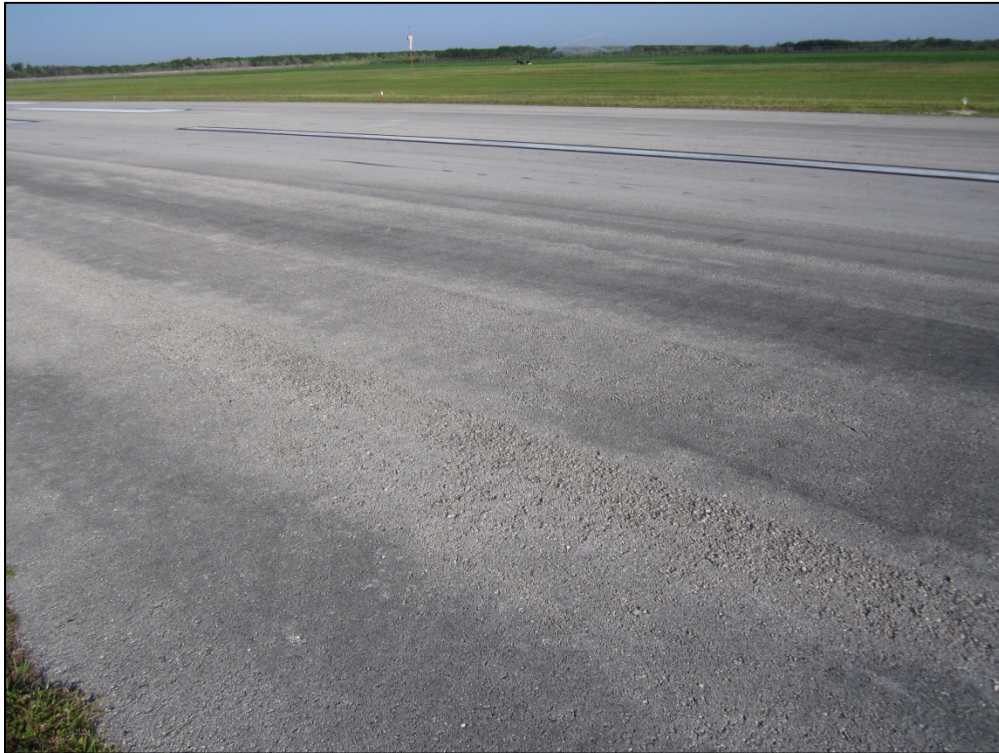
Runway 10-28, Section 6205, Sample Unit 107 – Low severity (48) Longitudinal and Transverse Cracking, low and medium severity (52) Weathering and Raveling

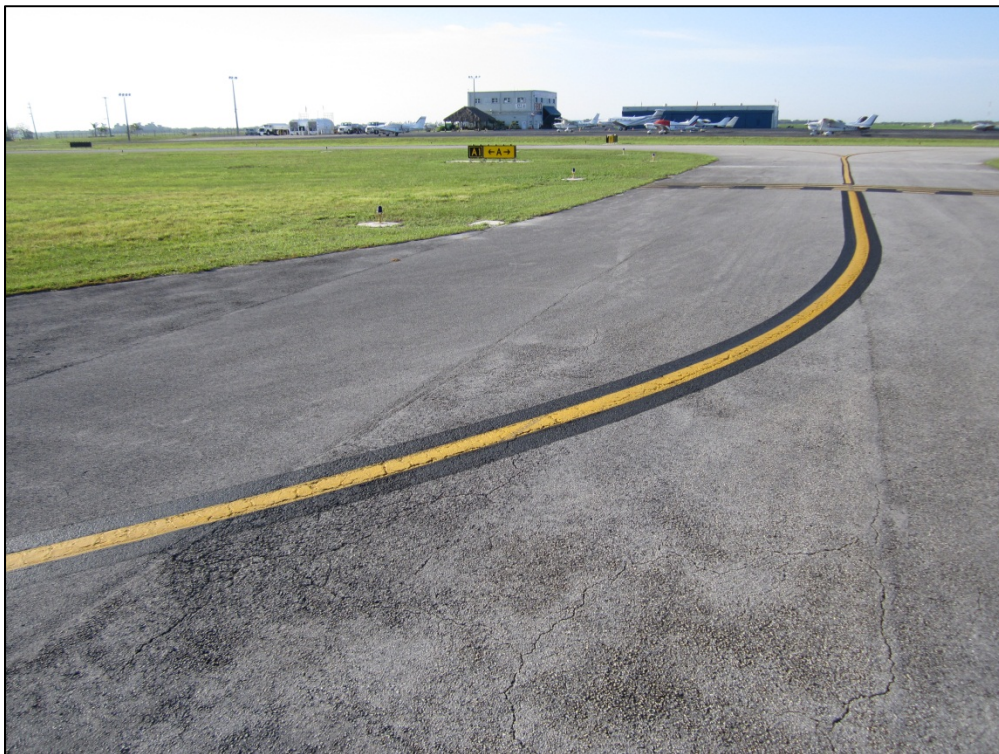
Taxiway A-1, Section 230, Sample Unit 100 – Low severity (48) Longitudinal and Transverse Cracking, low severity (52) Weathering and Raveling, low severity (41) Alligator Cracking

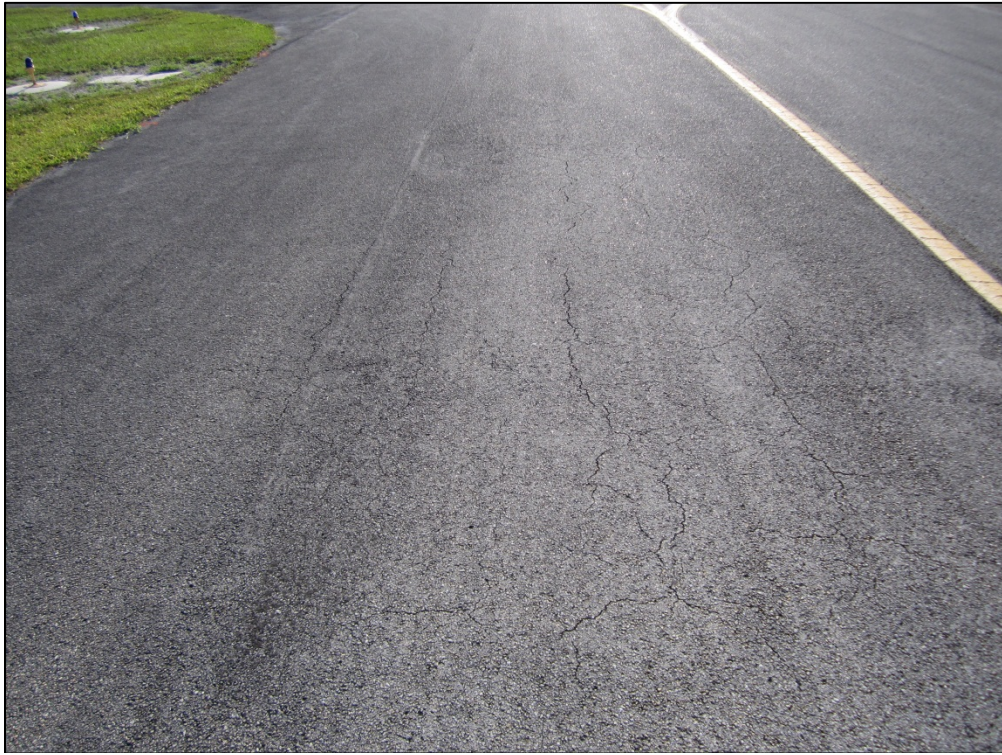
Taxiway Alpha, Section 215, Sample Unit 117 – Low severity (48) Longitudinal and Transverse Cracking, low severity (52) Weathering and Raveling, low severity (43) Block Cracking

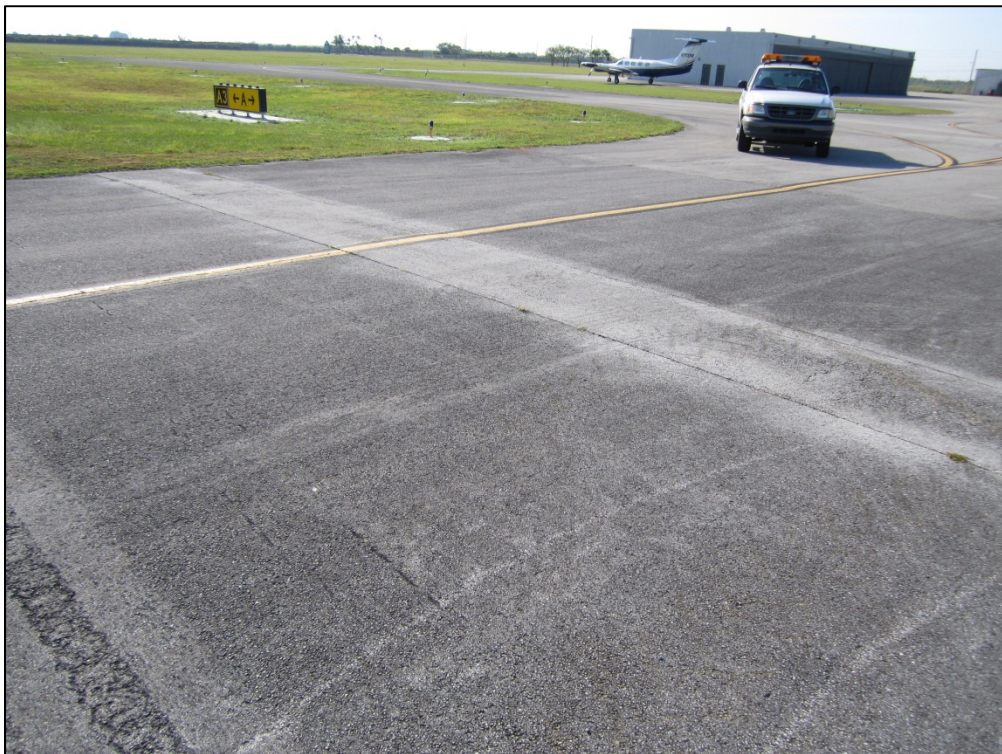
Taxiway A-3, Section 250, Sample Unit 301 – Low severity (48) Longitudinal and Transverse Cracking, low and medium severity (52) Weathering and Raveling, low severity (50) Patching

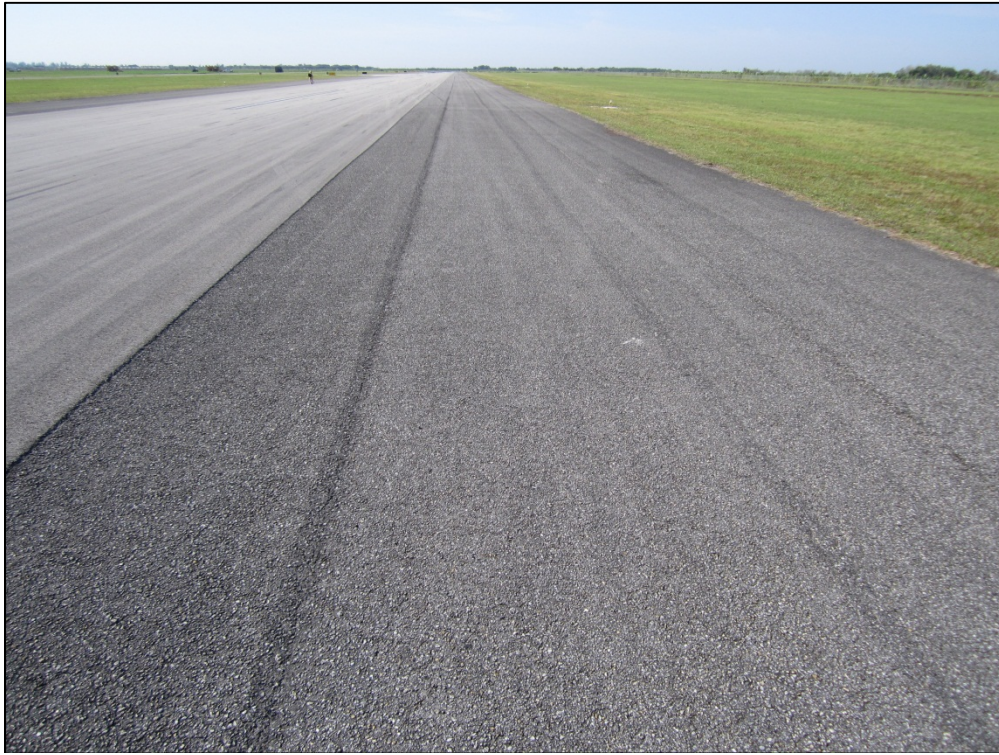
Runway 18-36, Section 6110, Sample Unit 164 – Low severity (48) Longitudinal and Transverse Cracking, low severity (52) Weathering and Raveling

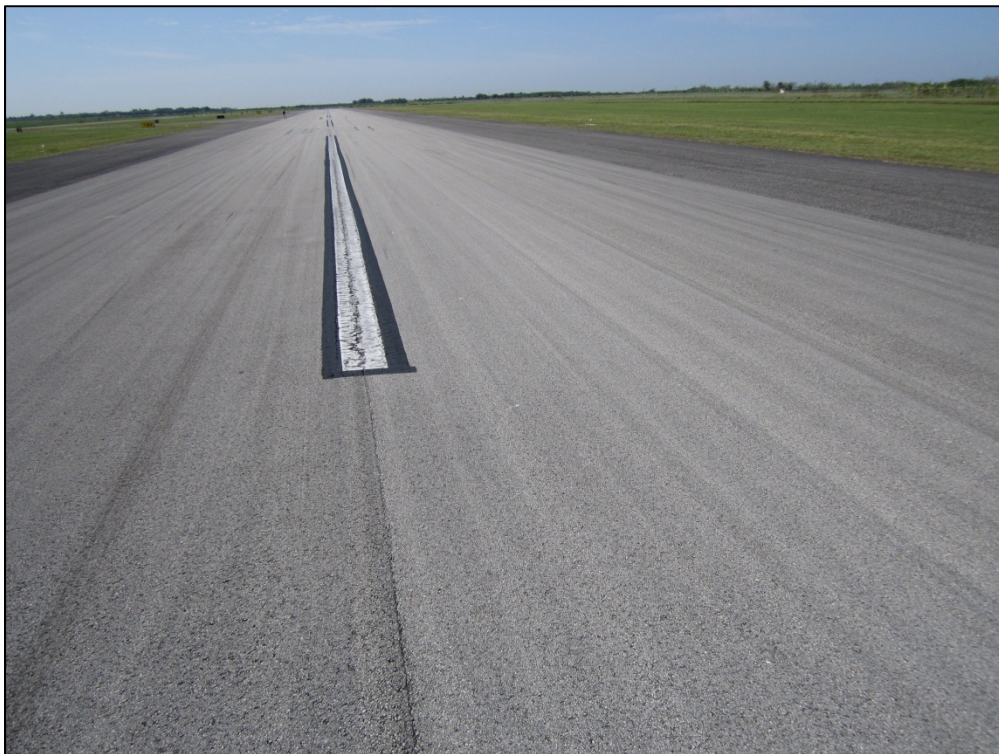
Runway 18-36, Section 6105, Sample Unit 320 – Low severity (48) Longitudinal and Transverse Cracking, low severity (52) Weathering and Raveling

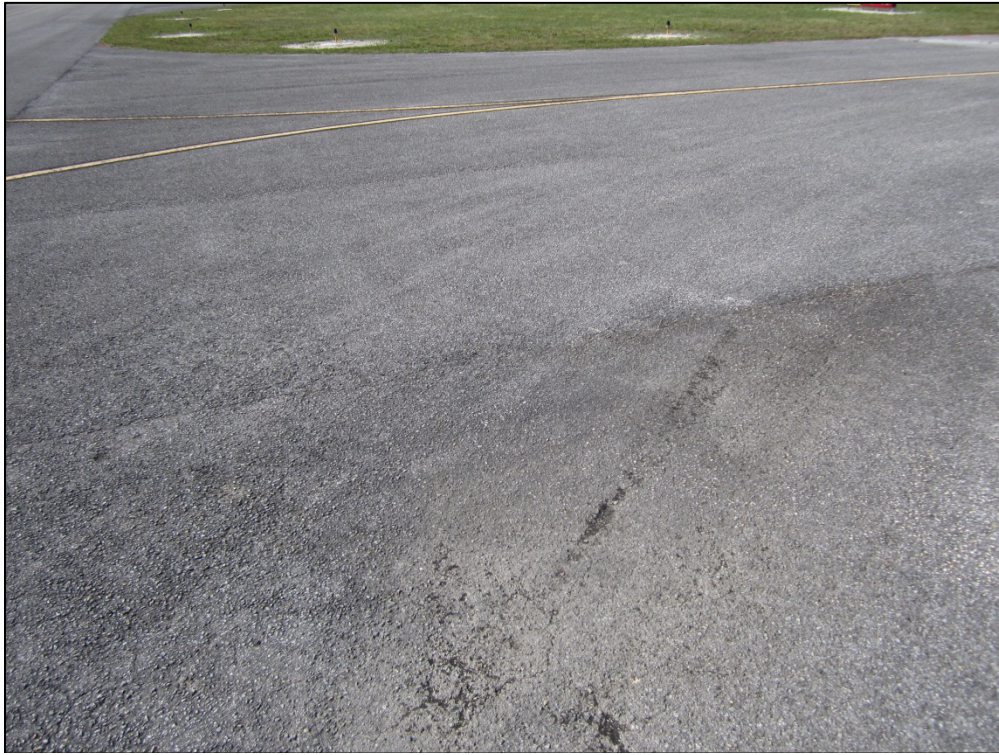
Taxiway B-3, Section 130, Sample Unit 302 – Low severity (48) Longitudinal and Transverse Cracking, low and medium severity (52) Weathering and Raveling

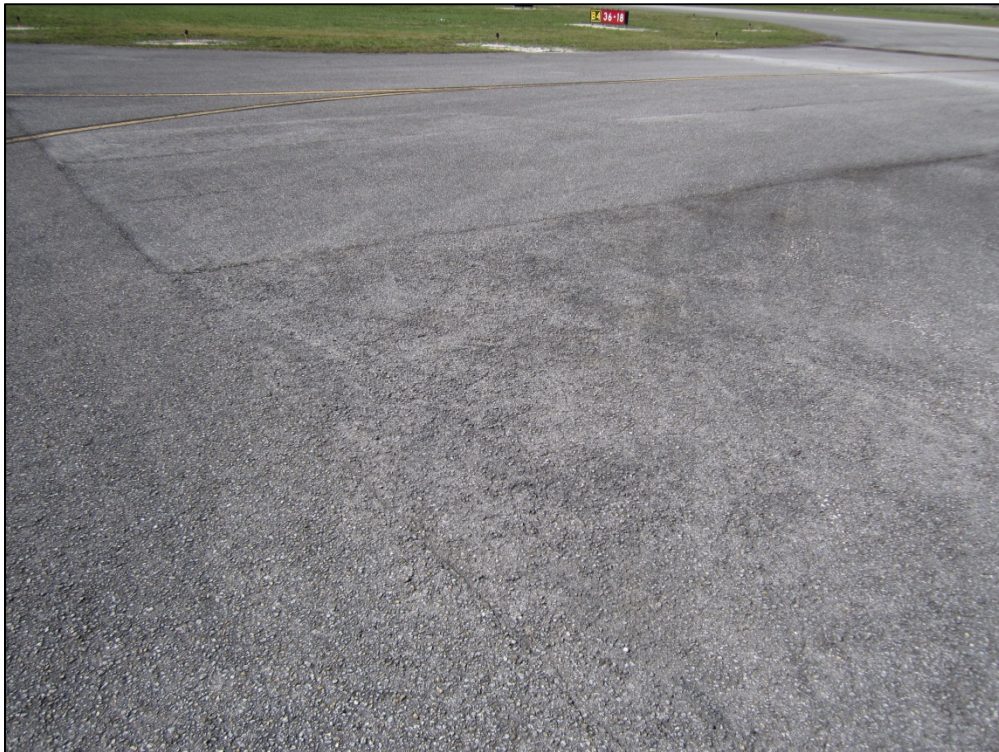
Taxiway B-4, Section 140, Sample Unit 402 – Low severity (48) Longitudinal and Transverse Cracking, low and medium severity (52) Weathering and Raveling

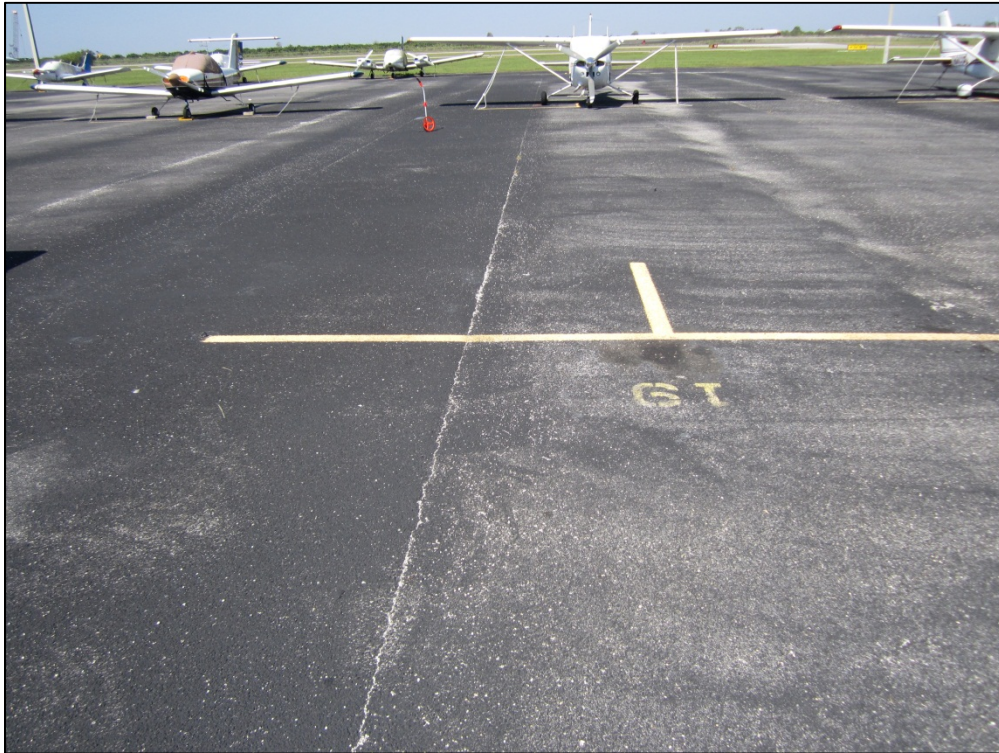
Northwest Apron, Section 4105, Sample Unit 153 – Low severity (48) Longitudinal and Transverse Cracking, low severity (52) Weathering and Raveling

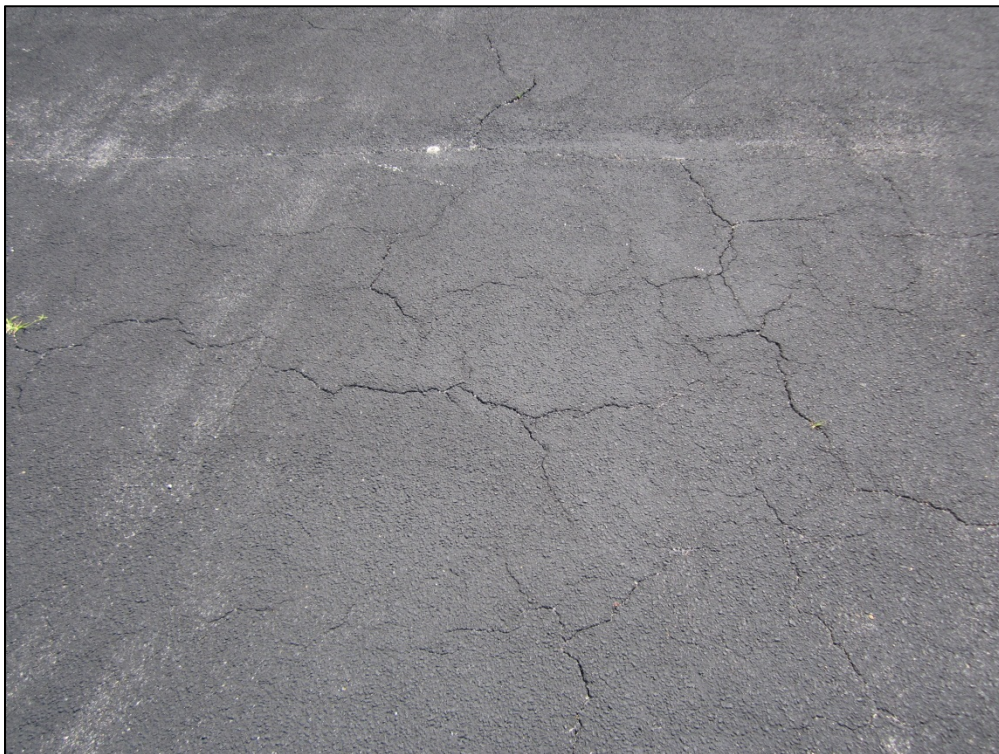
Northwest Apron, Section 4105, Sample Unit 454 – Low severity (48) Longitudinal and Transverse Cracking, low severity (43) Block Cracking, low severity (52) Weathering and Raveling

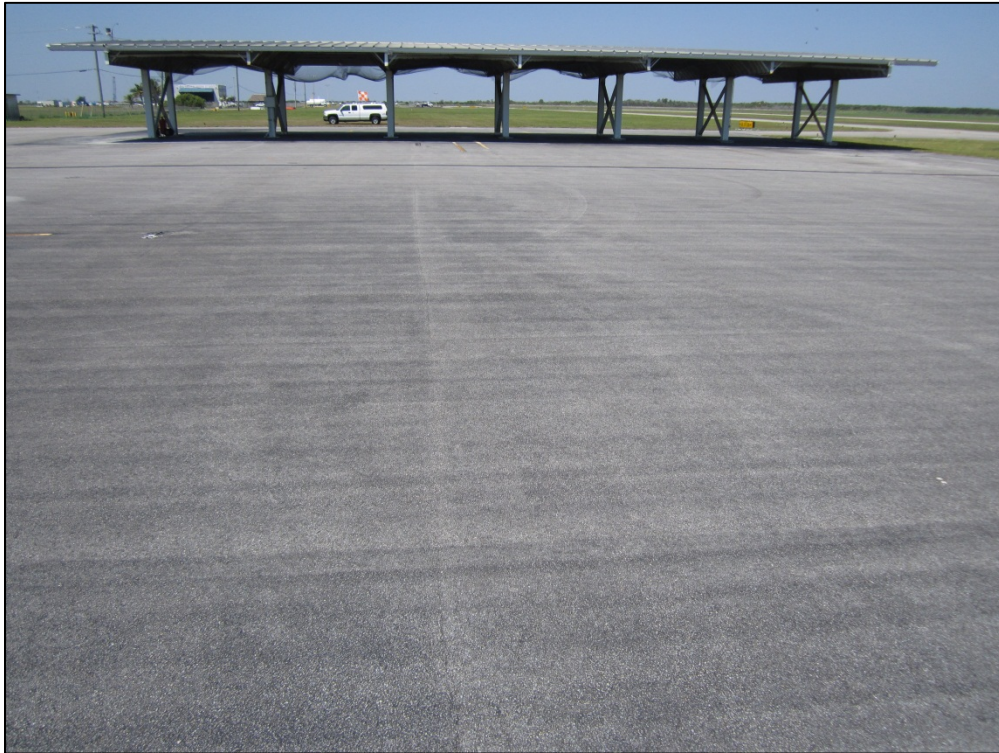
North Apron, Section 4205, Sample Unit 202 – Low severity (48) Longitudinal and Transverse Cracking, low severity (52) Weathering and Raveling

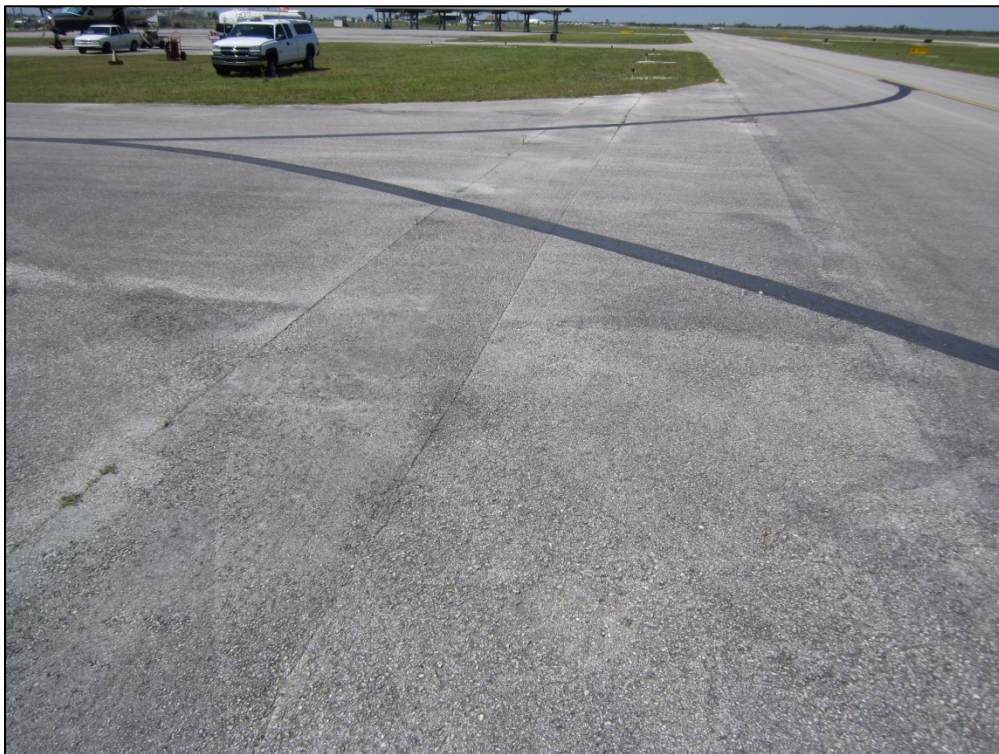
Taxiway Alpha, Section 295, Sample Unit 202 – Low severity (48) Longitudinal and Transverse Cracking, low and medium severity (52) Weathering and Raveling, medium severity (50) Patching
