STATE OF FLORIDA DEPARTMENT OF TRANSPORTATION AVIATION OFFICE

Statewide Airfield Pavement Management Program

Kendall-Tamiami Executive Airport- TMB
(Regional Reliever)
Miami, Florida
(District 6)

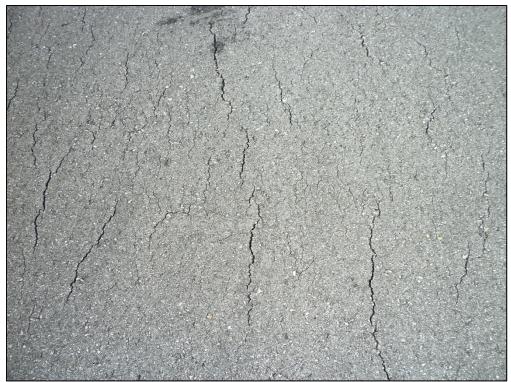
Runways 13-31, 9L-27R, and 9R-27L are all surfaced with asphalt concrete and exhibited frequent occurrences of low severity weathering and raveling and longitudinal and transverse cracking. Medium severity weathering and raveling, low severity patching, bleeding, and oil spillage were also observed on the runways. The runways are in Good condition with PCI values ranging from 90 to 91, which is above the FDOT and FAA minimum PCI levels.

Runway 13-31, Section 6210, Sample Unit 508 – Low severity (52) Weathering and Raveling; low severity (48) Longitudinal and Transverse Cracking

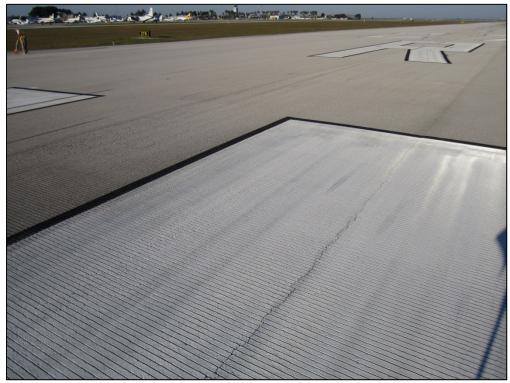
Runway 9L-27R, Section 6131, Sample Unit 396 – Low severity (52) Weathering and Raveling; low severity (48) Longitudinal and Transverse Cracking

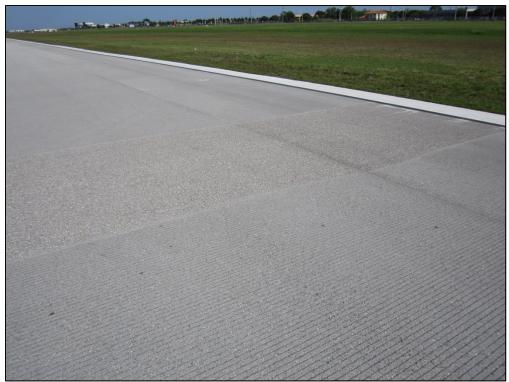
Runway 9R-27L, Section 6310, Sample Unit 544 – Low to medium severity (52) Weathering and Raveling

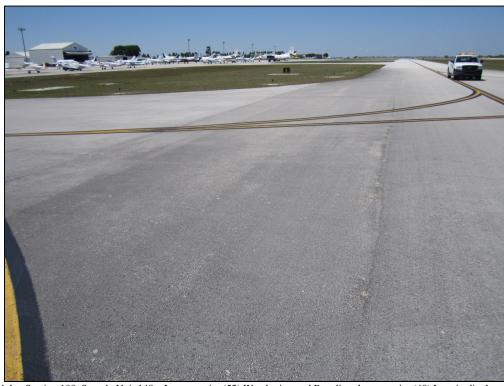
Taxiway Alpha, Section 108, Sample Unit 148 – Low severity (52) Weathering and Raveling; low severity (48) Longitudinal and Transverse Cracking

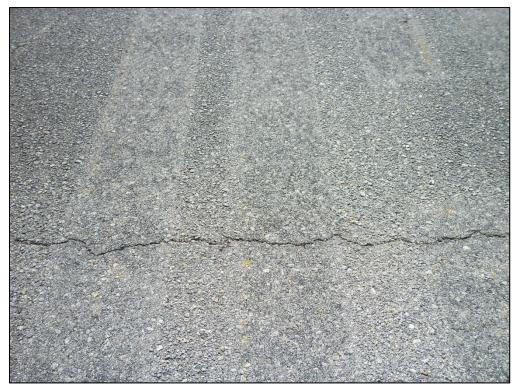
Taxiway D-1, Section 415, Sample Unit 101 – Low to medium severity (52) Weathering and Raveling; low severity (48) Longitudinal and Transverse Cracking

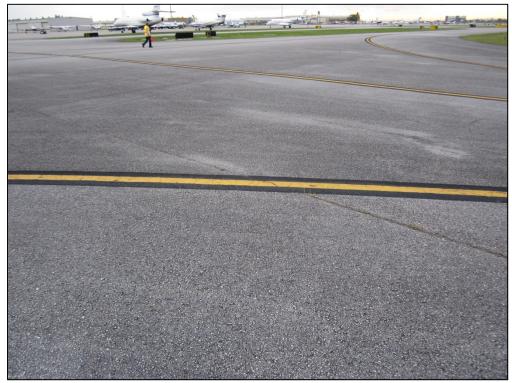
Taxiway D-2, Section 420, Sample Unit 205 – Low to medium severity (52) Weathering and Raveling; low severity (48) Longitudinal and Transverse Cracking

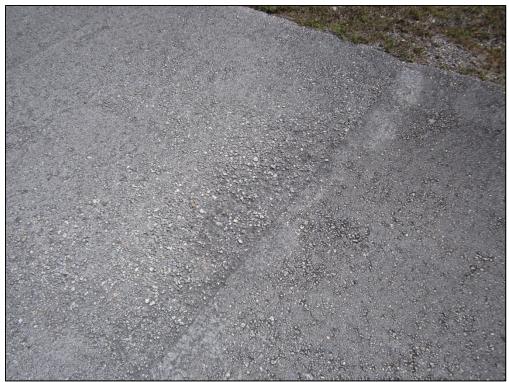
Taxiway Echo, Section 505, Sample Unit 159 – Medium severity (52) Weathering and Raveling

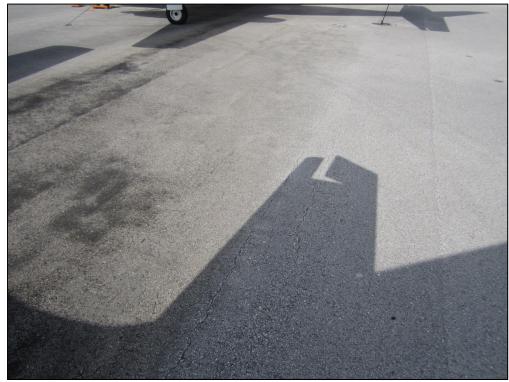
North Apron, Section 4205, Sample Unit 312 – Low severity (52) Weathering and Raveling; low severity (48) Longitudinal and Transverse Cracking; low severity (56) Swelling; (49) Oil Spillage

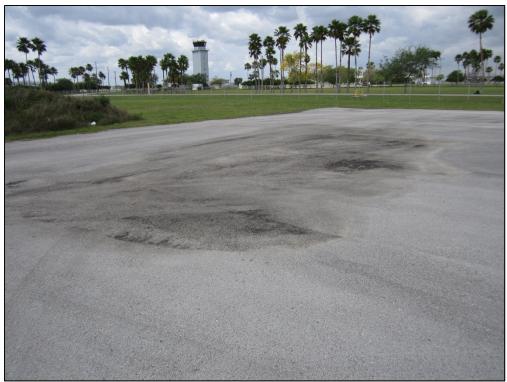
North Apron, Section 4230, Sample Unit 102 – Low severity (52) Weathering and Raveling; low severity (45) Depression

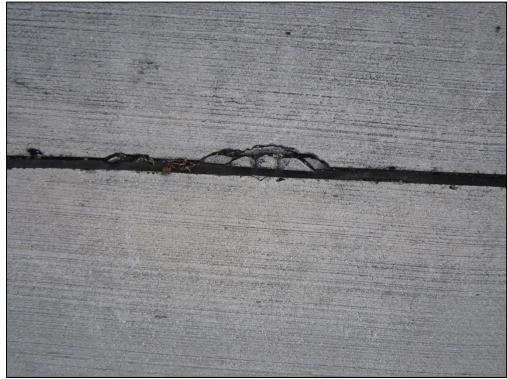
Northeast Apron, Section 4305, Sample Unit 201 – Low severity (74) Joint Spalling

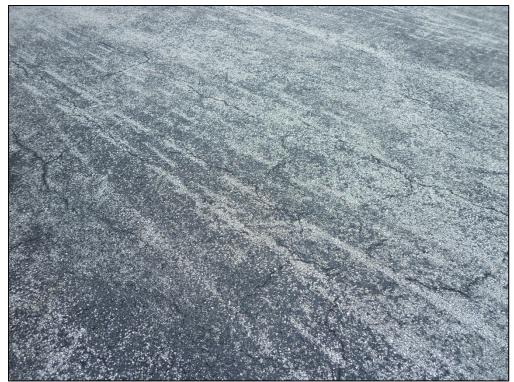
The aprons are typically in Good to Fair condition, with one section on the South Apron located within an area of T-Hangars in Very Poor condition. This area exhibited large expanses of medium severity weathering and raveling as well as low severity block cracking.

South Apron, Section 4140, Sample Unit 402 – Low severity (52) Weathering and Raveling; low severity (43) Block Cracking

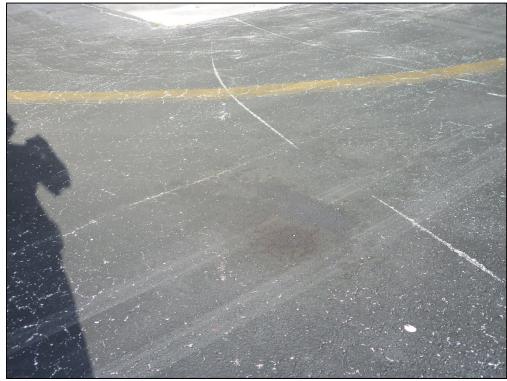
Southeast Apron, Section 4410, Sample Unit 501 – Low severity (52) Weathering and Raveling; low severity (48) Longitudinal and Transverse Cracking; (49) Oil Spillage
