STATE OF FLORIDA DEPARTMENT OF TRANSPORTATION AVIATION OFFICE

Statewide Airfield Pavement Management Program

Keystone Airpark – 42J (General Aviation) Keystone Heights, Florida (District 2)

May 2011

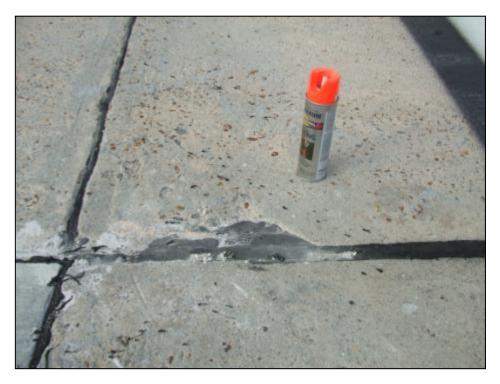
Runway 5-23, Section 6105, Sample Unit 301 – Low severity (62) Corner Break, low severity (63) Linear Cracking, low severity (65) Joint Seal Damage, low severity (67) Large Patch, low severity (70) Scaling, low severity (74) Joint Spalling.

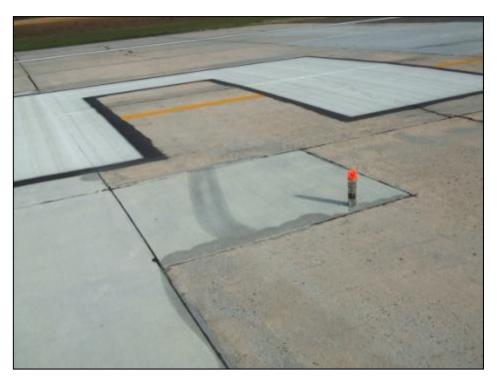
Runway 5-23, Section 6105, Sample Unit 305 – Low severity (62) Corner Break, low severity (63) Linear Cracking, low severity (65) Joint Seal Damage, low severity (67) Large Patch, low severity (70) Scaling.

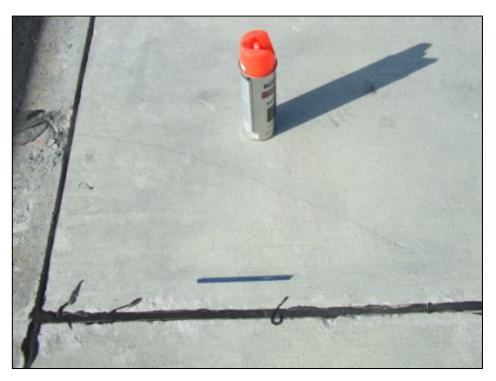
Runway 5-23, Section 6105, Sample Unit 301 – Low severity (62) Corner Break, low severity (63) Linear Cracking, low severity (65) Joint Seal Damage, low severity (67) Large Patch, low severity (70) Scaling, low severity (74) Joint Spalling.

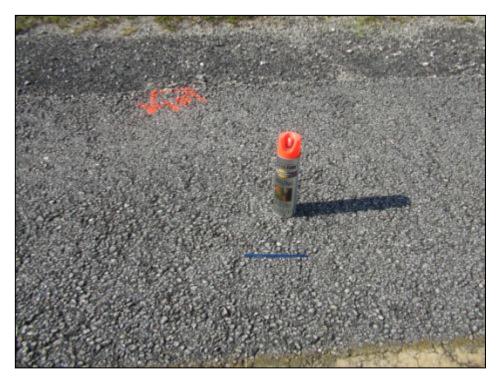
Taxiway Alpha, Section 105, Sample Unit 101 – Low and medium severity (48) Longitudinal and Transverse Cracking, low and medium severity (52) Weathering and Raveling.

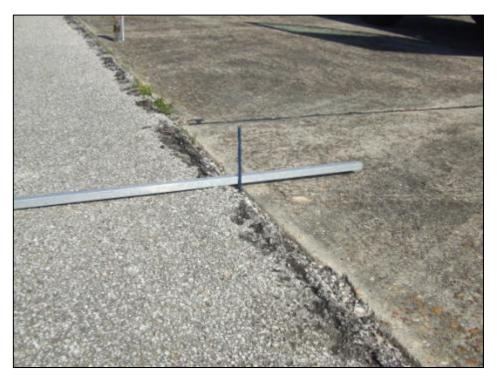
Apron, Section 4110, Sample Unit 200 – Low severity (48) Longitudinal and Transverse Cracking, low severity (54) Shoving, low and medium severity (52) Weathering and Raveling.

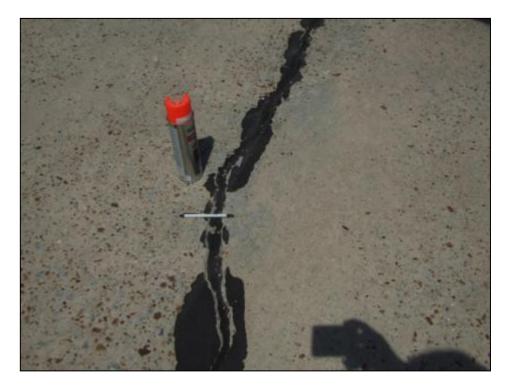
Runway 5-23, Section 6210, Sample Unit 500 – Low severity (62) Corner Break, low and medium severity (63) Linear Cracking, low severity (65) Joint Seal Damage, low severity (70) Scaling, low severity (72) Shattered Slabs, low severity (75) Corner Spall.

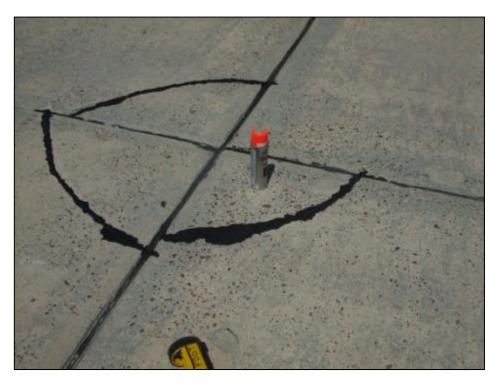
Runway 5-23, Section 6210, Sample Unit 500 – Low severity (62) Corner Break, low and medium severity (63) Linear Cracking, low severity (65) Joint Seal Damage, low severity (70) Scaling, low severity (72) Shattered Slabs, low severity (75) Corner Spall.
