**STATE OF FLORIDA
DEPARTMENT OF TRANSPORTATION
AVIATION OFFICE**

**Statewide Airfield Pavement
Management Program**

**La Belle Municipal Airport– X14
(General Aviation)
La Belle, Florida
(District 1)**

May 2011

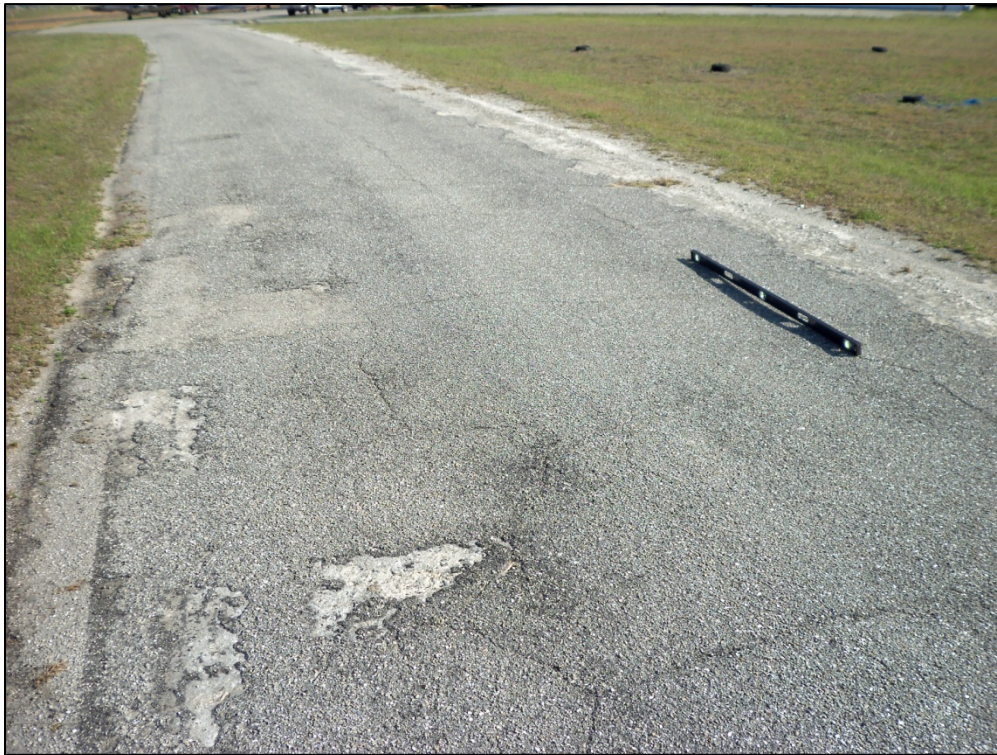
Taxiway NW Apron, Section 605, Sample Unit 101 – Low severity (43) Block Cracking, low severity (48) Longitudinal and Transverse Cracking, medium and high severity (52) Weathering and Raveling, low severity (56) Swell

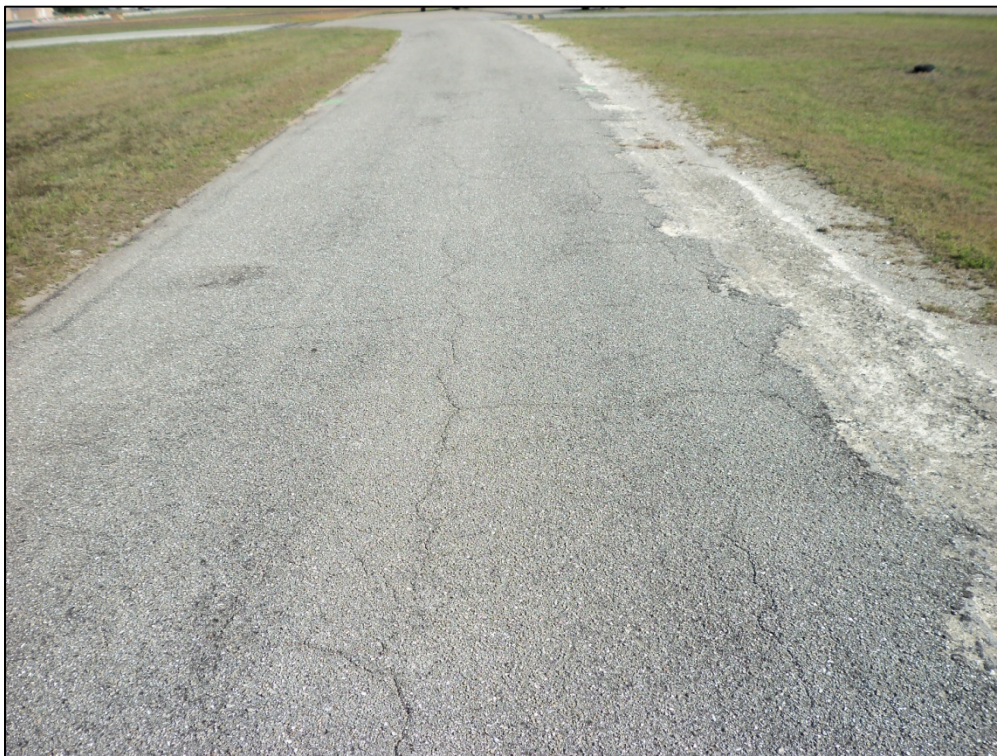
Taxiway NW Apron, Section 605, Sample Unit 101 – Low severity (43) Block Cracking, low severity (48) Longitudinal and Transverse Cracking, medium and high severity (52) Weathering and Raveling, low severity (56) Swell

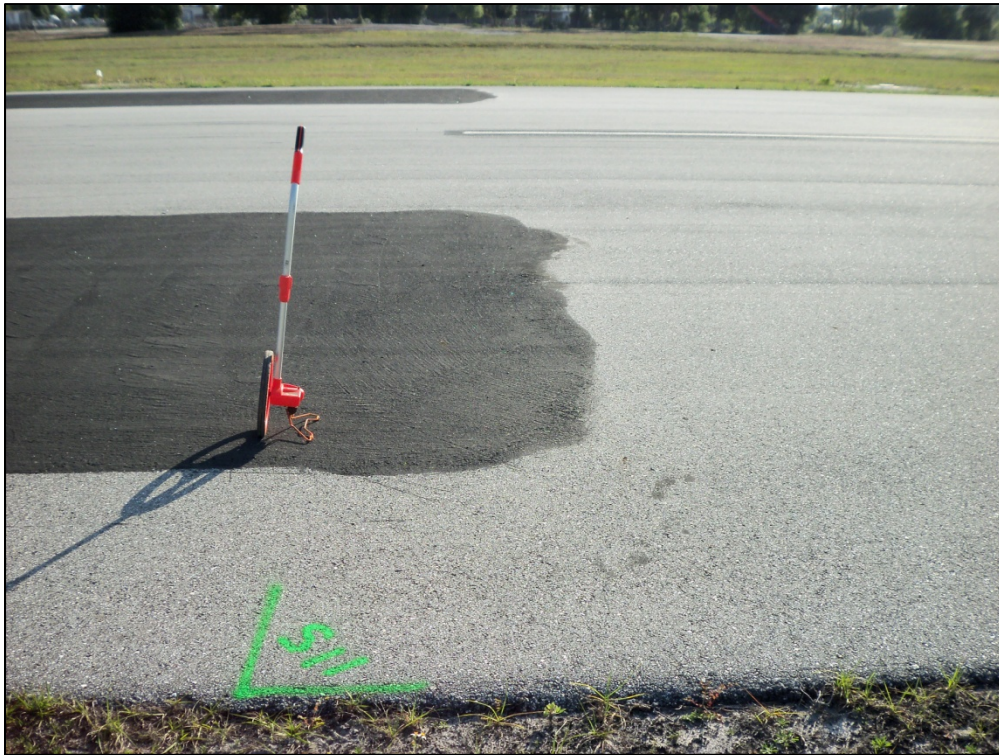
Runway 14-32 exhibited low severity weathering and raveling in addition to low severity longitudinal and transverse cracking. The 500-ft pavement section at the 14 end of RW 14-32 exhibited a higher quantity of higher severity distresses, which decreased the overall PCI for the

Runway 14-32, Section 6105, Sample Unit 115 – Low severity (48) Longitudinal and Transverse Cracking, low and medium severity (52) Weathering and Raveling

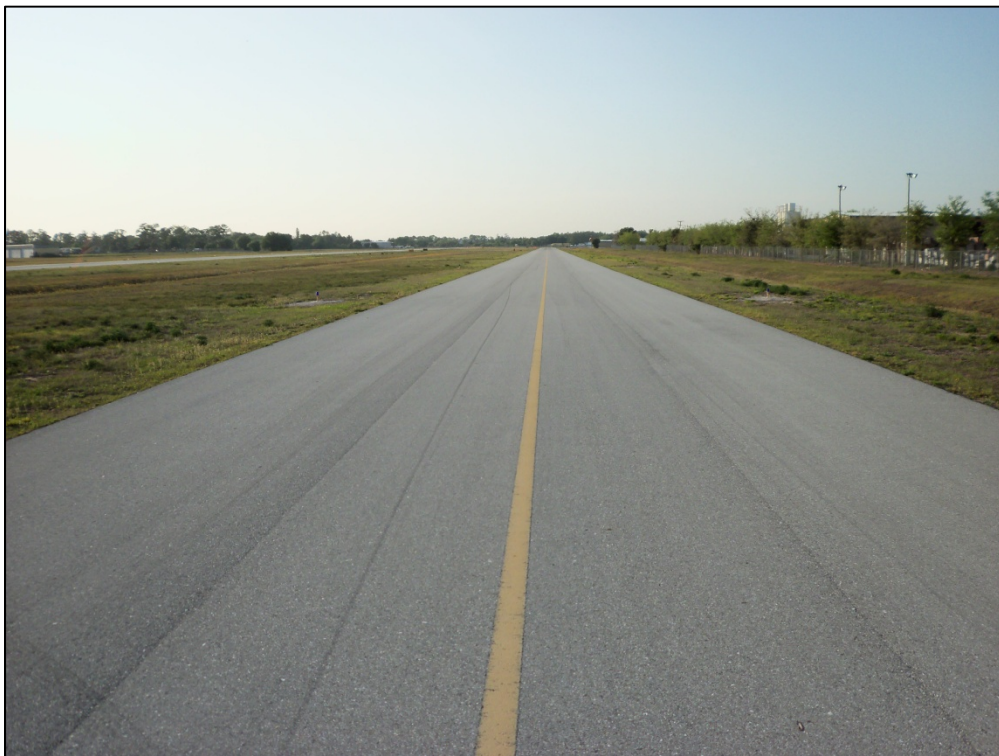
Taxiway Alpha, Section 105, Sample Unit 109 – Low severity (52) Weathering and Raveling

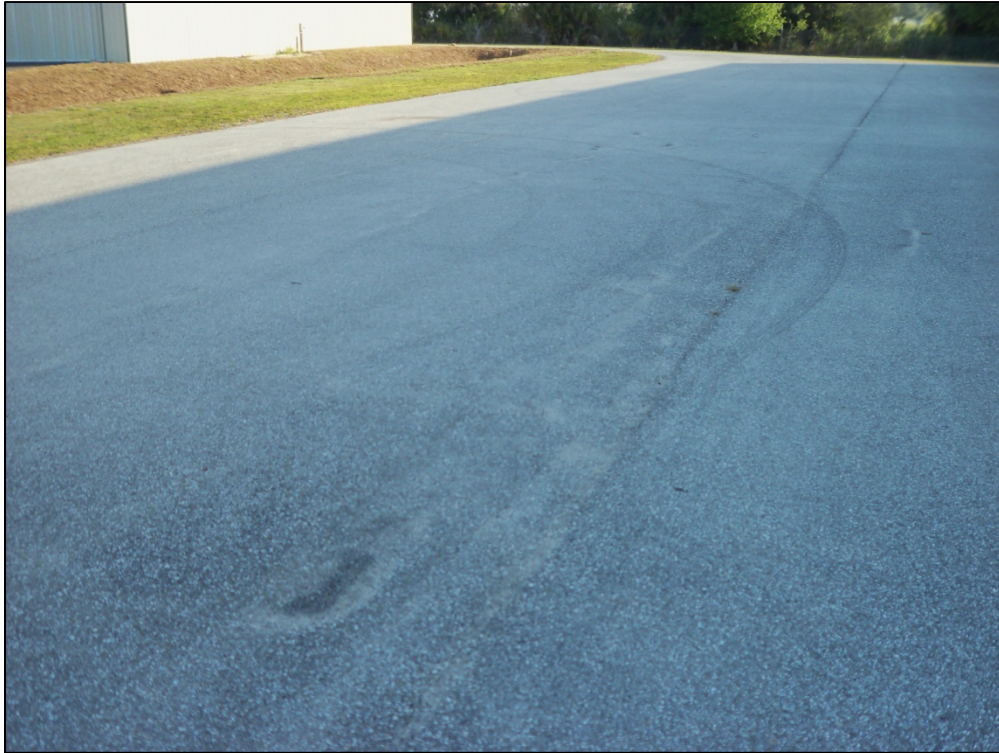
Hangars, Section 4305, Sample Unit 202 – Low severity (45) Depression, low severity (48) Longitudinal and Transverse Cracking, low and medium severity (52) Weathering and Raveling

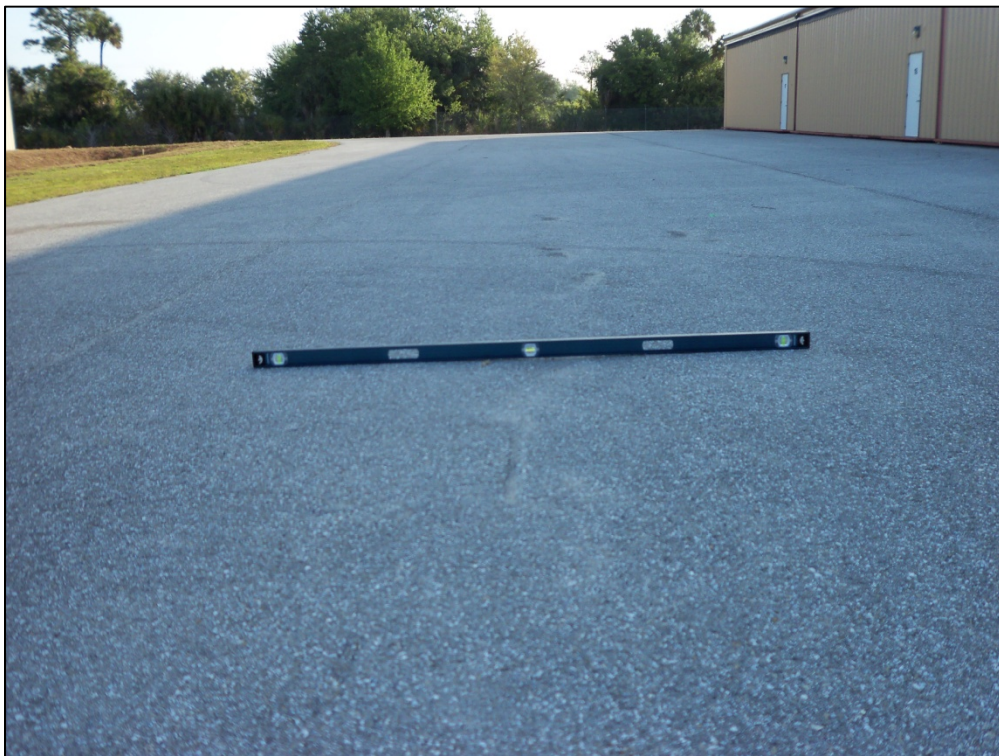
Hangars, Section 4305, Sample Unit 202 – Low severity (45) Depression, low severity (48) Longitudinal and Transverse Cracking, low and medium severity (52) Weathering and Raveling

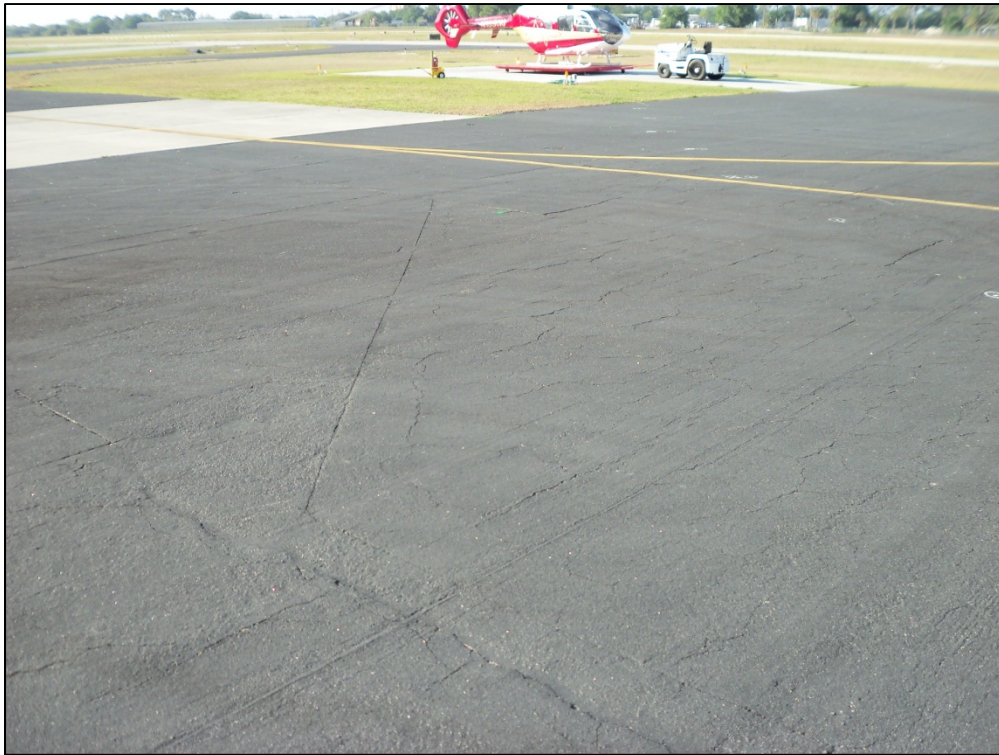
Apron, Section 4110, Sample Unit 505 – Low and medium severity (48) Longitudinal and Transverse Cracking, low and medium severity (52) Weathering and Raveling

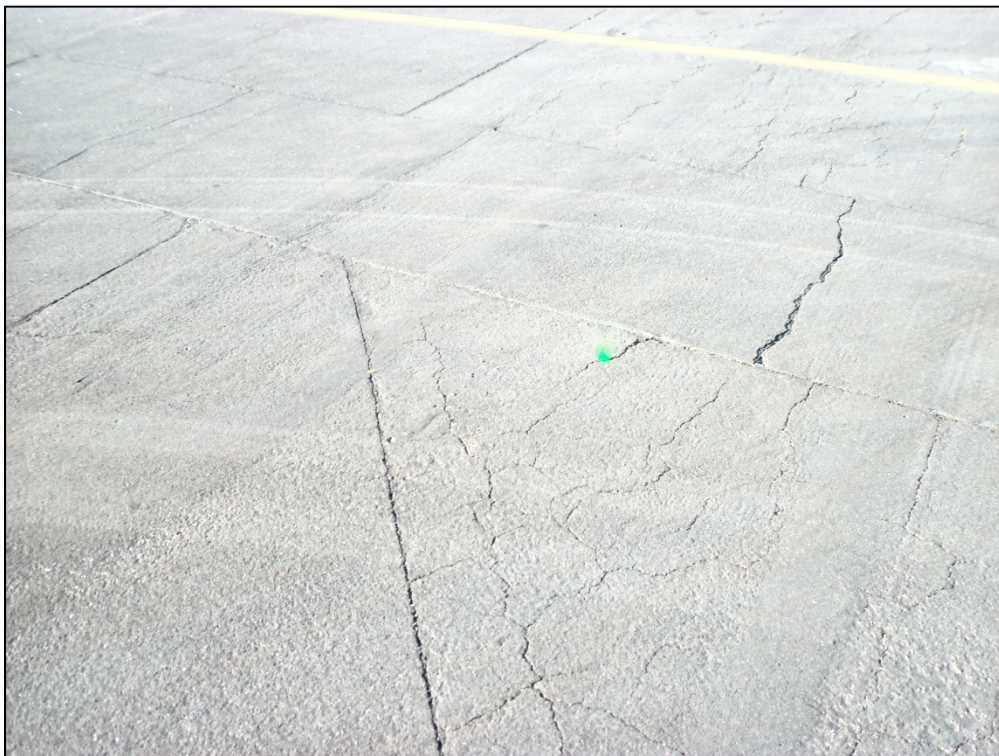
Apron, Section 4110, Sample Unit 505 – Low and medium severity (48) Longitudinal and Transverse Cracking, low and medium severity (52) Weathering and Raveling

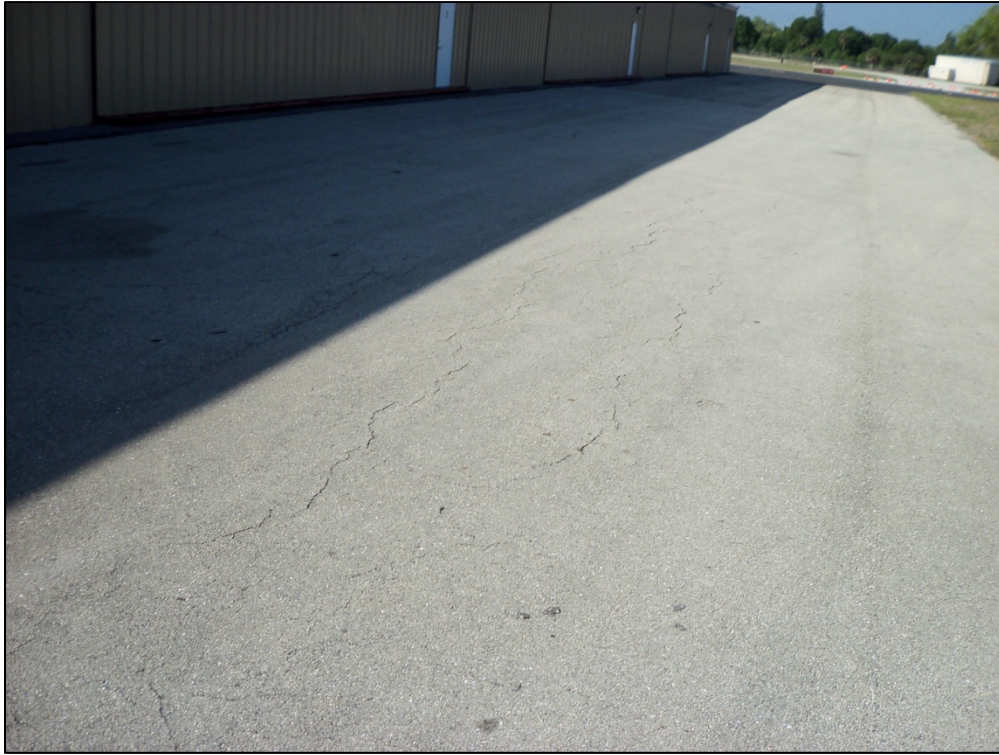
Hangars, Section 4135, Sample Unit 601 – Low severity (43) Block Cracking, low severity (48) Longitudinal and Transverse Cracking, low and medium severity (52) Weathering and Raveling

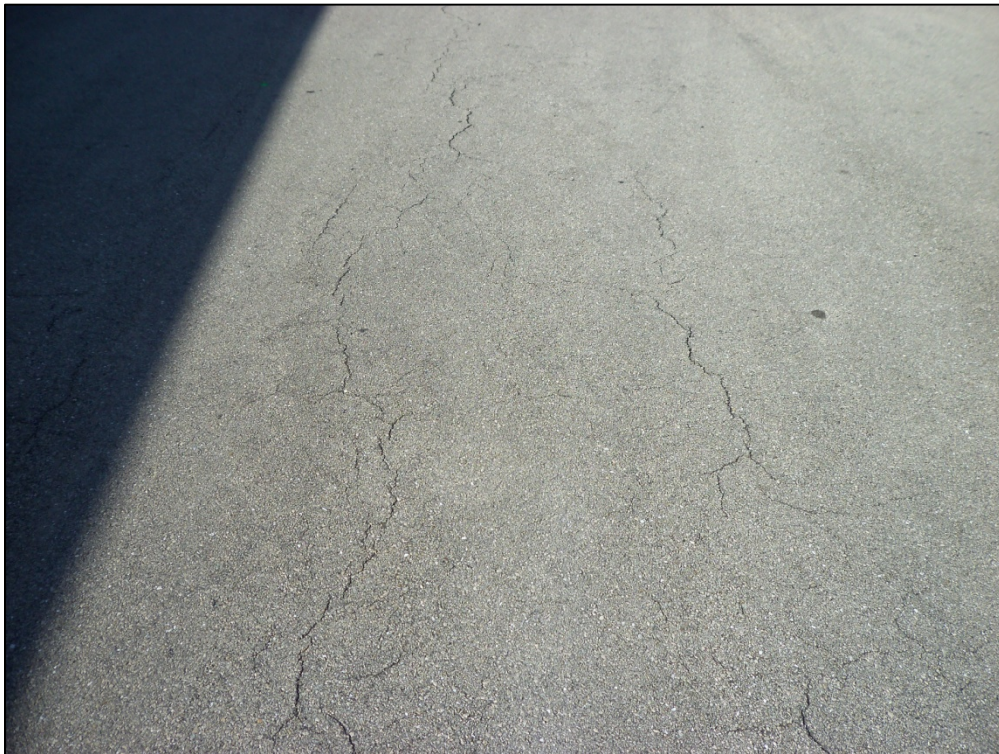
Hangars, Section 4135, Sample Unit 601 – Low severity (43) Block Cracking, low severity (48) Longitudinal and Transverse Cracking, (49) Oil Spillage, low and medium severity (52) Weathering and Raveling
