**STATE OF FLORIDA  
DEPARTMENT OF TRANSPORTATION  
AVIATION OFFICE**

**Statewide Airfield Pavement  
Management Program**

**Lake Wales Municipal Airport– X07  
(General Aviation)  
Lake Wales, Florida  
(District 1)**

**May 2011**

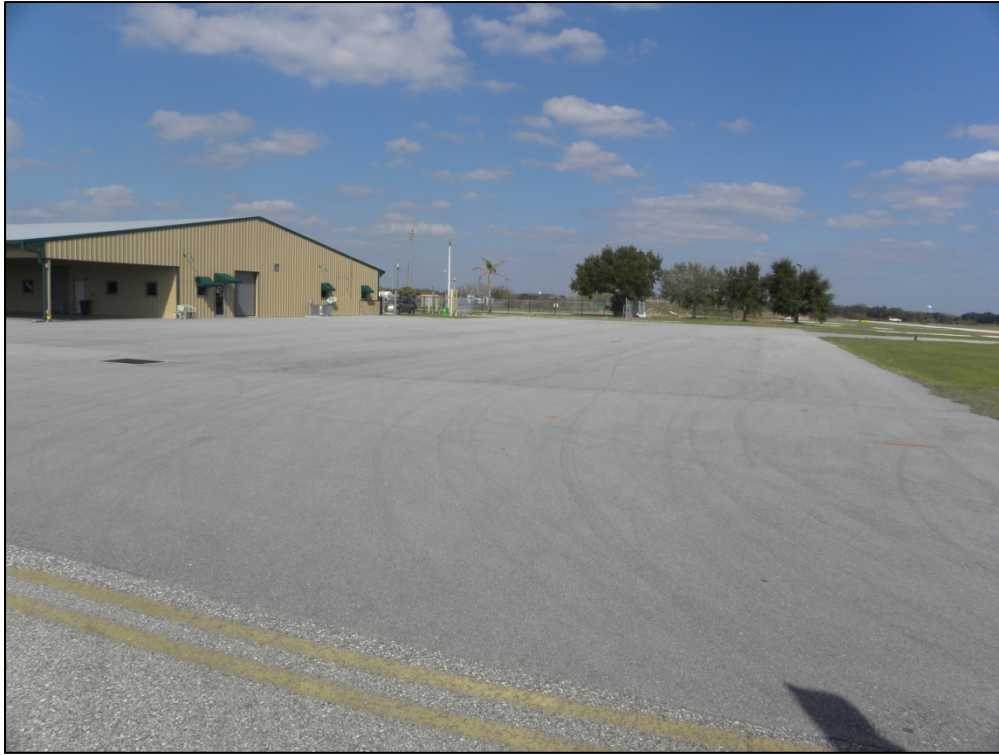
Apron, Section 4205, Sample Unit 602 – No distresses observed

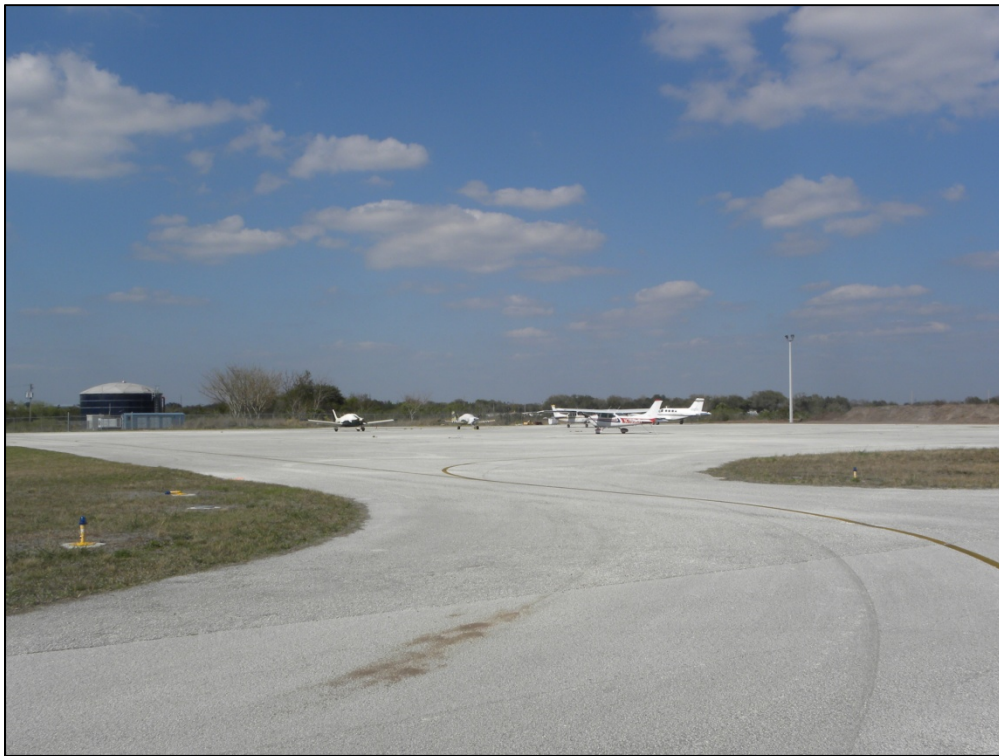
Apron, Section 110, Sample Unit 100 – Low severity (48) Longitudinal and Transverse Cracking, medium severity (52) Weathering and Raveling

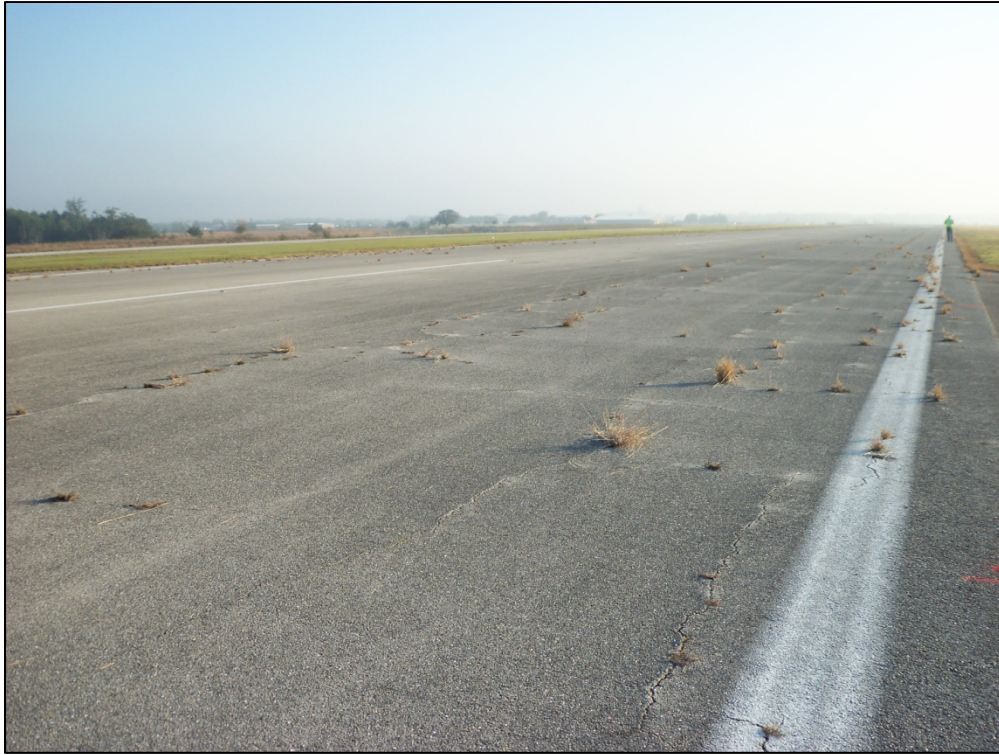
Runway 6-24 exhibited low and medium severity longitudinal and transverse cracking along with low and medium severity weathering and raveling. Low and medium severity block cracking distresses were also very prevalent throughout the runway pavement section. Multiple low severity patches were also located throughout the runway.

Runway 6-24, Section 6105, Sample Unit 103 – Low and medium severity (43) Block Cracking, low and medium severity (48) Longitudinal and Transverse Cracking, low severity (52) Weathering and Raveling

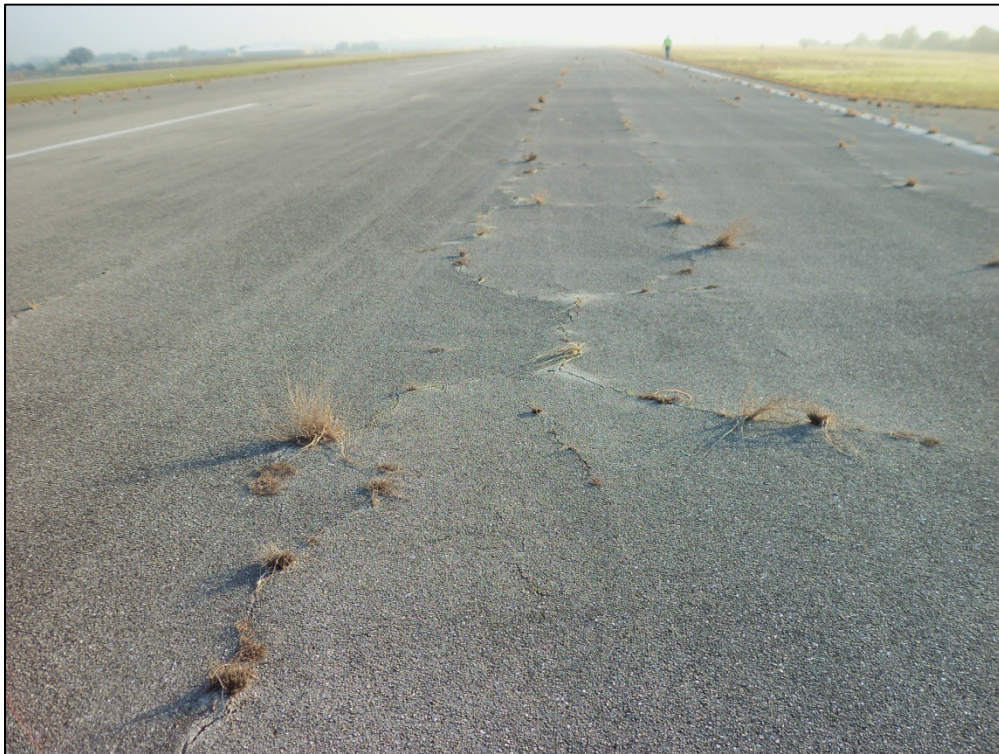
Runway 6-24, Section 6105, Sample Unit 103 – Low and medium severity (43) Block Cracking, low and medium severity (48) Longitudinal and Transverse Cracking, low severity (52) Weathering and Raveling

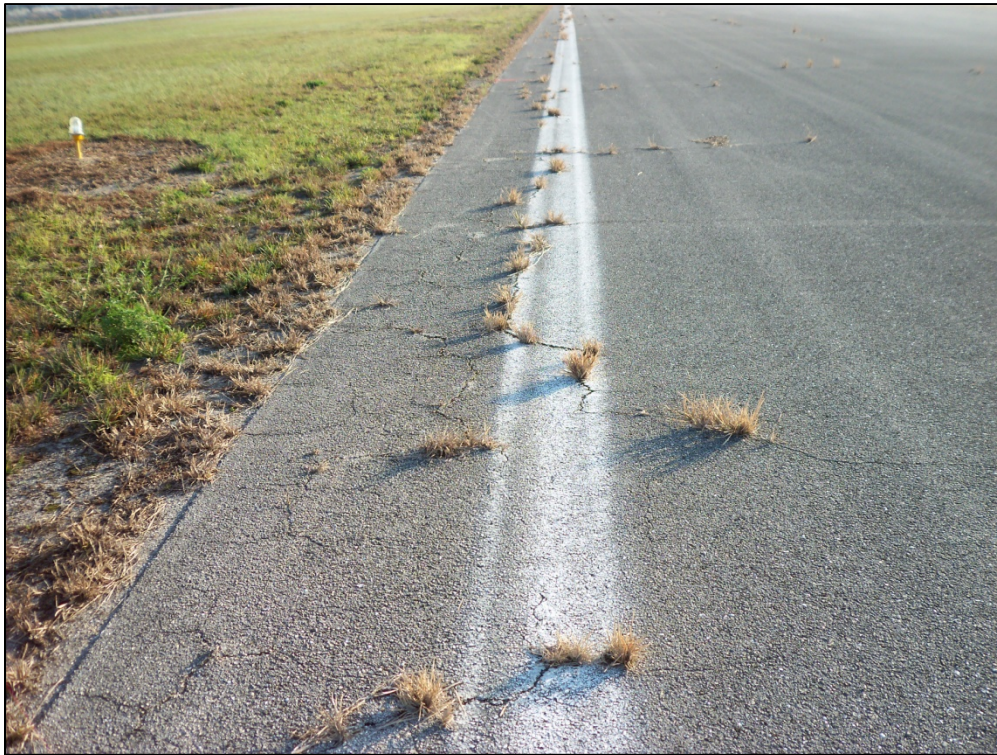
Runway 6-24, Section 6105, Sample Unit 107 – Low severity (43) Block Cracking, low severity (48) Longitudinal and Transverse Cracking, low severity (52) Weathering and Raveling

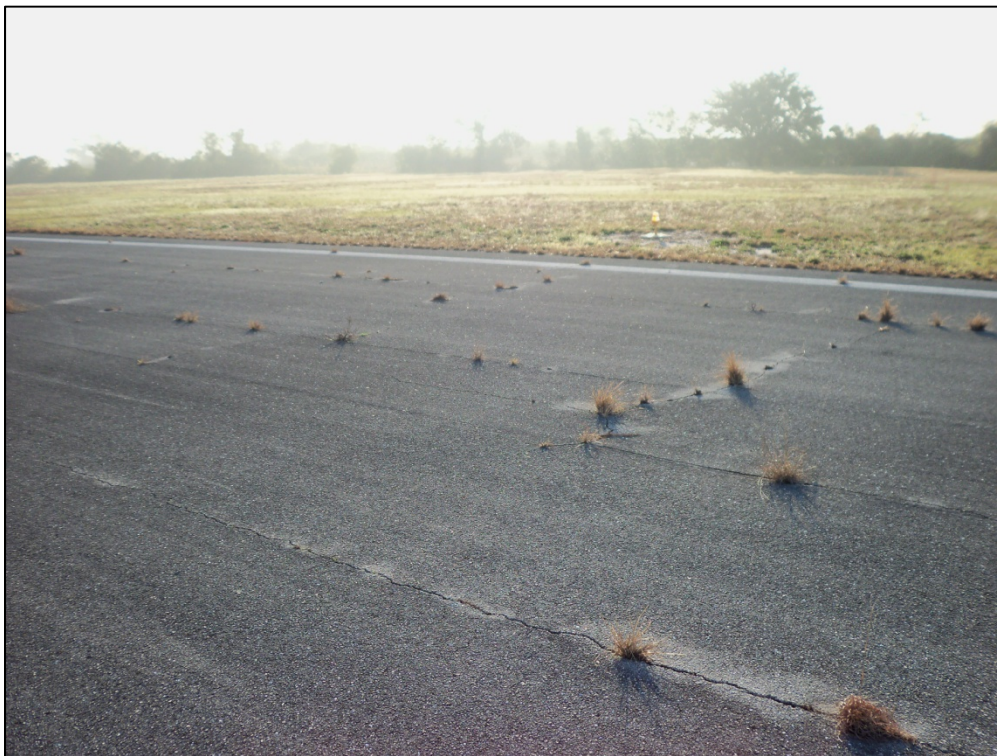
Runway 6-24, Section 6105, Sample Unit 107 – Low severity (43) Block Cracking, low severity (48) Longitudinal and Transverse Cracking, low severity (52) Weathering and Raveling

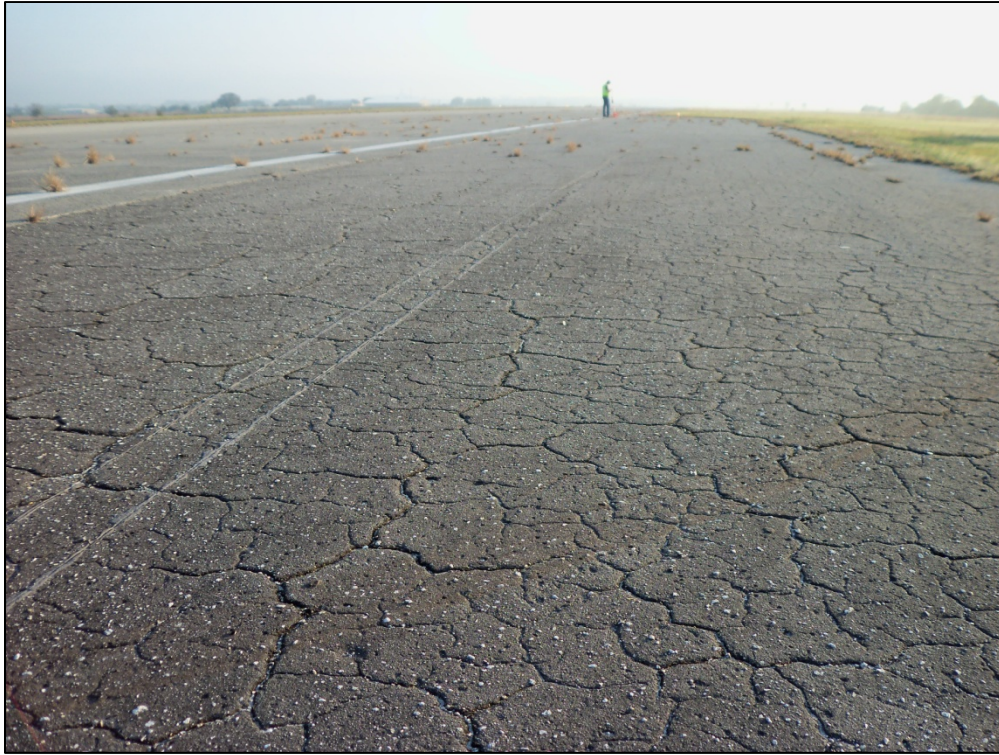
Runway 6-24 Shoulder, Section 5102, Sample Unit 181 – Medium severity (43) Block Cracking, medium severity (52) Weathering and Raveling

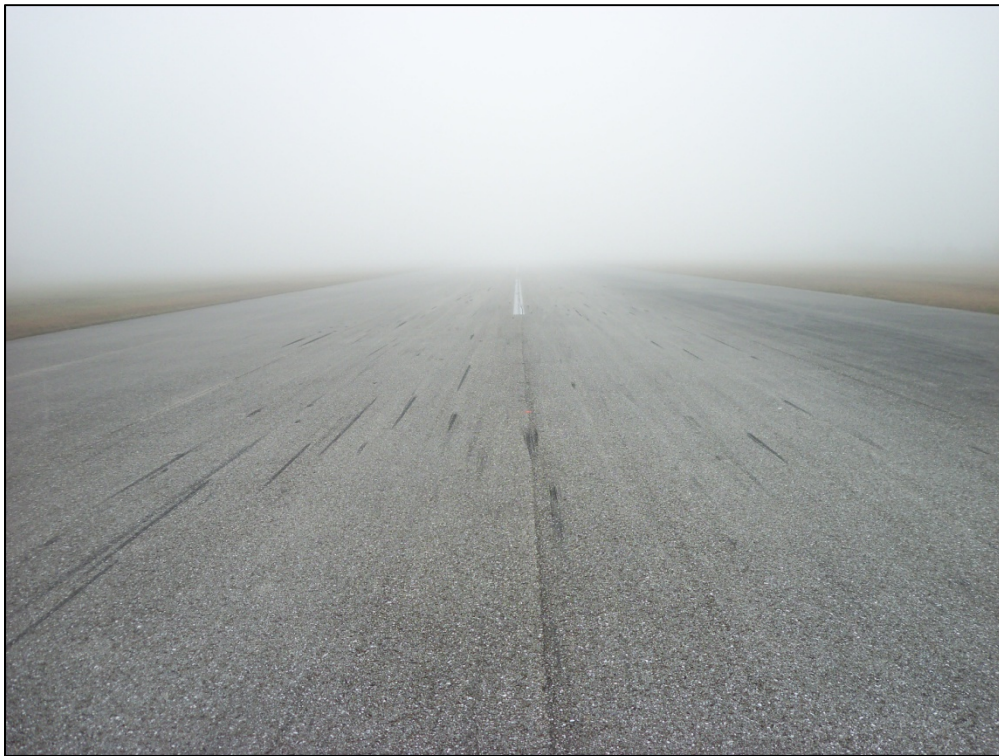
Runway 17-35 exhibited low severity longitudinal and transverse cracking along with low severity weathering and raveling. RW 17-35 was in an overall good condition with the majority of the longitudinal cracking being located along the pavement joints, which is a common distress due to the pavement being weakest at this location.

Runway 17-35, Section 6205, Sample Unit 166 – Low severity (48) Longitudinal and Transverse Cracking, low severity (52) Weathering and Raveling

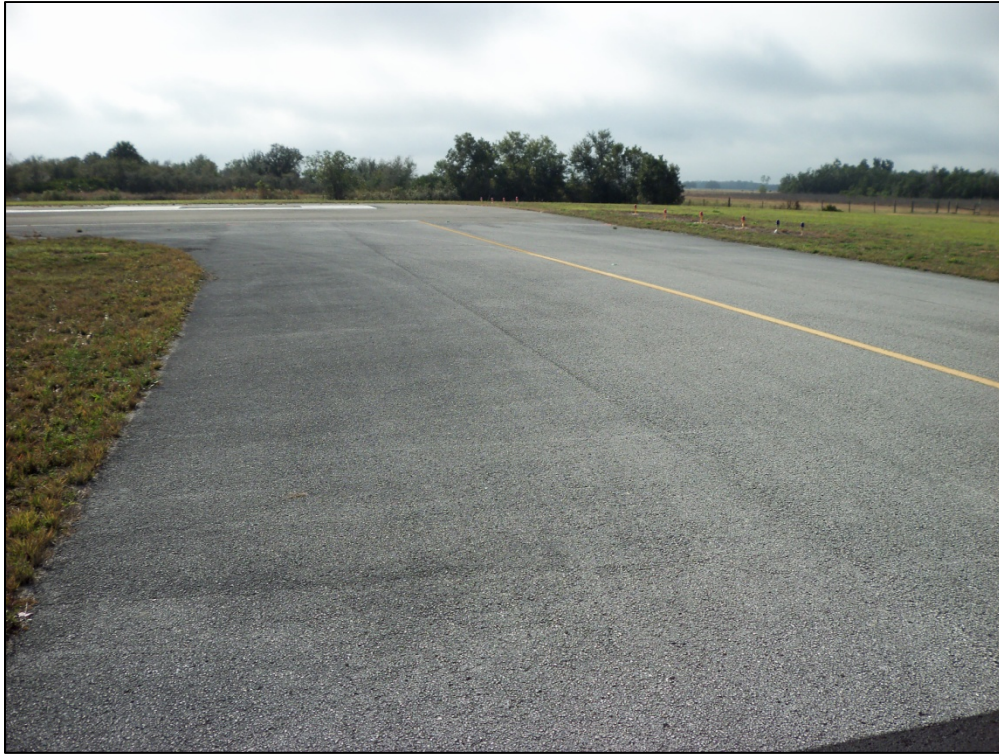
The taxiway and apron pavement exhibited low severity longitudinal and transverse cracking with low and medium severity weathering and raveling. Low severity block cracking distresses were recorded along taxiway Delta.

Taxiway Delta, Section 410, Sample Unit 100 – Low severity (43) Block Cracking, low severity (48) Longitudinal and Transverse Cracking, low severity (50) Patch, low severity (52) Weathering and Raveling

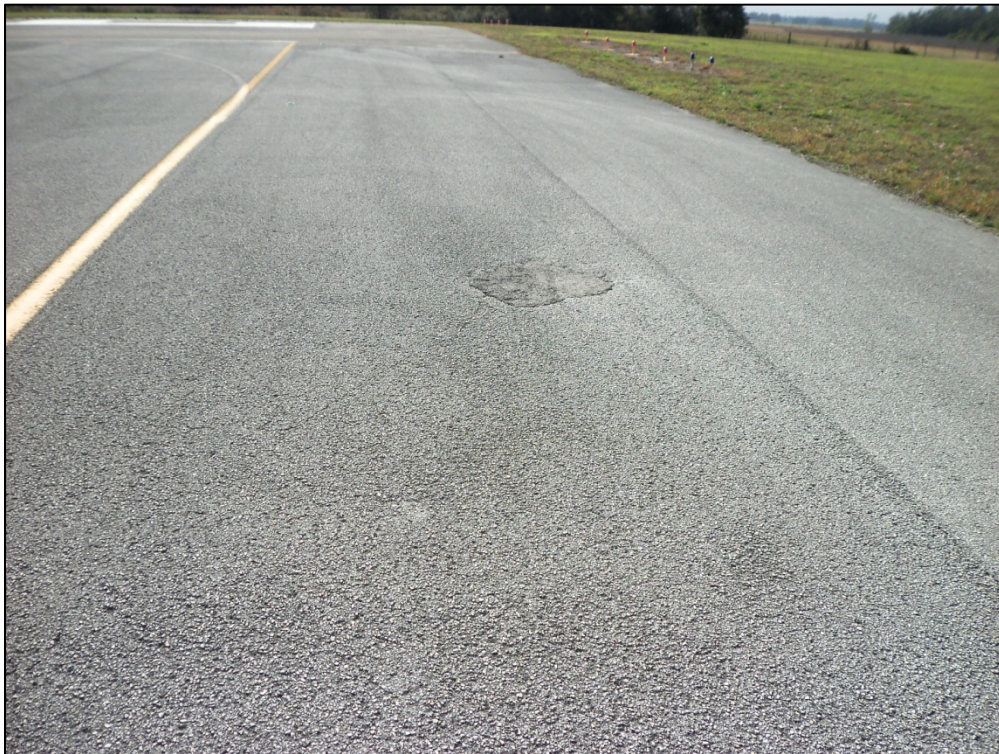
Taxiway Delta, Section 410, Sample Unit 100 – Low severity (43) Block Cracking, low severity (48) Longitudinal and Transverse Cracking, low severity (50) Patch, low severity (52) Weathering and Raveling

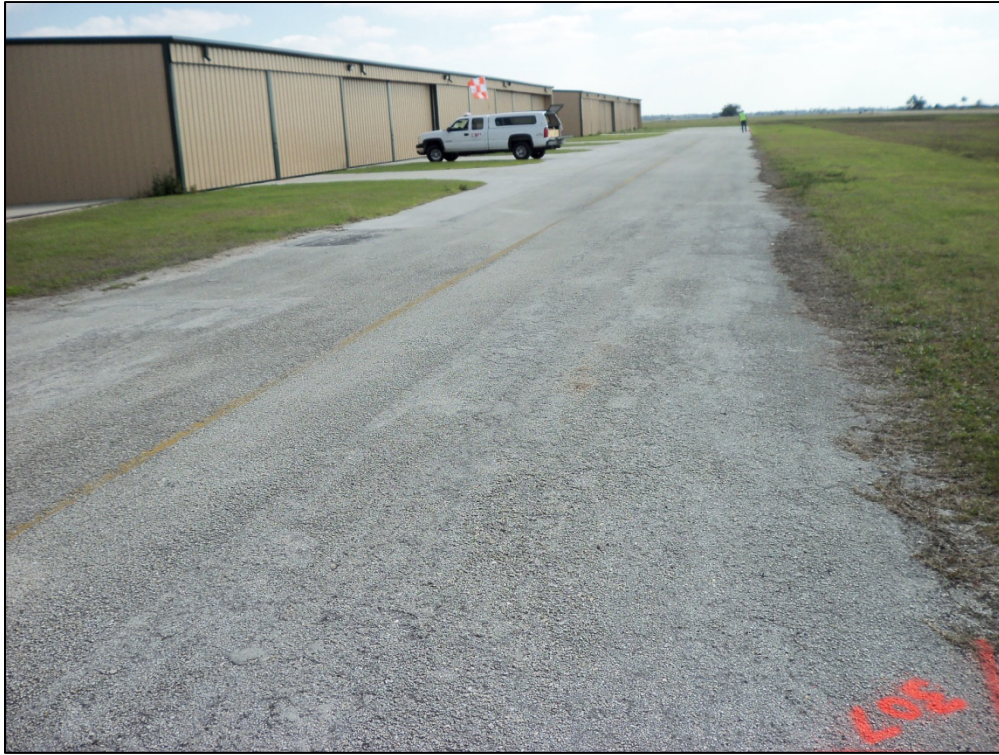
Hangars, Section 4110, Sample Unit 307 – Low and medium severity (52) Weathering and Raveling

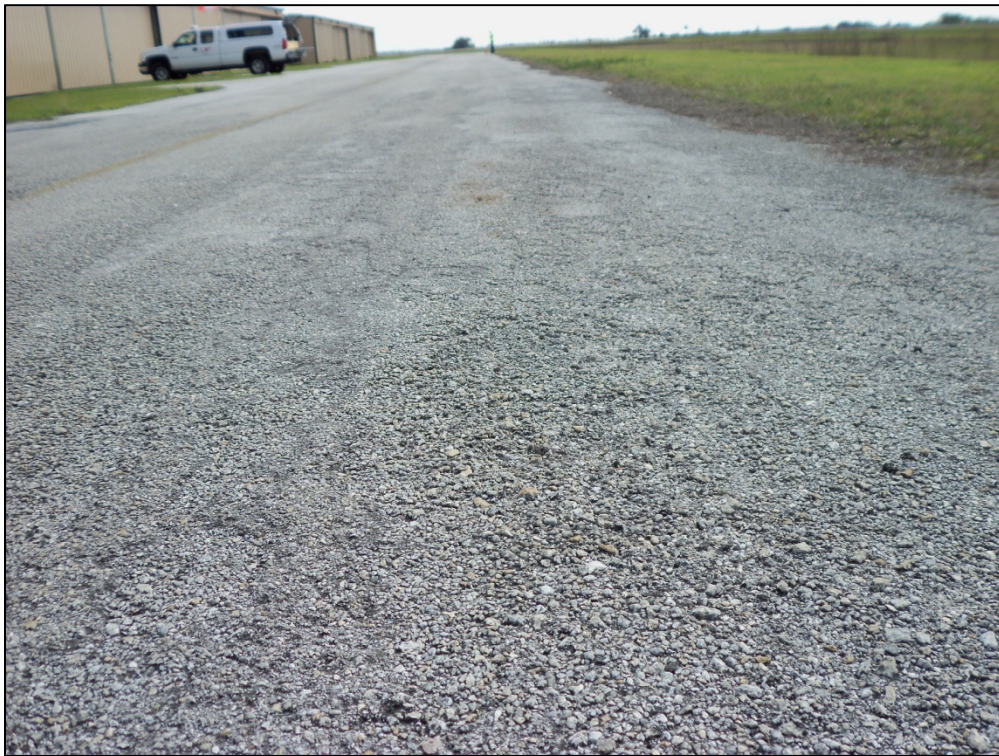
Hangars, Section 4110, Sample Unit 307 – Low and medium severity (52) Weathering and Raveling
