**STATE OF FLORIDA
DEPARTMENT OF TRANSPORTATION
AVIATION OFFICE**

**Statewide Airfield Pavement
Management Program**

**Marco Island Executive Airport– MKY
(General Aviation)
Naples, Florida
(District 1)**

May 2011

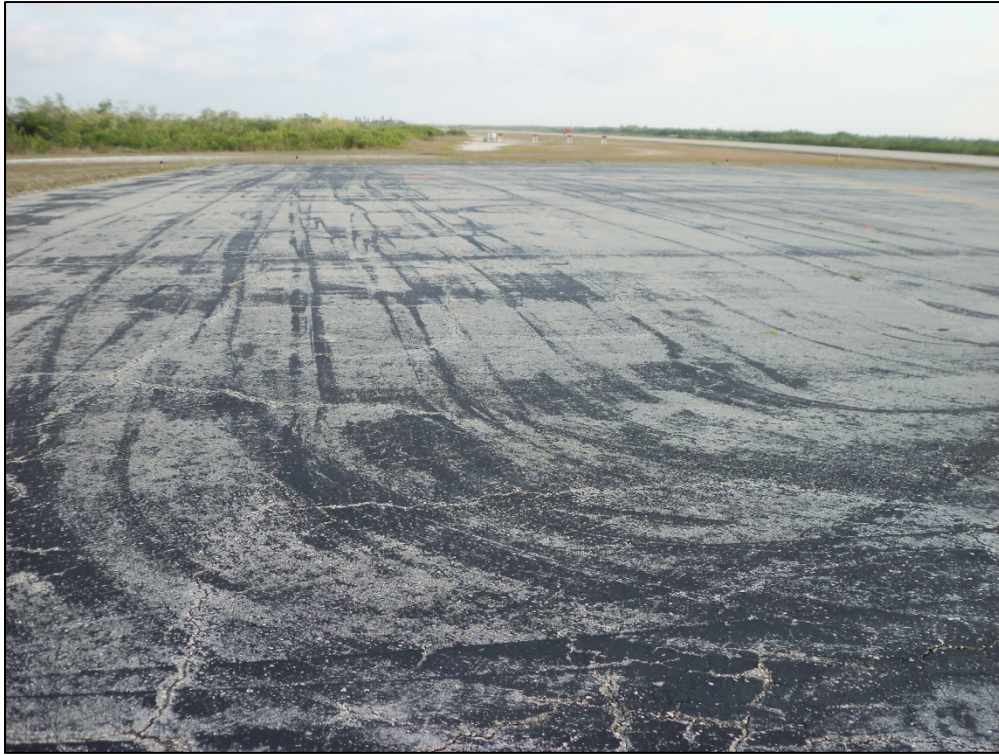
AP TA RW 35, Section 5105, Sample Unit 300 – Low and medium severity (43) Block Cracking, low severity (52) Weathering and Raveling

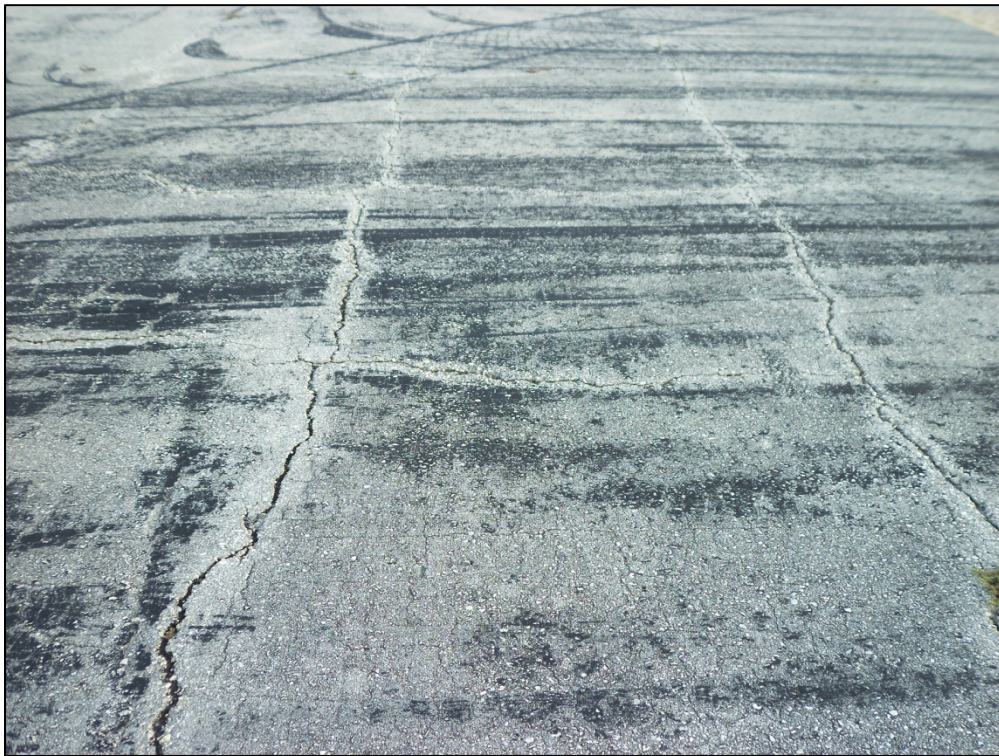
AP TA RW 35, Section 5105, Sample Unit 300 – Low and medium severity (43) Block Cracking, low severity (52) Weathering and Raveling

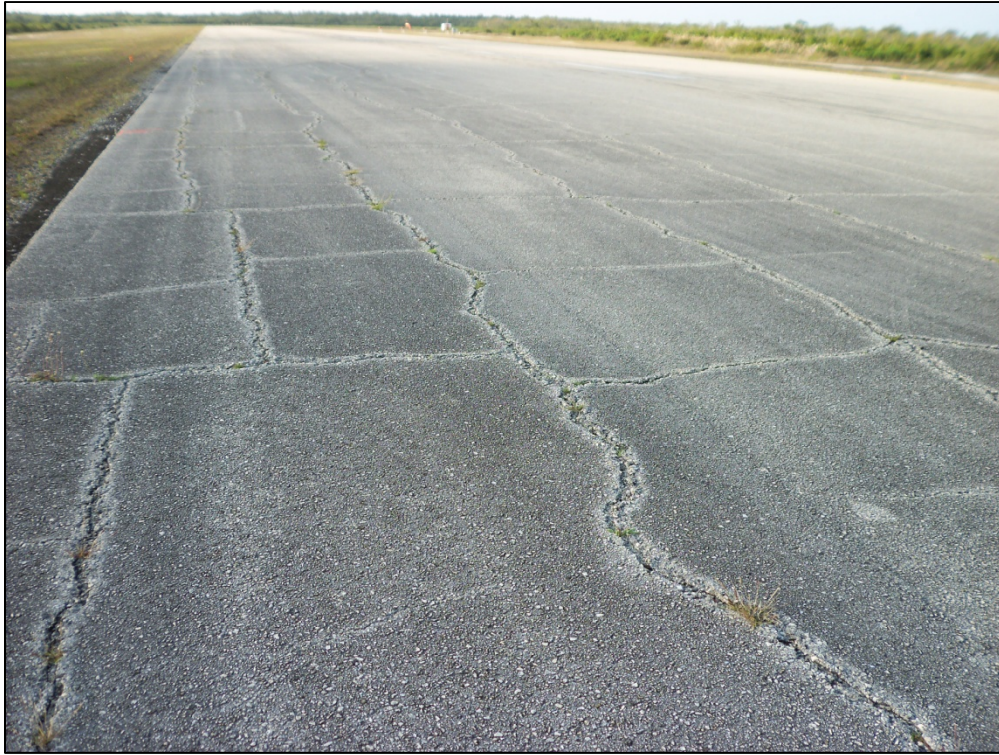
Runway 17-35, Section 6110, Sample Unit 130 – Medium severity (43) Block Cracking, medium severity (52) Weathering and Raveling

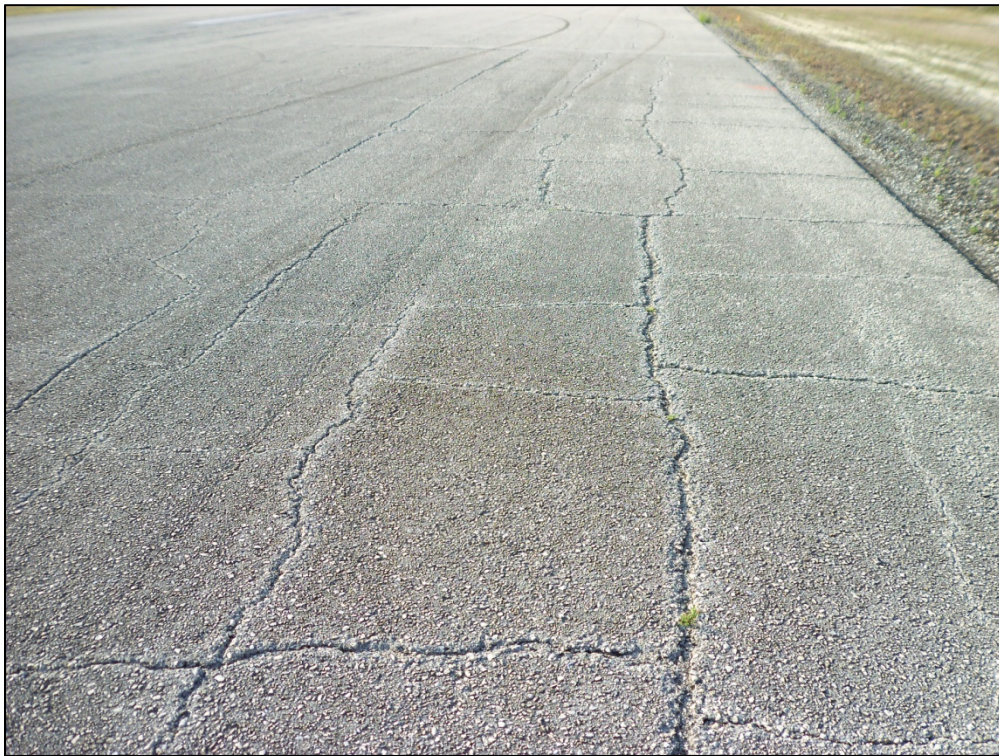
Runway 17-35, Section 6110, Sample Unit 130 – Medium severity (43) Block Cracking, medium severity (52) Weathering and Raveling

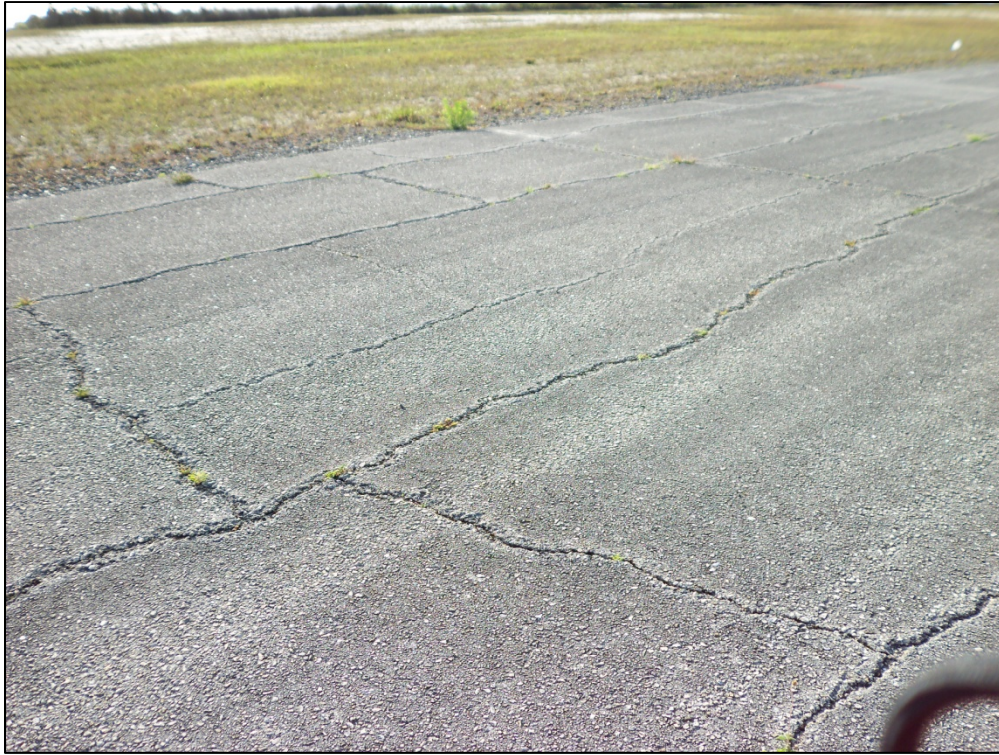
Runway 17-35, Section 6110, Sample Unit 145 – Medium severity (43) Block Cracking, medium severity (52) Weathering and Raveling

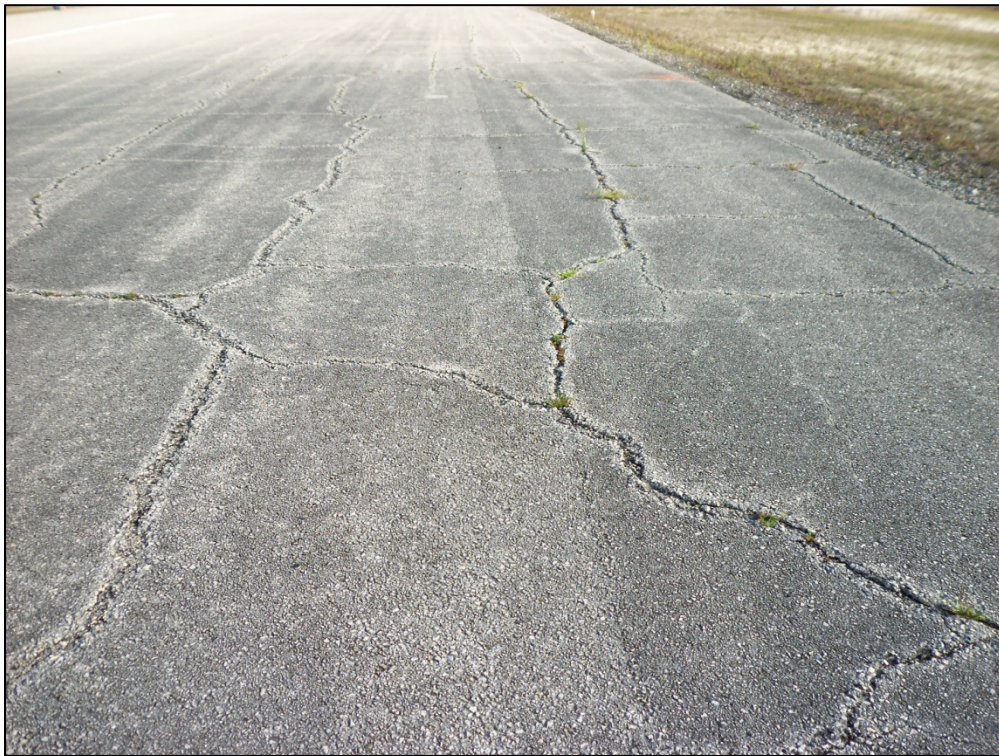
Runway 17-35, Section 6110, Sample Unit 145 – Medium severity (43) Block Cracking, medium severity (52) Weathering and Raveling

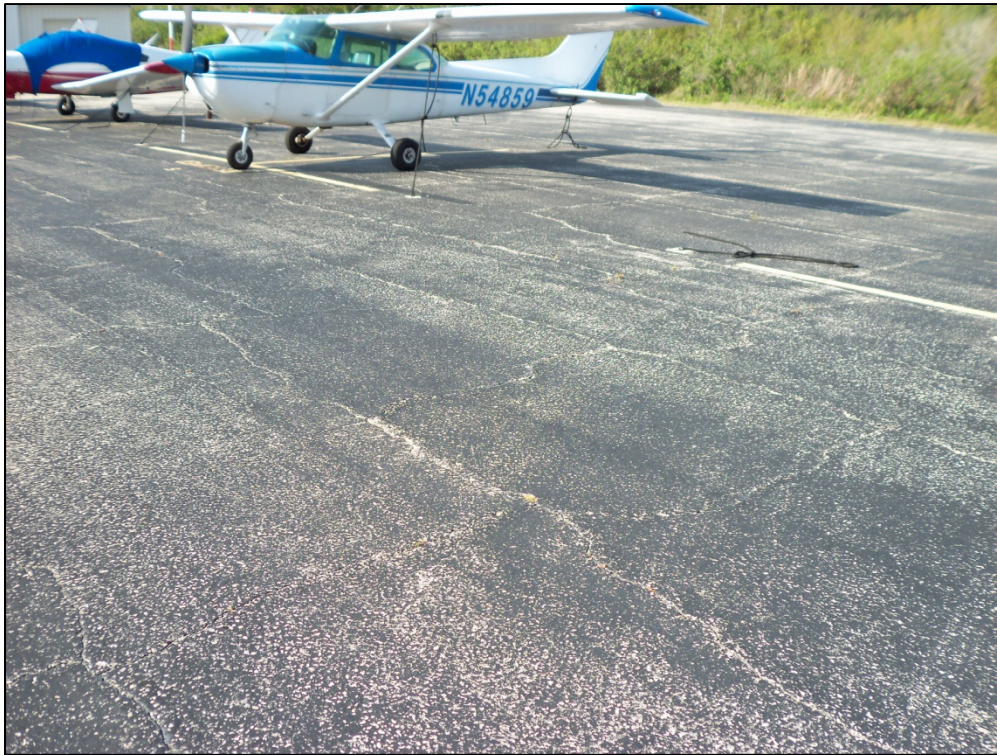
Apron, Section 4205, Sample Unit 455 – Low and medium severity (43) Block Cracking, low severity (52) Weathering and Raveling

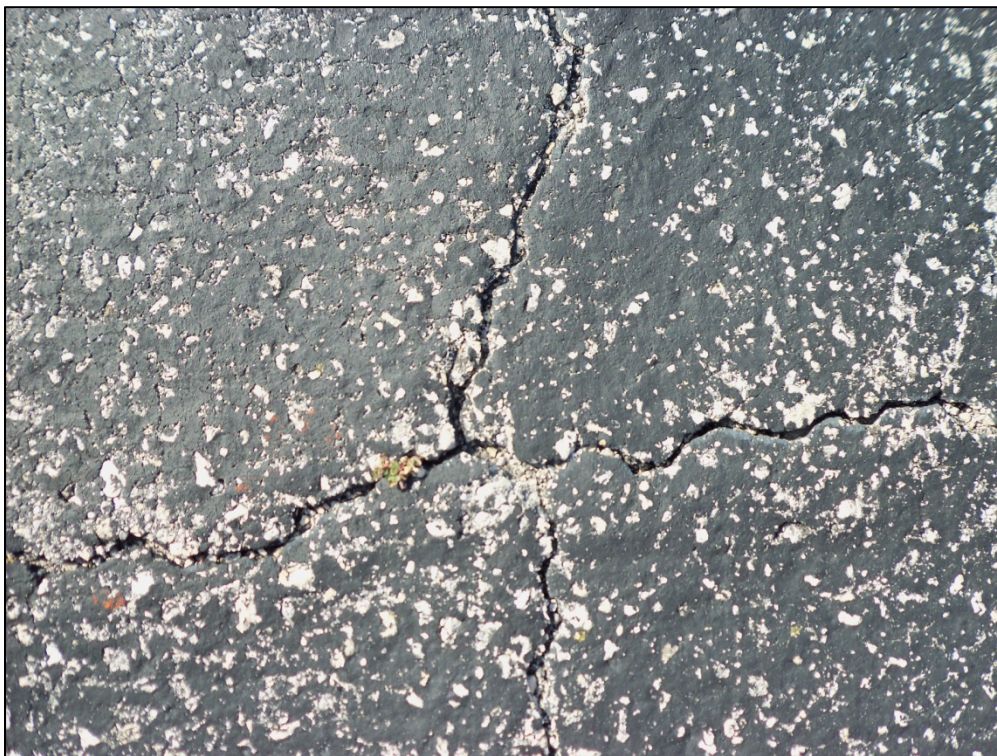
Apron, Section 4205, Sample Unit 455 – Low and medium severity (43) Block Cracking, low severity (52) Weathering and Raveling

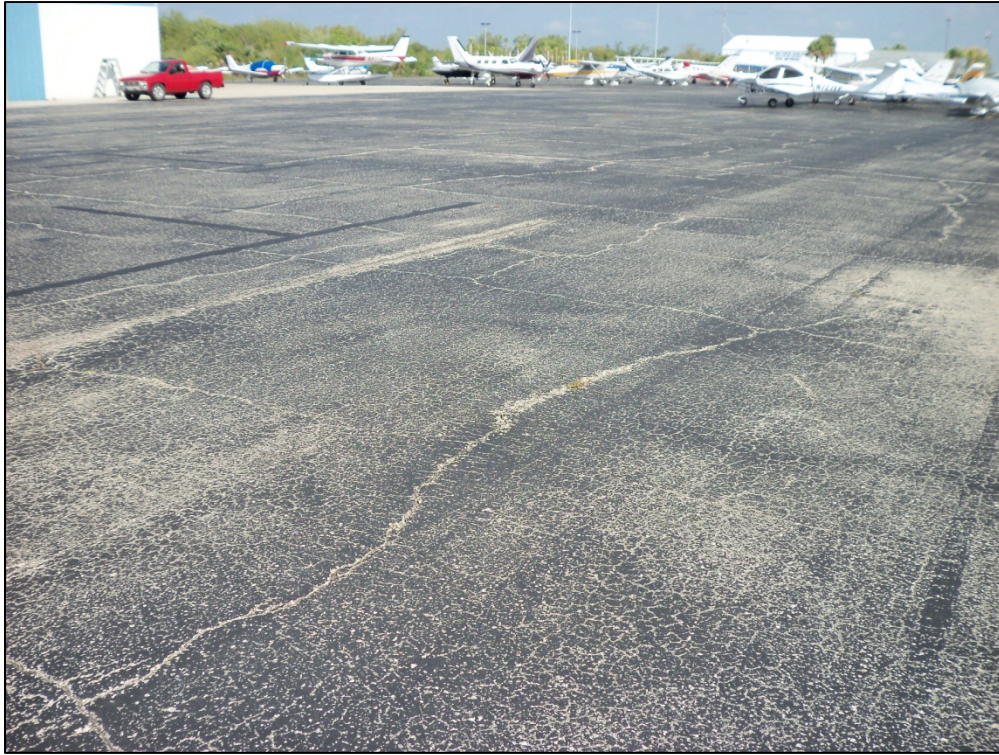
Apron, Section 4205, Sample Unit 257 – Low and medium severity (43) Block Cracking, low severity (52) Weathering and Raveling

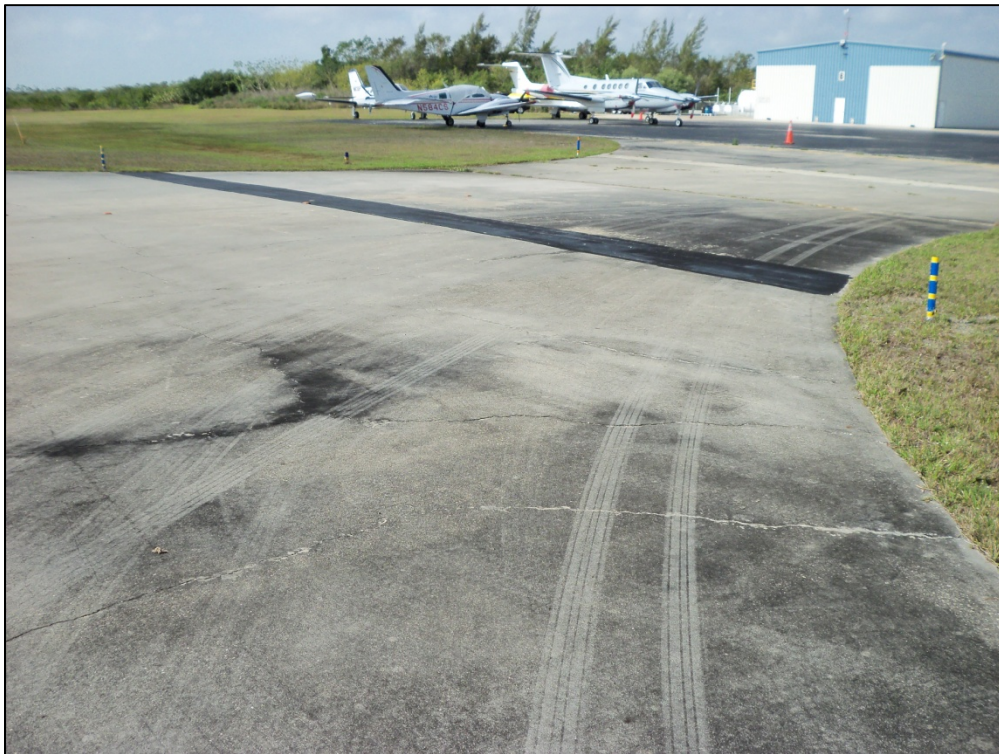
Taxiway Connector, Section 105, Sample Unit 100 – Low severity (63) LTD Cracking, medium severity (66) Patch, low severity (70) Scaling/Map Cracking, medium severity (72) Shattered Slabs, (73) Shrinkage Cracks, low severity (74) Joint Spalling
