**STATE OF FLORIDA
DEPARTMENT OF TRANSPORTATION
AVIATION OFFICE**

**Statewide Airfield Pavement
Management Program**

**Marianna Municipal Airport– MAI
(General Aviation)
Marianna, Florida
(District 3)**

May 2011

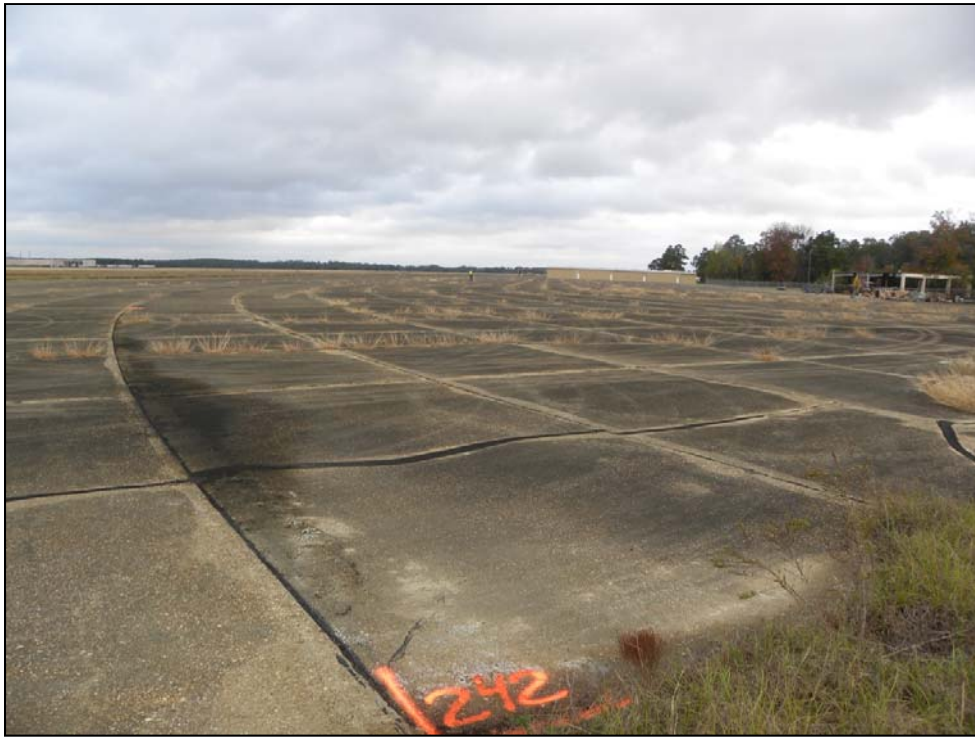
Apron, Section 4105, Sample Unit 242 – Low, medium, and high severity (63) Longitudinal/Transverse/Diagonal Cracking, medium severity (65) Joint Seal Damage, low severity (75) Corner Spalling, and low severity (74) Joint Spalling

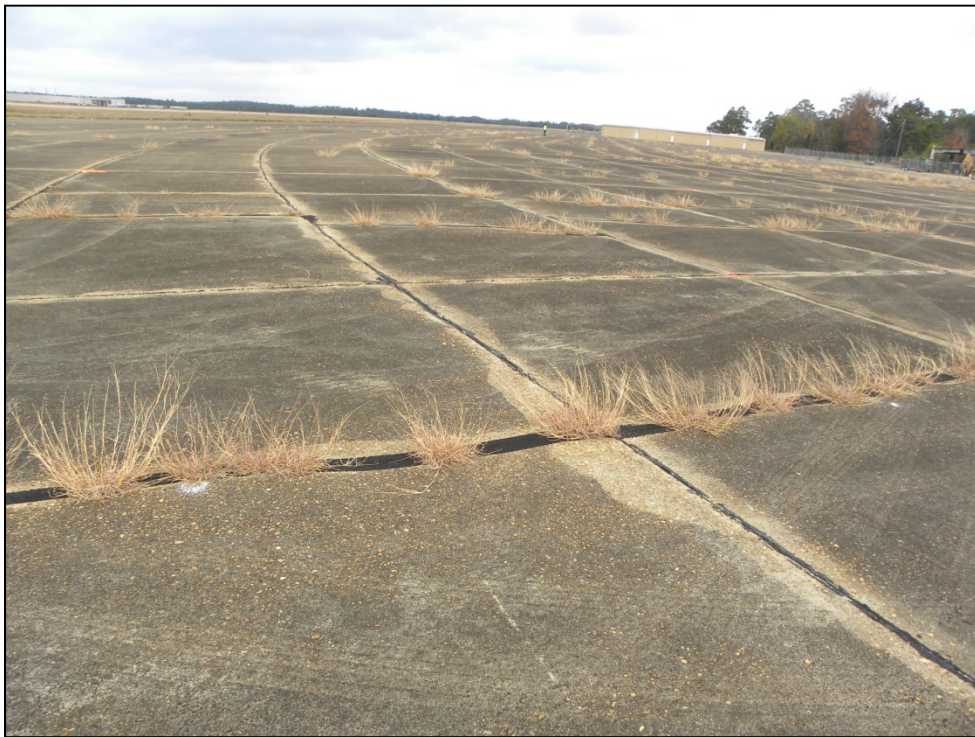
Apron, Section 4105, Sample Unit 242 – Low, medium, and high severity (63) Longitudinal/Transverse/Diagonal Cracking, medium severity (65) Joint Seal Damage, low severity (75) Corner Spalling, and low severity (74) Joint Spalling

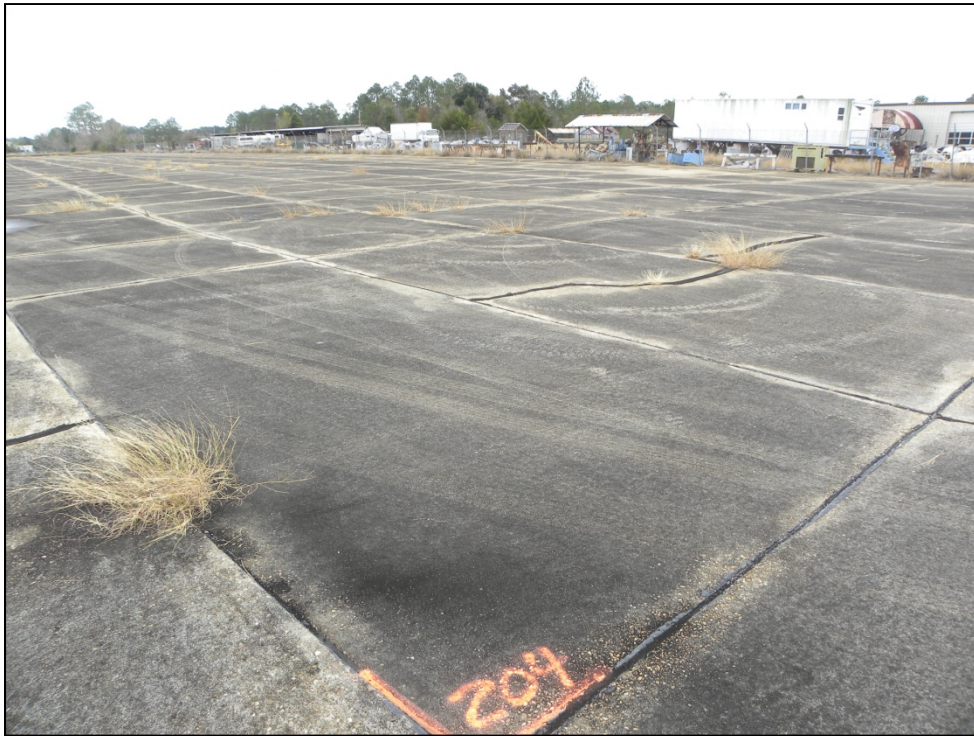
Apron, Section 4105, Sample Unit 204 – Medium, and high severity (63) Longitudinal/Transverse/Diagonal Cracking, medium severity (65) Joint Seal Damage, and low and medium (71) Faulting of Slabs

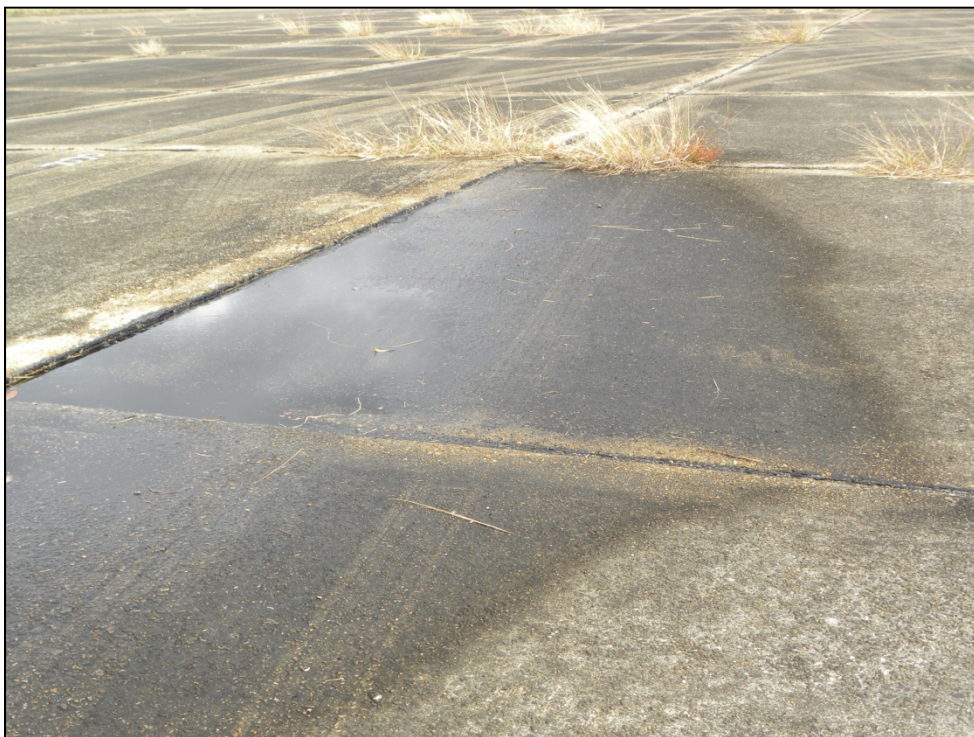
Apron, Section 4105, Sample Unit 204 – Medium, and high severity (63) Longitudinal/Transverse/Diagonal Cracking, medium severity (65) Joint Seal Damage, and low and medium (71) Faulting of Slabs

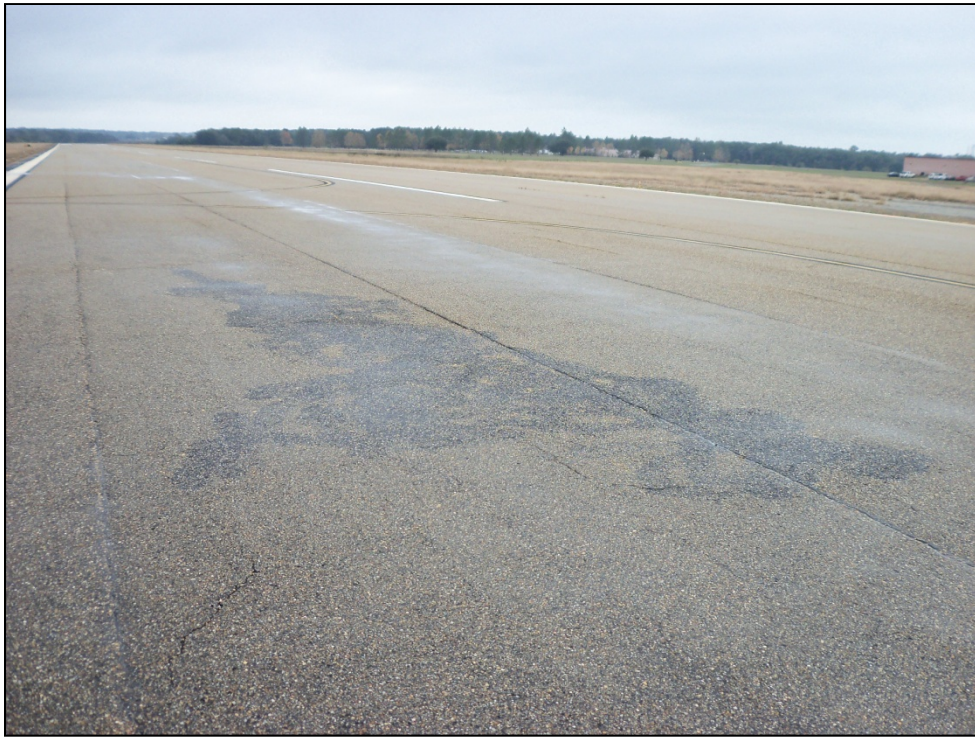
Runway 18-36, exhibited low to medium severity longitudinal and transverse cracking in addition to low to medium weathering and raveling distresses. Longitudinal cracks are apparent along the paving joints. No load based distresses were encountered on the runway.

Runway 18-36, Section 6205, Sample Unit 165 – Low severity (52) Weathering and Raveling; low, medium, and high severity (48) Longitudinal and Transverse Cracking; N/A severity

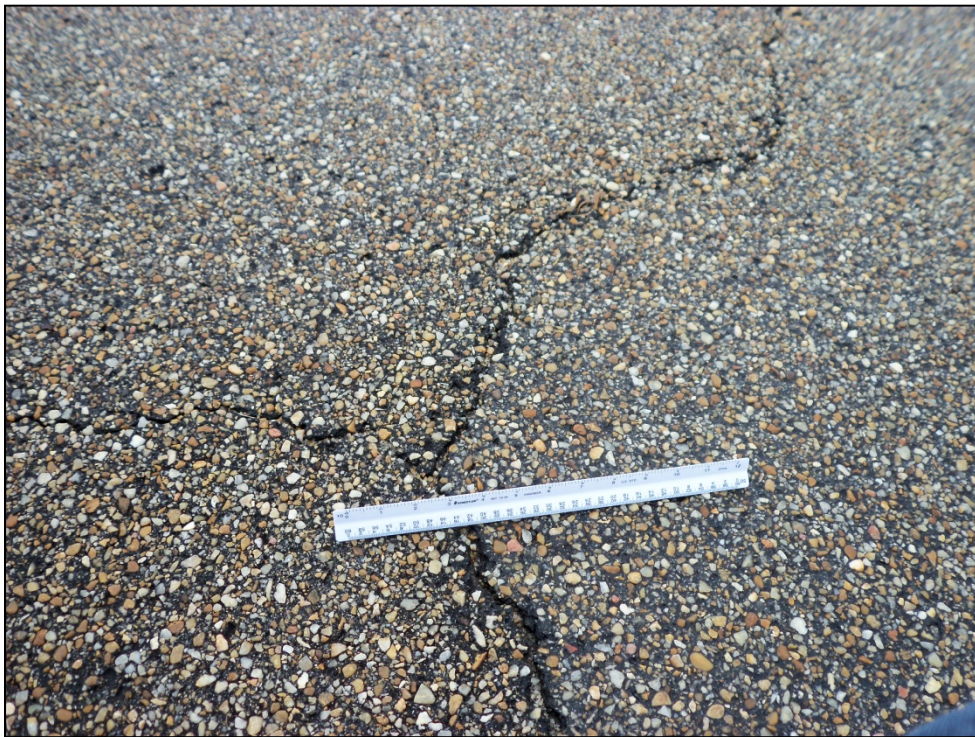
Runway 18-36, Section 6205, Sample Unit 165 – Low severity (52) Weathering and Raveling; low, medium, and high severity (48) Longitudinal and Transverse Cracking; N/A severity

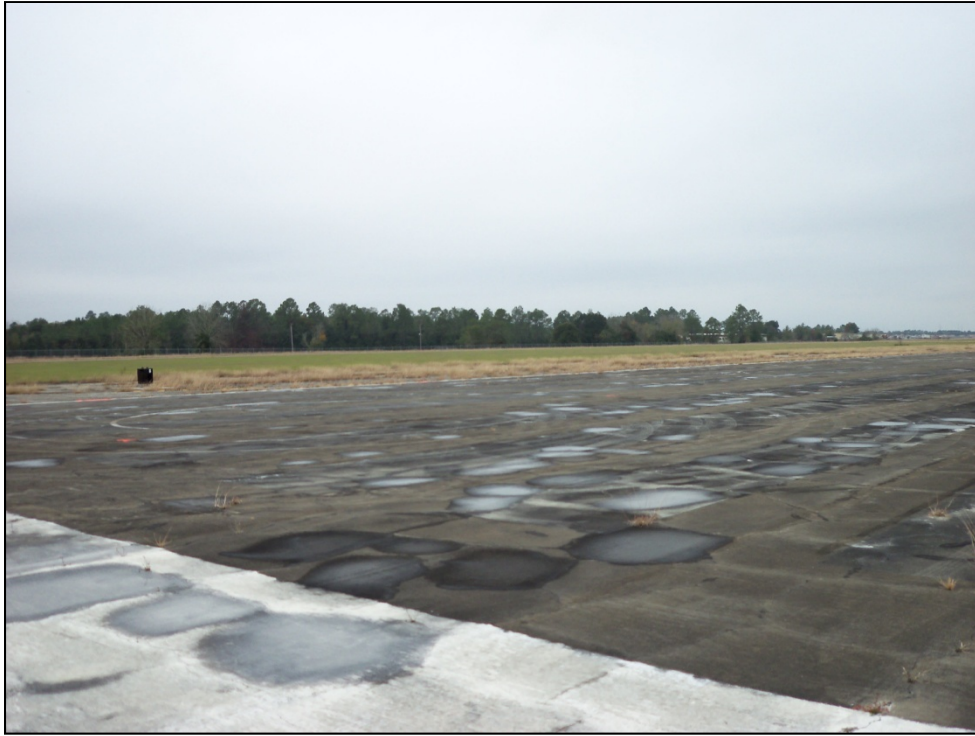
Runway 8-26, exhibited medium to high severity block cracking, weathering and raveling distresses. Based on conversations with airport staff, RW 8-26 has been overlaid with thin layers of “E-Crete” (less than ¼”) twice over the last decade. The E-Crete overlay reflects the underlying asphalt block cracking distresses. The curling effect caused by this crack reflection results in the retention of water, or creation of “bird baths”, after storm events. The rideability of the runway is greatly affected by the curling due to the block cracking distresses. In multiple areas the E-Crete layers have raveled completely off thus exposing the underlying pavement to the elements. The intrusion of water between the E-Crete and asphalt further exacerbate the curling and degradation of the overall runway pavement. The exacerbated “E-Crete” layers that have been curling due to the intrusion of water and the climate cycling create significant separations or voids between the overlay layer and the original pavement.

Runway 8-26, Section 6105, Sample Unit 300 – Medium severity (52) Weathering and Raveling; low severity (43) Block Cracking.

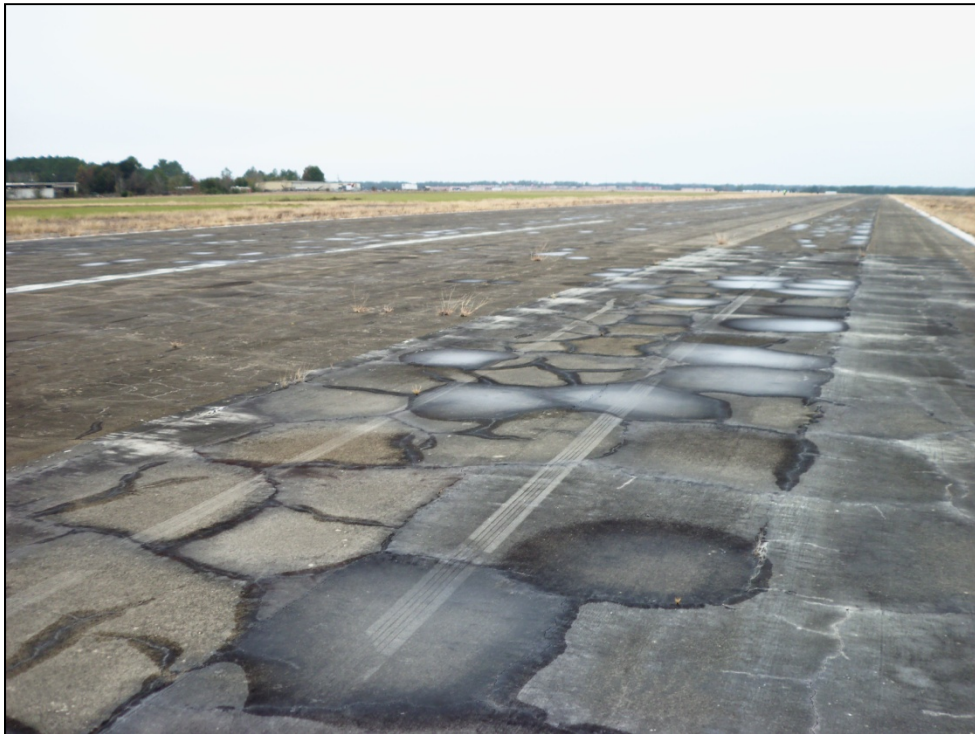
Runway 8-26, Section 6105, Sample Unit 300 – Medium severity (52) Weathering and Raveling; low severity (43) Block Cracking

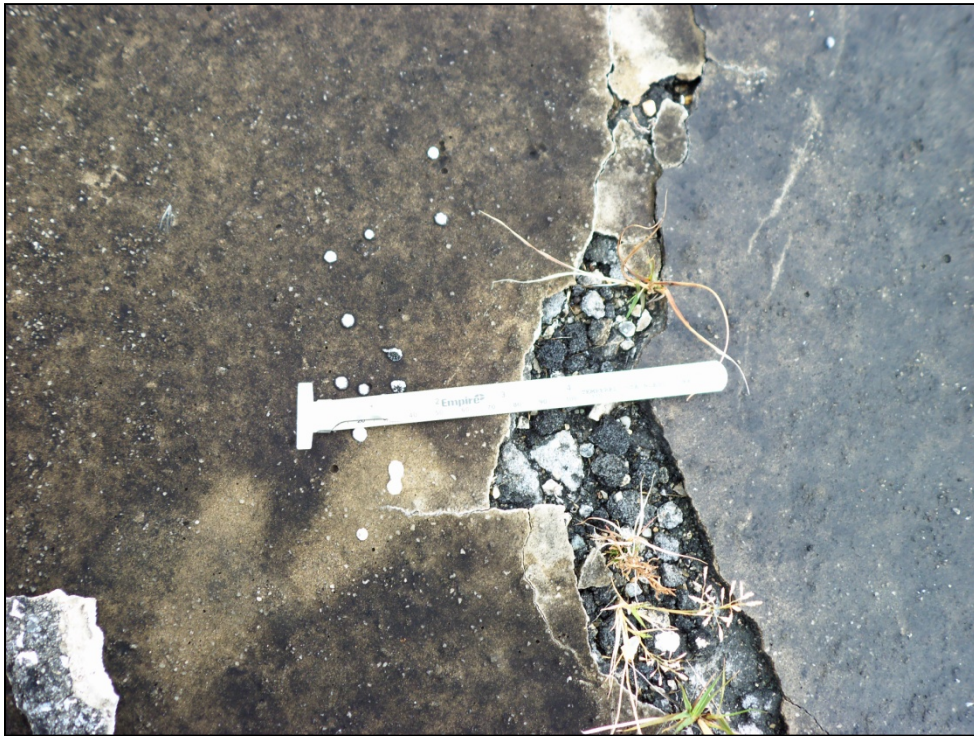
Runway 8-26, Section 6105, Sample Unit 300 – Medium severity (52) Weathering and Raveling; low severity (43) Block Cracking. Image depicts a close up of raveling “E-Crete” overlay material as well as raveled underlying asphalt material.

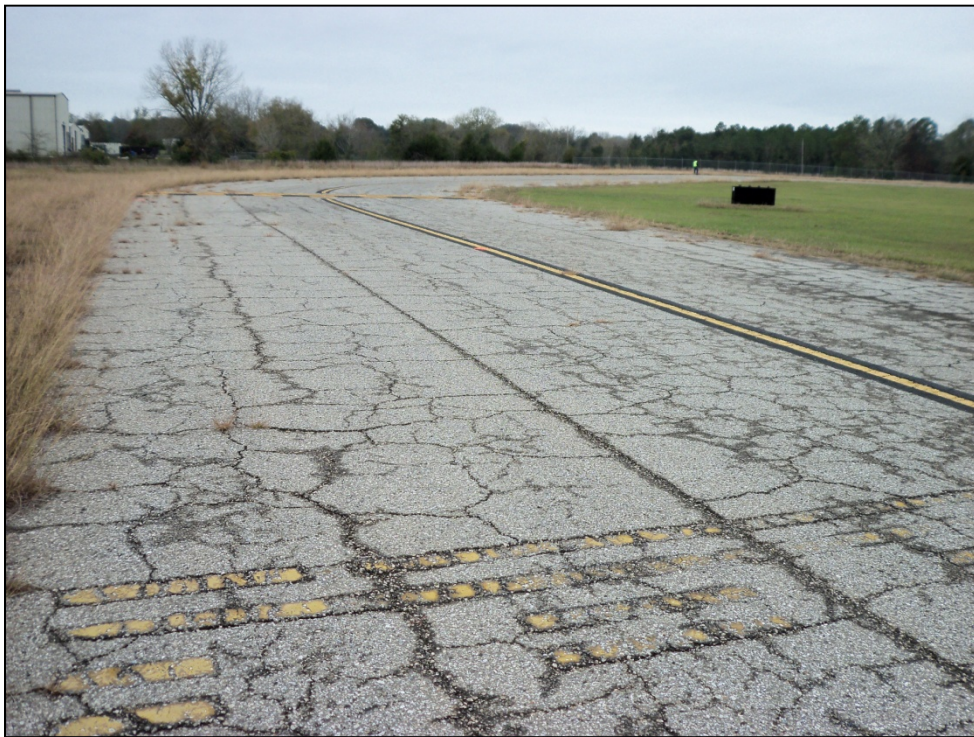
The taxiway system overall has exhibited distresses attributed to the climate cycling in the area and the age of the pavement. Taxiway Golf; specifically the asphalt pavement from beginning at the end of the concrete apron to the connection to the 26-end of Runway 8-26, exhibited medium to high severity block cracking, weathering and raveling, and the alligator cracking. Of particular note the alligator cracking a load based distressed that implies that based on current loading patterns from aircraft the pavement section may not be adequately designed.

Taxiway Golf, Section 105, Sample Unit 101 – Medium severity (43) Block Cracking, medium severity (52) Weathering and Raveling.

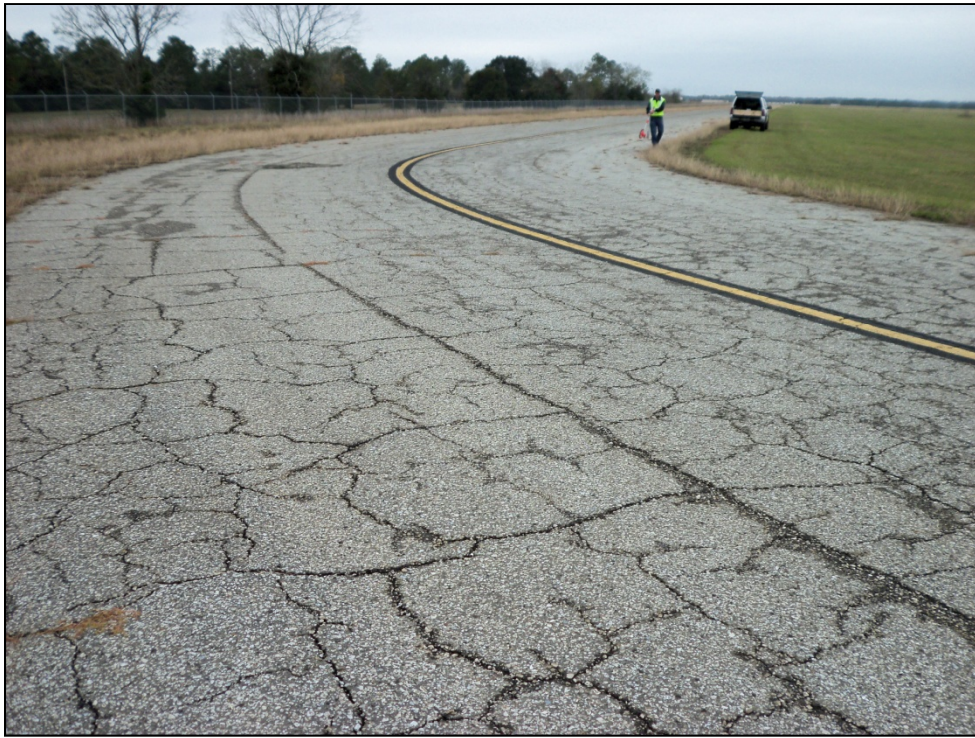
Taxiway Golf, Section 105, Sample Unit 105 – Medium severity (43) Block Cracking, medium severity (52) Weathering and Raveling.

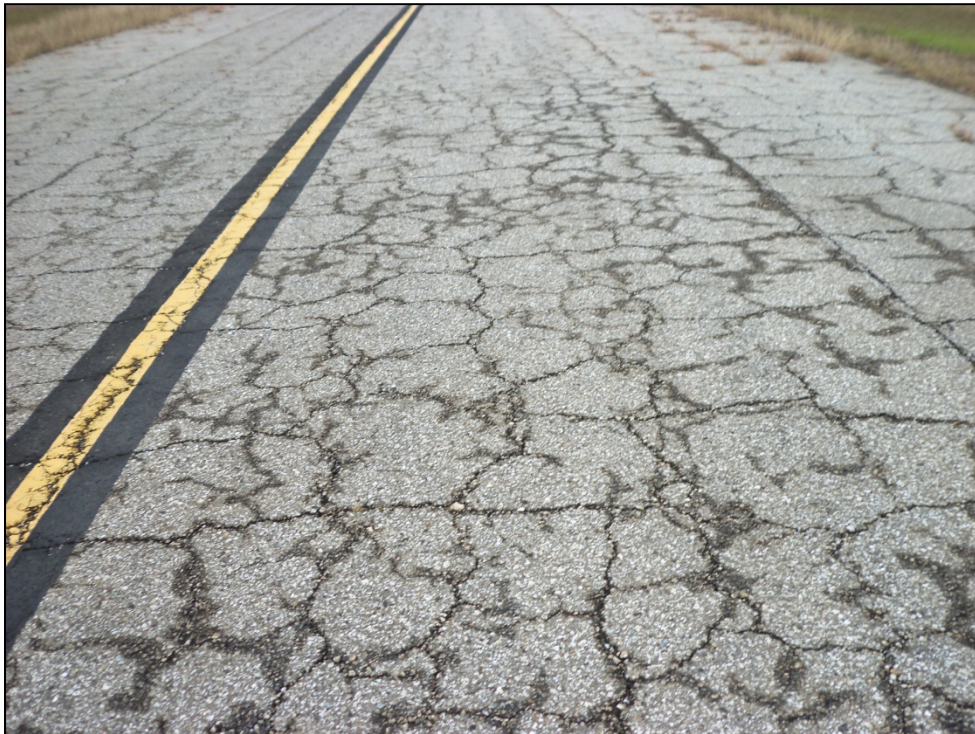
Taxiway Golf, Section 105, Sample Unit 107 – Medium severity (43) Block Cracking, medium severity (52) Weathering and Raveling.
