**STATE OF FLORIDA
DEPARTMENT OF TRANSPORTATION
AVIATION OFFICE**

**Statewide Airfield Pavement
Management Program**

**Marion County Airport – X35
(General Aviation)
Dunnellon, Florida
(District 5)**

May 2011

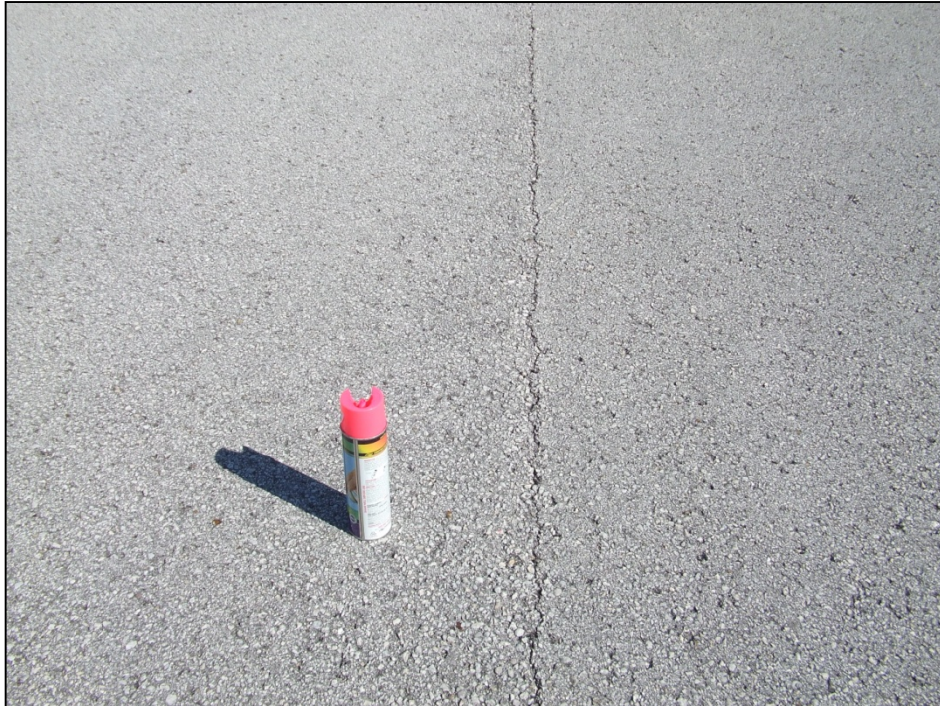
Taxiway Echo, Section 105, Sample Unit 100 - Low severity (48) Longitudinal and Transverse Cracking, low severity (50) Patch, low and medium severity (52) Weathering and Raveling.

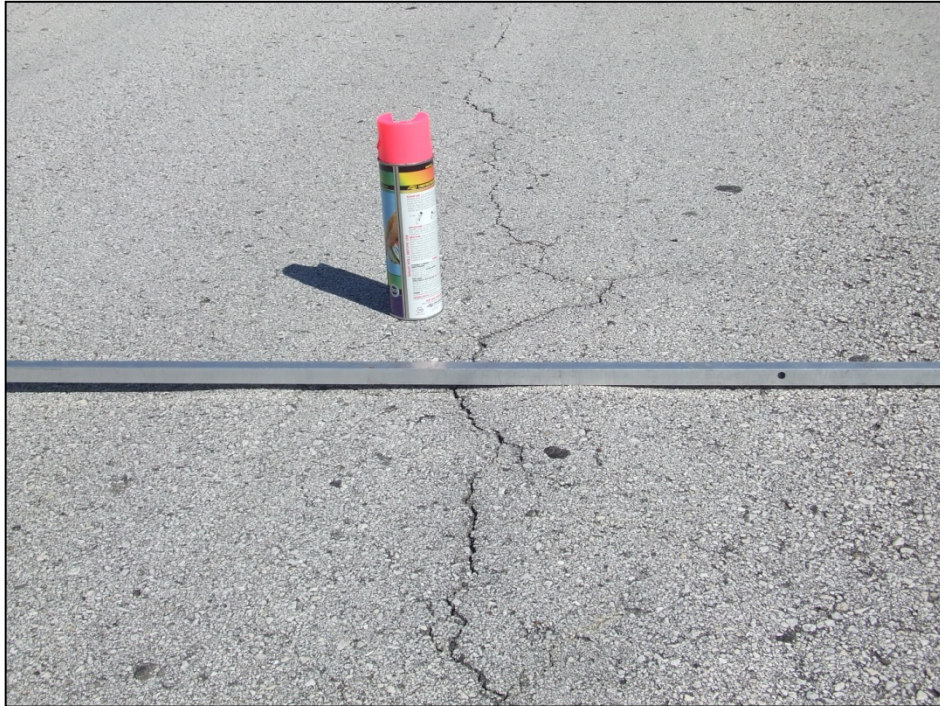
Taxiway Echo, Section 110, Sample Unit 105 – Low severity (43) Block Cracking, low and medium severity (52) Weathering and Raveling, low severity (56) Swelling.

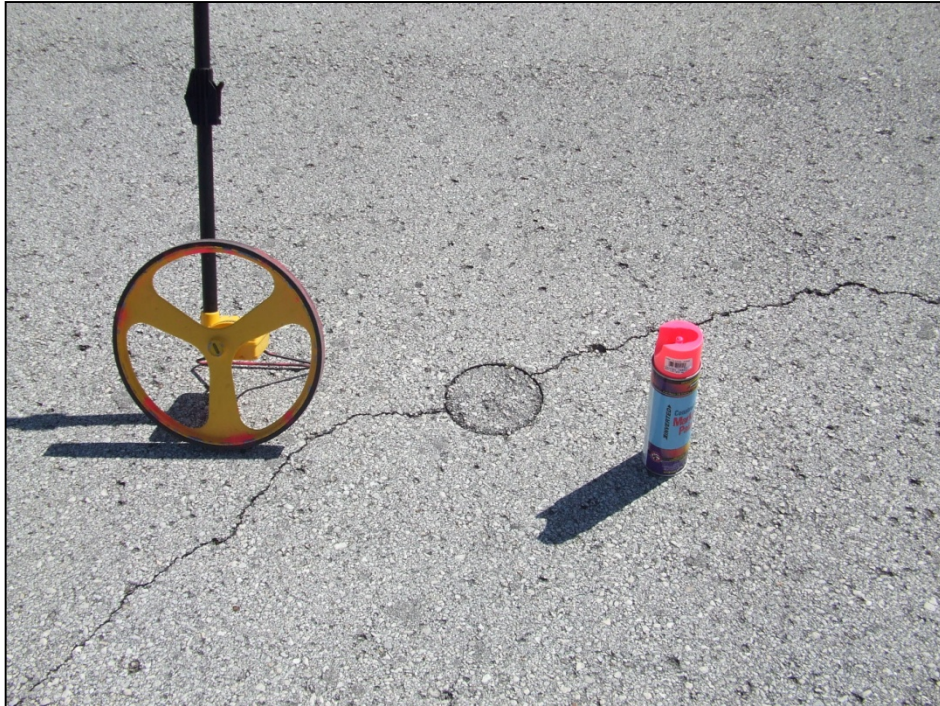
Apron, Section 4105, Sample Unit 101 - Low severity (48) Longitudinal and Transverse Cracking, low severity (49) Oil Spillage, low severity (50) Patch, low severity (52) Weathering and Raveling.

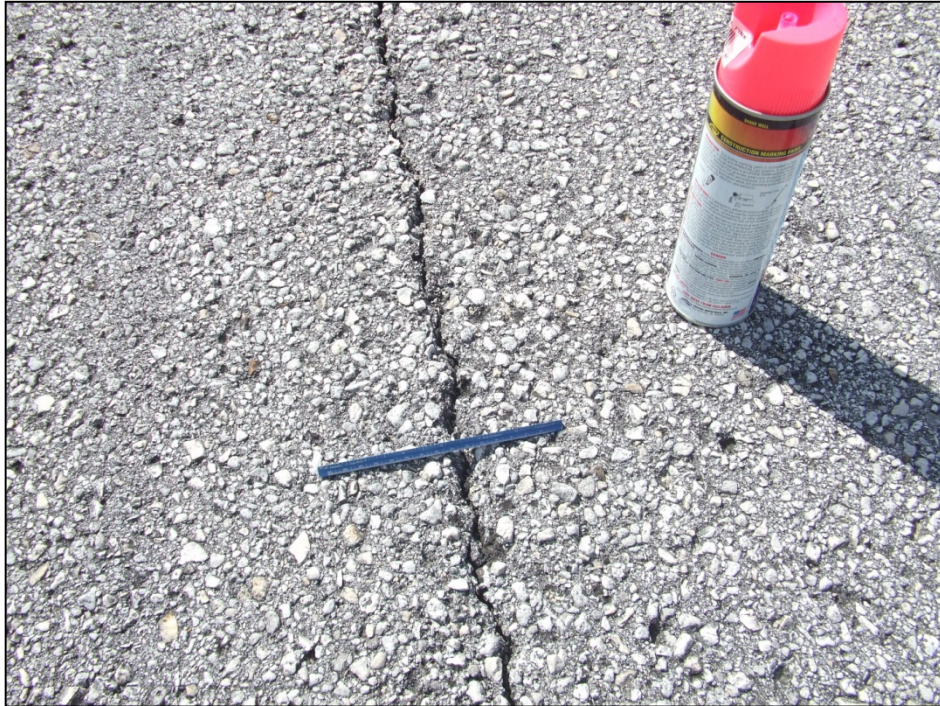
Runway 9-27, Section 6105, Sample Unit 108 – Low and medium severity (48) Longitudinal and Transverse Cracking, low and medium severity (52) Weathering and Raveling.

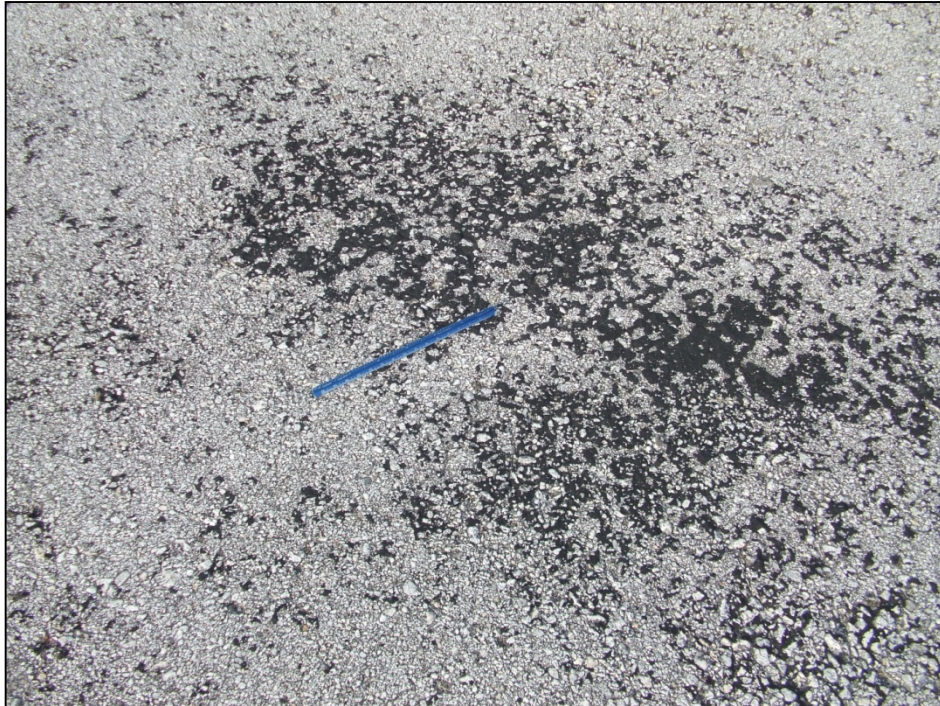
Runway 5-23, Section 6210, Sample Unit 162 - (42) Bleeding, low severity (48) Longitudinal and Transverse Cracking, low severity (52) Weathering and Raveling, low severity (56) Swelling.

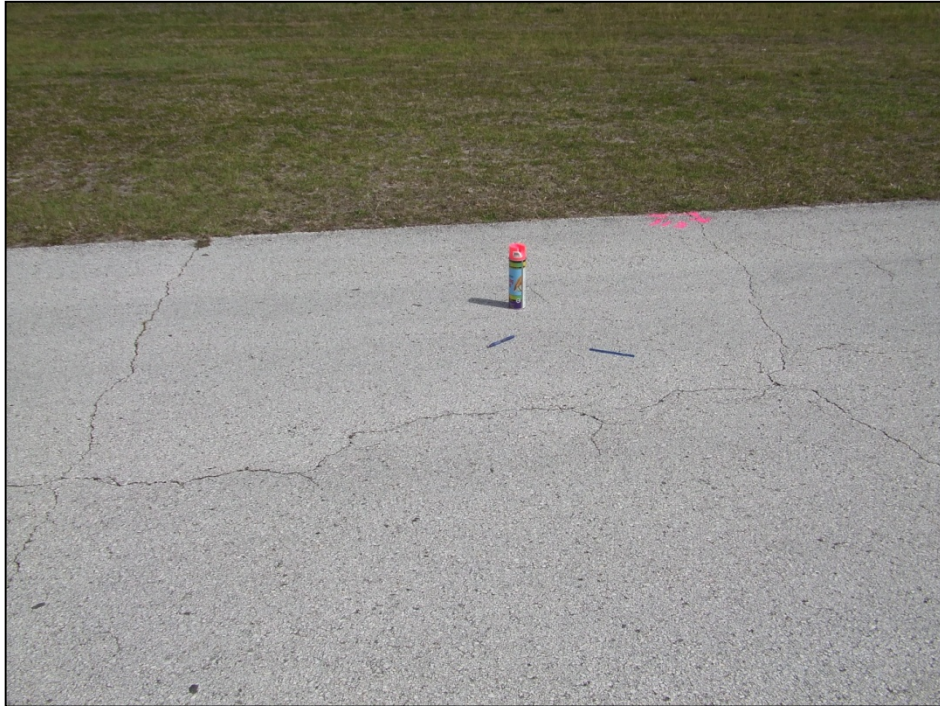
Taxiway Echo, Section 110, Sample Unit 113 - Low severity (43) Block Cracking, low and medium severity (48) Longitudinal and Transverse Cracking, low severity (52) Weathering and Raveling, low severity (56) Swelling.
