**STATE OF FLORIDA
DEPARTMENT OF TRANSPORTATION
AVIATION OFFICE**

**Statewide Airfield Pavement
Management Program**

**Merritt Island Airport– COI
(General Aviation)
Titusville, Florida
(District 5)**

May 2012

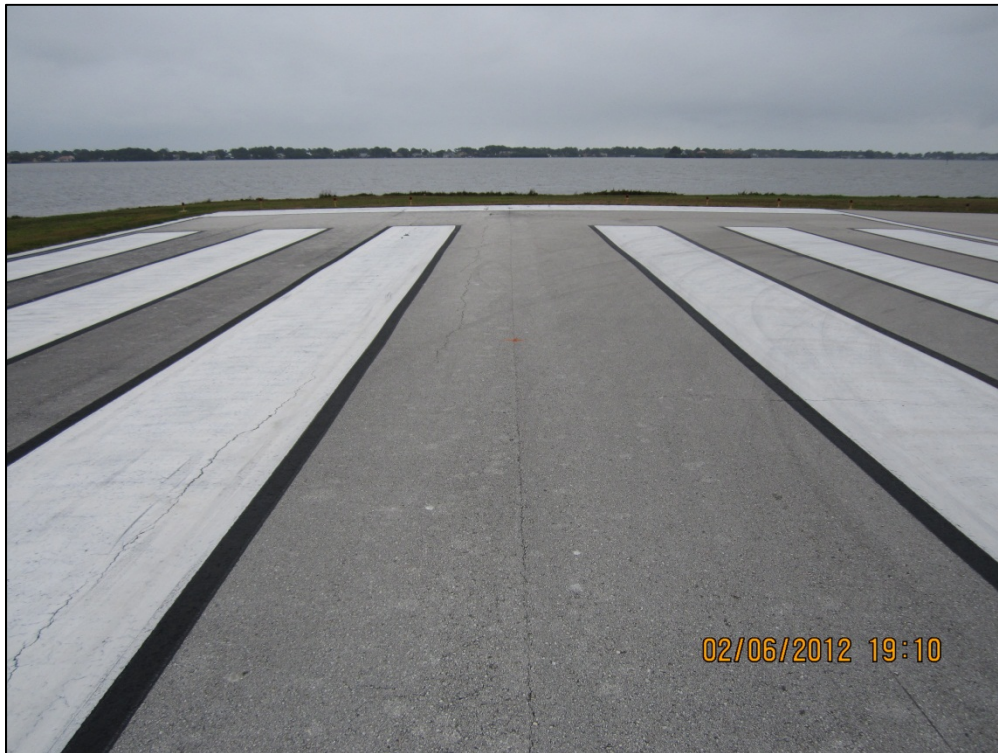
Runway 11-29, Section 6105, Sample Unit 170 – Low severity (48) Longitudinal and Transverse Cracking, low severity (52) Weathering and Raveling

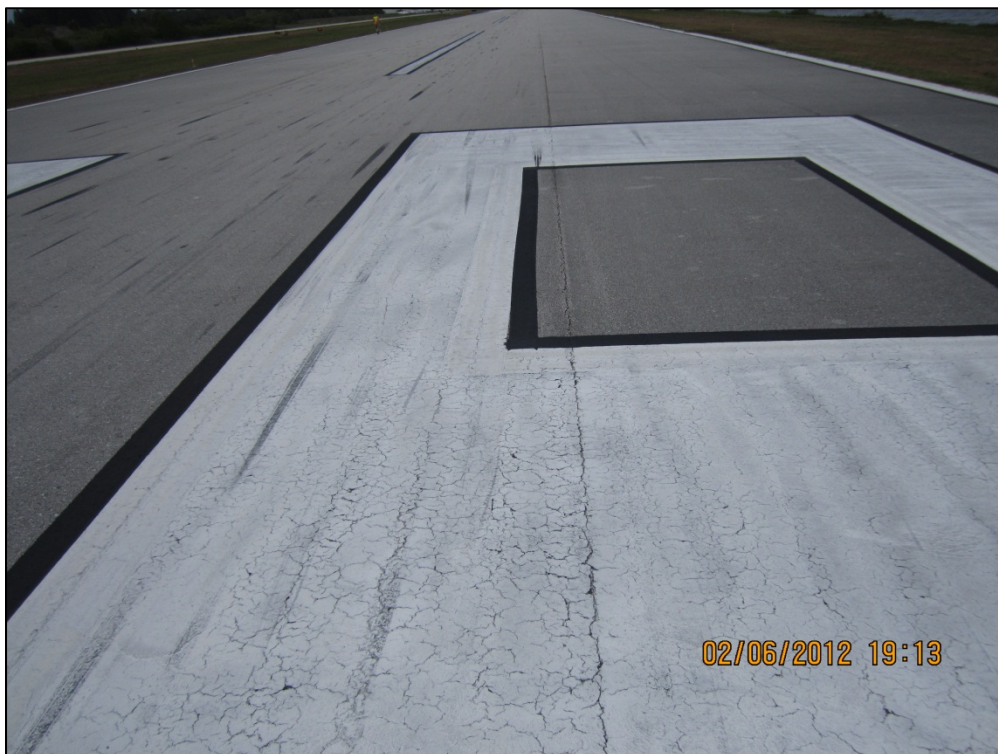
Runway 11-29, Section 6105, Sample Unit 167 – Low severity (48) Longitudinal and Transverse Cracking, low severity (52) Weathering and Raveling

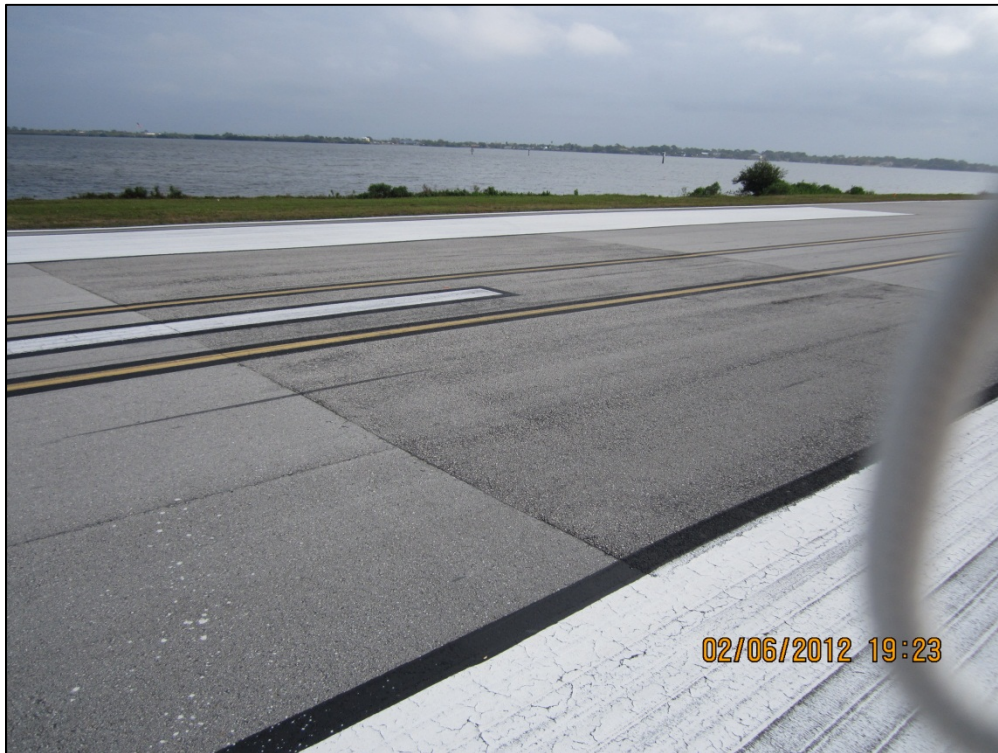
Runway 11-29, Section 6105, Sample Unit 149 – Low severity (48) Longitudinal and Transverse Cracking, medium severity (50) Patching

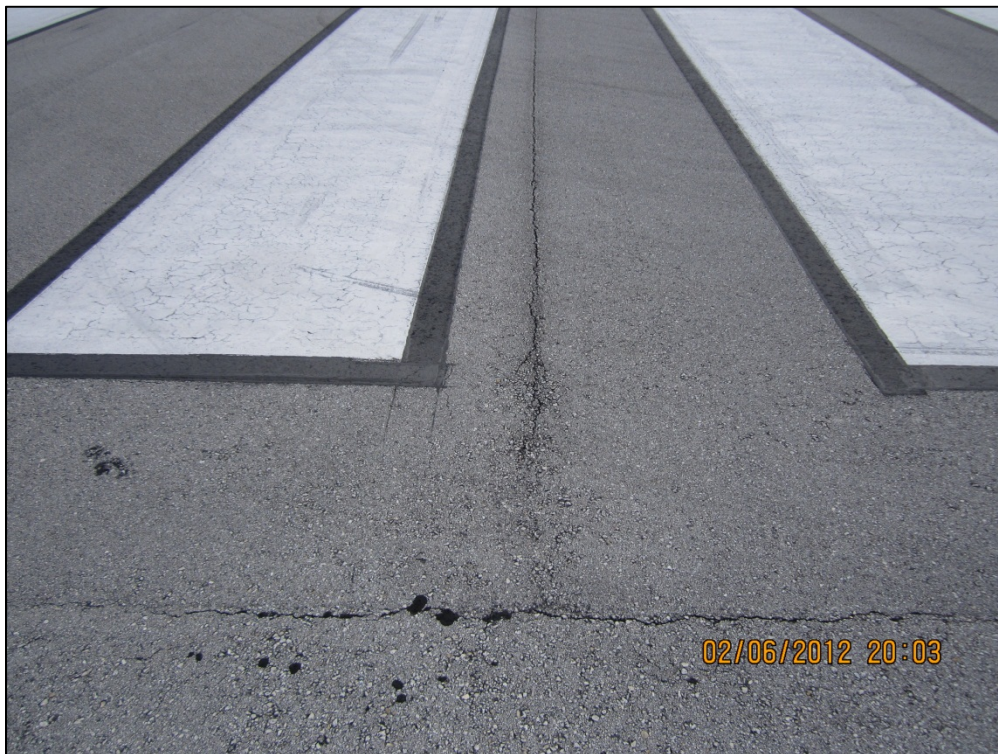
Runway 11-29, Section 6105, Sample Unit 100 – Low severity (48) Longitudinal and Transverse Cracking, low severity (52) Weathering and Raveling

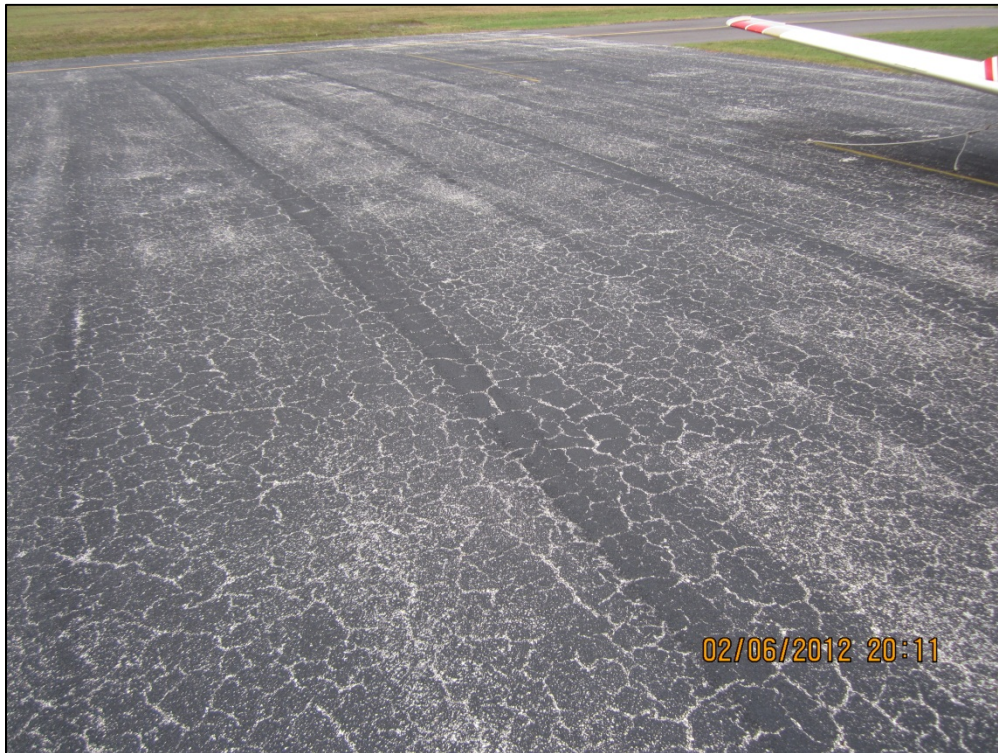
North Apron, Section 4205, Sample Unit 197 – Low severity (43) Block Cracking, medium severity (52) Weathering and Raveling

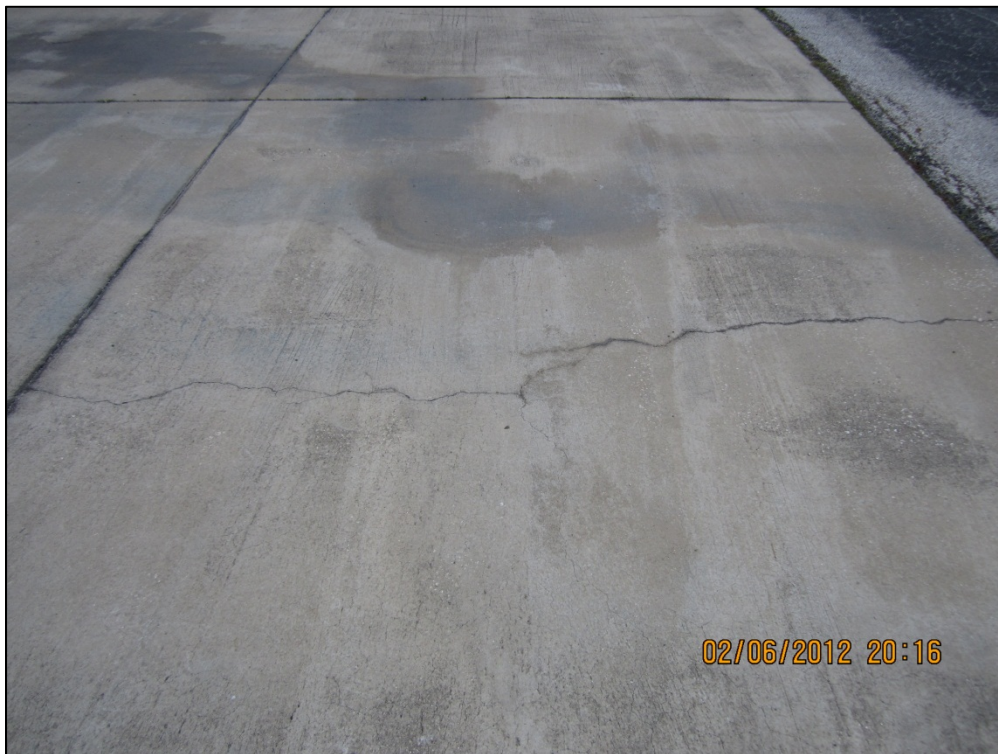
North Apron, Section 4203, Sample Unit 100 – Low severity (70) Scaling, Crazing and Map Cracking; low severity (63) Longitudinal, Transverse, and Diagonal Cracking; low severity (65) Joint Seal Damage

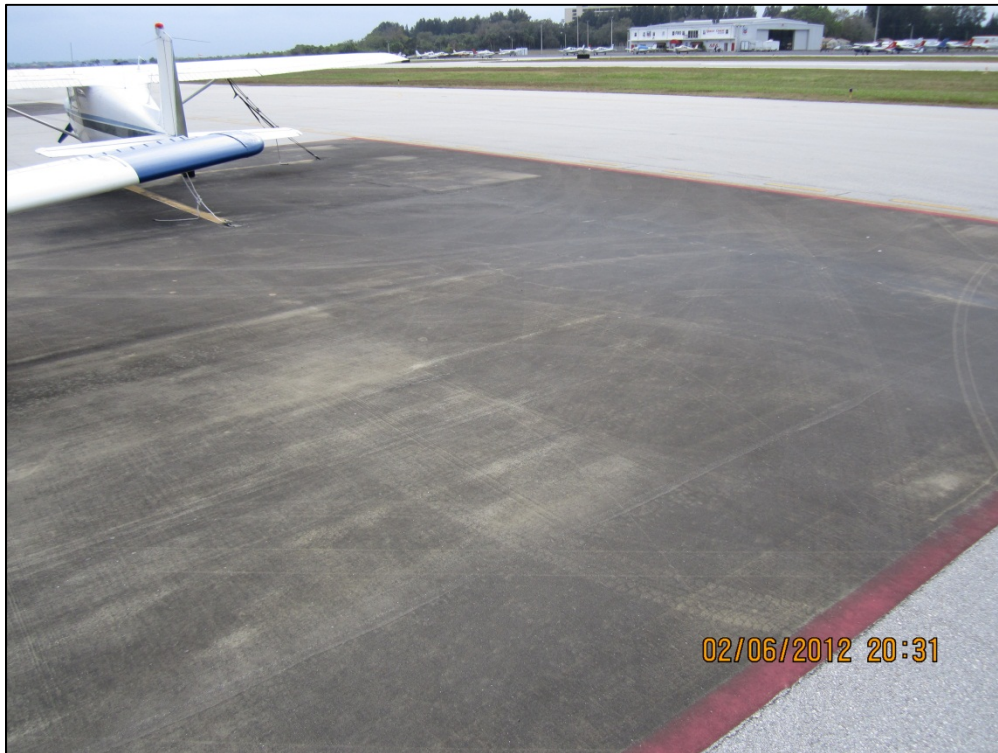
North Apron, Section 4218, Sample Unit 820 – Low severity (50) Patching

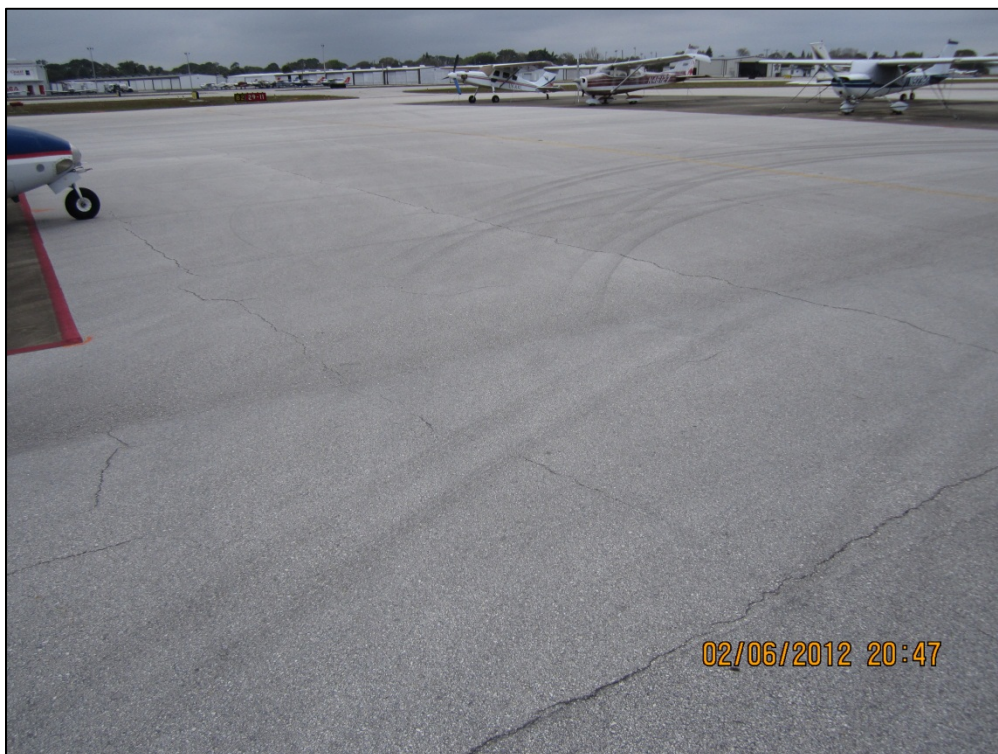
North Apron, Section 4215, Sample Unit 355 – Low severity (48) Longitudinal and Transverse Cracking, low severity (52) Weathering and Raveling

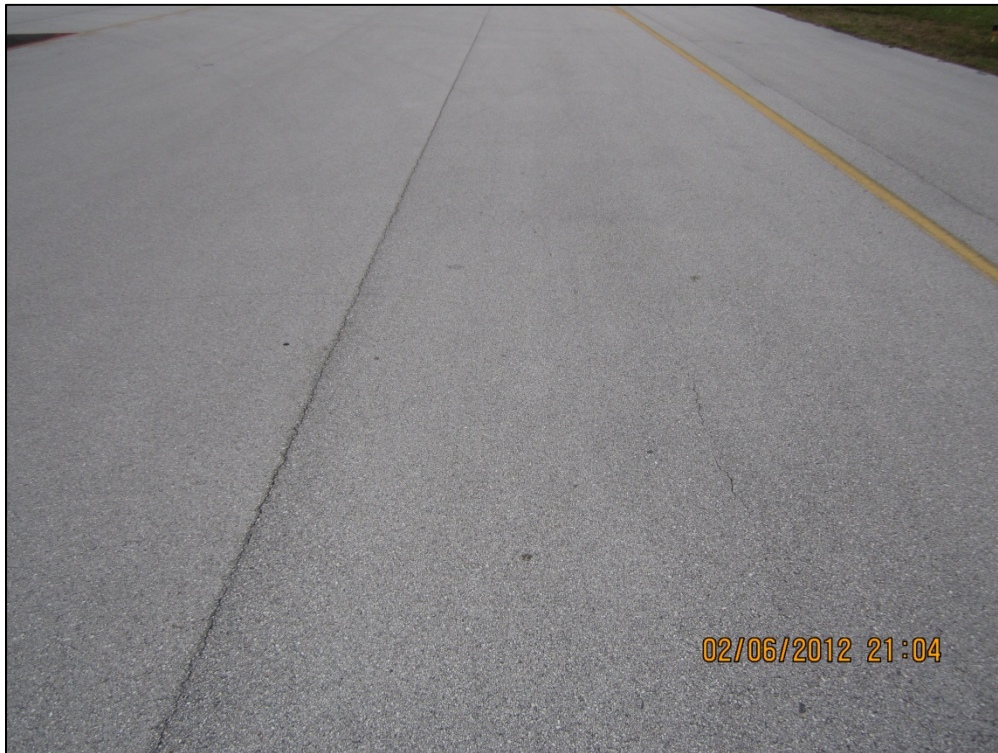
Taxiway Bravo, Section 205, Sample Unit 102 – Low severity (48) Longitudinal and Transverse Cracking

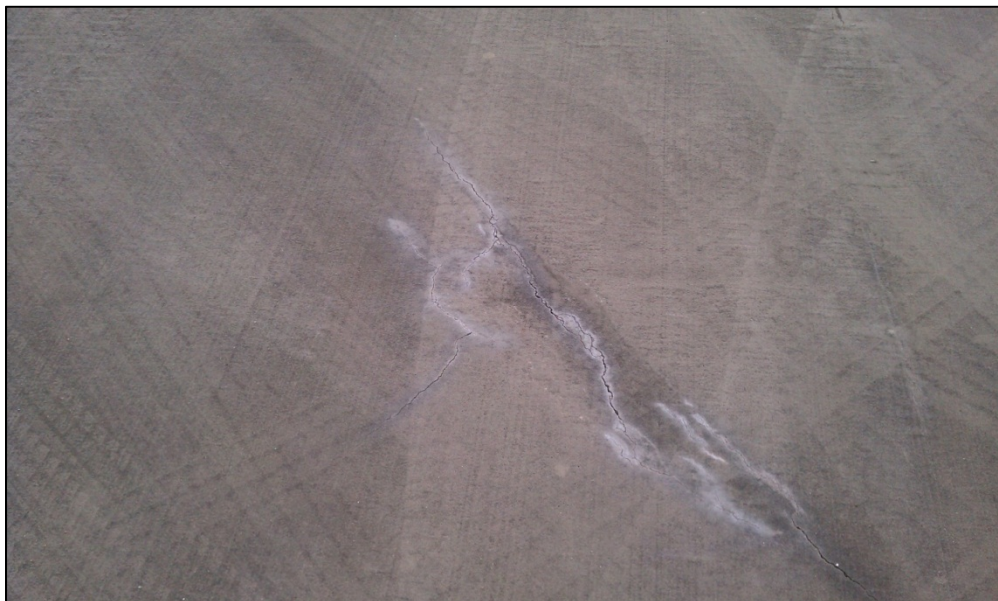
Southwest Apron, Section 4305, Sample Unit 200 – Low severity (48) Longitudinal and Transverse Cracking

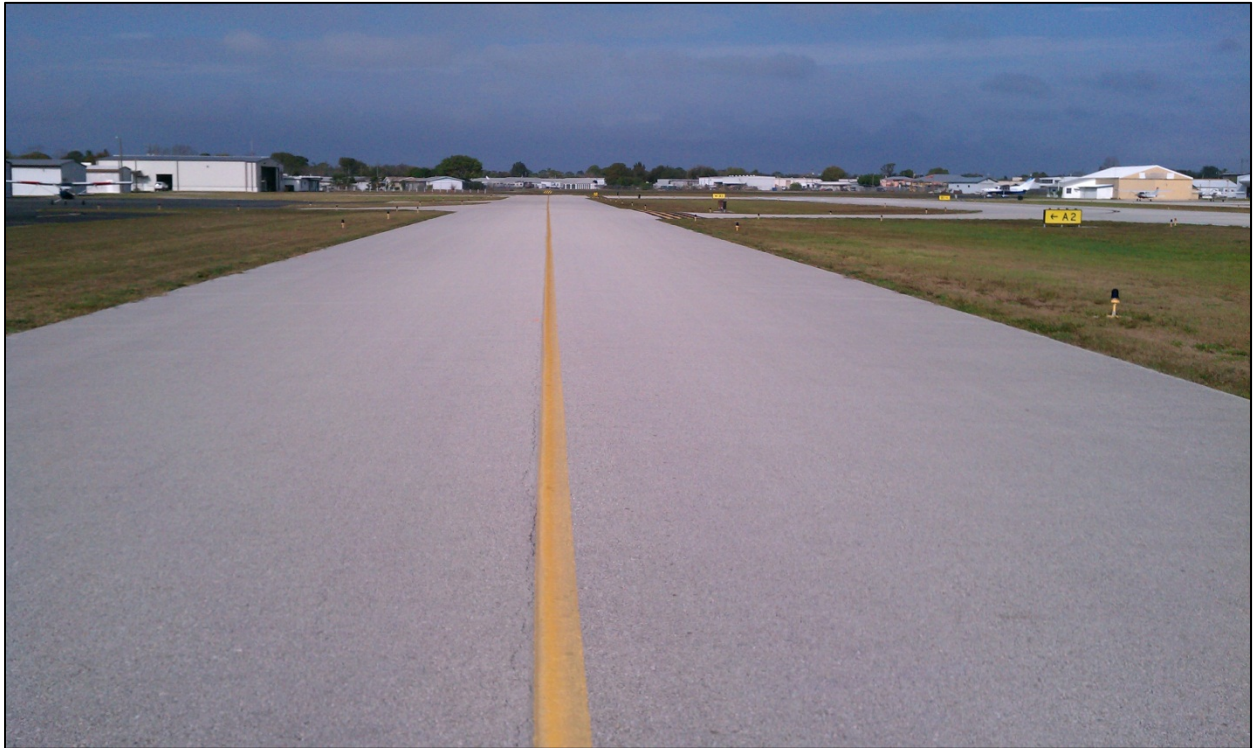
Taxiway Alpha, Section 105, Sample Unit 107 – Low severity (48) Longitudinal and Transverse Cracking

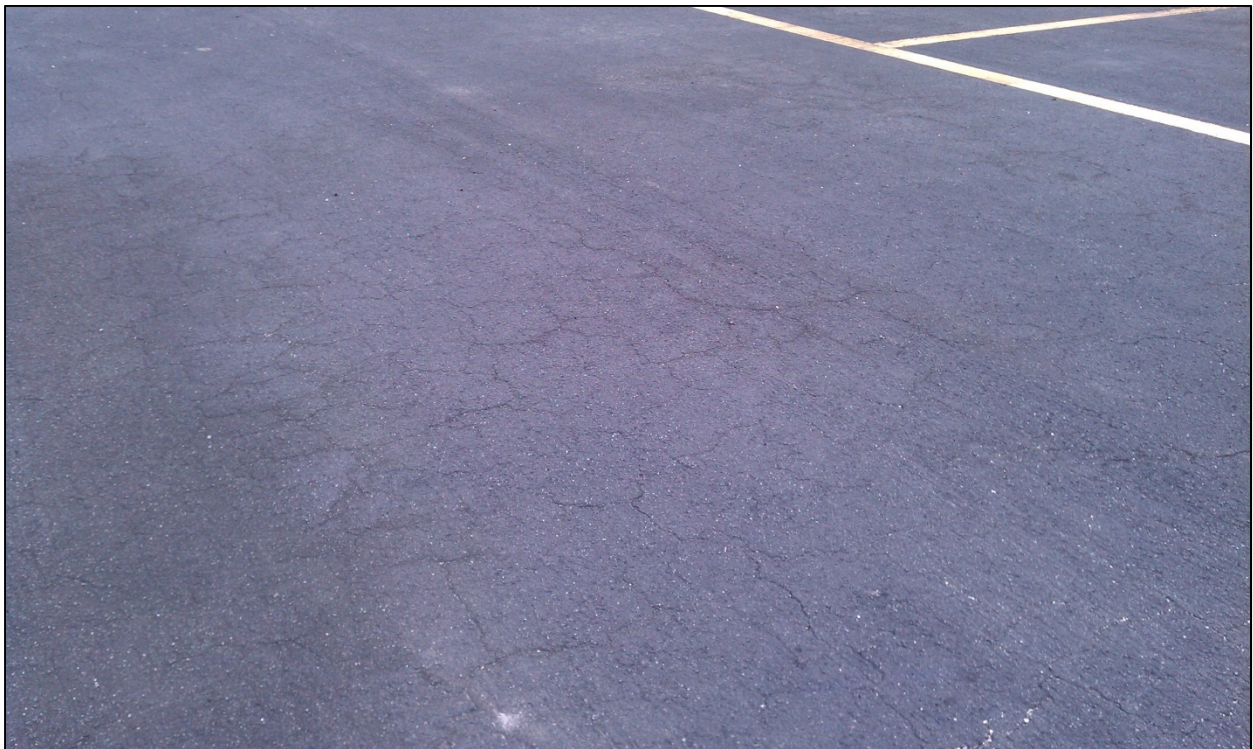
South Apron, Section 4106, Sample Unit 199 – Medium severity (52) Weathering and Raveling

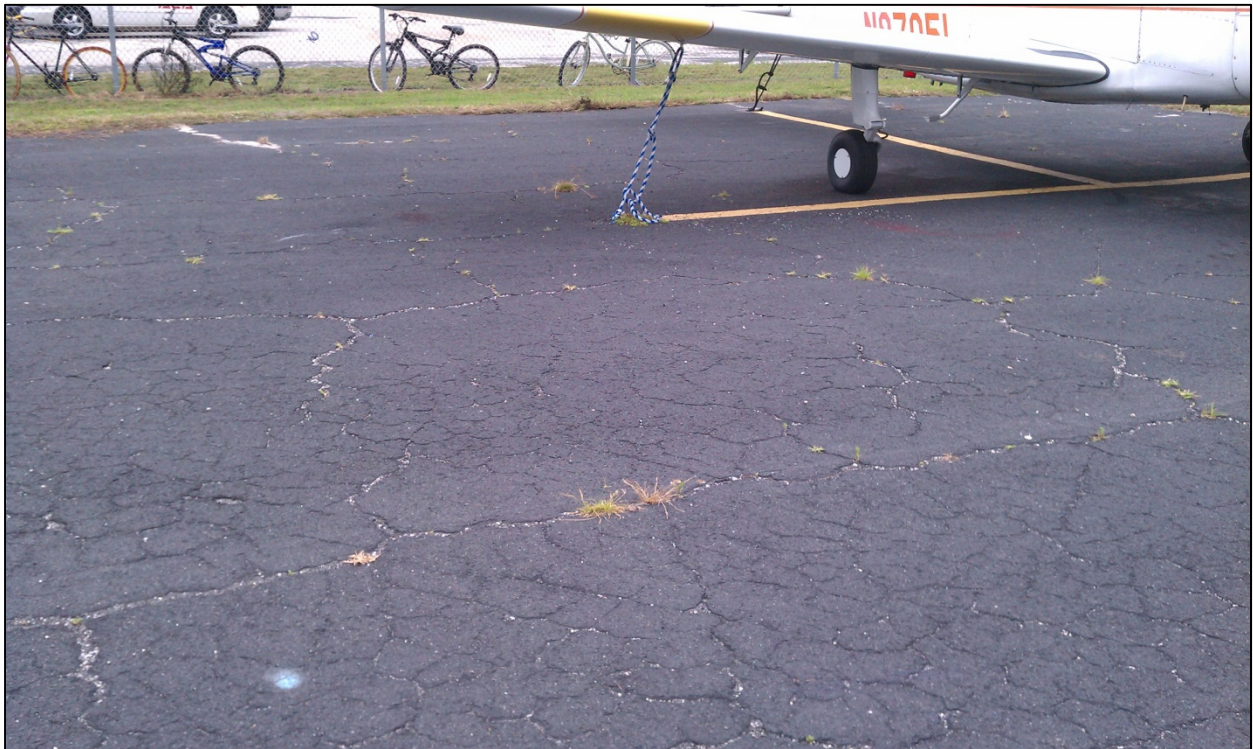
South Apron, Section 4115, Sample Unit 177 – Medium Severity (43) Block Cracking, medium severity (52) Weathering and Raveling
