**STATE OF FLORIDA  
DEPARTMENT OF TRANSPORTATION  
AVIATION OFFICE**

**Statewide Airfield Pavement  
Management Program**

**North Palm Beach County General Aviation Airport– F45  
(Regional Reliever)  
West Palm Beach, Florida  
(District 4)**

**May 2012**

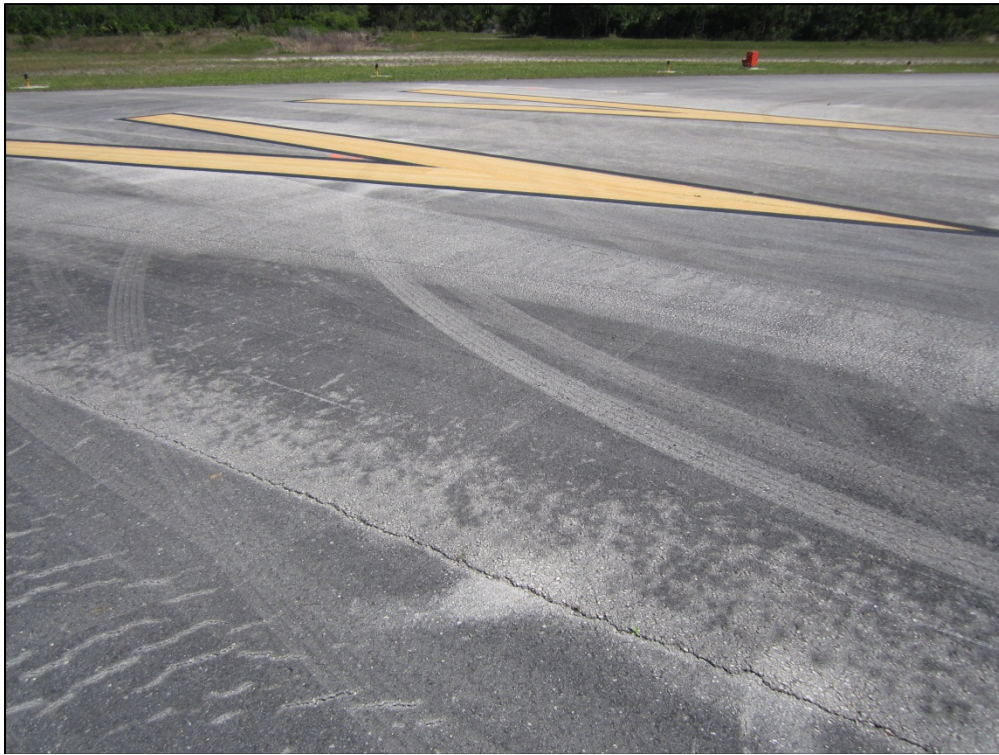
Runway 13-31, Section 6205, Sample Unit 186 – Low severity (48) Longitudinal and Transverse Cracking, low severity (52) Weathering and Raveling

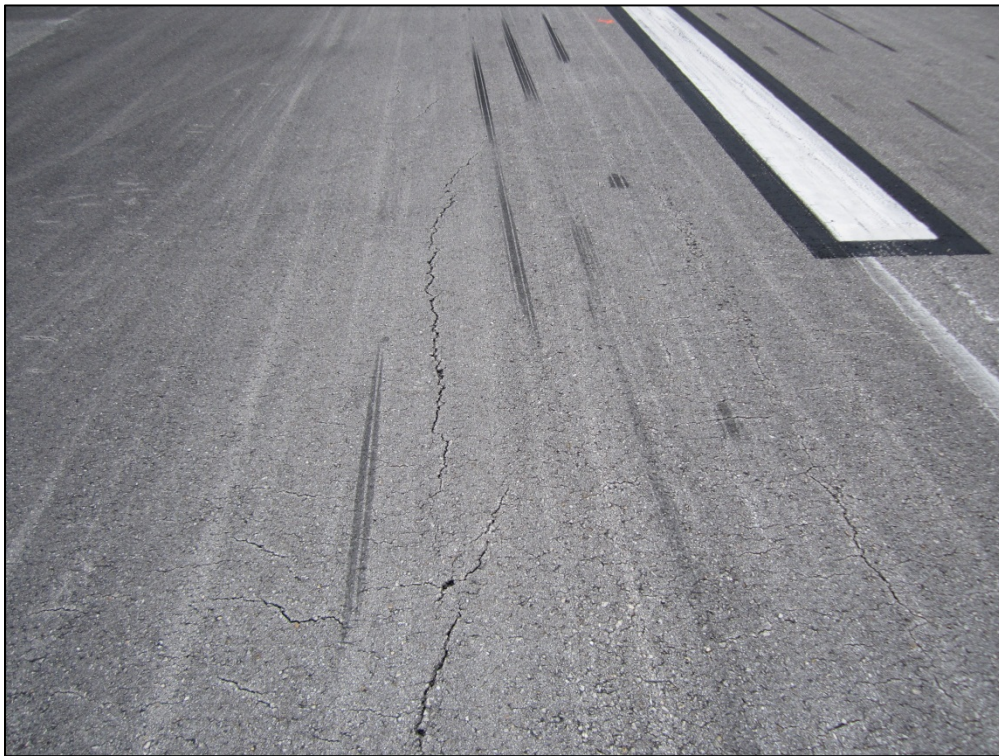
Runway 13-31, Section 6205, Sample Unit 120 – Low severity (48) Longitudinal and Transverse Cracking, low severity (52) Weathering and Raveling

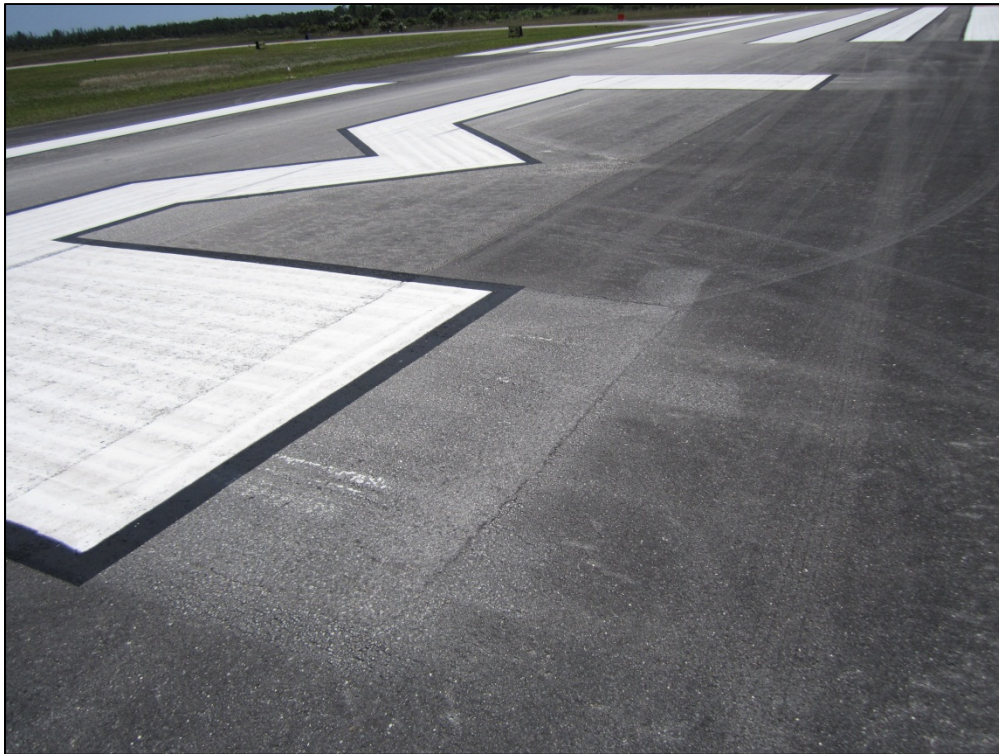
Runway 13-31, Section 6205, Sample Unit 105– Low severity (48) Longitudinal and Transverse Cracking, low severity (52) Weathering and Raveling

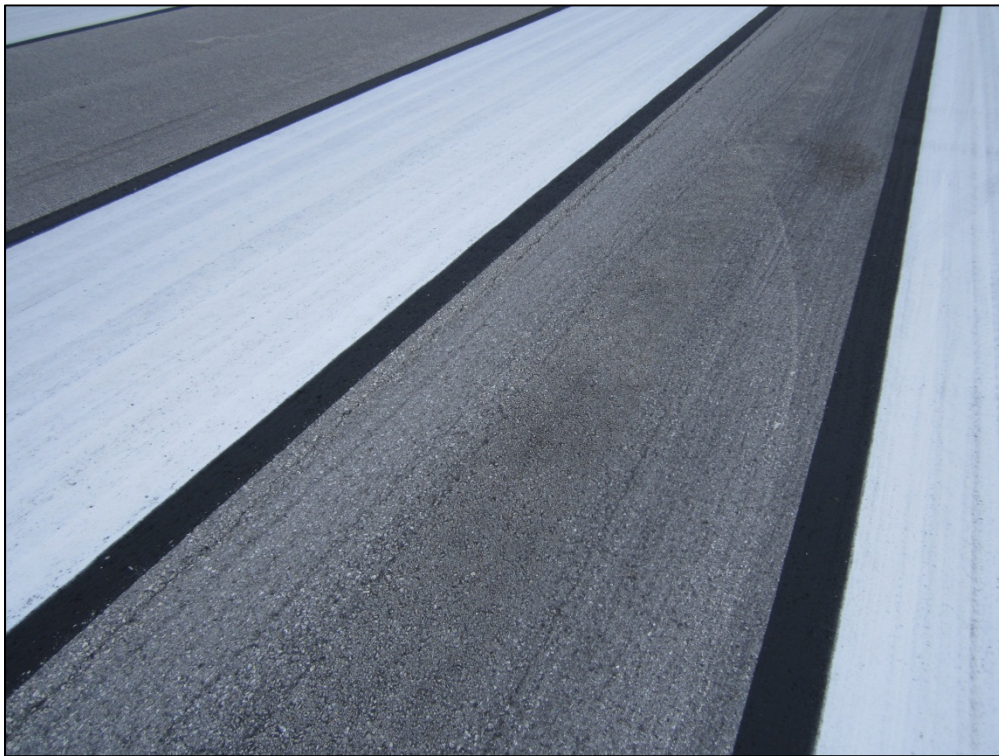
Runway 8R-26L, Section 6105, Sample Unit 101 – Low severity (48) Longitudinal and Transverse Cracking, low and medium severity (52) Weathering and Raveling

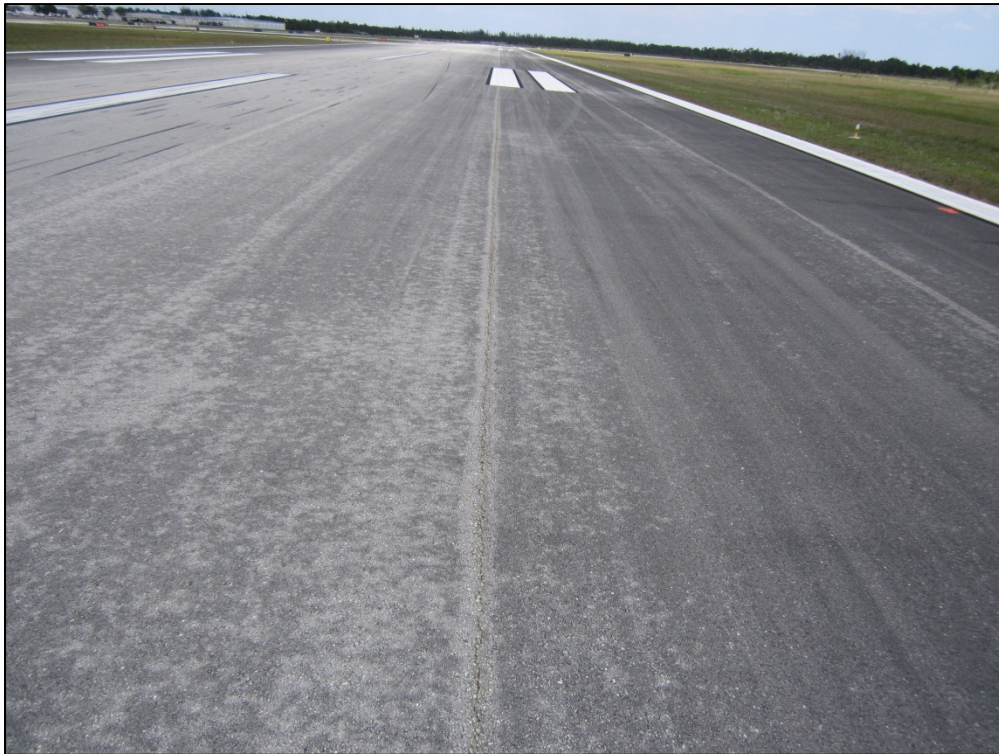
Runway 8R-26L, Section 6105, Sample Unit 128 – Low severity (48) Longitudinal and Transverse Cracking, low severity (52) Weathering and Raveling

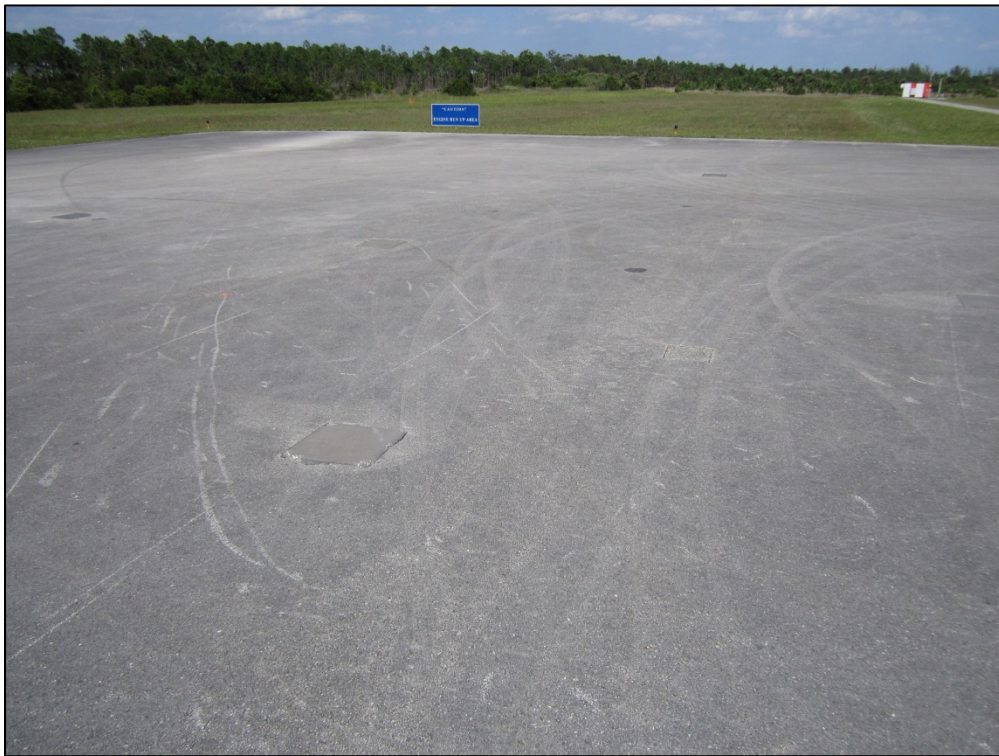
Apron Run-Up, Section 5110, Sample Unit 101– Low severity (48) Longitudinal and Transverse Cracking, low severity (52) Weathering and Raveling, low severity (50) Patching

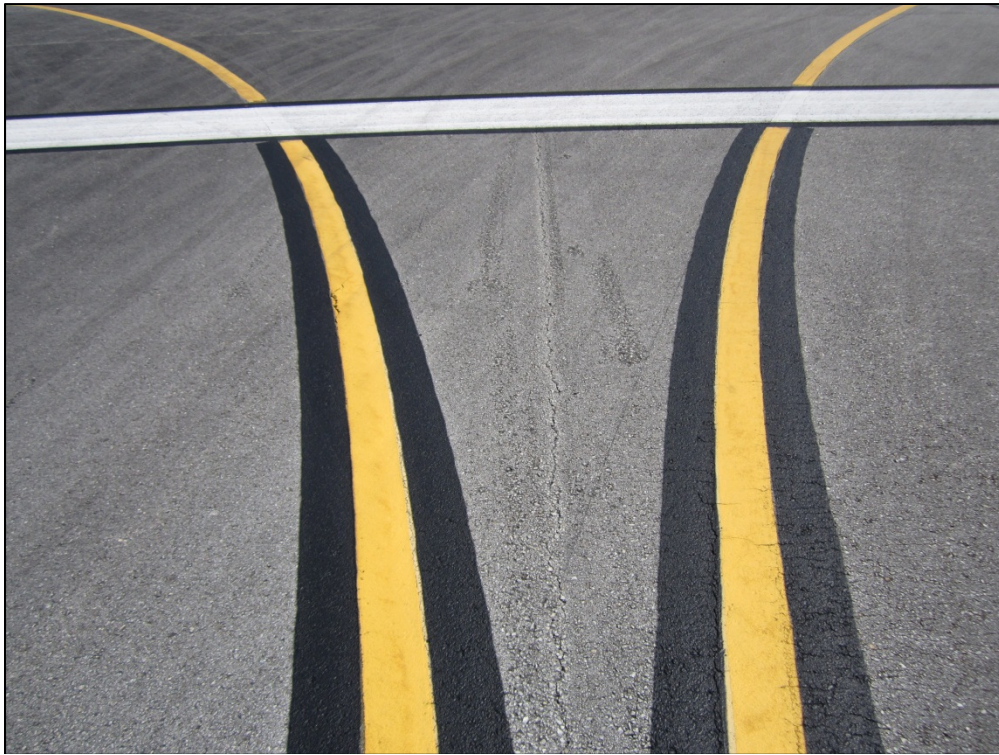
Taxiway Oscar, Section 1505, Sample Unit 400 – Low severity (48) Longitudinal and Transverse Cracking, low and medium severity (52)  
Weathering and Raveling

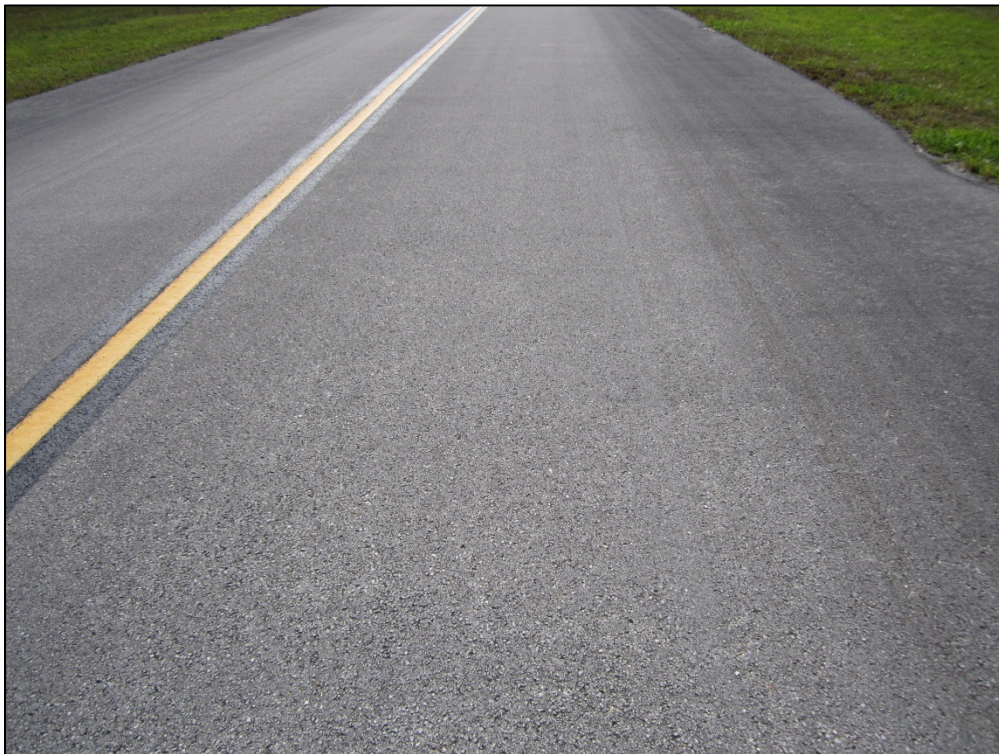
Taxiway Kilo, Section 1105, Sample Unit 110 – Low severity (52) Weathering and Raveling

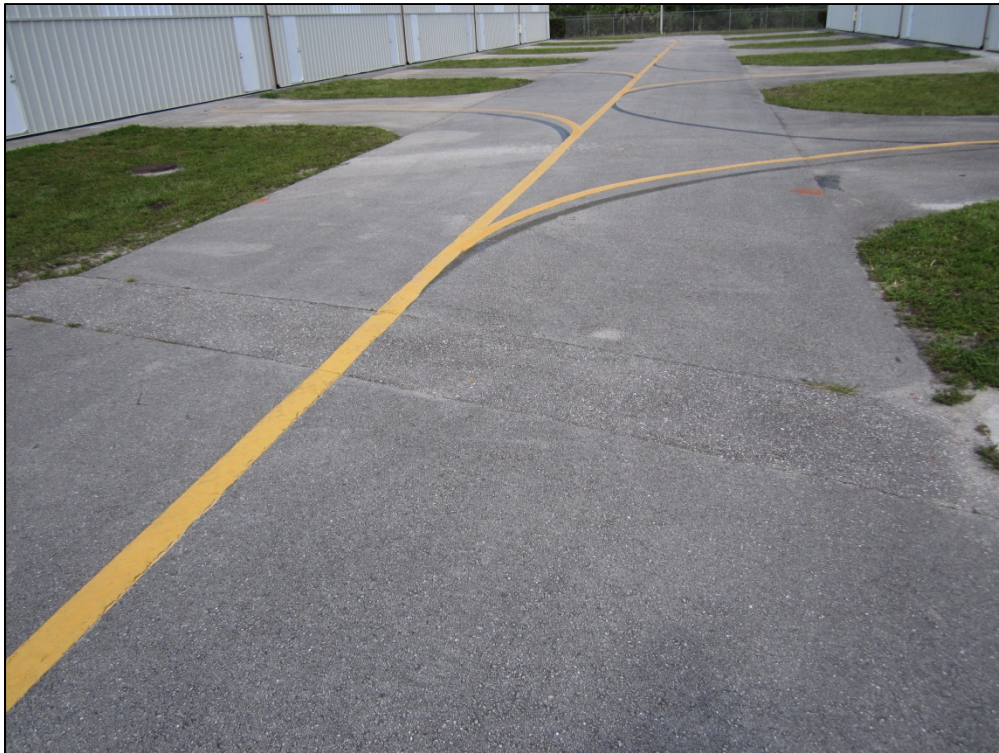
T-Hangar Apron E, Section 4420, Sample Unit 706 – Low severity (52) Weathering and Raveling, low severity (50) Patching

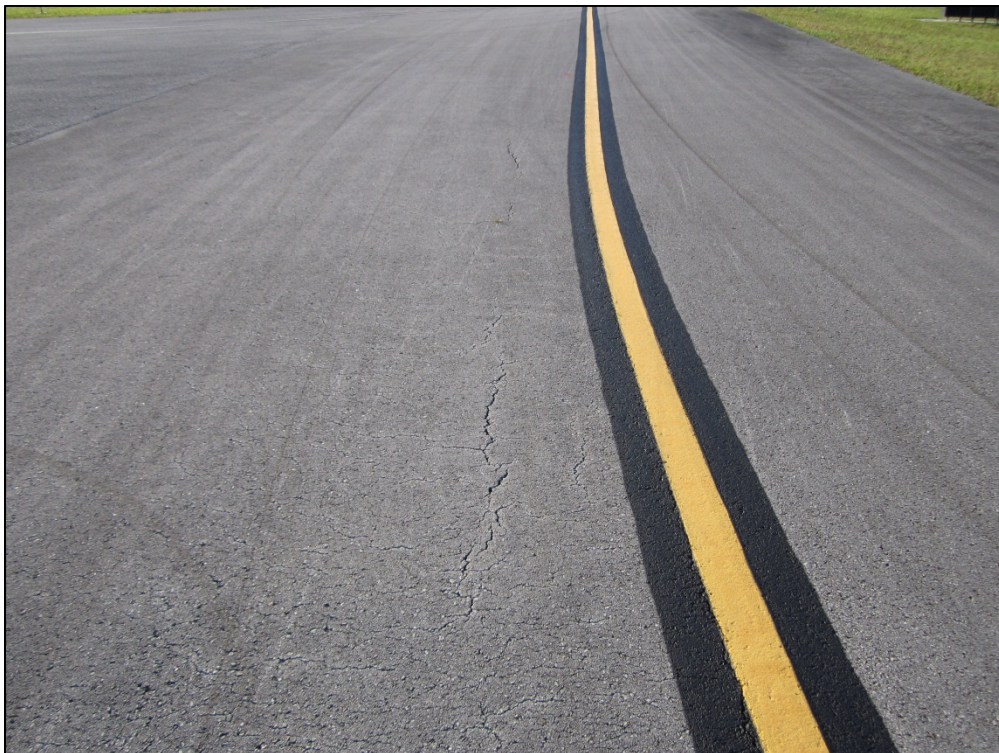
Taxiway Foxtrot, Section 605, Sample Unit 142 – Low severity (48) Longitudinal and Transverse Cracking, low severity (52) Weathering and Raveling

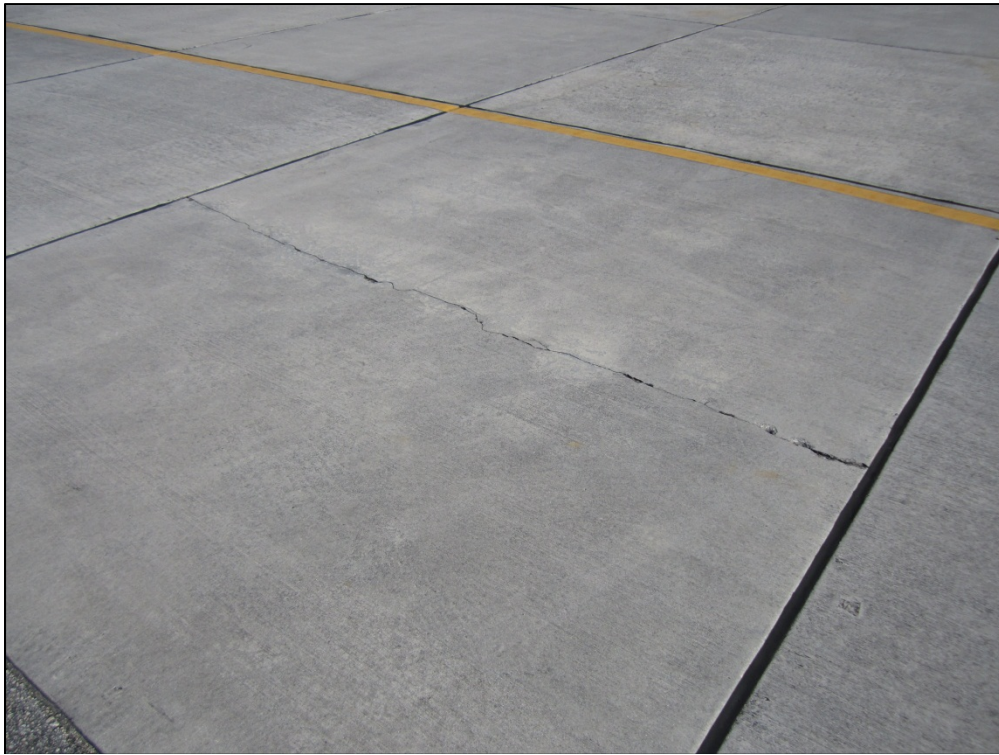
North Apron, Section 4115, Sample Unit 751 – low severity (63) Longitudinal, Transverse and Diagonal Cracking

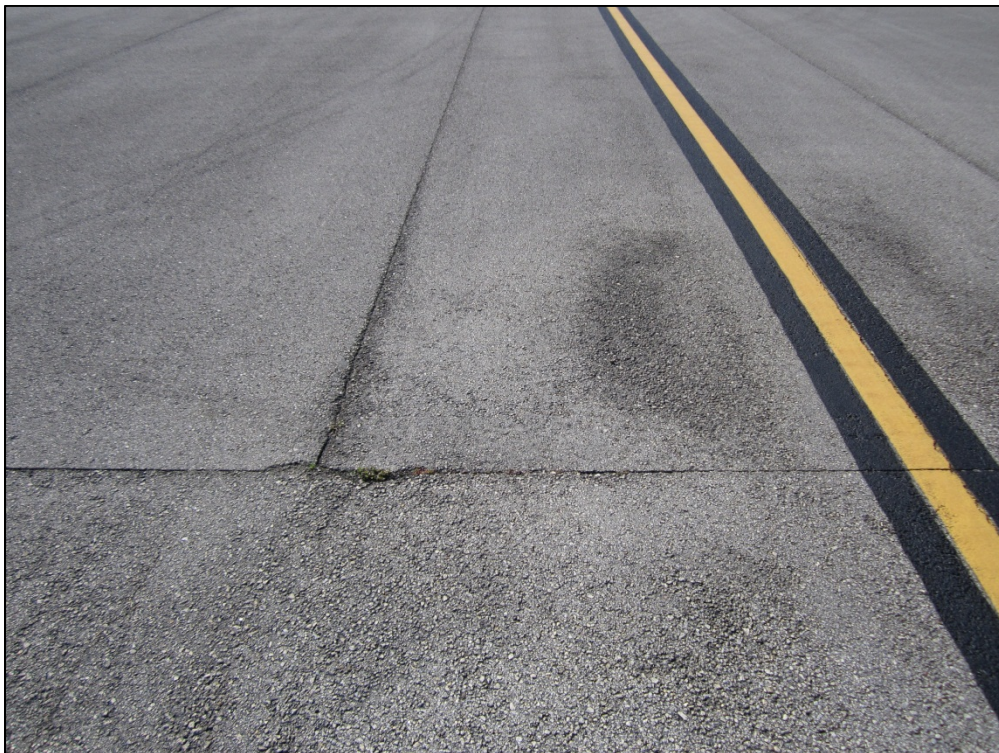
North Apron, Section 4105, Sample Unit 704 – Low severity (48) Longitudinal and Transverse Cracking, low and medium severity (52) Weathering and Raveling

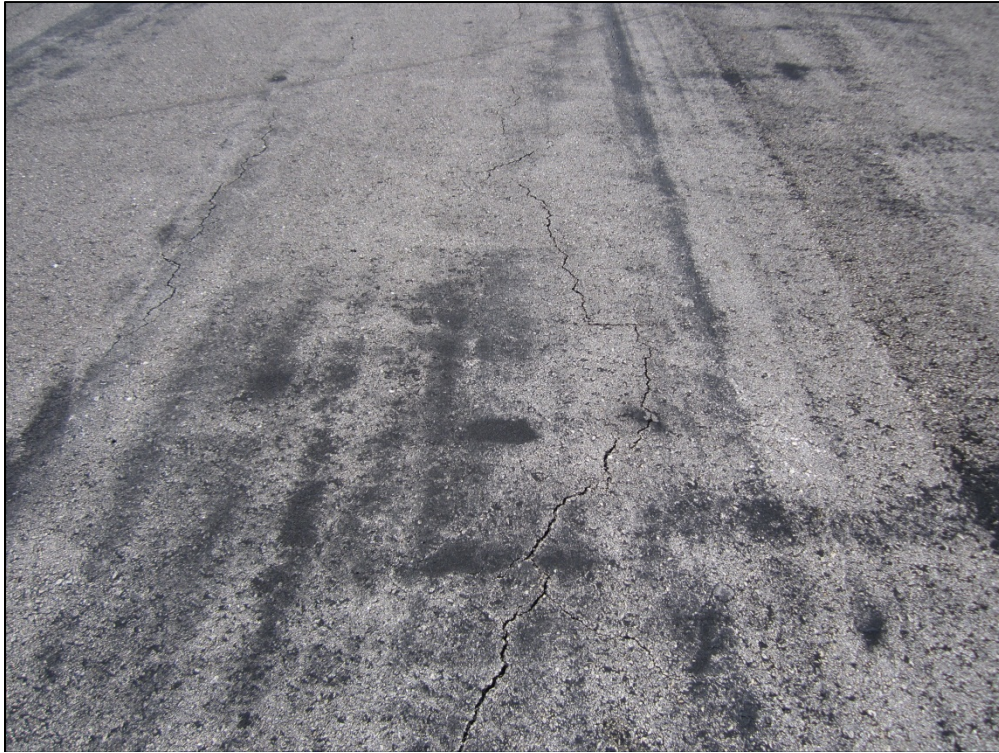
North Apron, Section 4120, Sample Unit 206 – Low severity (48) Longitudinal and Transverse Cracking, low severity (52) Weathering and Raveling, low severity (56) Swelling

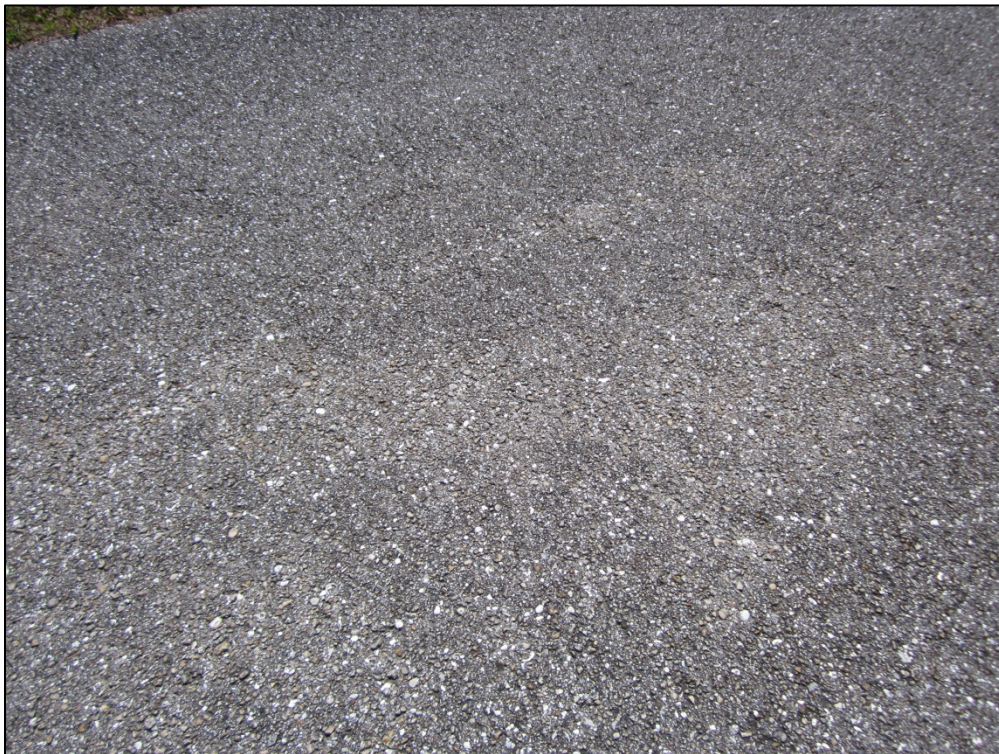
T-Hangar Apron N, Section 4305, Sample Unit 801 – Low severity (52) Weathering and Raveling
