**STATE OF FLORIDA  
DEPARTMENT OF TRANSPORTATION  
AVIATION OFFICE**

**Statewide Airfield Pavement  
Management Program**

**Okeechobee County Airport– OBE  
(General Aviation)  
Okeechobee, Florida  
(District 1)**

**May 2011**

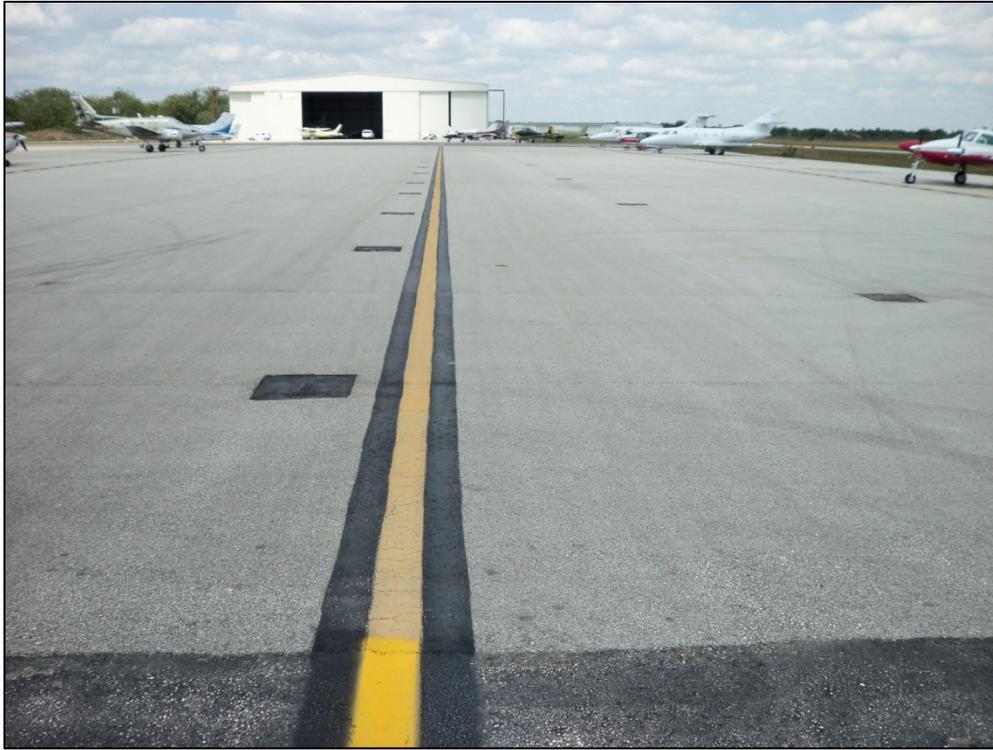
Apron, Section 4105, Sample Unit 460 – Low severity (50) Patching

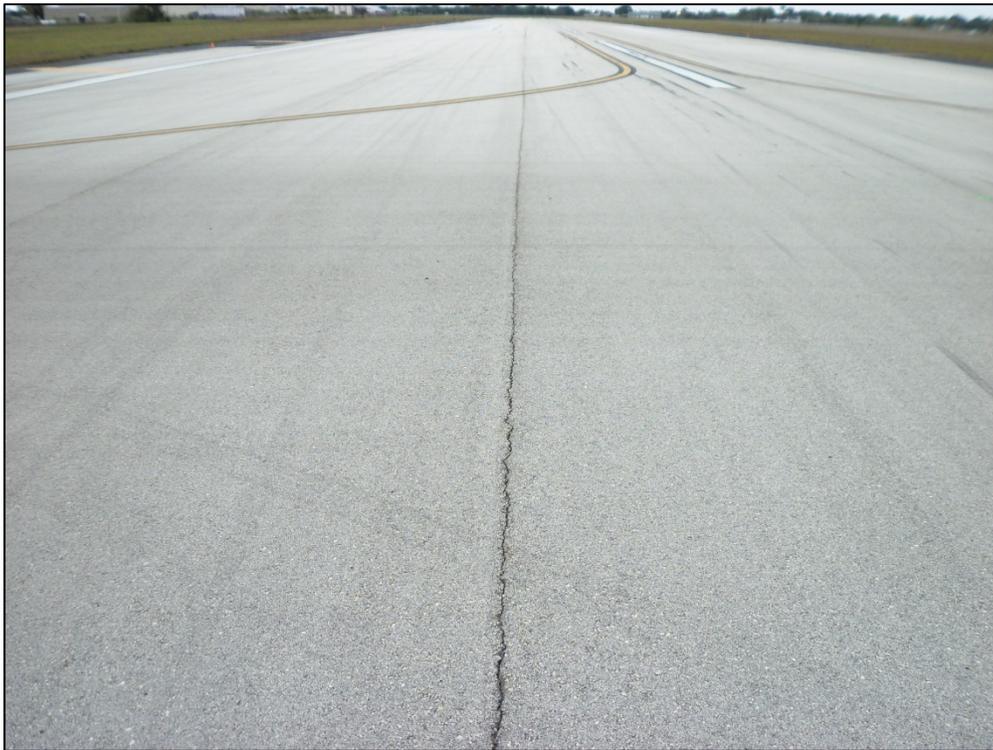
The full strength pavement for Runway 5-23 at the width of 100-ft exhibited low severity weathering and raveling in addition to longitudinal cracks primarily located along the paving joints. This is a common distress due to the pavement being weakest at the joint locations. Other than these isolated distresses, RW 5-23 appeared to be in a good overall condition. The full strength pavement section for Runway 5-23 has a PCI of 92 with a condition rating of ‘Good’. The shoulders which are composed of the original runway pavement have a PCI of 25 with a condition rating of ‘Serious’, which is below the recommended condition based on both the FDOT and FAA General Aviation minimum PCI.

Runway 5-23, Section 6105, Sample Unit 129 – Low severity (48) Longitudinal Cracking and low severity (52) Weathering and Raveling

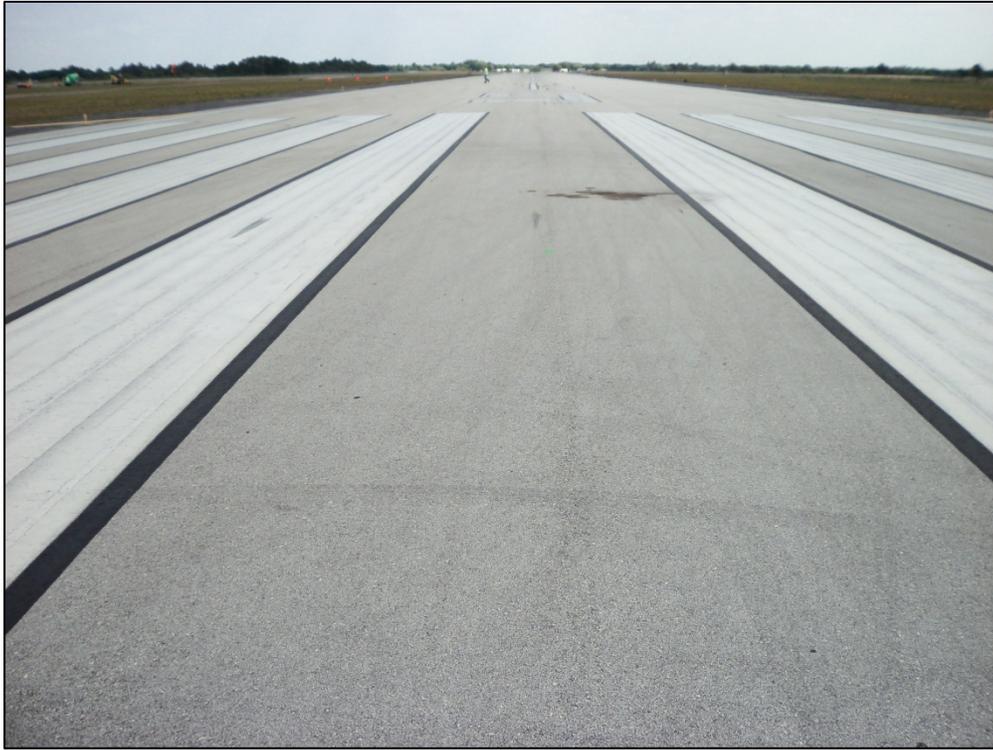
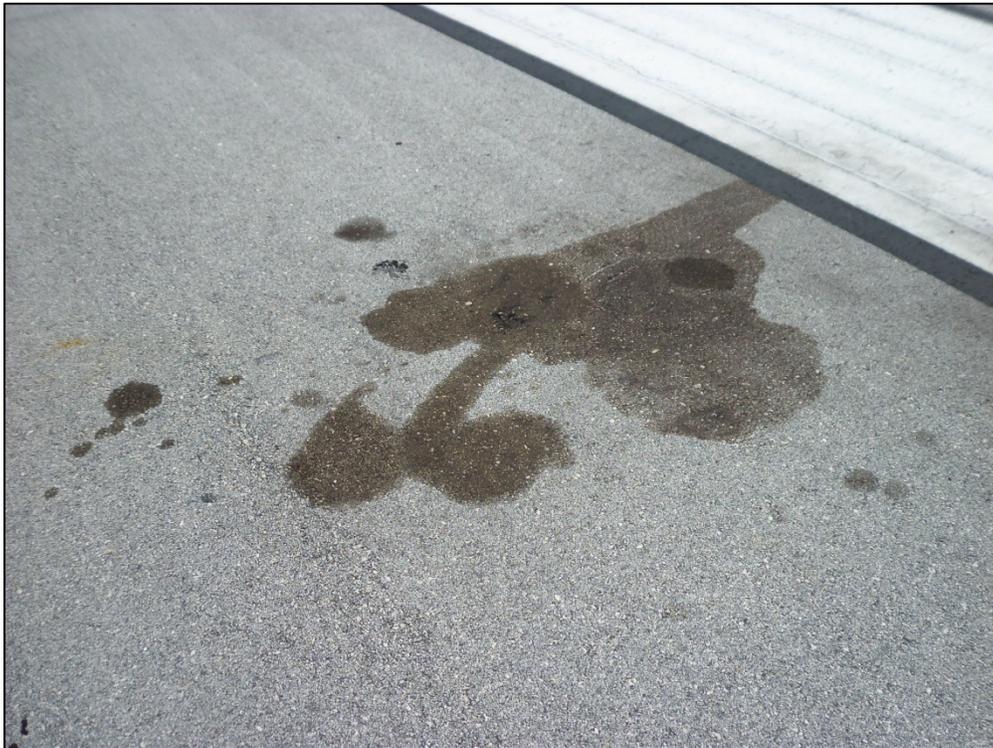
Runway 5-23, Section 6105, Sample Unit 101 – Low severity (48) Longitudinal Cracking, (49) Oil Spillage, and low severity (52) Weathering and Raveling

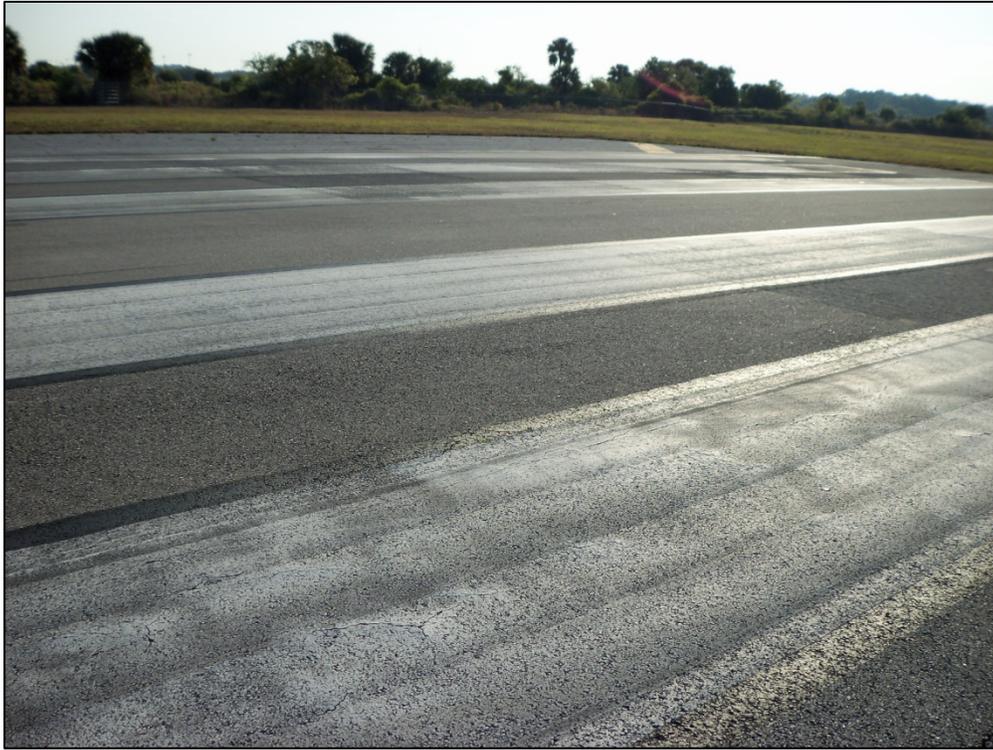
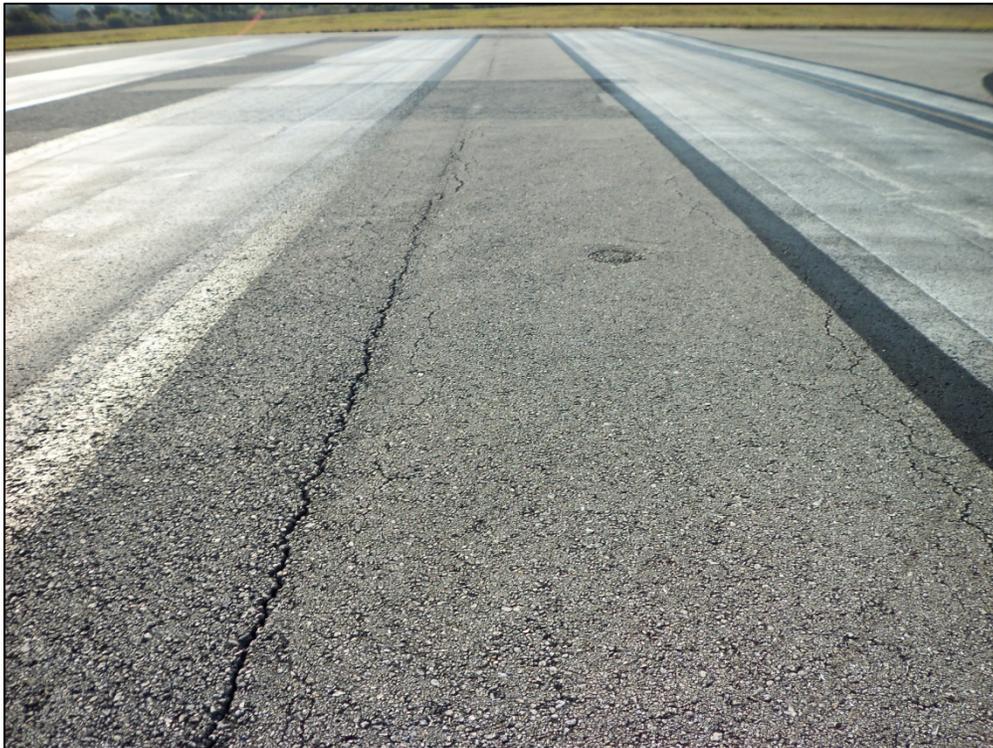
The full strength pavement for Runway 14-32 exhibited low to medium severity weathering and raveling in addition to longitudinal and transverse cracking. Small instances of swelling were observed where water had infiltrated into longitudinal or transverse cracks and expanded through heat cycles, resulting in swelling of the asphalt pavement. The full strength pavement section for Runway 14-32 has a PCI of 74 with a condition rating of ‘Satisfactory’. The shoulders which are composed of the original runway pavement have a PCI of 22 with a condition rating of ‘Serious’, which is below the recommended condition based on both the FDOT and FAA General Aviation minimum PCI.

Runway 14-32, Section 6205, Sample Unit 301 – Low severity (48) Longitudinal Cracking, low severity (52) Weathering and Raveling, low severity (56) Swell

FY 2016  
RUNWAY 14-32: 6205  
MILL AND OVERLAY  
\$0.78M

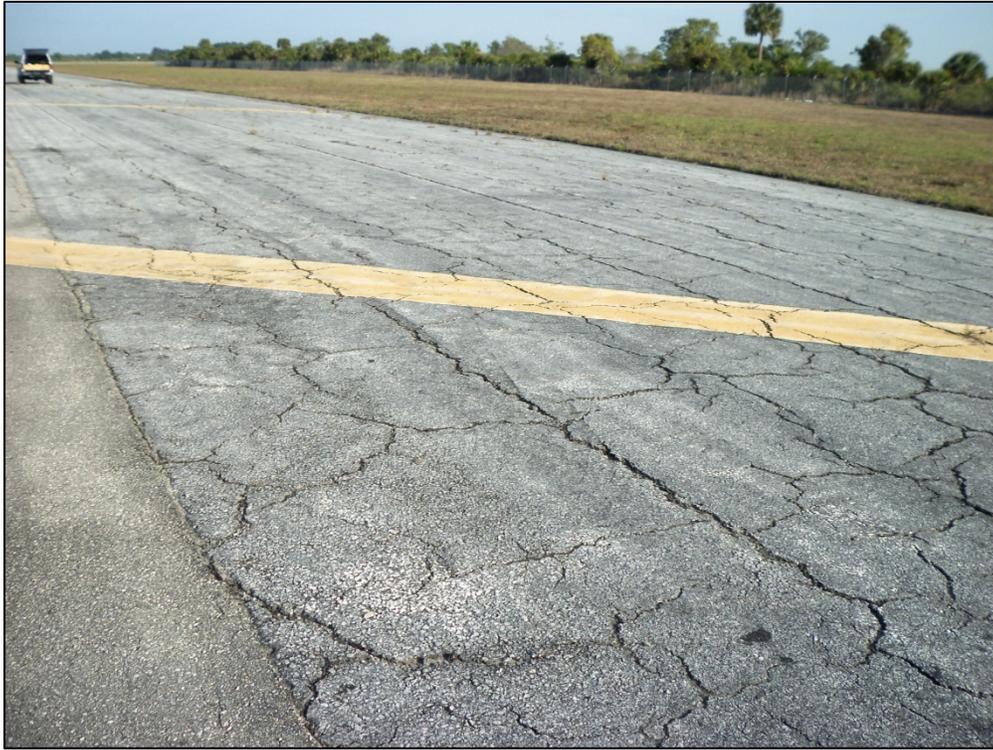
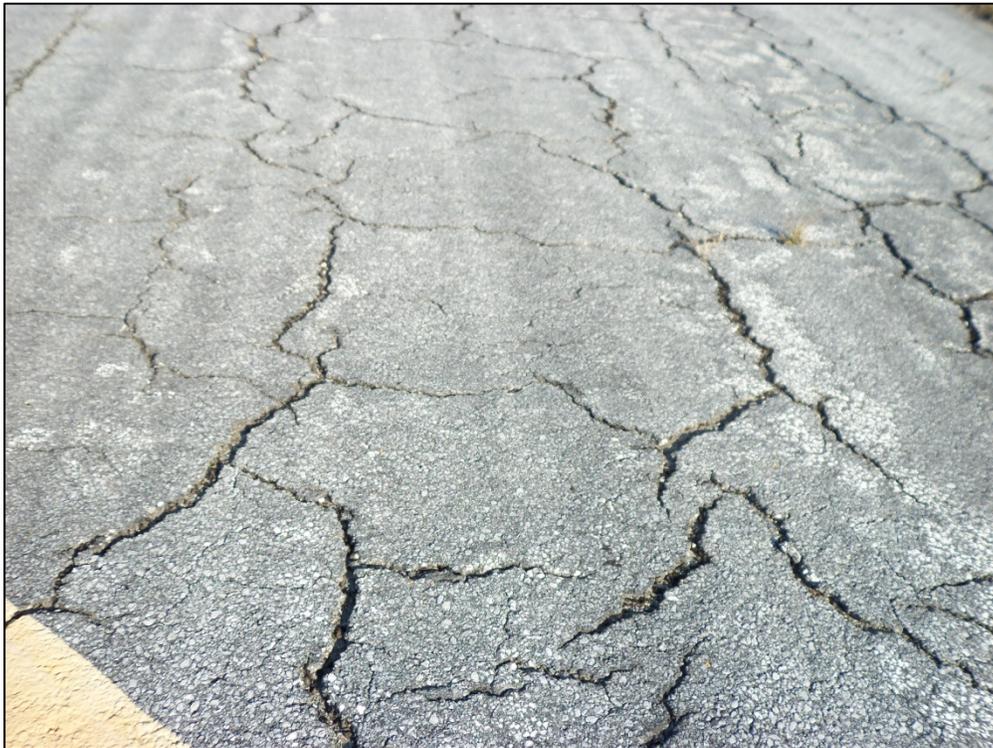
\*Runway condition reflects very poor and serious condition runway shoulders. This degrades the overall PCI of the runway section.

Runway 14-32 Shoulder, Section 6210, Sample Unit 500 – Medium and high severity (43) Block Cracking, medium severity (52) Weathering and Raveling

The immediate M&R needs, or needs that have been programmed to be completed in the first year of the 10-year M&R plan based on an unlimited budget at Okeechobee County Airport, include: Shoulder pavement for both Runways 14-32 and 5-23. These pavement sections exhibited medium and high severity block cracking along with low and medium severity weathering and raveling. Due to the extent of these distresses, both runway shoulders justify full pavement reconstruction. The immediate needs are summarized in Table IV below.

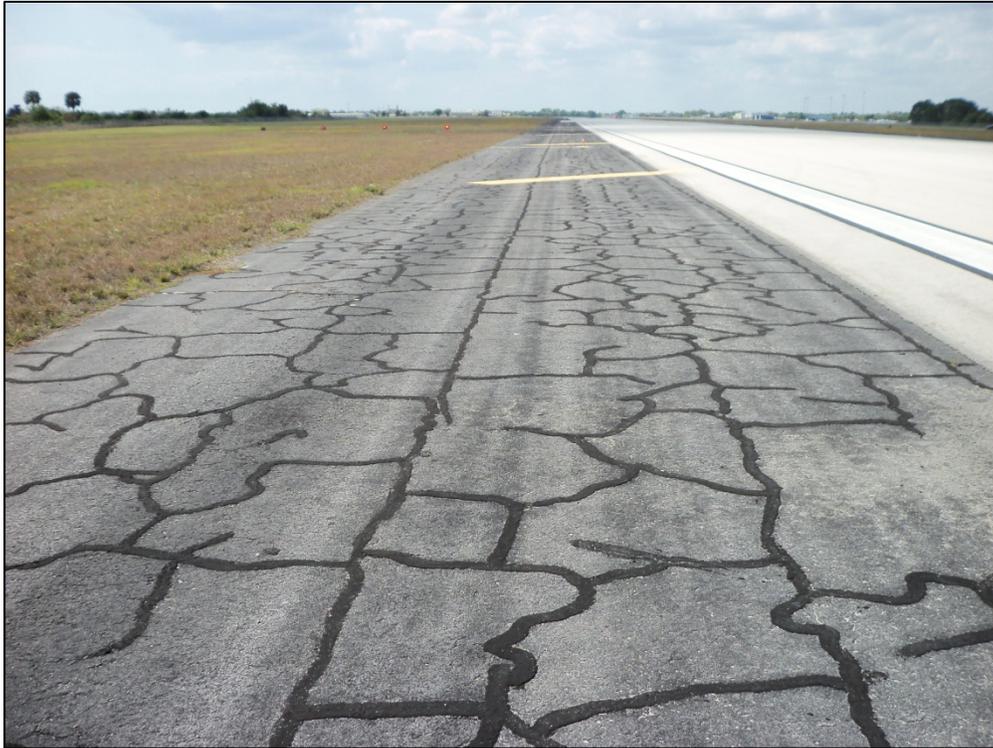
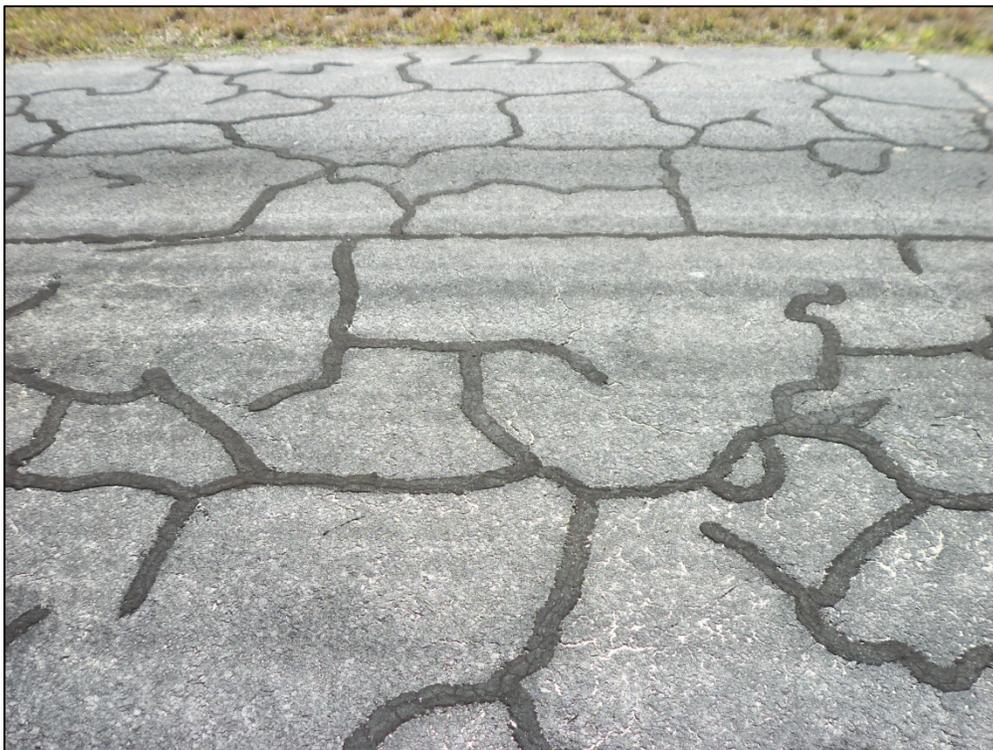
Runway 5-23 Shoulder, Section 6110 – Medium and high severity (43) Block Cracking, medium severity (52) Weathering and Raveling

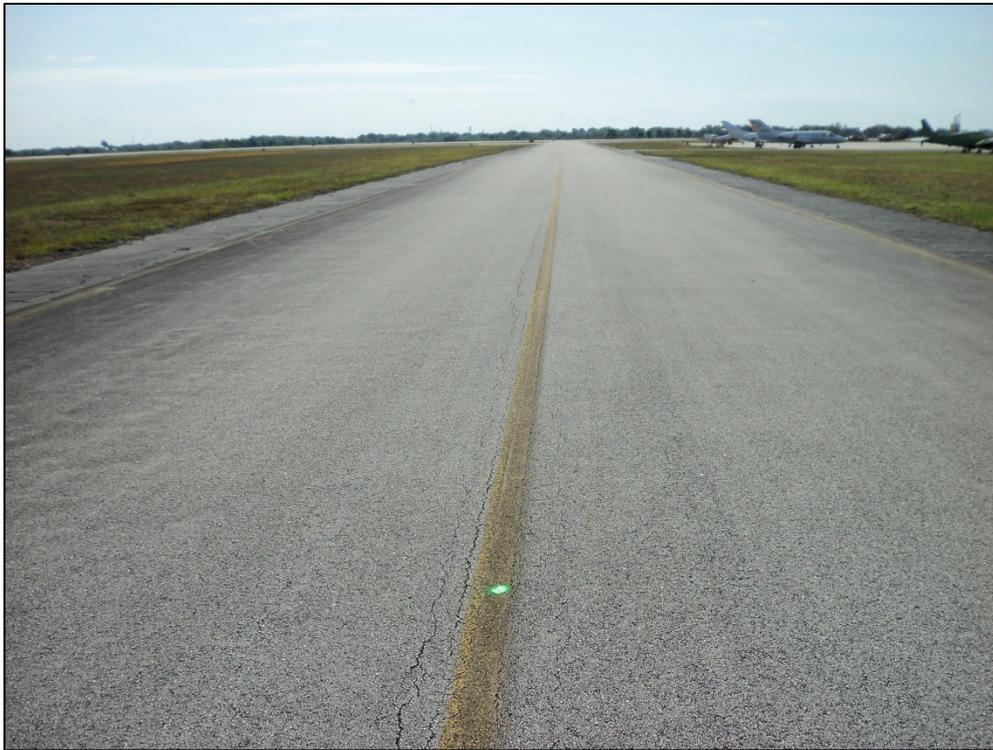
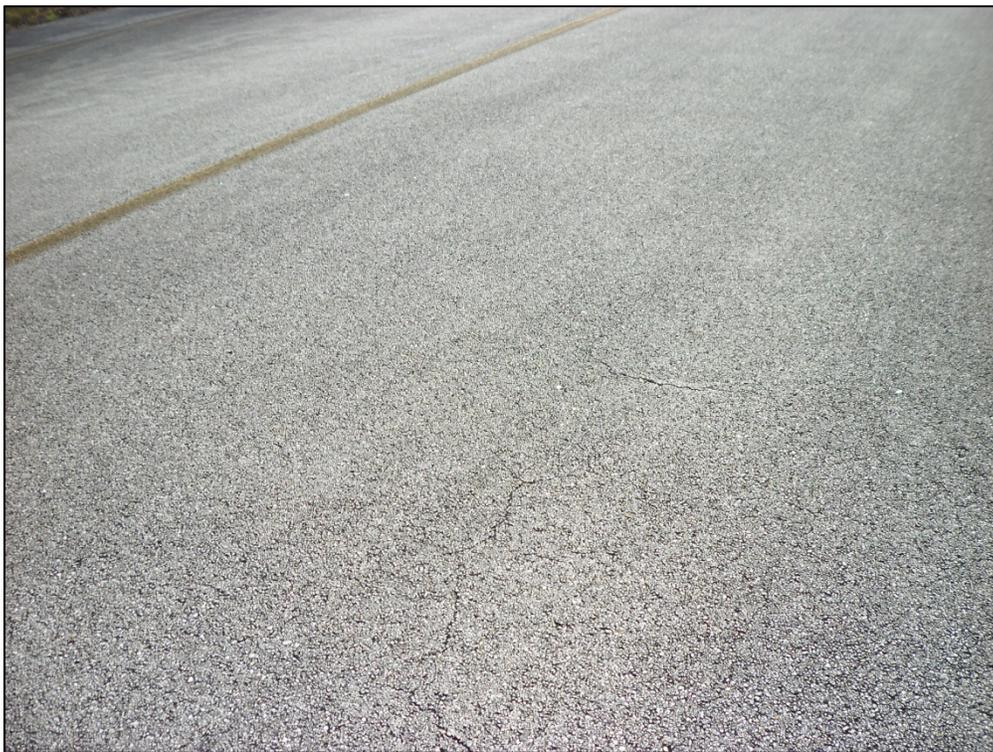
Taxiway Bravo, Section 205, Sample Unit 137 – Low severity (48) Longitudinal Cracking, low severity (52) Weathering and Raveling

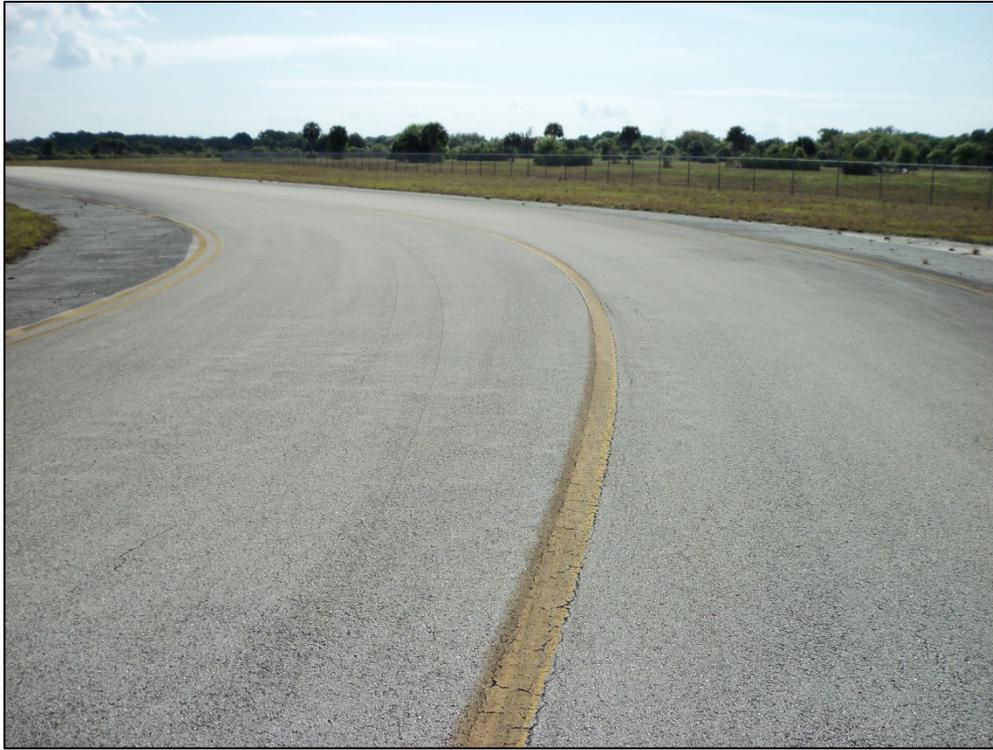
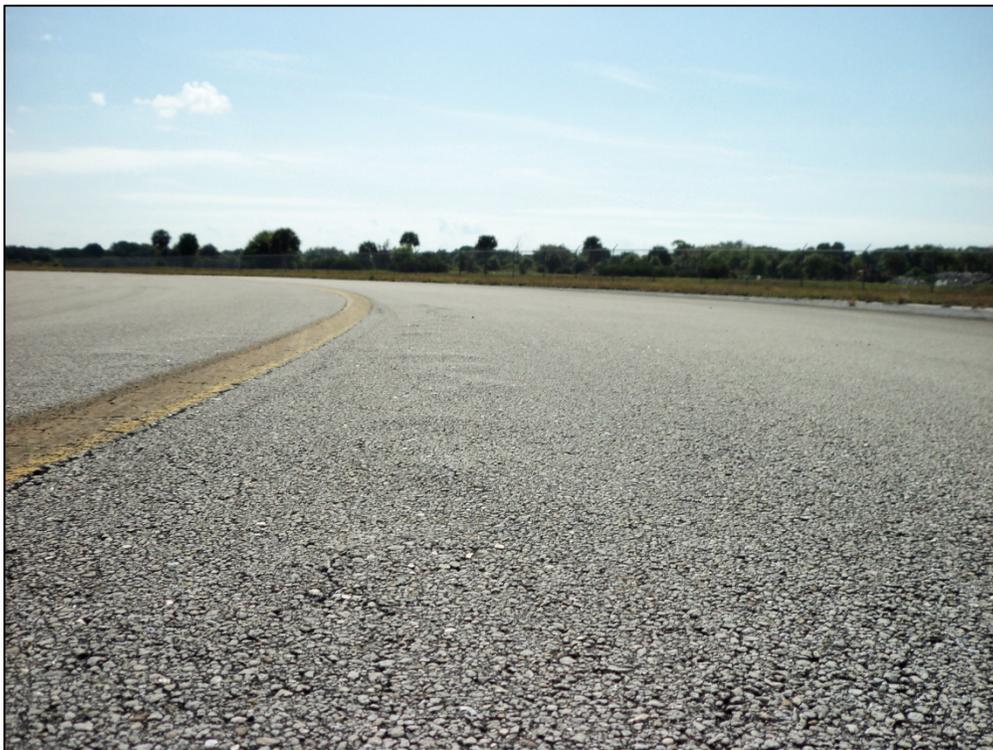
Taxiway Bravo, Section 205, Sample Unit 105 – Low severity (48) Longitudinal and Transverse Cracking, low severity (52) Weathering and Raveling, low severity (56) Swell
