STATE OF FLORIDA DEPARTMENT OF TRANSPORTATION AVIATION OFFICE

Statewide Airfield Pavement Management Program

Ormond Beach Municipal Airport- OMN
(Regional Reliever)
Ormond Beach, Florida
(District 5)

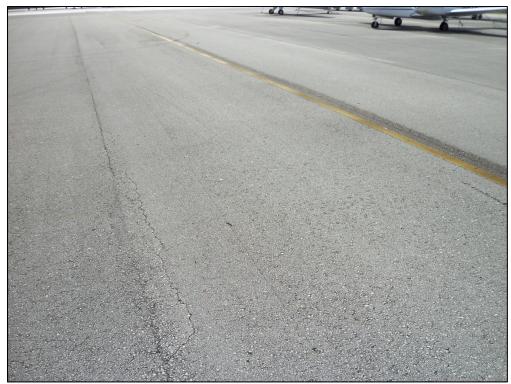
Apron, Section 4105, Sample Unit 205 – Low and medium severity (48) Longitudinal and Transverse Cracking, (49) Oil Spillage, low severity (52) Weathering and Raveling

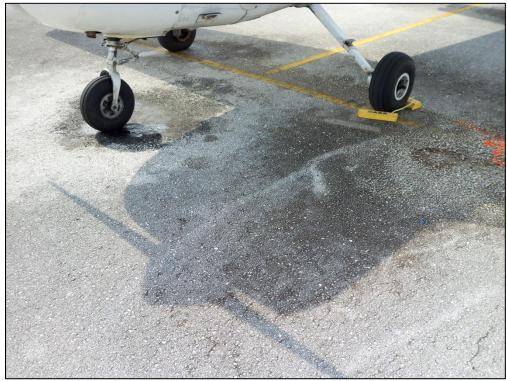
Apron, Section 4105, Sample Unit 205 – Low and medium severity (48) Longitudinal and Transverse Cracking, (49) Oil Spillage, low severity (52) Weathering and Raveling

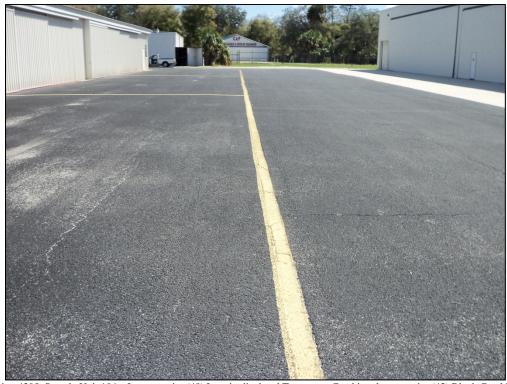
Apron, Section 4305, Sample Unit 104 – Low severity (48) Longitudinal and Transverse Cracking, low severity (43) Block Cracking, medium severity (52) Weathering and Raveling

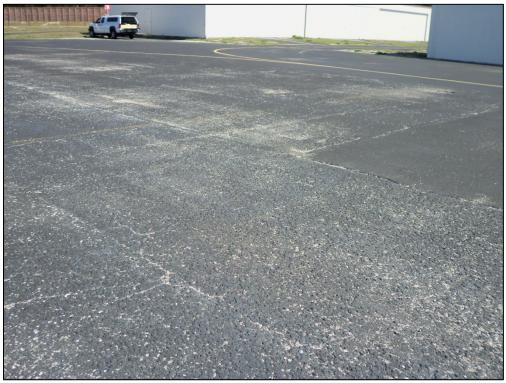
Apron, Section 4205, Sample Unit 111 – Low severity (48) Longitudinal and Transverse Cracking, low severity (43) Block Cracking, medium severity (52) Weathering and Raveling

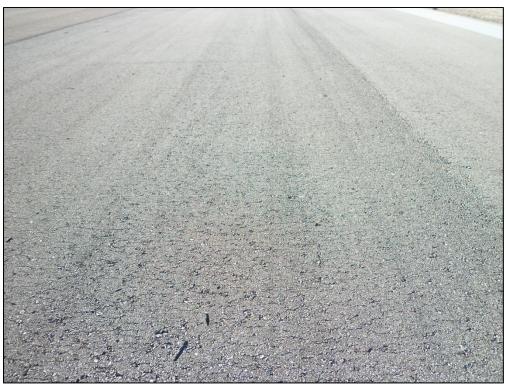
Other than the small amount of low severity weathering and raveling, Runway 17-35 was in an overall good condition.

Runway 17-35, Section 6205, Sample Unit 164 – Low severity (52) Weathering and Raveling

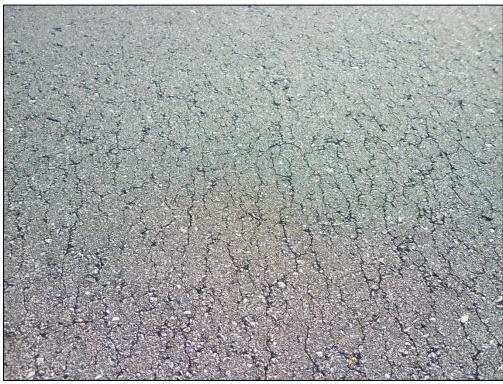
Runway 17-35, Section 6205, Sample Unit 164 – Low severity (52) Weathering and Raveling

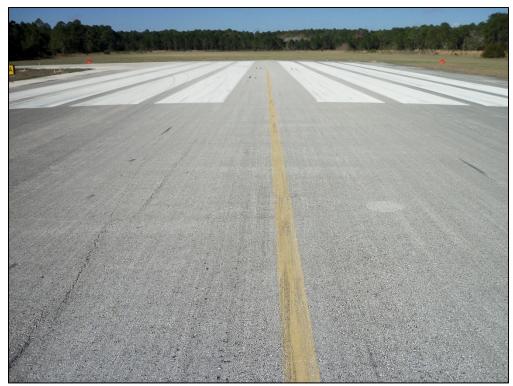
Runway 8-26 exhibited low to medium severity weathering and raveling in addition to longitudinal cracks primarily located along the paving joints. This distress is common along the paving joints due to the pavement being weakest at this location.

Runway 8-26, Section 6105, Sample Unit 103 – Low severity (48) Longitudinal and Transverse Cracking, low and medium severity (52) Weathering and Raveling

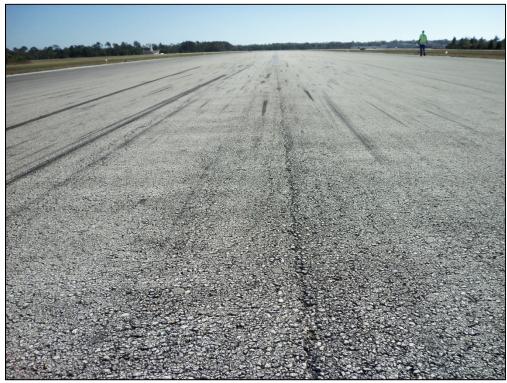
Runway 8-26, Section 6105, Sample Unit 117 – Medium severity (48) Longitudinal and Transverse Cracking, low and medium severity (52) Weathering and Raveling

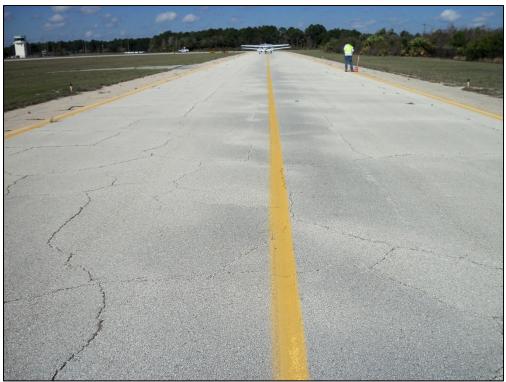
Taxiway Echo, Section 505, Sample Unit 107 – Low and medium severity (43) Block Cracking, low severity (52) Weathering and Raveling

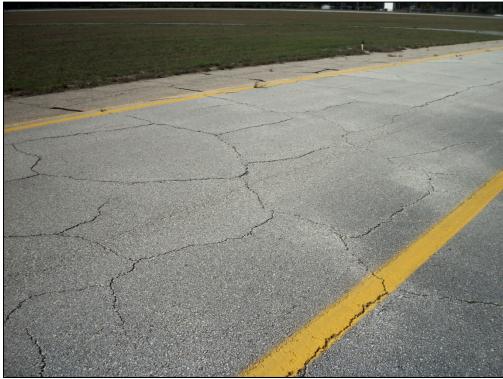
Taxiway Echo, Section 505, Sample Unit 107 - Low and medium severity (43) Block Cracking, low severity (52) Weathering and Raveling

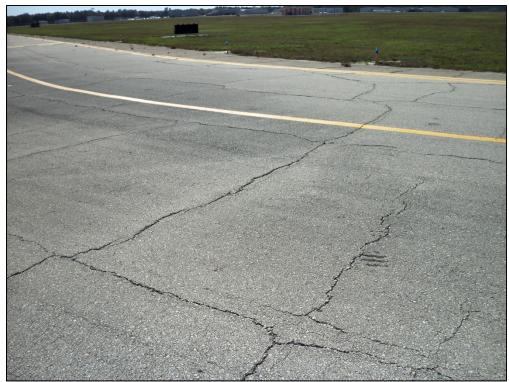
Taxiway Echo, Section 505, Sample Unit 101 - Low and medium severity (43) Block Cracking, low severity (52) Weathering and Raveling

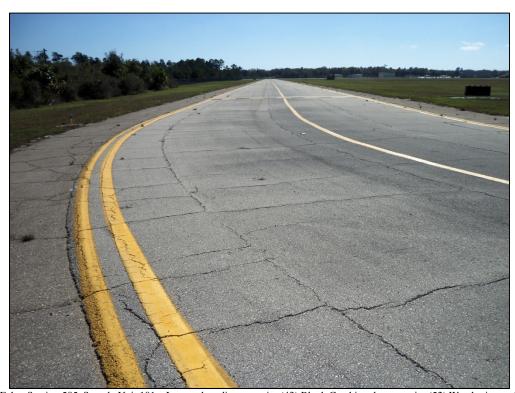
Taxiway Echo, Section 505, Sample Unit 101 – Low and medium severity (43) Block Cracking, low severity (52) Weathering and Raveling

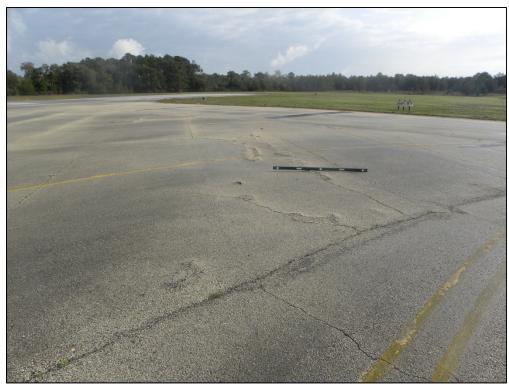
Taxiway Charlie, Section 805, Sample Unit 100 – Low and medium severity (43) Block Cracking, medium severity (48) Longitudinal and Transverse Cracking, medium severity (52) Weathering and Raveling, medium severity (56) Swell

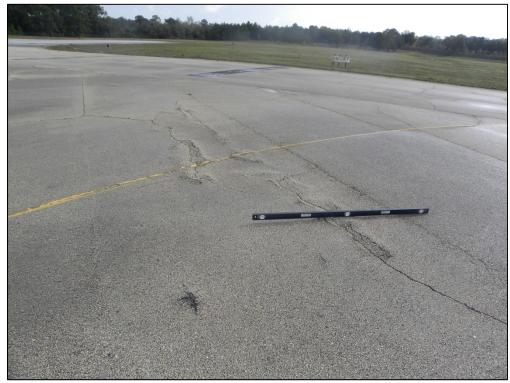
Taxiway Charlie, Section 805, Sample Unit 100 – Low and medium severity (43) Block Cracking, medium severity (48) Longitudinal and Transverse Cracking, medium severity (52) Weathering and Raveling, medium severity (56) Swell
