**STATE OF FLORIDA
DEPARTMENT OF TRANSPORTATION
AVIATION OFFICE**

**Statewide Airfield Pavement
Management Program**

**Palm Beach County Park Airport– LNA
(Regional Reliever)
Lantana, Florida
(District 4)**

May 2012

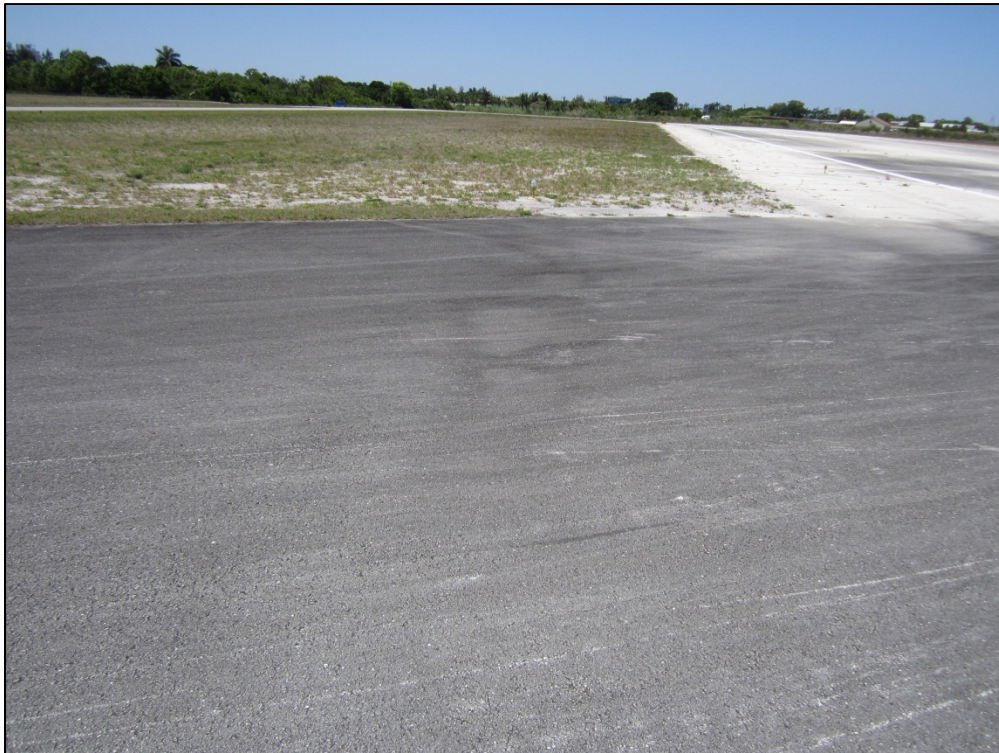
Runway 3-21, Section 6305, Sample Unit 156 – Low severity (52) Weathering and Raveling, low severity (45) Depression

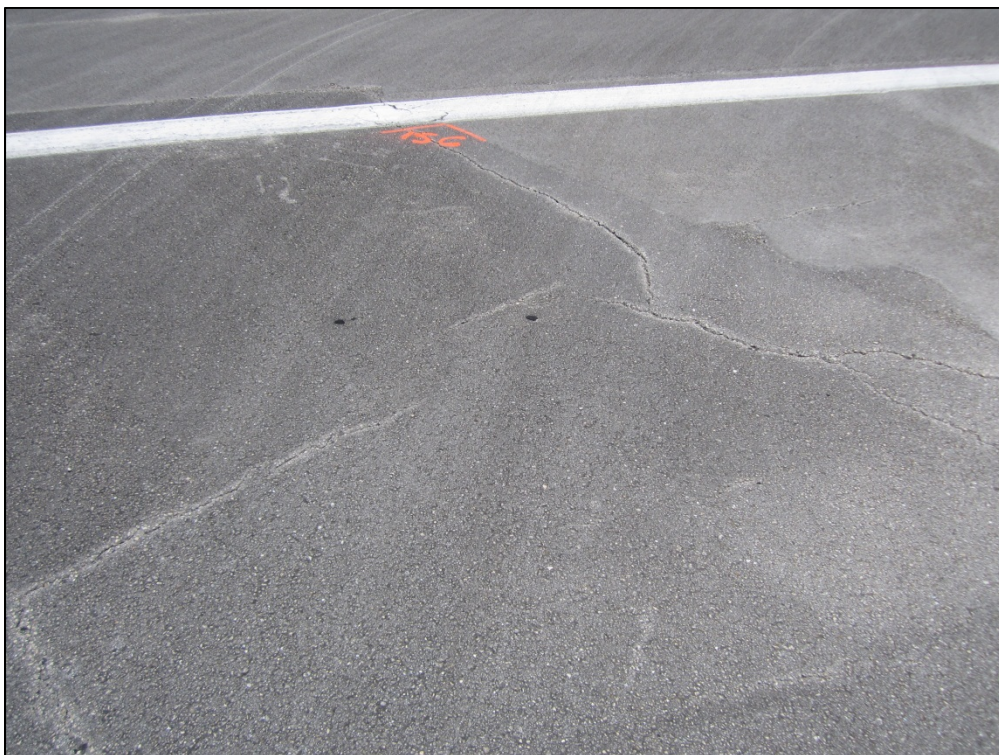
Runway 3-21, Section 6305, Sample Unit 156 – Low severity (52) Weathering and Raveling, low and medium severity (48) Longitudinal and Transverse Cracking

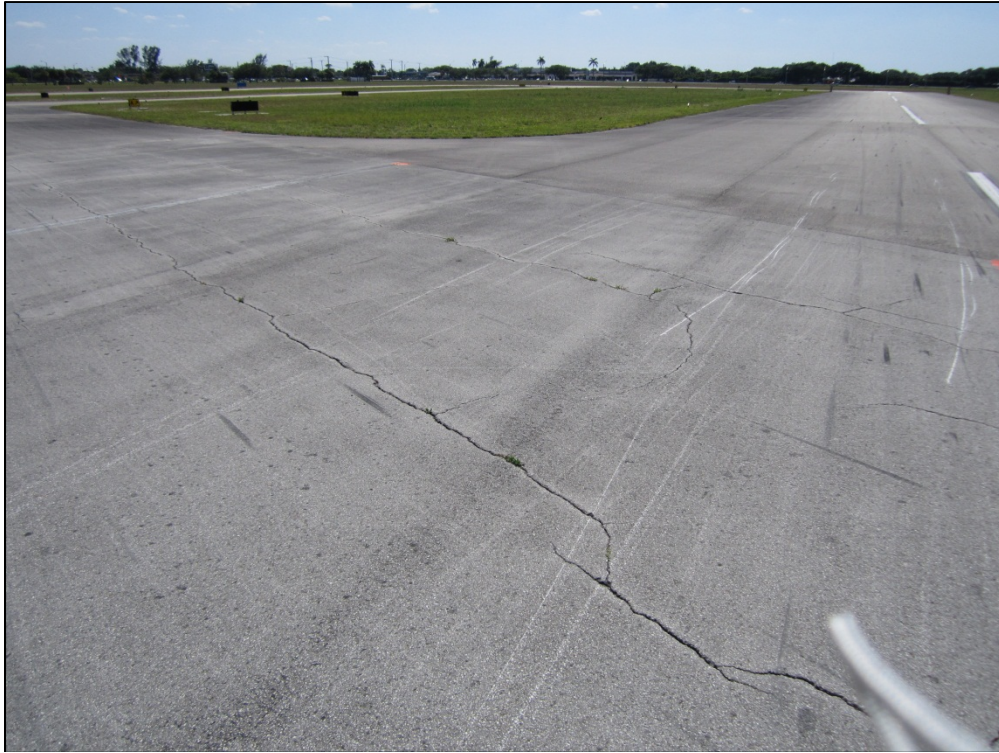
Runway 3-21 was mostly in Satisfactory condition with a PCI of 72. The pavement in the intersection with Runway 9-27 was more severely distressed with a PCI of 38, representing a Very Poor condition. Distresses include low severity patching; low severity weathering and raveling; and low and medium, and high severity longitudinal and transverse cracking. These are climate and age related distresses.

Runway 3-21, Section 6310, Sample Unit 109 – Low, medium, and high severity (48) Longitudinal and Transverse Cracking; low severity (52) Weathering and Raveling

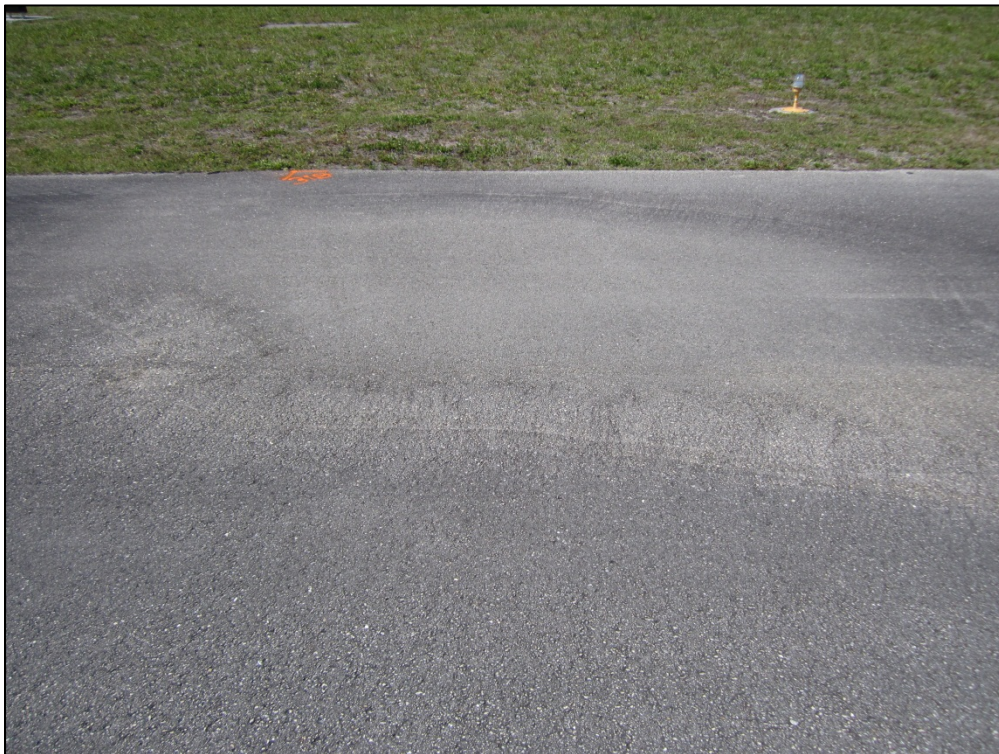
Runway 9-27 was in Good condition with a PCI of 87. Distresses include low severity depression; low severity weathering and raveling; and low severity longitudinal and transverse cracking. These are climate, subgrade quality, and age related distresses.

Runway 9-27, Section 6105, Sample Unit 319 – Low severity (52) Weathering and Raveling, low severity (45) Depression

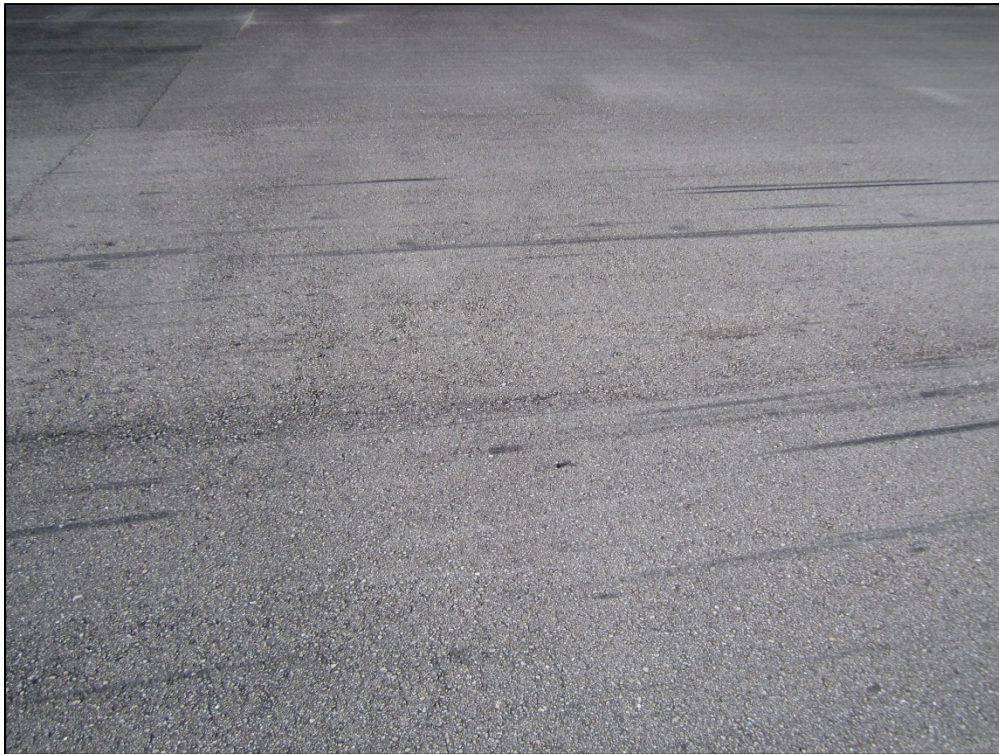
Runway 9-27, Section 6105, Sample Unit 6105, Sample Unit 313 – Low severity (48) Longitudinal and Transverse Cracking, low severity (52) Weathering and Raveling

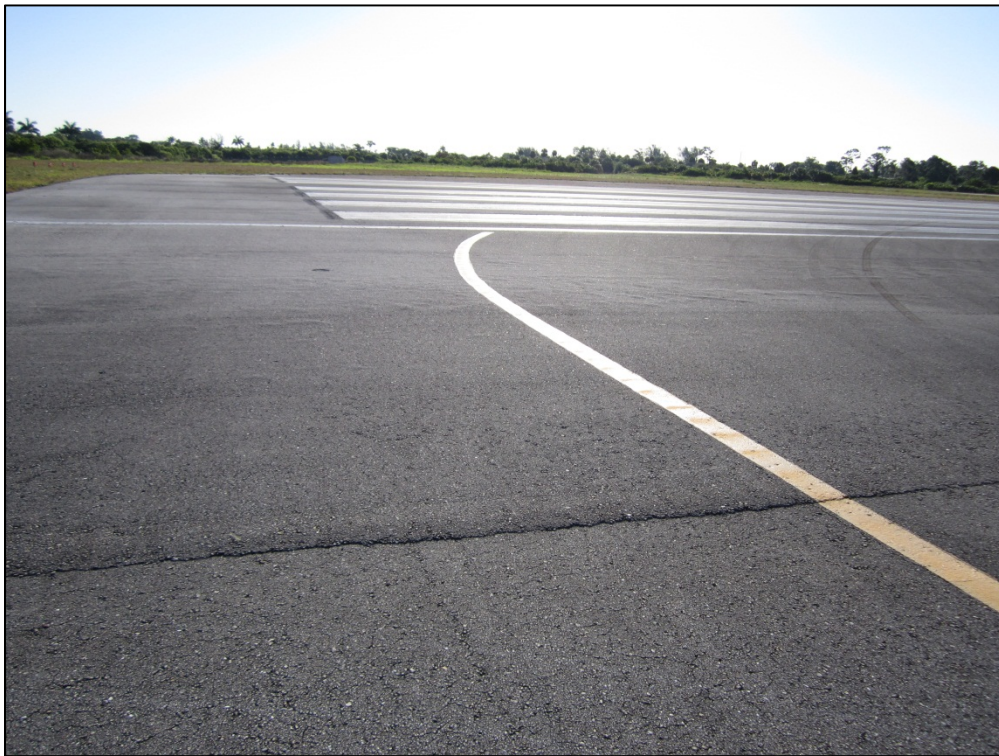
Taxiway Bravo, Section 215, Sample Unit 100 – Low severity (48) Longitudinal and Transverse Cracking, low severity (56) Swelling

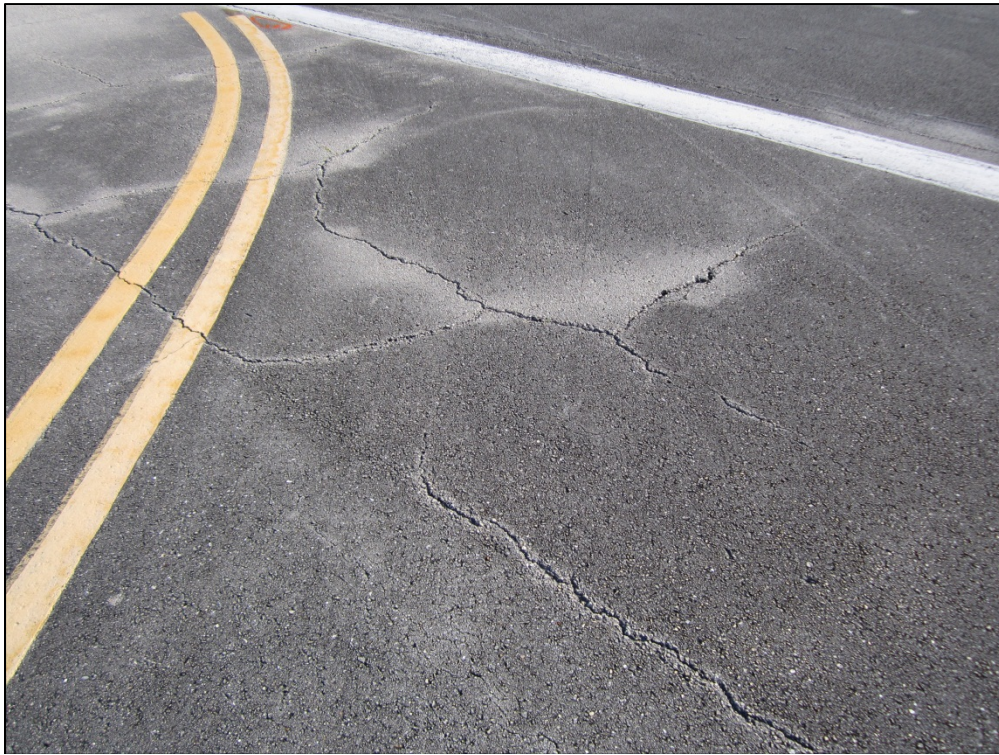
Taxiway B-1, Section 220, Sample Unit 100 – Low and medium severity (48) Longitudinal and Transverse Cracking, low severity (52) Weathering and Raveling

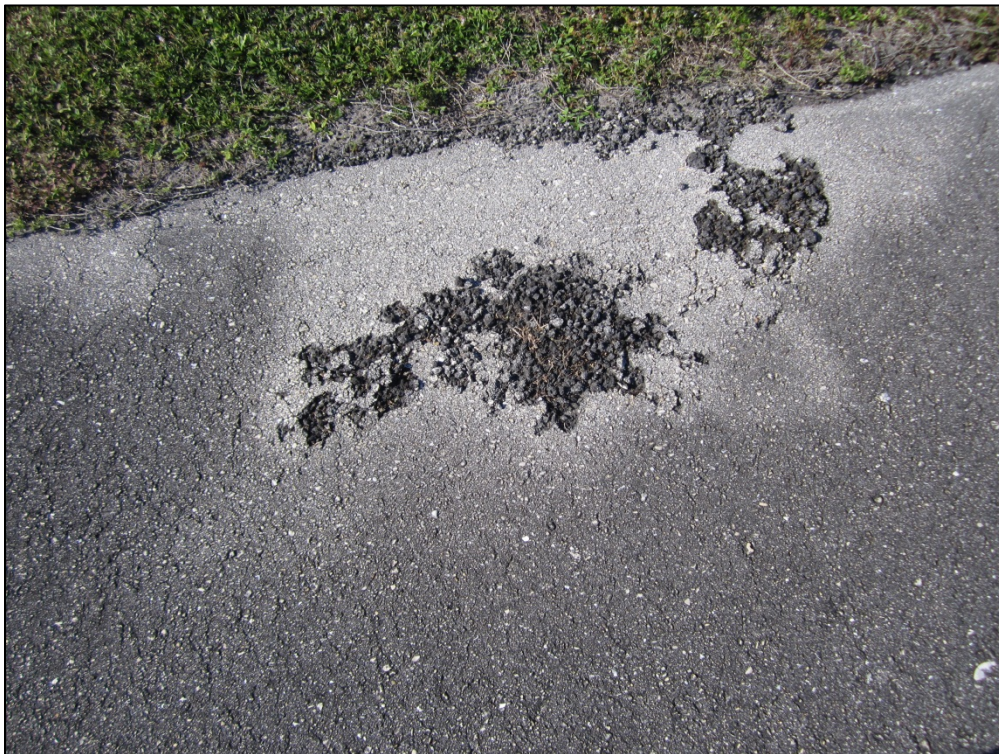
Taxiway Alpha, Section 310, Sample Unit 322 – High severity (52) Weathering and Raveling

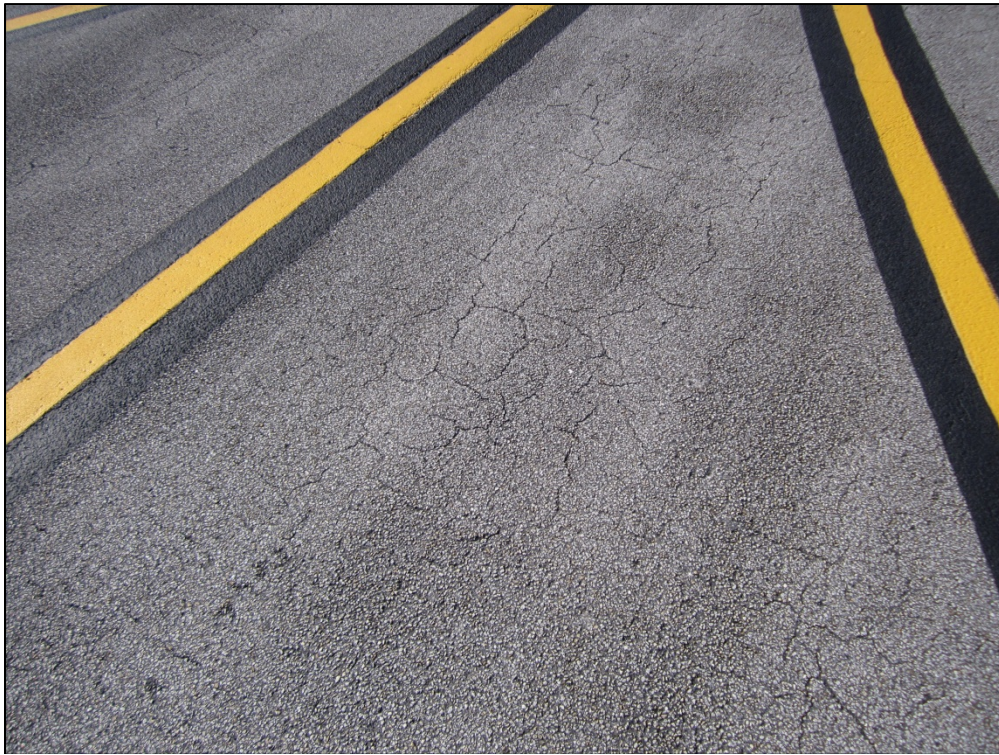
Taxiways were in Fair to Good condition, with the exception of Taxiway A-1, which had a PCI of 51, representing a Poor condition. Distresses on Taxiway A-1 include low severity block cracking, low severity longitudinal and transverse cracking, low and medium severity patching, and low severity weathering and raveling. These distresses were found on other taxiways, but in lower quantities. Other distresses found on the taxiways include low severity block cracking and low severity swelling. These are climate and age related distresses. Areas of medium and high severity weathering and raveling were localized and not indicative of overall pavement condition.

Taxiway A-1, Section 120, Sample Unit 302 – Low severity (52) Weathering and Raveling, low severity (43) Block Cracking

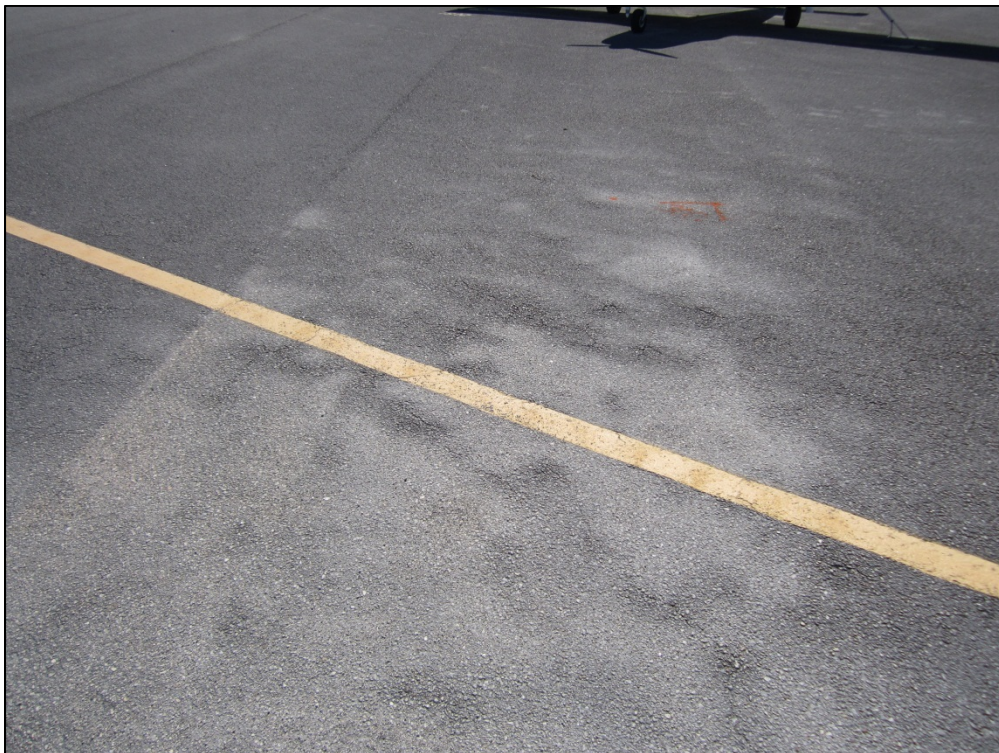
The GA Apron was in Fair condition with PCI’s ranging from 56 to 62. Distresses include low, medium, and high severity longitudinal and transverse cracking; low, medium, and high severity weathering and raveling; low and medium severity patching; low severity shoving; oil spillage; low severity swelling; low severity depression; and low and medium severity block cracking. These are age, climate, PCC pavement growth, aircraft operation, and subgrade quality related distresses.

GA Apron, Section 4105, Sample Unit 302 – Low severity (48) Longitudinal and Transverse Cracking, low severity (52) Weathering and Raveling, low severity (56) Swelling

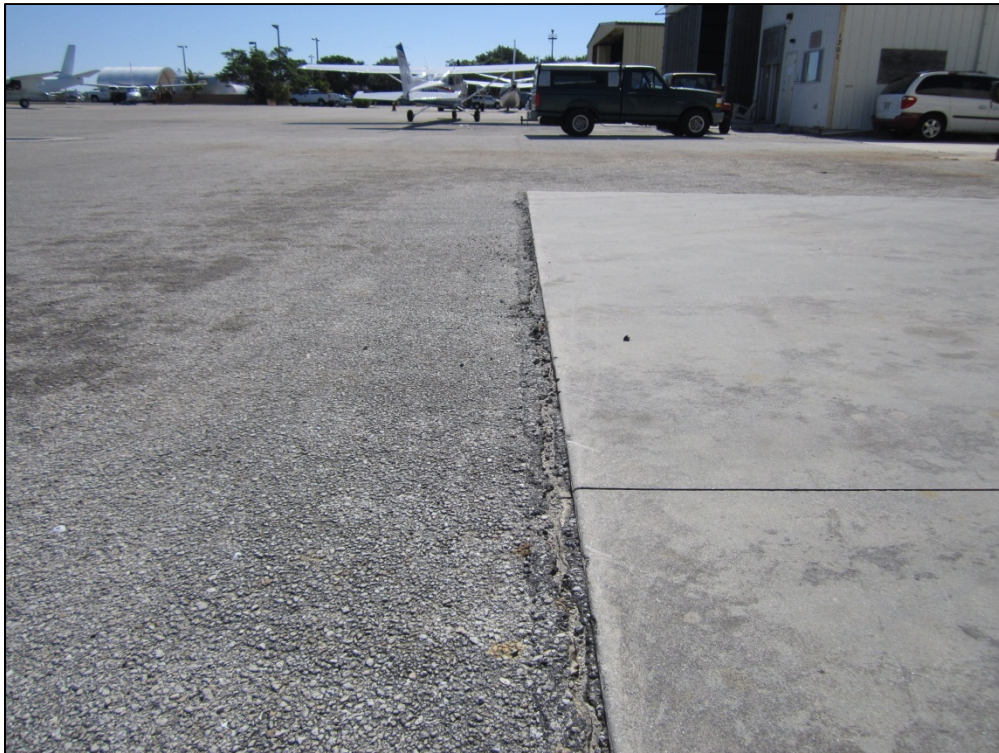
GA Apron, Section 4105, Sample Unit 258 – Low severity (52) Weathering and Raveling, low severity (54) Shoving, (49) Oil Spillage

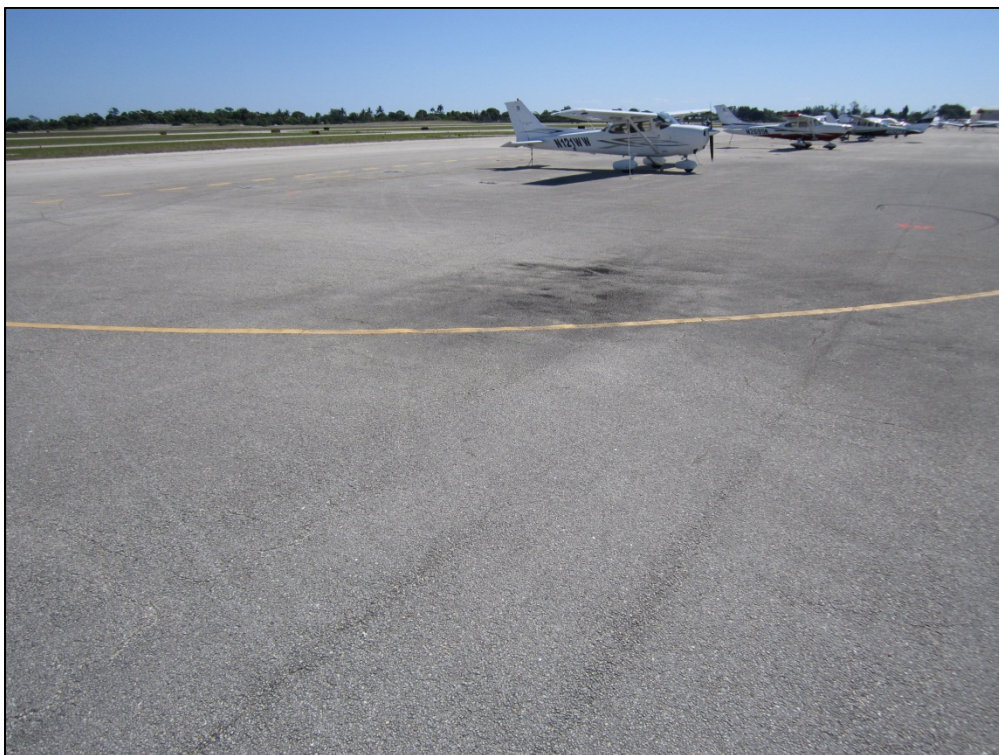
GA Apron, Section 4115, Sample Unit 661 – Low severity (48) Longitudinal and Transverse Cracking, low and medium (52) Weathering and Raveling, low severity (45) Depression

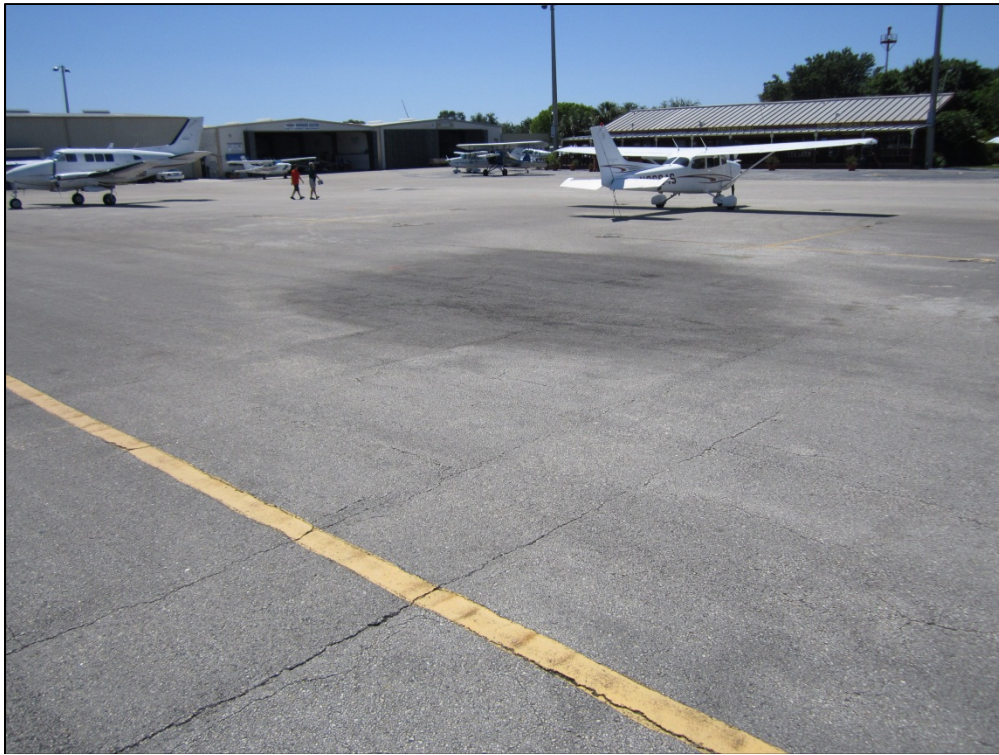
GA Apron, Section 4115, Sample Unit 614 – Low and medium severity (48) Longitudinal and Transverse Cracking, low and high severity (52) Weathering and Raveling, low severity (56) Swelling

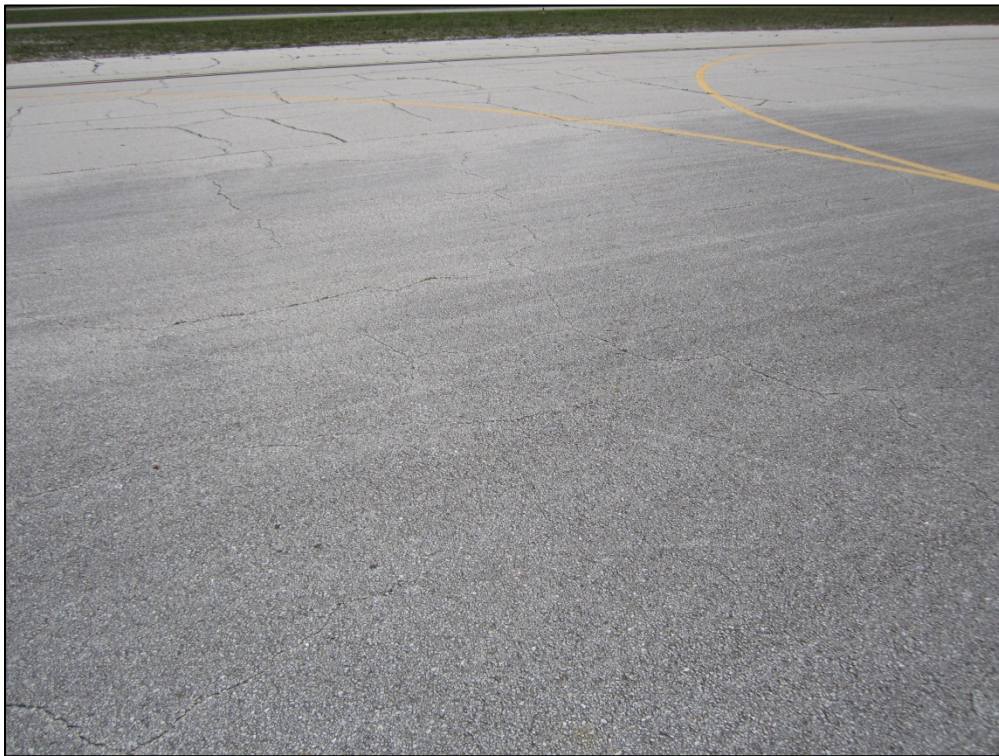
GA Apron, Section 4115, Sample Unit 720 – Low severity (48) Longitudinal and Transverse Cracking, low severity (43) Block Cracking, low severity (52) Weathering and Raveling
