**STATE OF FLORIDA  
DEPARTMENT OF TRANSPORTATION  
AVIATION OFFICE**

**Statewide Airfield Pavement  
Management Program**

**Perry-Foley Airport – 40J  
(General Aviation)  
Perry, Florida  
(District 2)**

**May 2011**

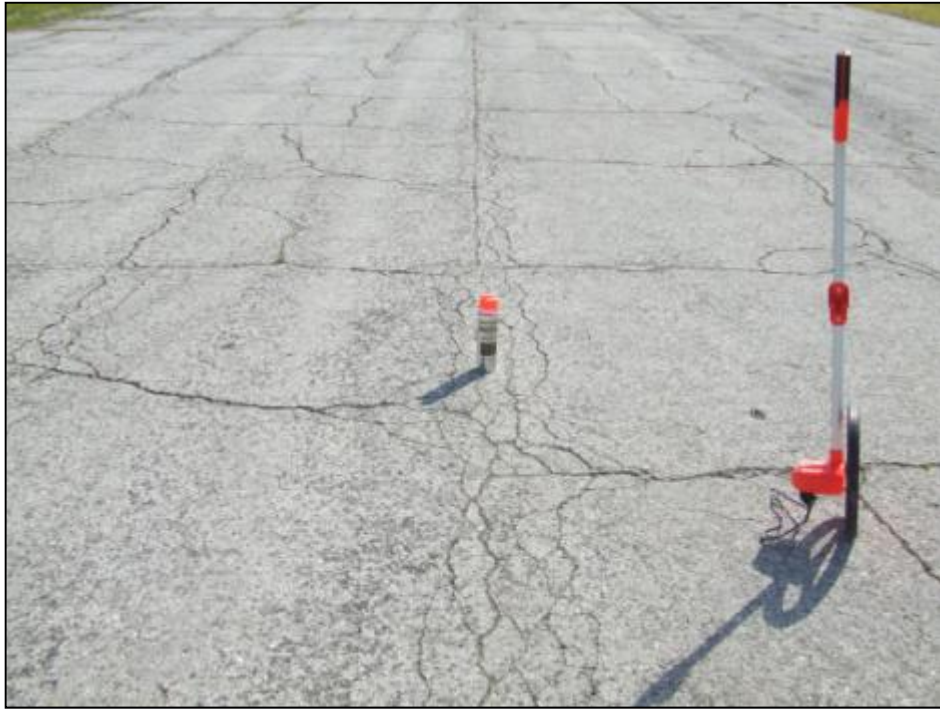
Taxiway Bravo, Section 705, Sample Unit 101 – Medium severity (41) Alligator Cracking; medium severity (43) Block Cracking; low severity (45) Depression; low, medium and high severity (52) Weathering and Raveling.

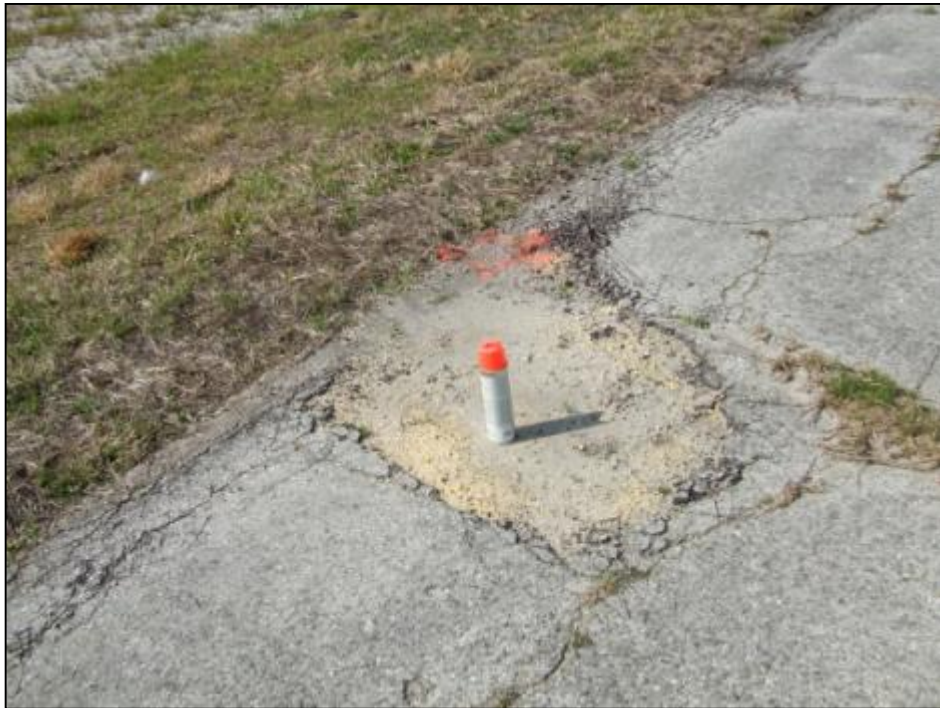
Taxiway Bravo, Section 705, Sample Unit 105 – Medium severity (41) Alligator Cracking, low and medium severity (43) Block Cracking, low and medium severity (50) Patching, medium and high severity (52) Weathering and Raveling, low severity (56) Swelling.

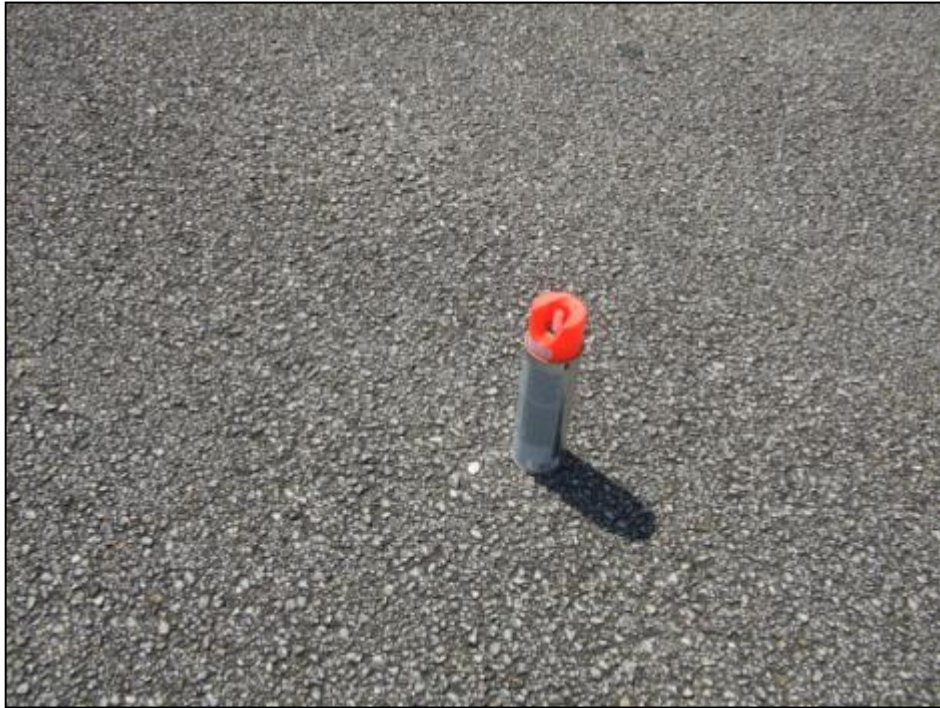
Taxiway Bravo, Section 2003, Sample Unit 100 – Low severity (48) Longitudinal and Transverse Cracking, low severity (50) Patching, low severity (52) Weathering and Raveling, low severity (56) Swelling.

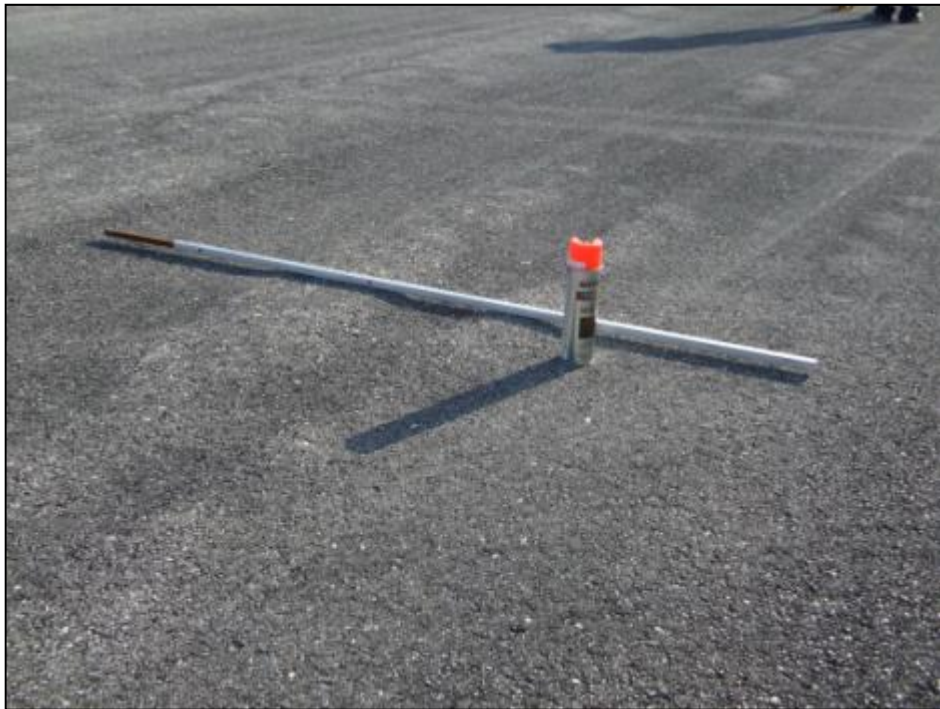
Runway 9-27, Section 6105, Sample Unit 105 – Low severity (48) Longitudinal and Transverse Cracking, low severity (52) Weathering and Raveling, low severity (56) Swelling.

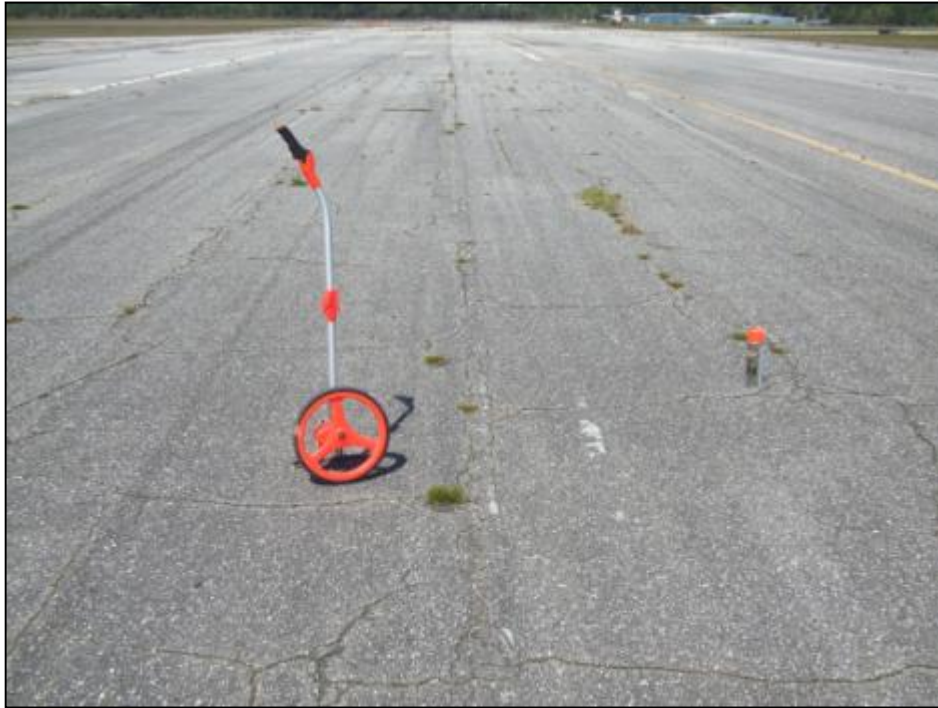
Runway 12-30, Section 6315, Sample Unit 143 – Low severity (41) Alligator Cracking, low and medium severity (43) Block Cracking, low severity (50) Patching, low and medium severity (52) Weathering and Raveling.

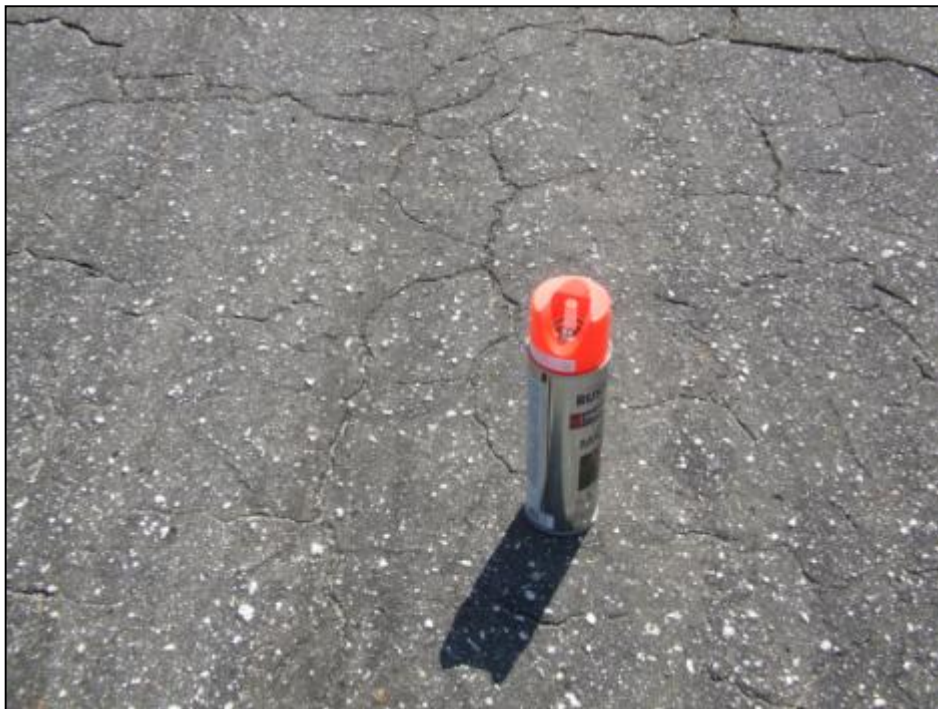
Runway 12-30, Section 6315, Sample Unit 143 – Low severity (41) Alligator Cracking, low and medium severity (43) Block Cracking, low severity (50) Patching, low and medium severity (52) Weathering and Raveling.

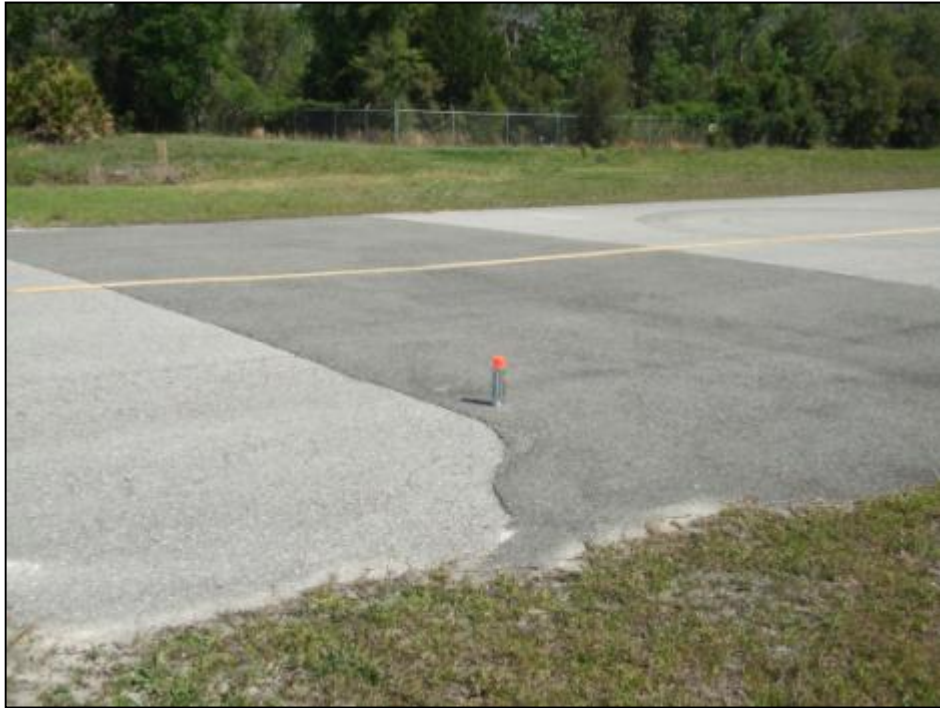
Taxiway Charlie, Section 310, Sample Unit 115 – Low severity (48) Longitudinal and Transverse Cracking, low severity (50) Patching, low and medium severity (52) Weathering and Raveling.

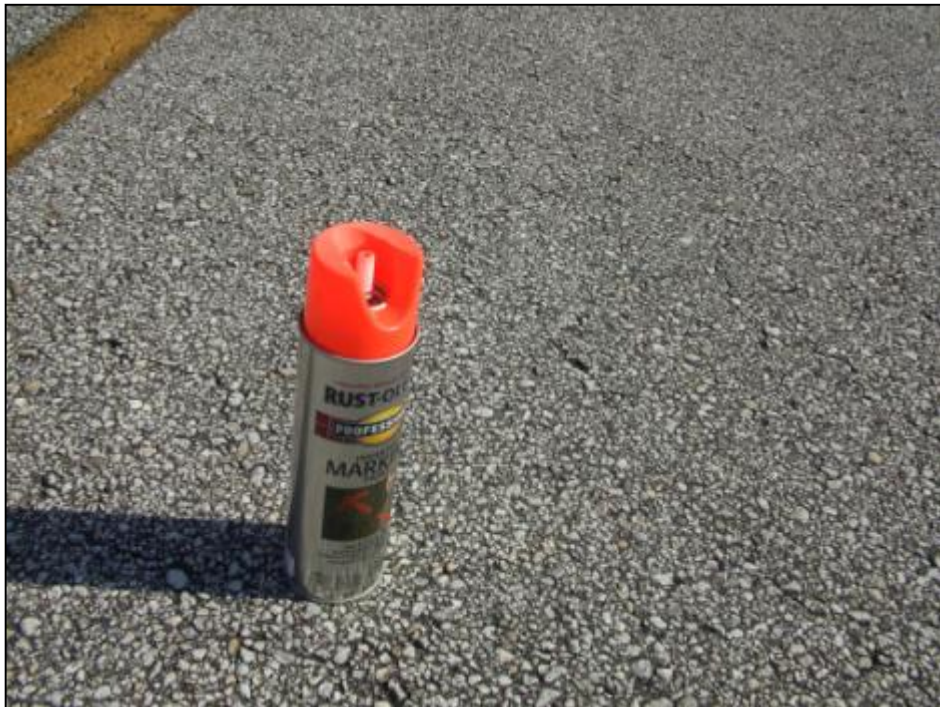
Taxiway Charlie, Section 305, Sample Unit 106 – Low severity (48) Longitudinal and Transverse Cracking, low severity (50) Patching, low and medium severity (52) Weathering and Raveling, low severity (56) Swelling.
