**STATE OF FLORIDA
DEPARTMENT OF TRANSPORTATION
AVIATION OFFICE**

**Statewide Airfield Pavement
Management Program**

**Peter Prince Field– 2R4
(General Aviation)
Milton, Florida
(District 3)**

May 2011

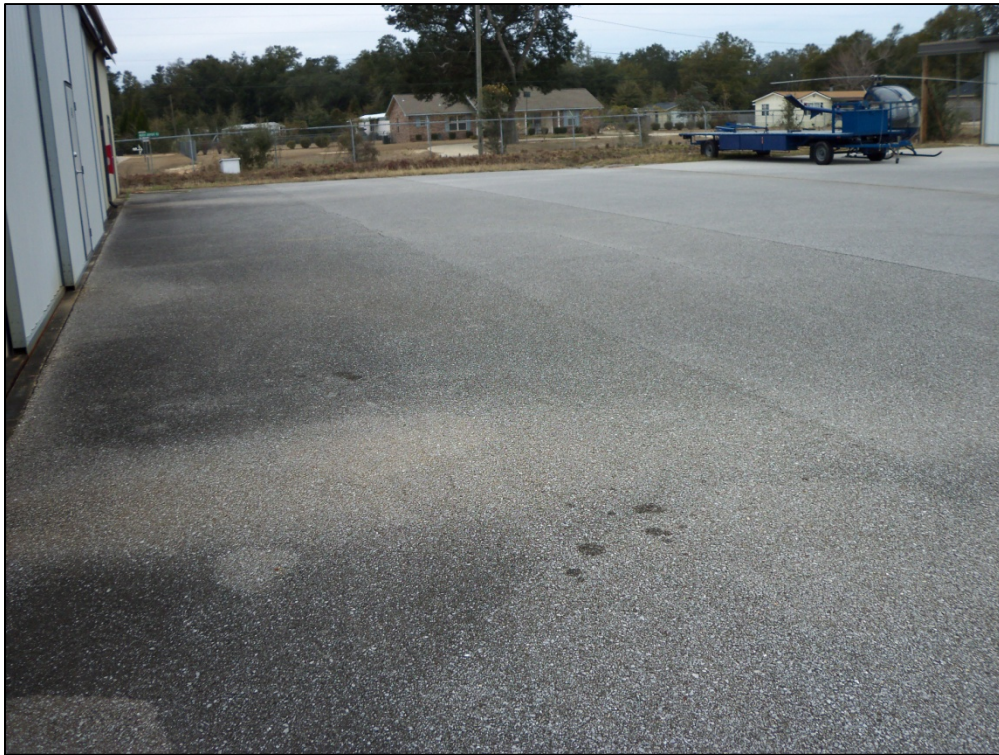
Hangars, Section 4125, Sample Unit 500 – Low severity (48) Longitudinal and Transverse Cracking, low severity (52) Weathering and Raveling

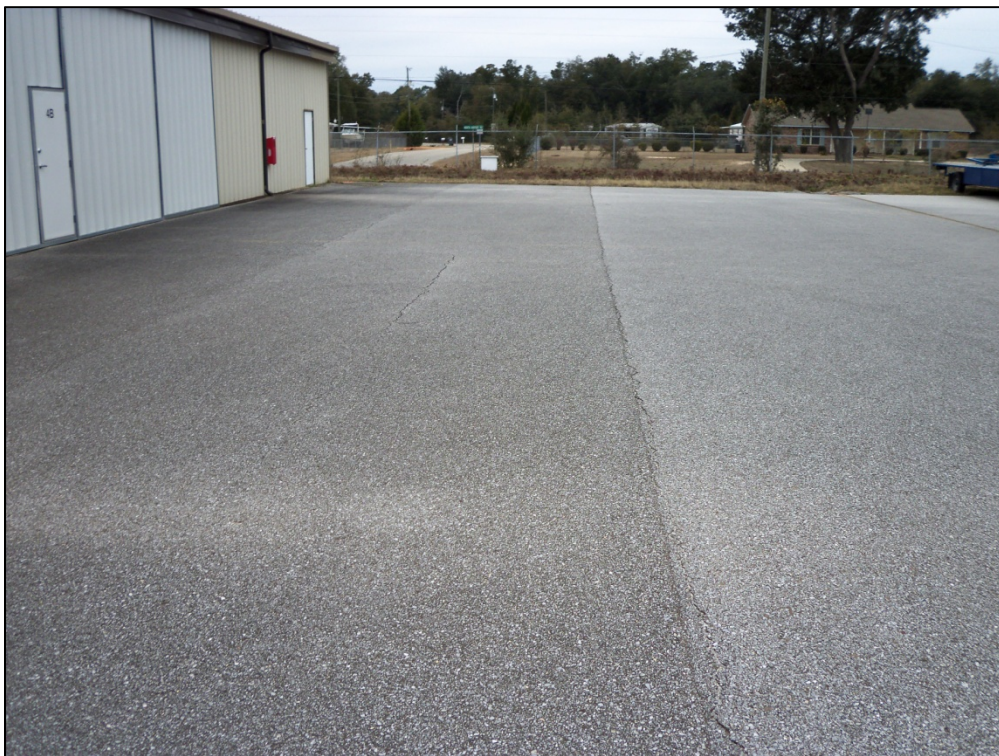
Hangars, Section 4125, Sample Unit 500 – Low severity (48) Longitudinal and Transverse Cracking, low severity (52) Weathering and Raveling

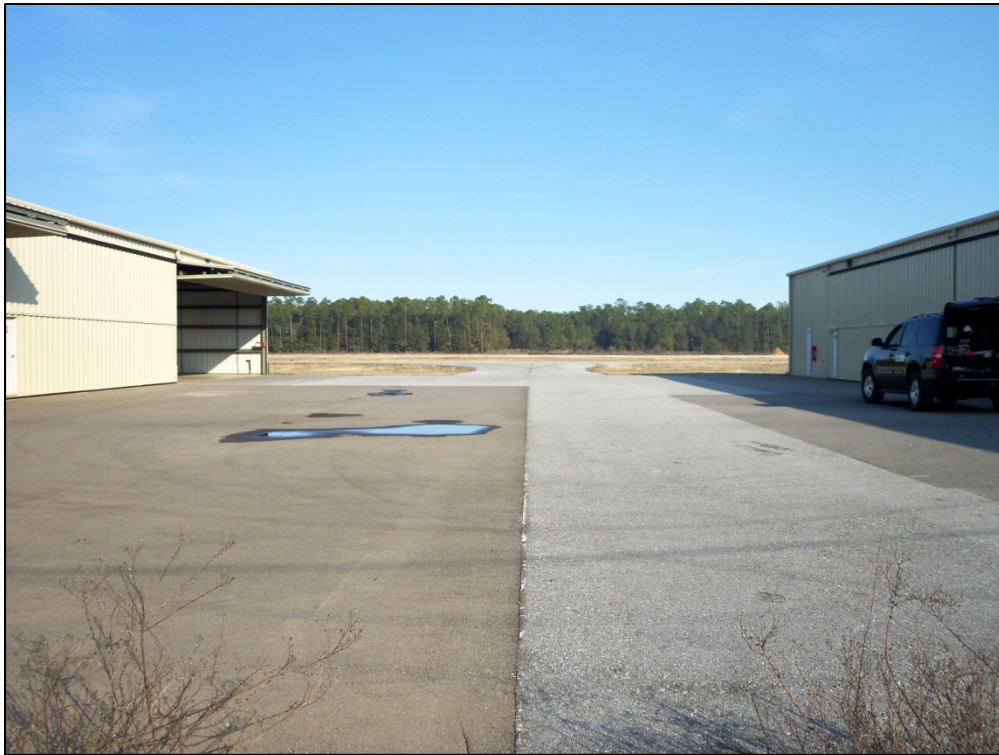
Hangars, Section 4130, Sample Unit 116 – Low severity (48) Longitudinal and Transverse Cracking, low severity (52) Weathering and Raveling

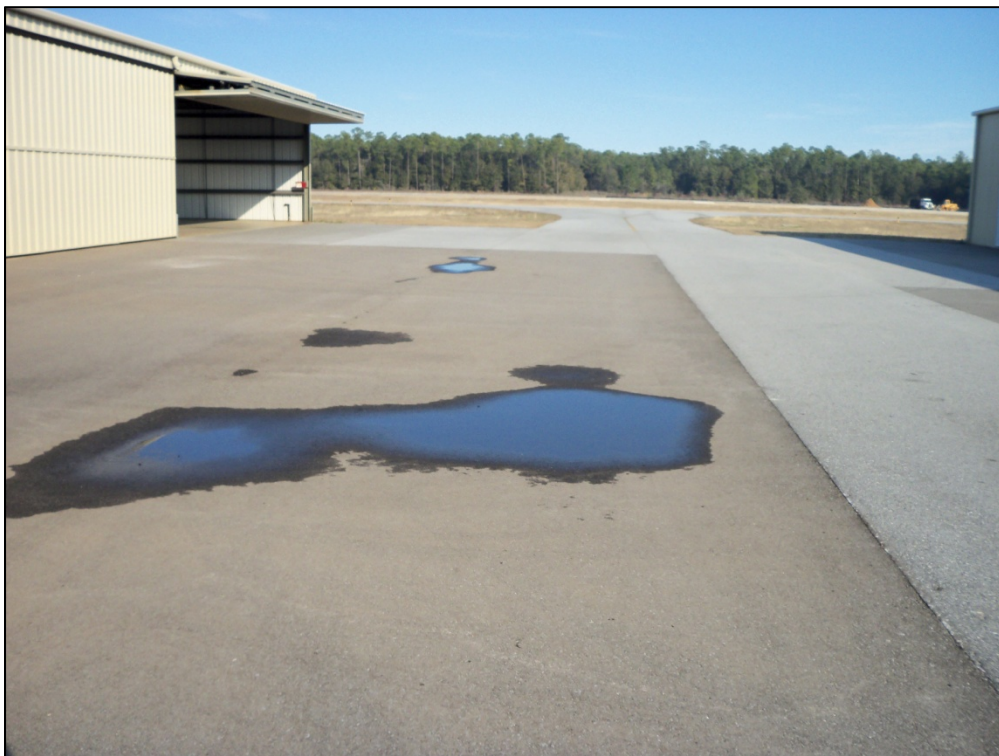
Hangars, Section 4130, Sample Unit 116 – Low severity (48) Longitudinal and Transverse Cracking, low severity (52) Weathering and Raveling

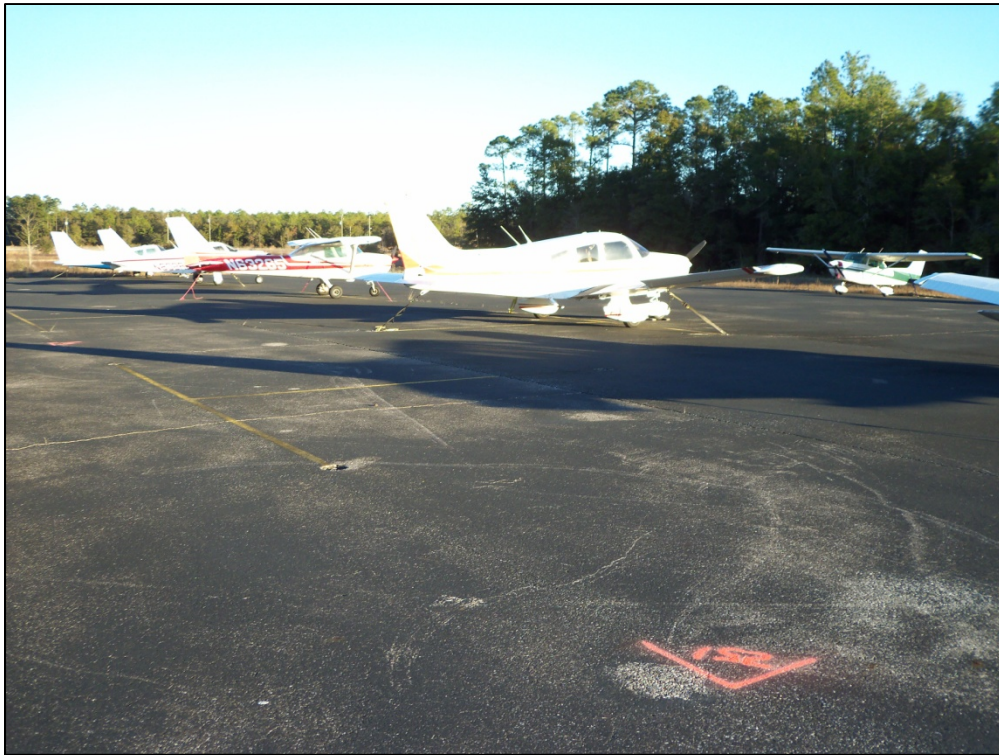
Apron, Section 4205, Sample Unit 251 – Medium severity (43) Block Cracking, high severity (48) Longitudinal and Transverse Cracking, low severity (52) Weathering and Raveling

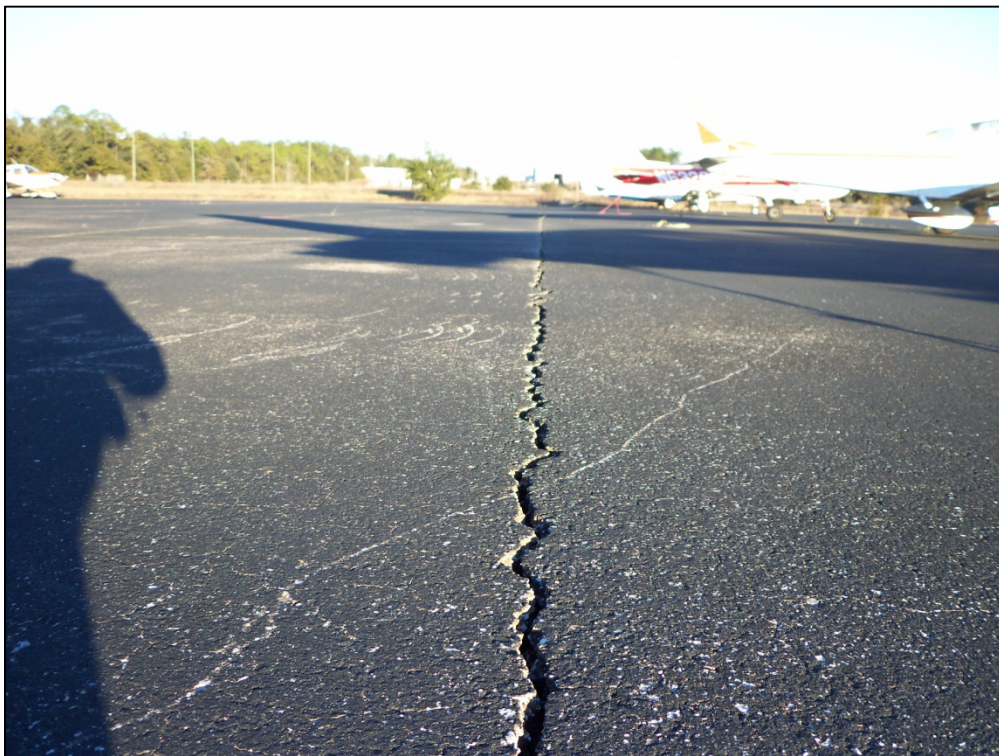
Apron, Section 4205, Sample Unit 251 – Medium severity (43) Block Cracking, high severity (48) Longitudinal and Transverse Cracking, low severity (52) Weathering and Raveling

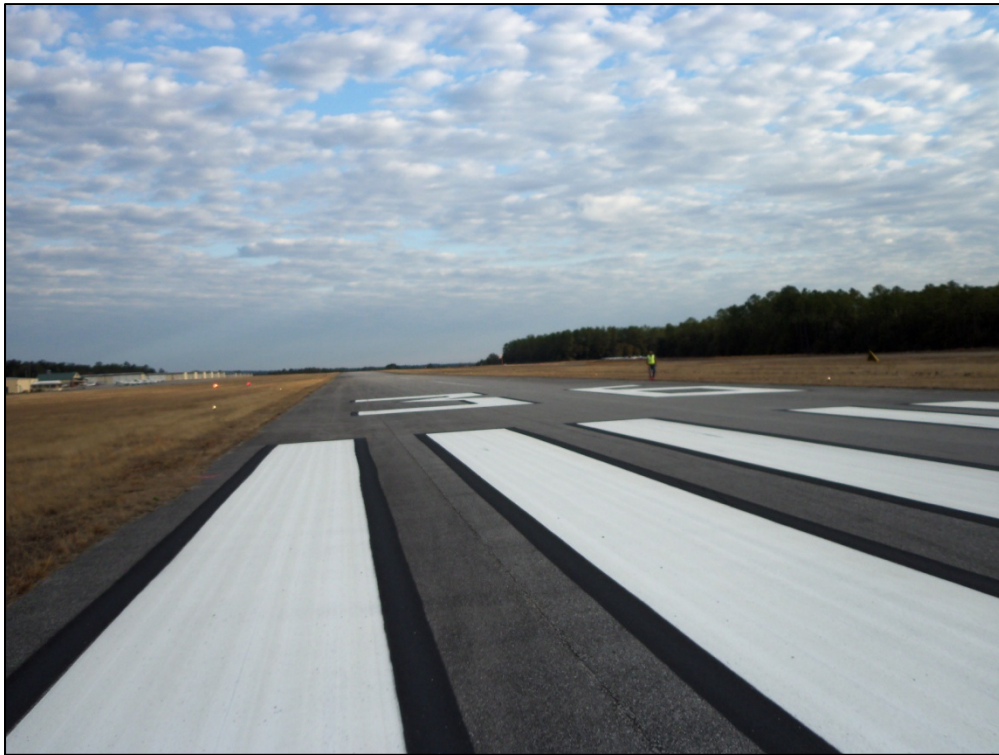
Runway 18-36, Section 6105, Sample Unit 171 – Low and medium severity (48) Longitudinal and Transverse Cracking, low severity (52) Weathering and Raveling

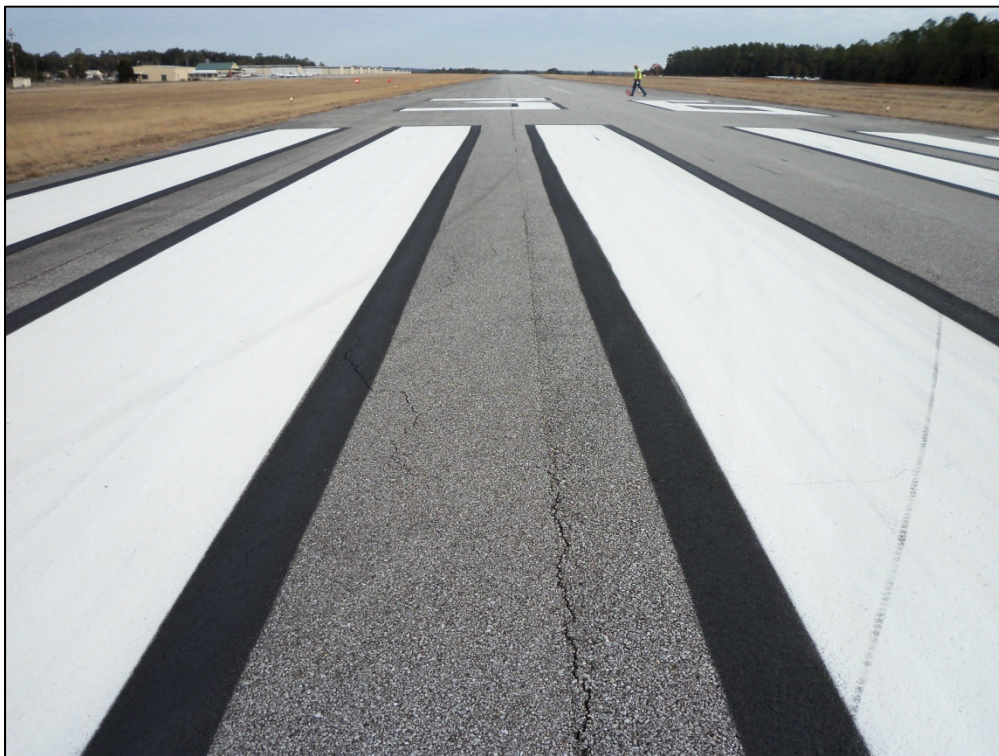
Runway 18-36, Section 6105, Sample Unit 171 – Low and medium severity (48) Longitudinal and Transverse Cracking, low severity (52) Weathering and Raveling

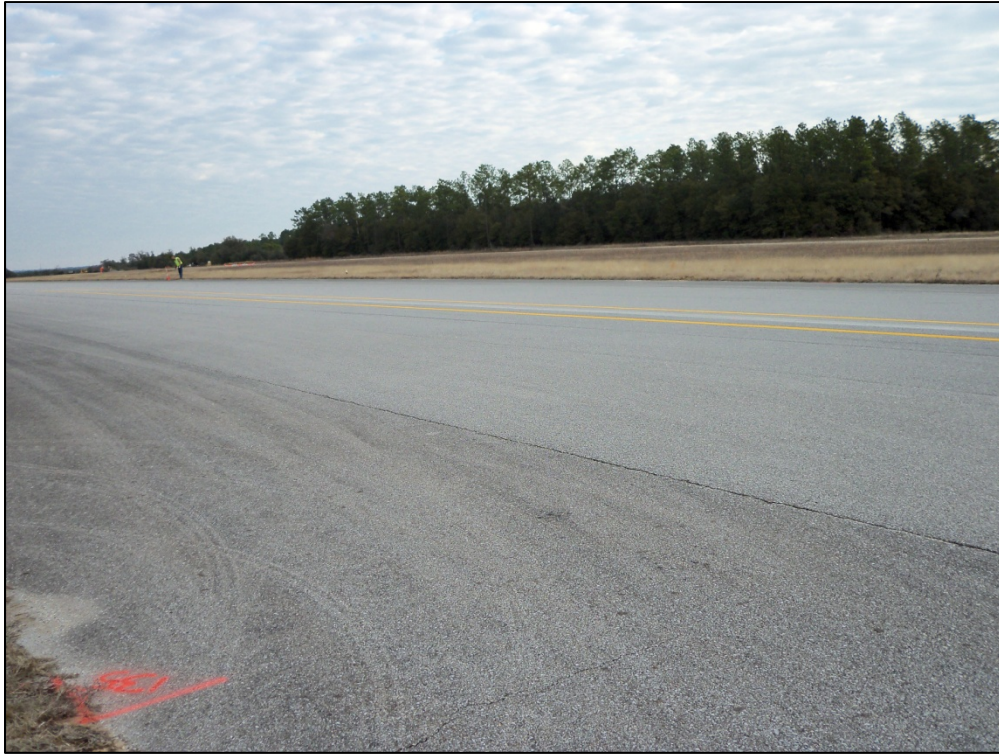
Runway 18-36, Section 6105, Sample Unit 135 – Low severity (48) Longitudinal and Transverse Cracking, low severity (52) Weathering and Raveling

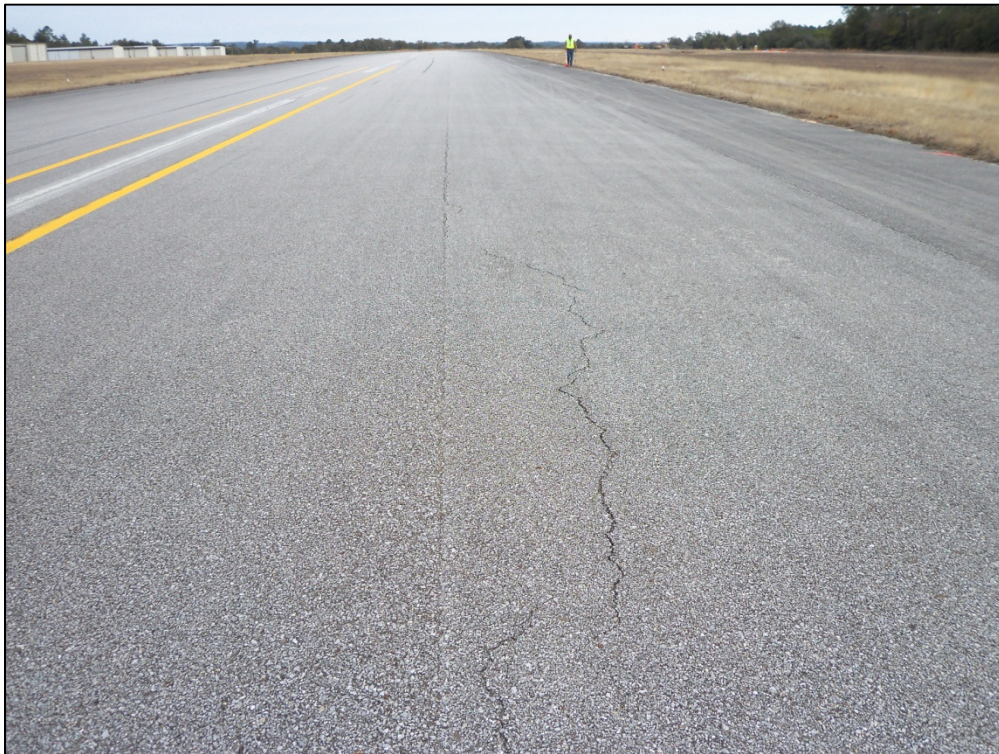
Runway 18-36, Section 6105, Sample Unit 135 – Low severity (48) Longitudinal and Transverse Cracking, low severity (52) Weathering and Raveling

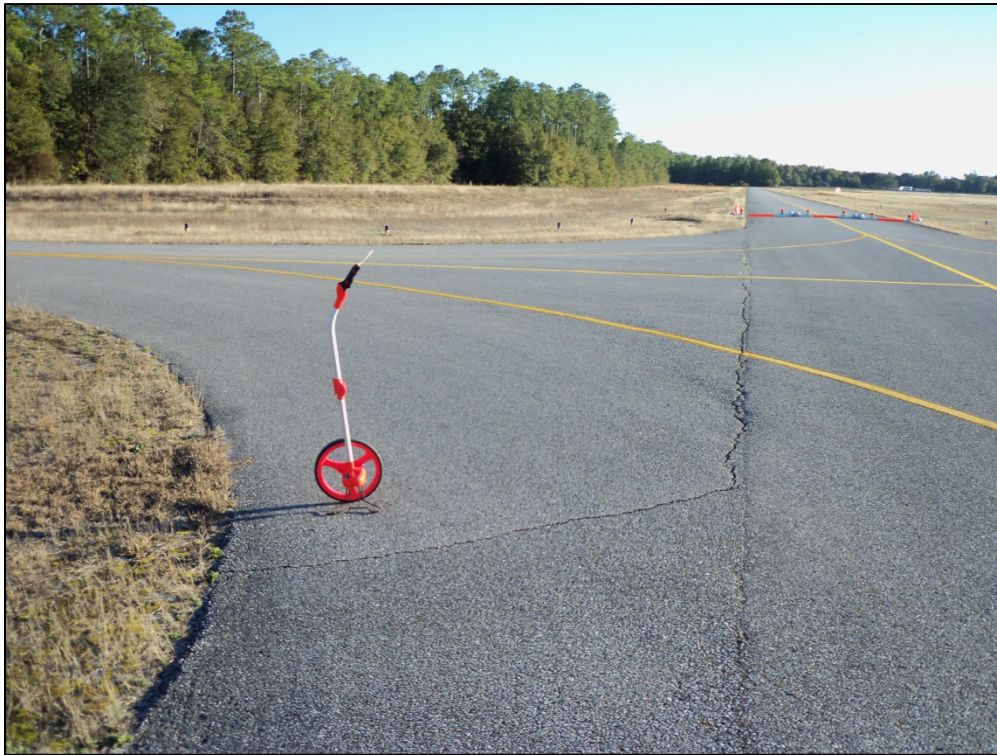
Taxiway Connector, Section 250, Sample Unit 200 – Low, medium and high severity (48) Longitudinal and Transverse Cracking, low severity (52) Weathering and Raveling

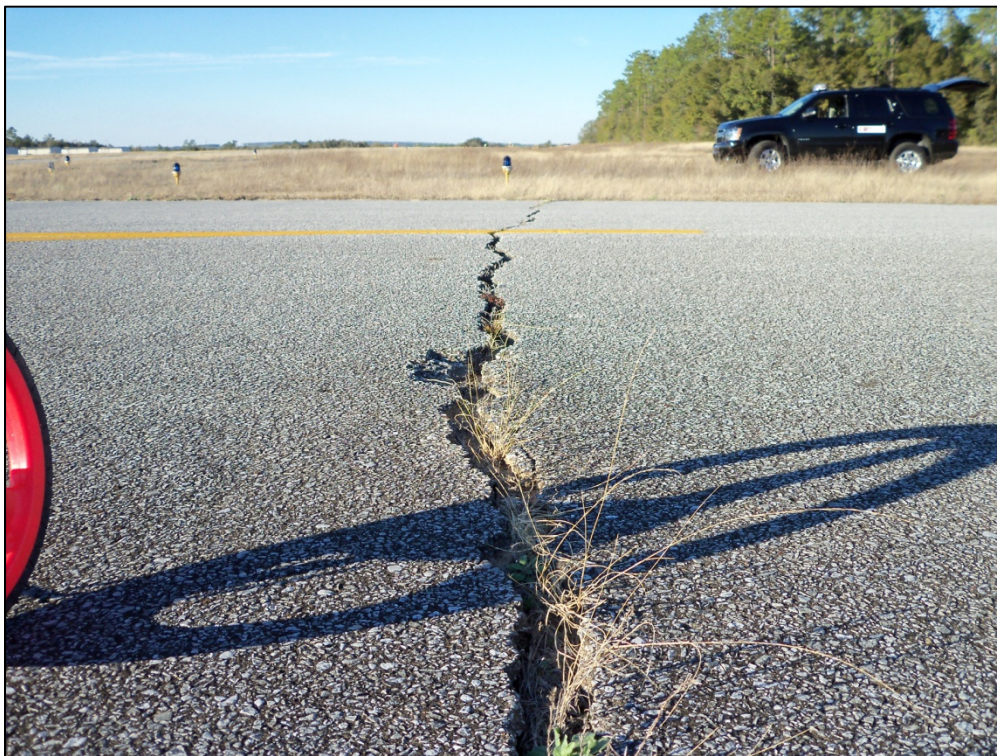
Taxiway Connector, Section 250, Sample Unit 200 – Low, medium and high severity (48) Longitudinal and Transverse Cracking, low severity (52) Weathering and Raveling

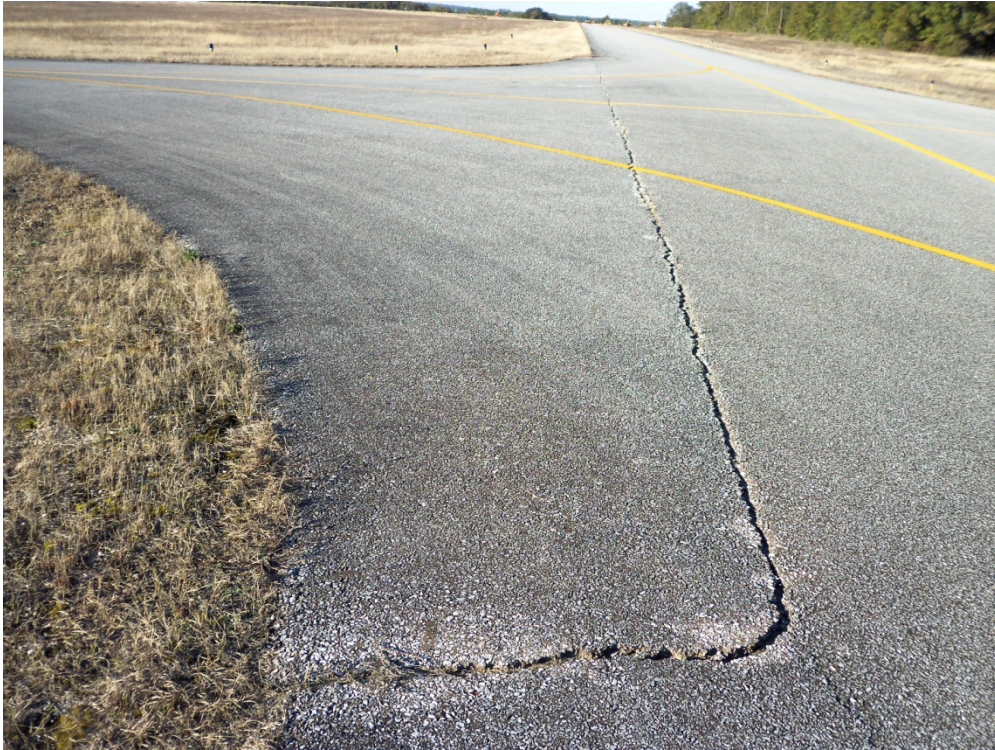
Taxiway B-3, Section 210, Sample Unit 200 – Medium and high severity (48) Longitudinal and Transverse Cracking, low severity (52) Weathering and Raveling

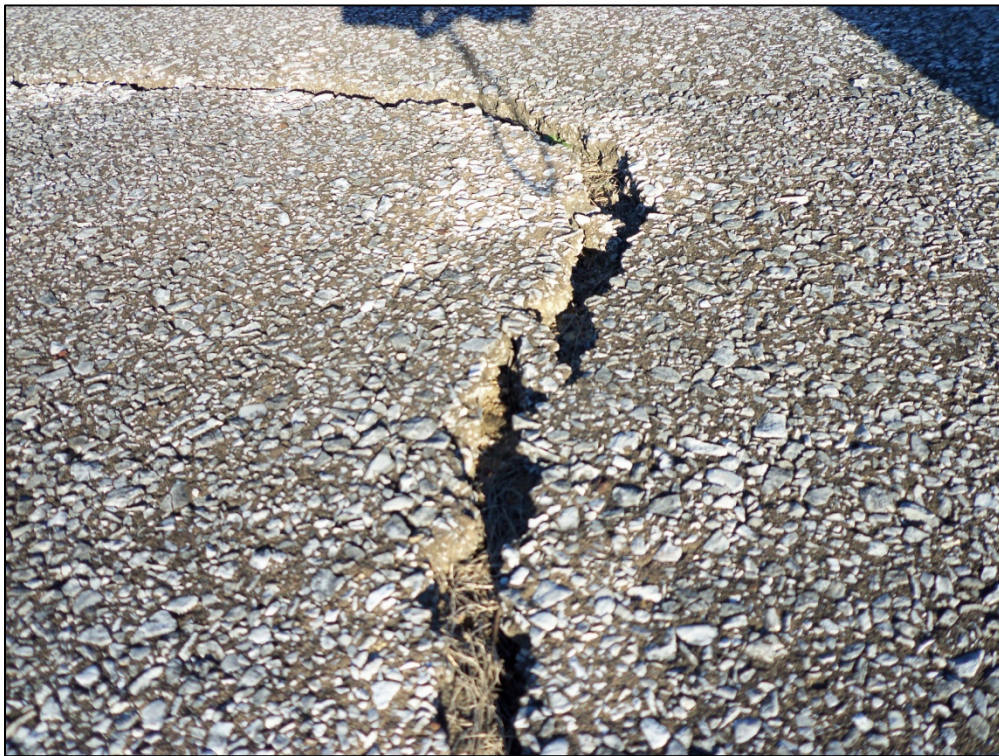
Taxiway B-3, Section 210, Sample Unit 200 – Medium and high severity (48) Longitudinal and Transverse Cracking, low severity (52) Weathering and Raveling
