**STATE OF FLORIDA
DEPARTMENT OF TRANSPORTATION
AVIATION OFFICE**

**Statewide Airfield Pavement
Management Program**

**Plant City Airport– PCM
(General Aviation)
Tampa, Florida
(District 7)**

January 2012

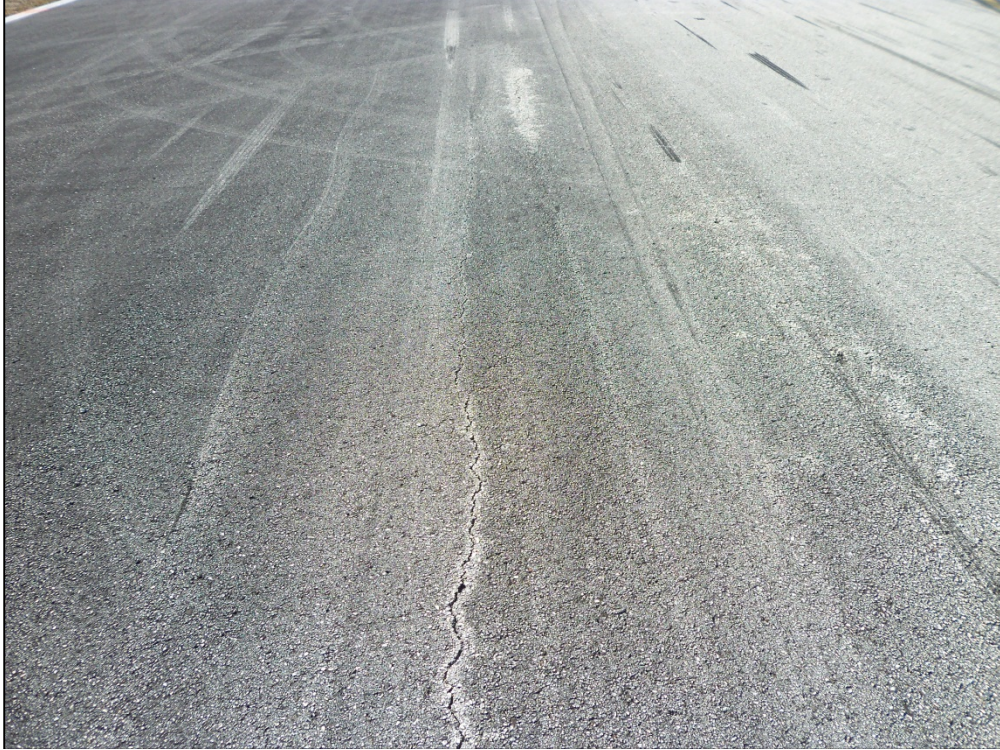
The pavement on Runway 10-28 exhibited low and medium severity longitudinal/transverse cracking, low and medium severity weathering/raveling and low severity swelling. These distresses are mostly attributed to the climate and age of the pavement.

Runway 10-28, Section 6120, Sample Unit 362 – Low severity (48) Longitudinal and Transverse Cracking, (52) Raveling and Weathering

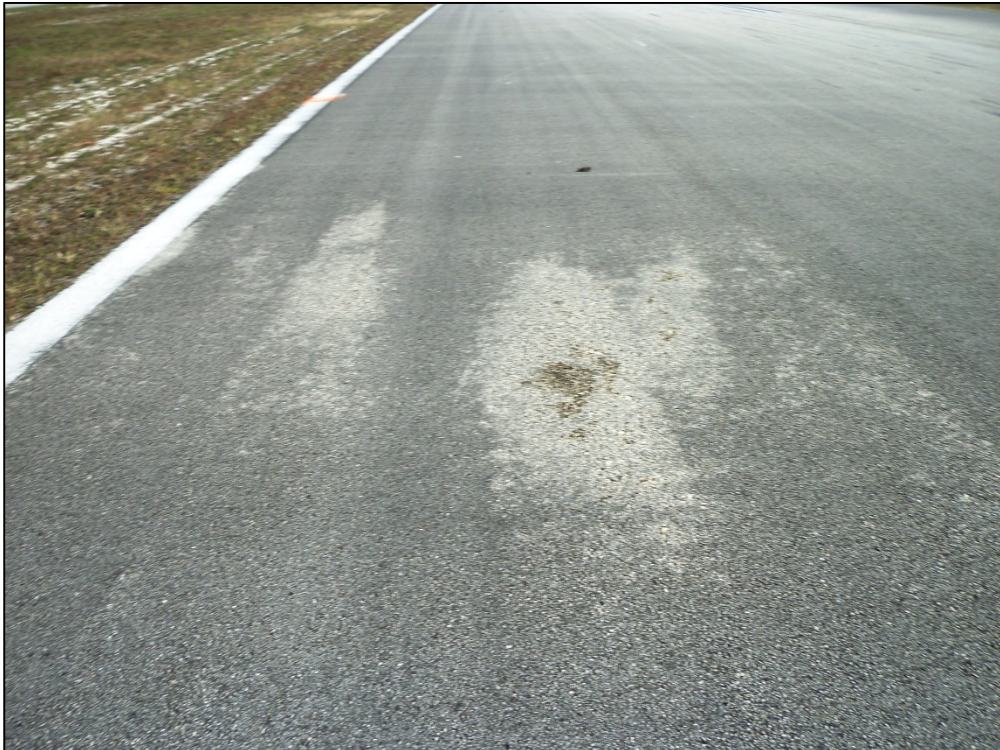
Runway 10-28, Section 6115, Sample Unit 316 – Low severity (52) Raveling and Weathering

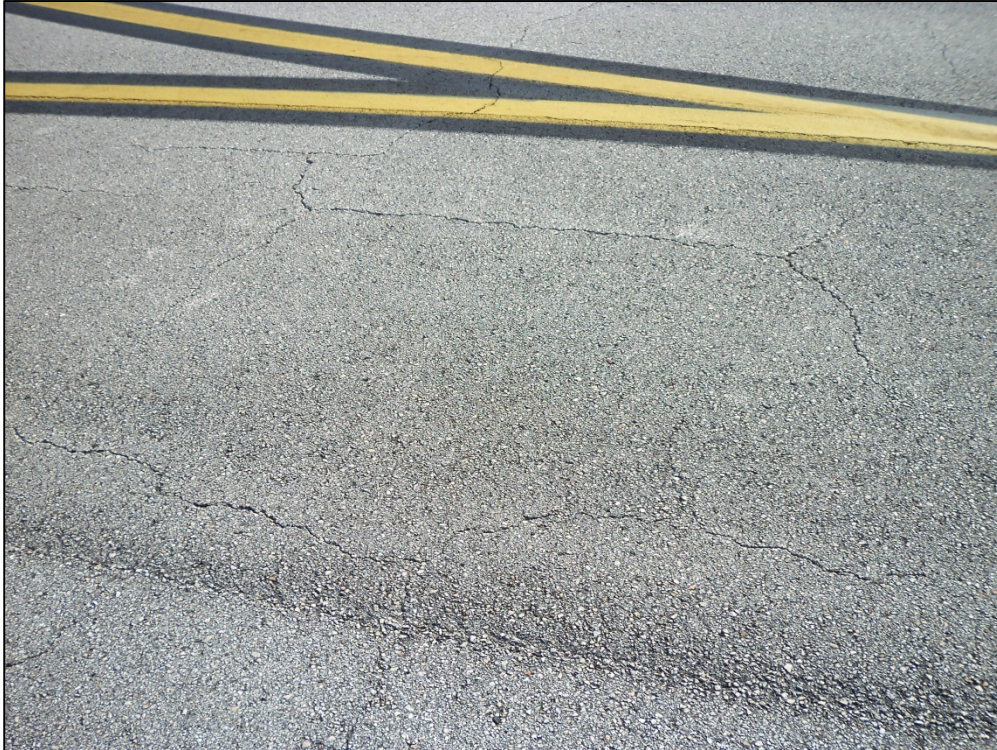
Taxiway A pavements exhibited low severity block cracking, low and medium severity weathering/raveling, low severity patching and low severity longitudinal/transverse cracking. These are climate and age related distresses. Taxiway A connectors exhibited low and medium severity longitudinal/transverse cracking and low and medium severity weathering/raveling. The west apron connector was in Very Poor condition. These are climate and age related distresses.

Taxiway Alpha, Section 110, Sample Unit 130 – Low severity (43) Block Cracking, (48) Longitudinal and Transverse Cracking, (52) Raveling and Weathering

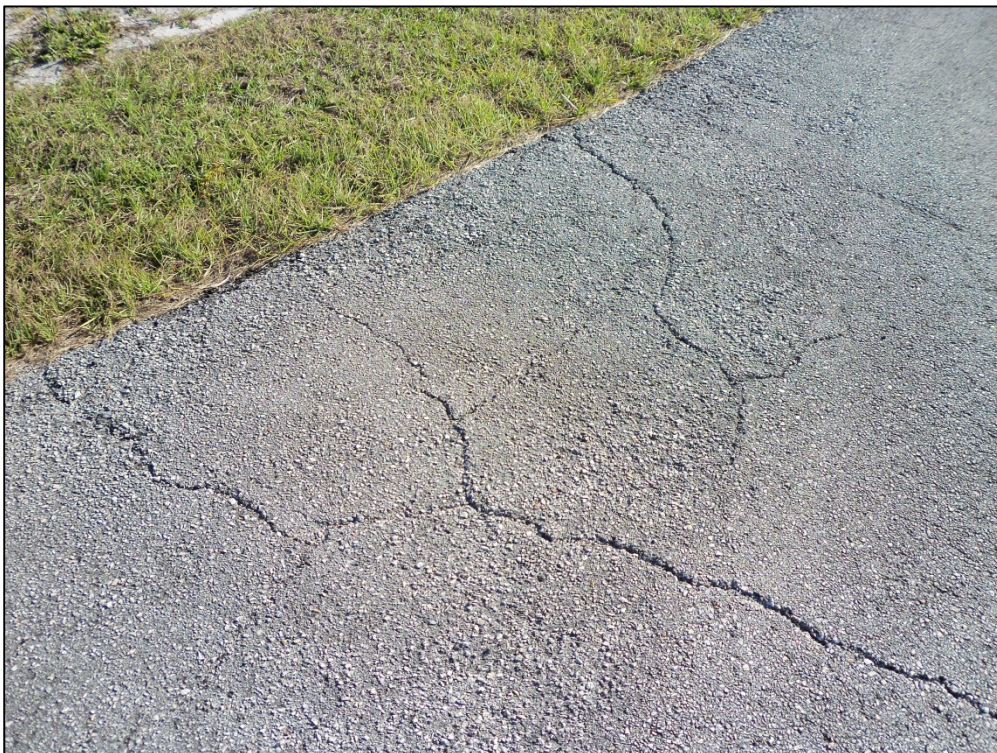
Taxiway Connector Alpha, Section 170, Sample Unit 400 – Low severity (48) Longitudinal and Transverse Cracking, (52) Raveling and Weathering

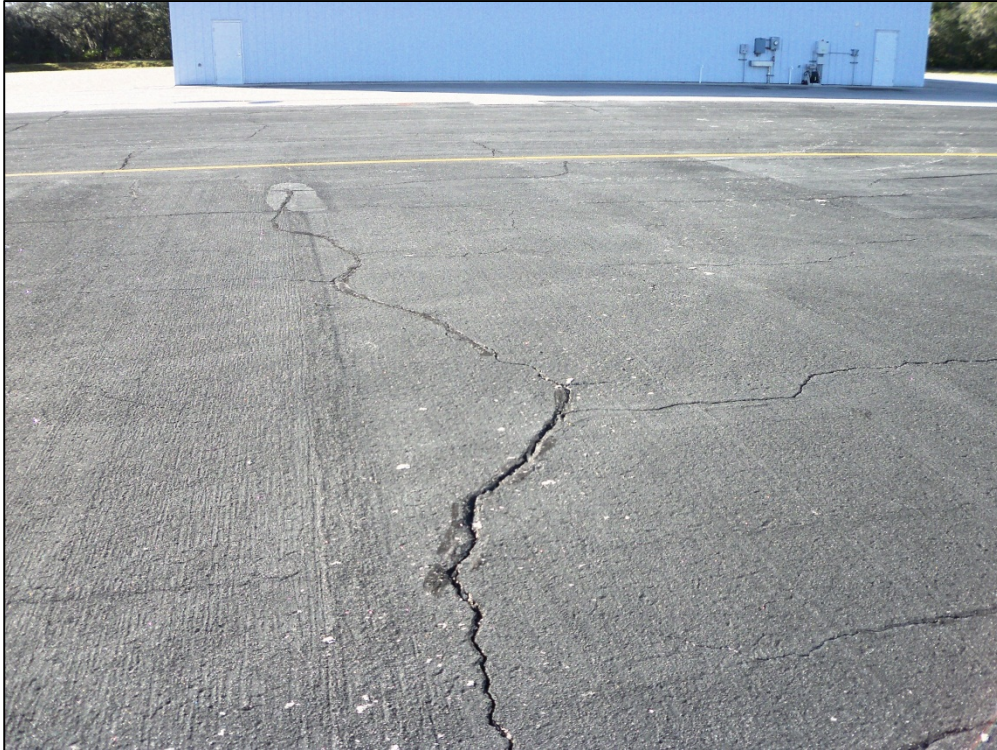
Apron, Section 4105, Sample Unit 300 – Low severity (43) Block Cracking, (52) Raveling and Weathering

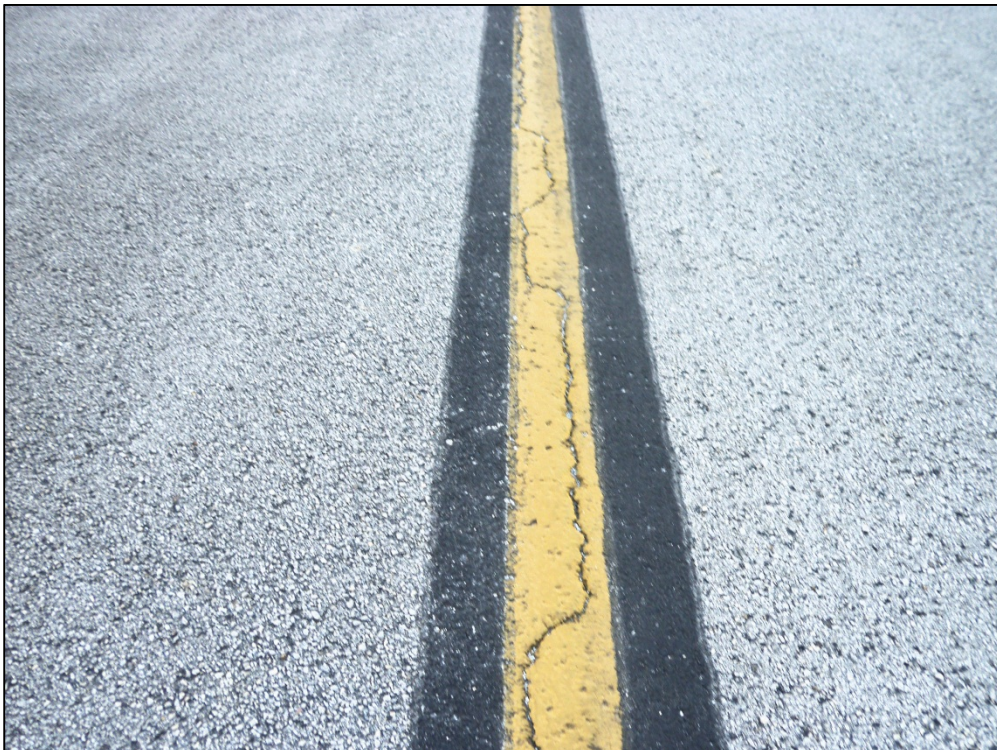
Taxiway T-Hangar, Section 710, Sample Unit 200 – Low severity (48) Longitudinal and Transverse Cracking, (52) Raveling and Weathering
