**STATE OF FLORIDA  
DEPARTMENT OF TRANSPORTATION  
AVIATION OFFICE**

**Statewide Airfield Pavement  
Management Program**

**Sebastian Municipal Airport– X26  
(General Aviation)  
Sebastian, Florida  
(District 4)**

**January 2012**

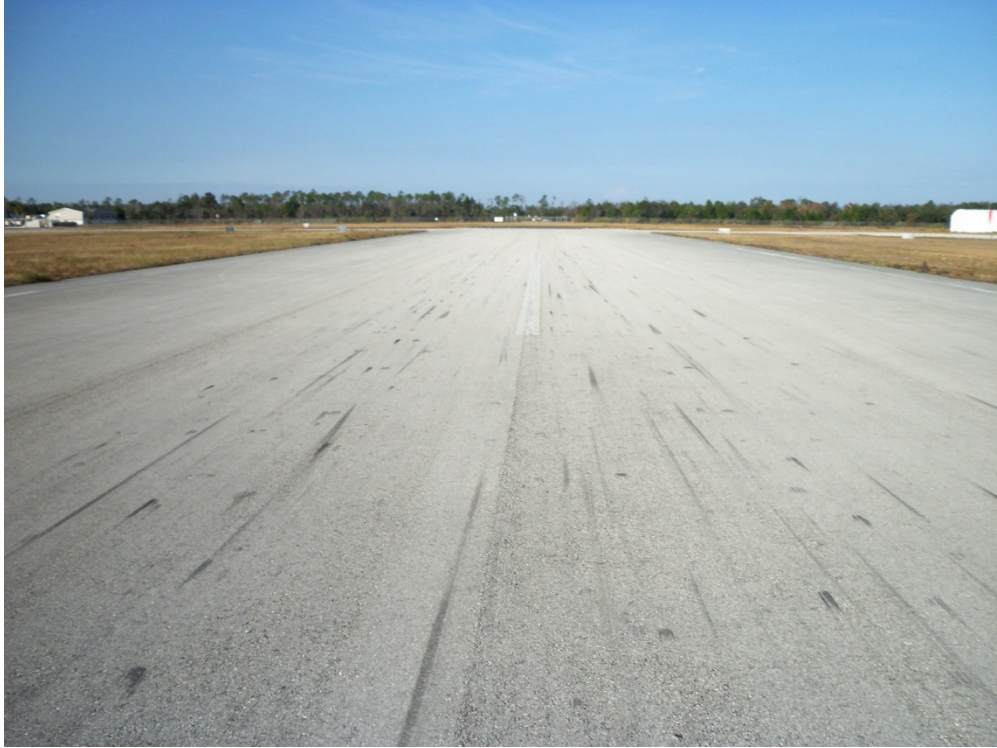
Runway 4-22 exhibited low severity longitudinal/transverse cracking, low and medium severity weathering/raveling and low severity patching. Runway 8-26 exhibited low and high severity weathering/raveling and low severity longitudinal/transverse cracking. These are age and climate related distresses.

Runway 8-26, Section 6305, Sample Unit 504 – Low severity (48) Longitudinal and Transverse Cracking, low severity (52) Weathering and Raveling

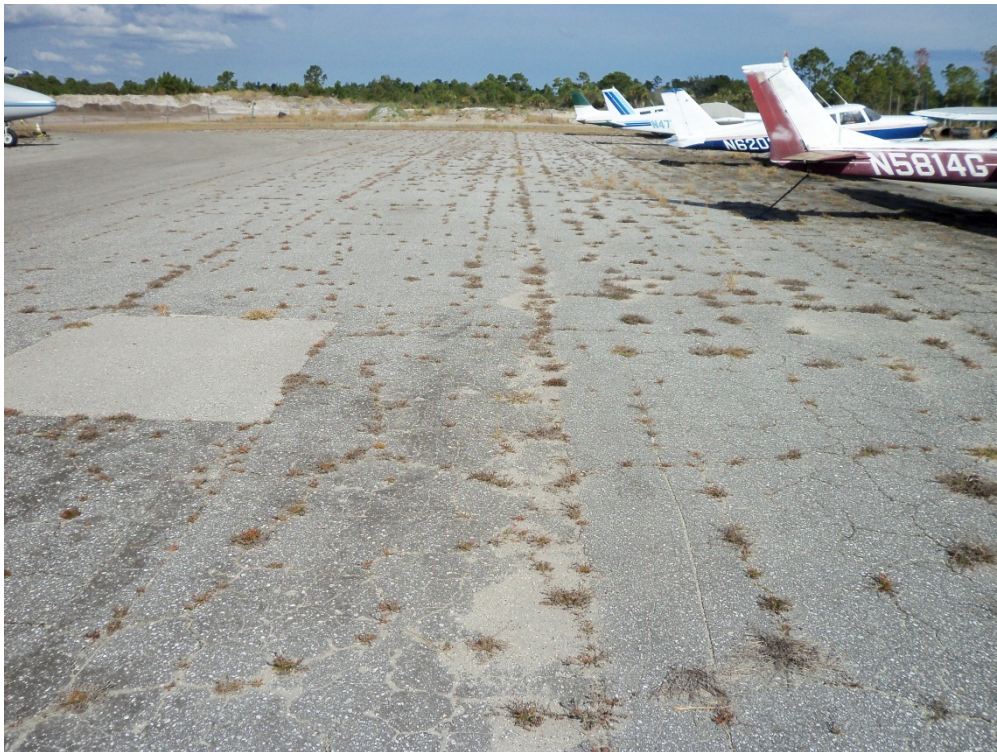
Taxiway C and the northern areas of the West Apron exhibited low, medium and high severity weathering/raveling, low and medium severity block cracking, medium severity alligator cracking and low and medium severity patching. These pavements were by far the oldest on the airport and the stresses were indicative of their age.

West Apron, Section 410, Sample Unit 435 – Medium severity (43) Block Cracking, low severity (52) Weathering and Raveling, low severity (50) patching

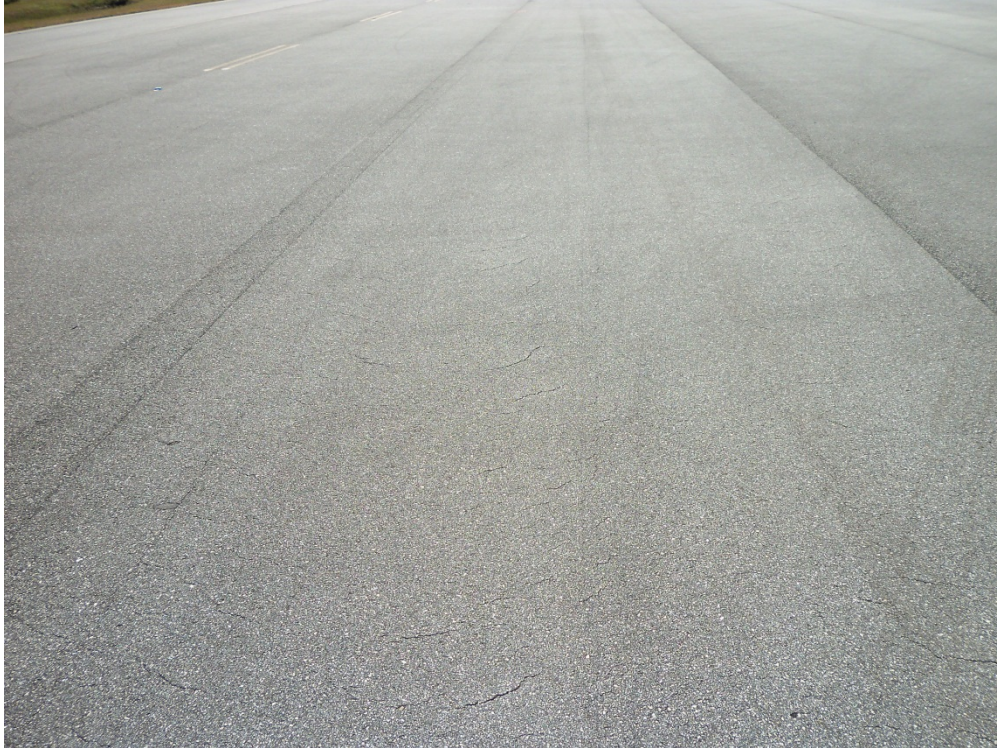
West Apron, Section 5105, Sample Unit 431 – Low severity (48) Longitudinal and Transverse Cracking

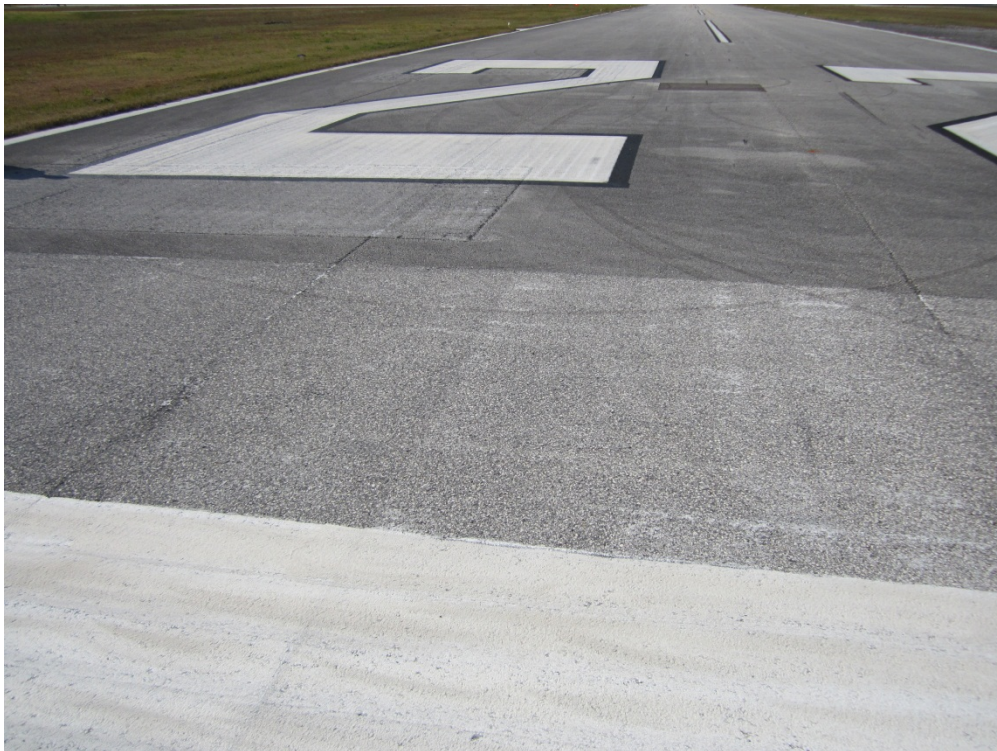
Runway 4-22, Section 6205, Sample Unit 379 – Low and medium severity (52) Weathering and Raveling, low severity (50) patching, low severity (48) Longitudinal and Transverse Cracking

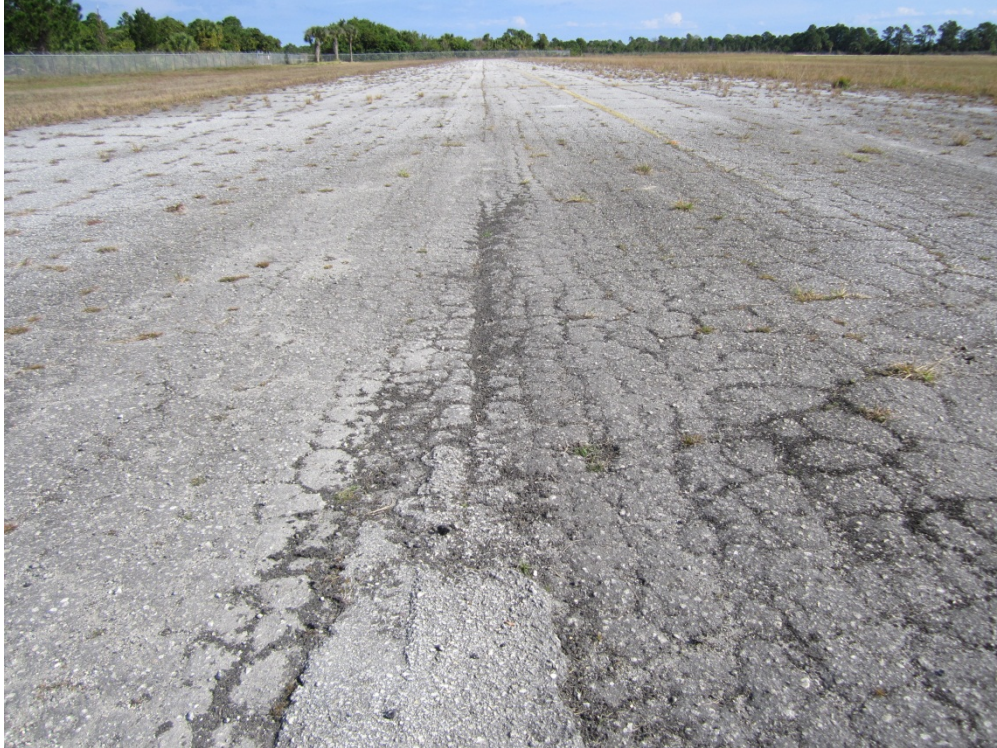
Taxiway C, Section 305, Sample Unit 300 – Medium severity (52) Weathering and Raveling, medium severity (41) Alligator Cracking, medium severity (43) Block Cracking
