**STATE OF FLORIDA
DEPARTMENT OF TRANSPORTATION
AVIATION OFFICE**

**Statewide Airfield Pavement
Management Program**

**Sebring Regional Airport– SEF
(General Aviation)
Sebring, Florida
(District 1)**

May 2012

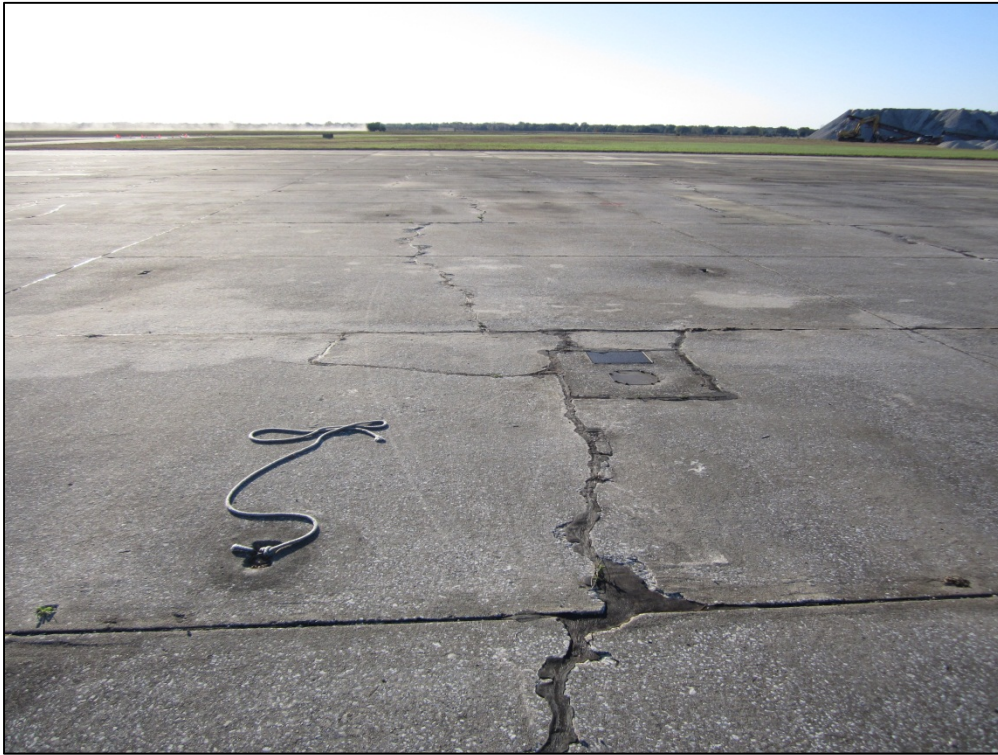
West Apron, Section 4105, Sample Unit 505 – Low severity (65) Joint Seal Damage; high severity (63) Longitudinal, Transverse, and Diagonal Cracking

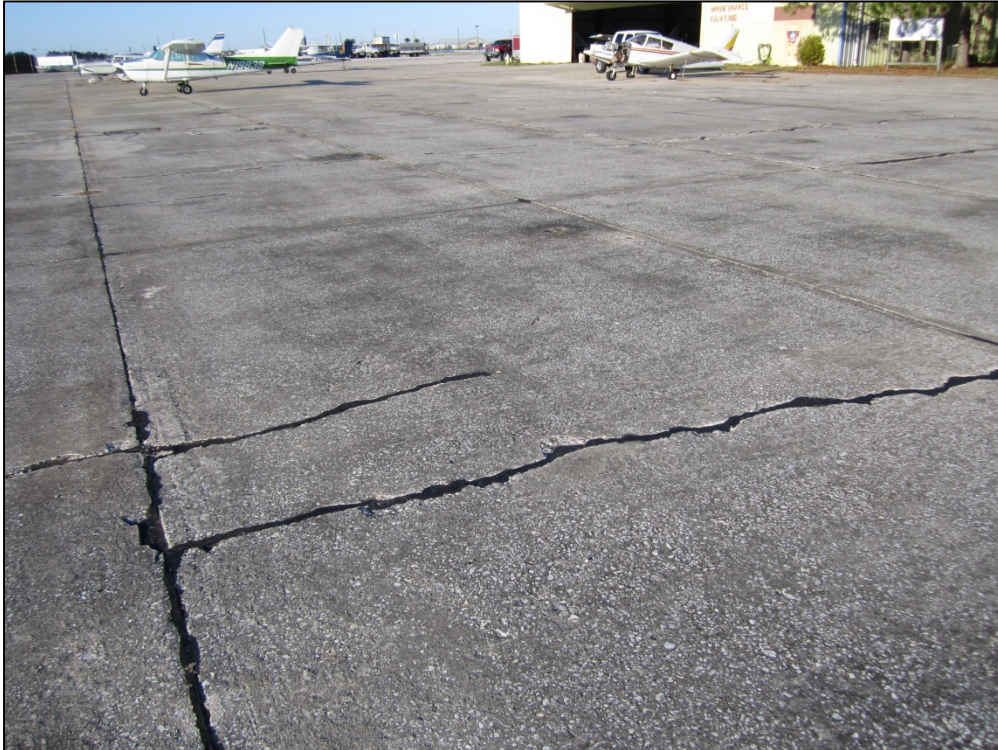
West Apron, Section 4105, Sample Unit 505 – Low severity (65) Joint Seal Damage; high severity (63) Longitudinal, Transverse, and Diagonal Cracking; (73) Shrinkage Cracking

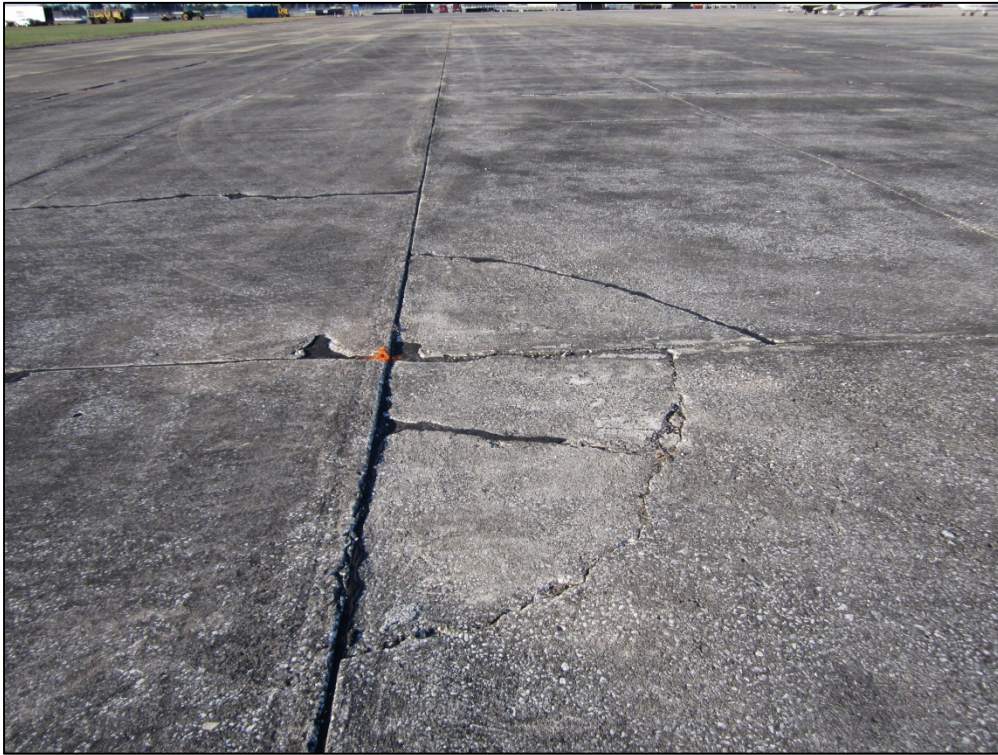
West Apron, Section 4105, Sample Unit 206 – Low severity (65) Joint Seal Damage; high severity (63) Longitudinal, Transverse, and Diagonal Cracking; medium and high severity (62) Corner Break; low severity (74) Joint Spalling

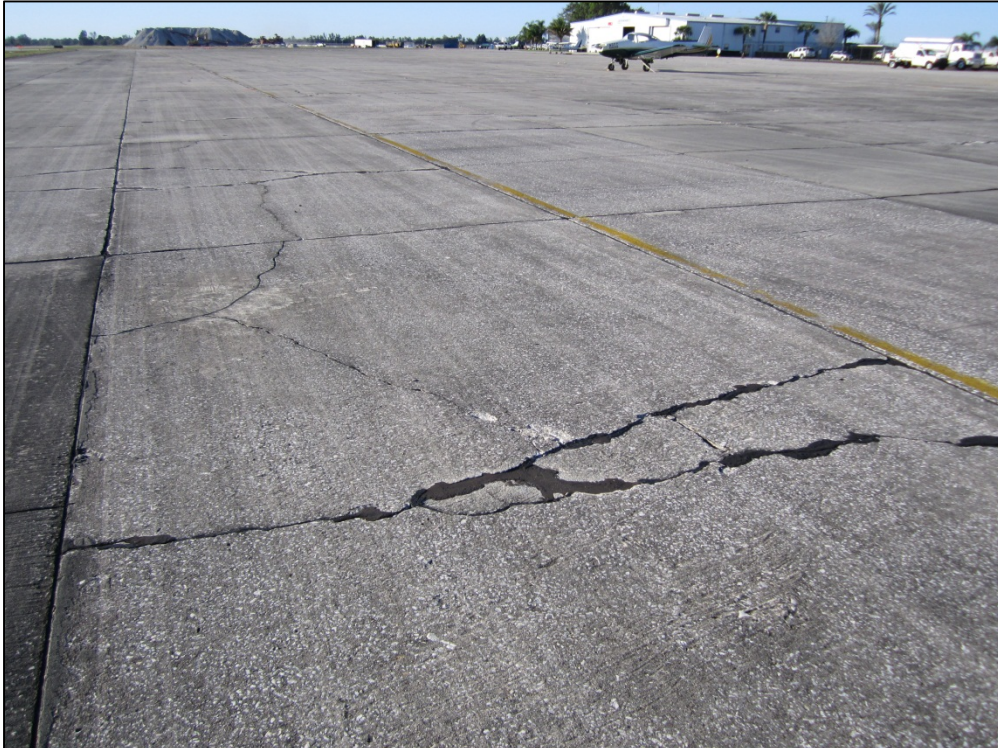
West Apron, Section 4105, Sample Unit 114 – Low severity (65) Joint Seal Damage; high severity (72) Shattered Slab

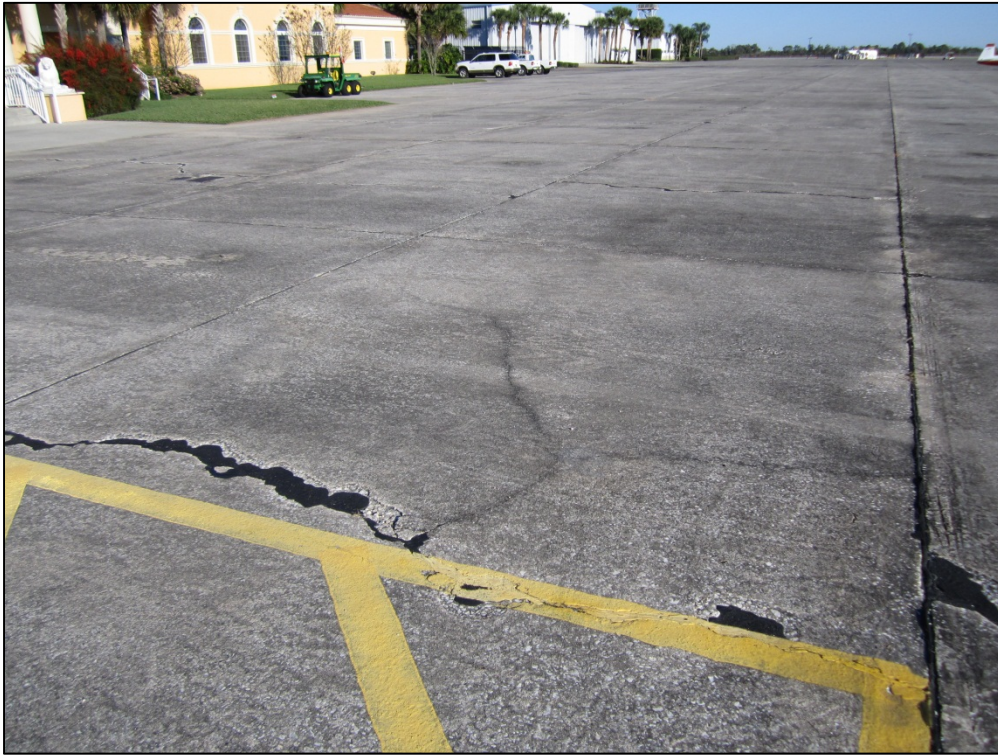
West Apron, Section 4105, Sample Unit 414 – Low severity (65) Joint Seal Damage; high severity (63) Longitudinal, Transverse, and Diagonal Cracking; low severity (75) Corner Spalling

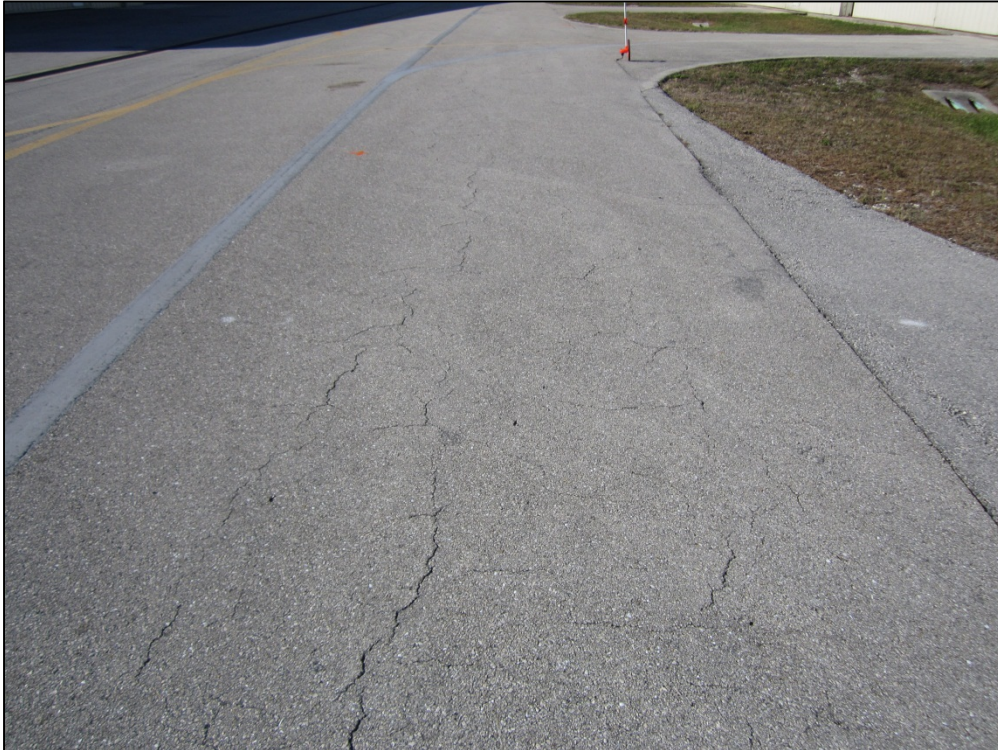
T-Hangars Taxiway, Section 505, Sample Unit 100 – Low severity (48) Longitudinal and Transverse Cracking, low severity (43) Block Cracking, low severity (56) Swelling

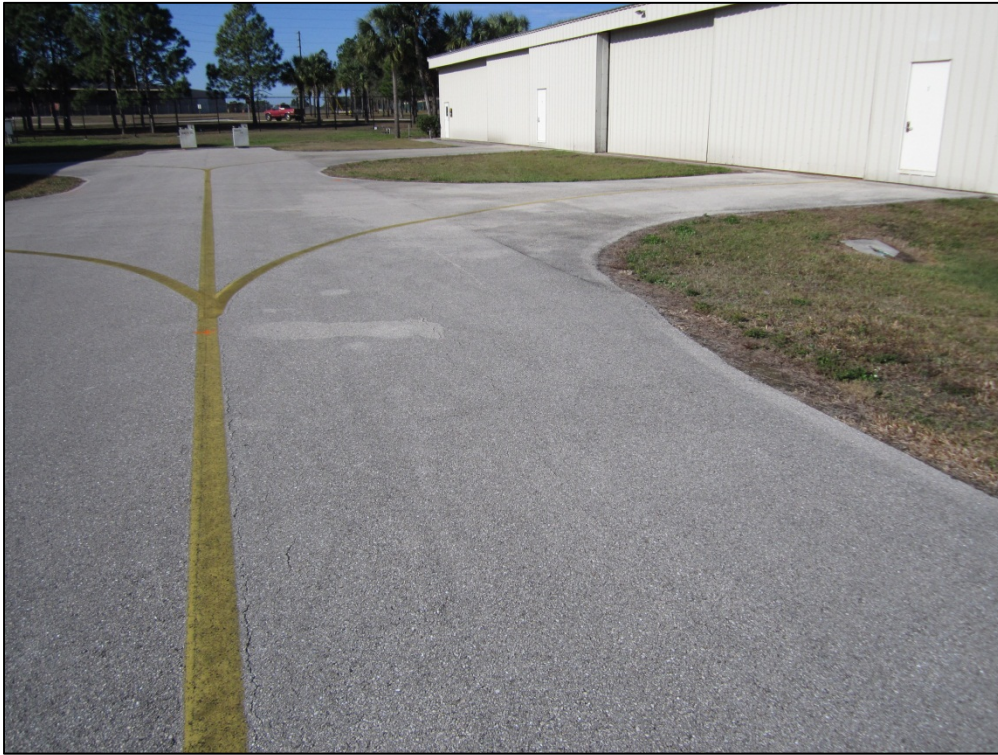
T-Hangars Taxiway, Section 505, Sample Unit 302 – Low severity (48) Longitudinal and Transverse Cracking, low severity (52) Weathering and Raveling, low severity (56) Swelling

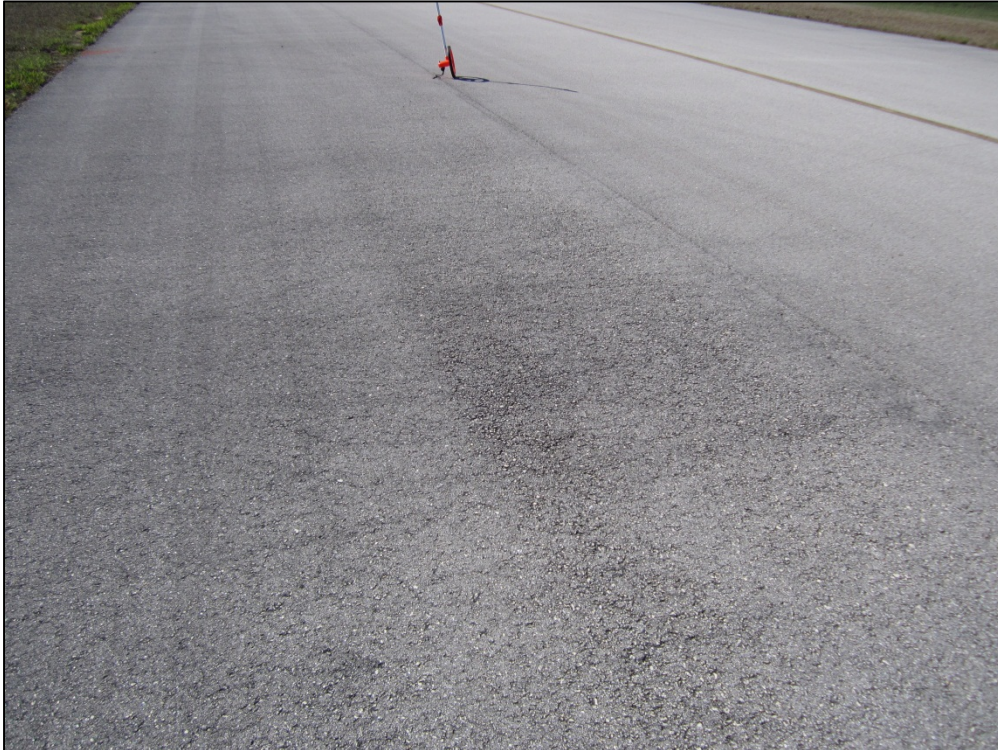
Taxiway Alpha, Section 420, Sample Unit 250 – Low severity (52) Weathering and Raveling

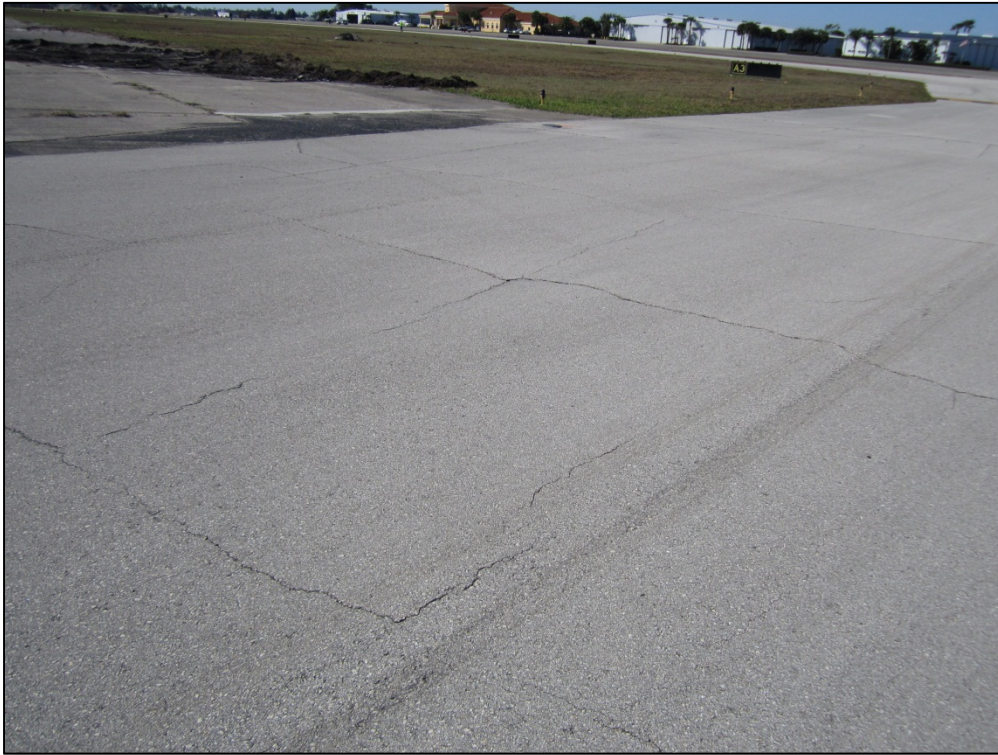
Taxiway A-3, Section 205, Sample Unit 101 – Low severity (48) Longitudinal and Transverse Cracking, low severity (52) Weathering and Raveling

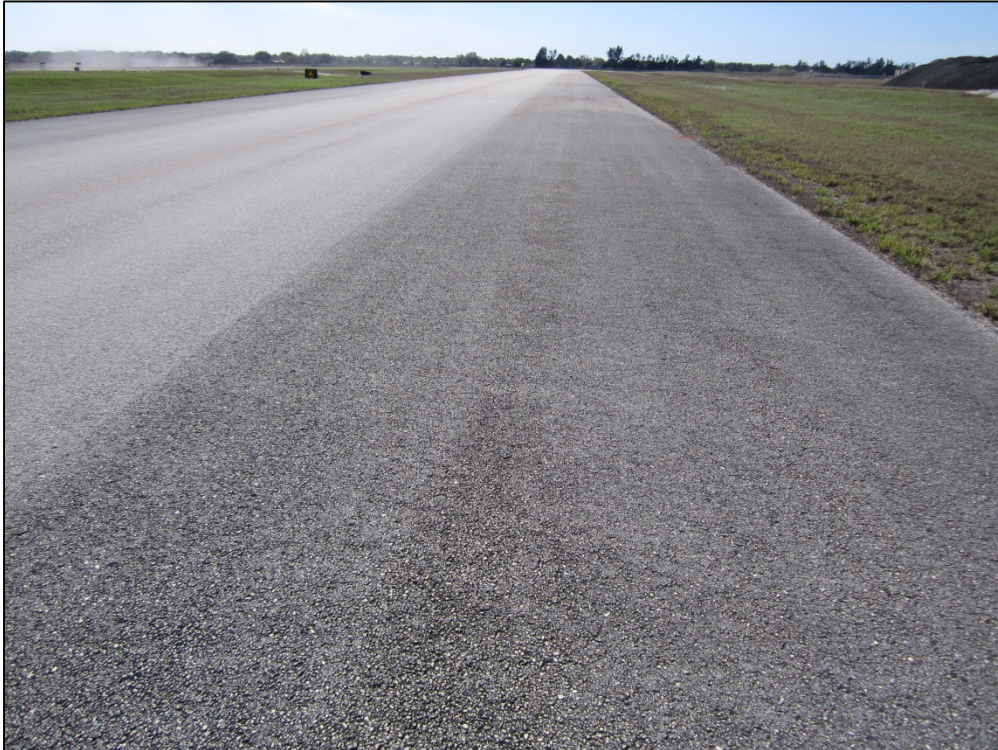
Taxiway Alpha, Section 405, Sample Unit 214 – Low severity (52) Weathering and Raveling
