**STATE OF FLORIDA
DEPARTMENT OF TRANSPORTATION
AVIATION OFFICE**

**Statewide Airfield Pavement
Management Program**

**Space Coast Regional Airport– TIX
(Primary Airport)
Titusville, Florida
(District 5)**

April 2012

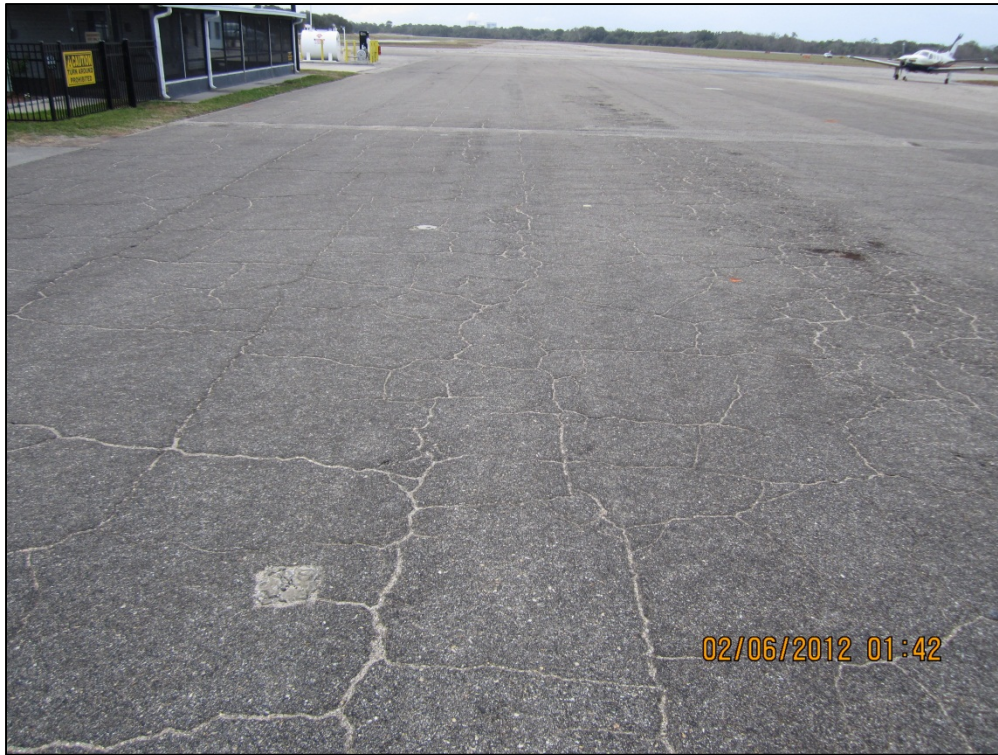
Taxiway Foxtrot, Section 610, Sample Unit 101 – Medium severity (50) Patching, medium severity (52) Weathering and Raveling, medium severity (43) Block Cracking

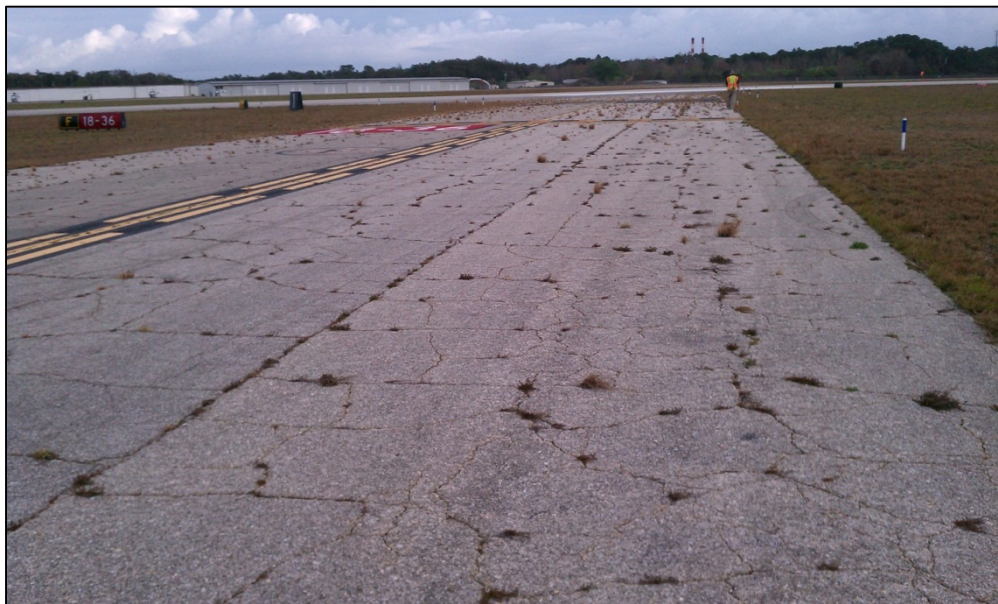
Taxiway Foxtrot, Section 605, Sample Unit 304 – Medium severity (43) Block Cracking, low severity (52) Weathering and Raveling

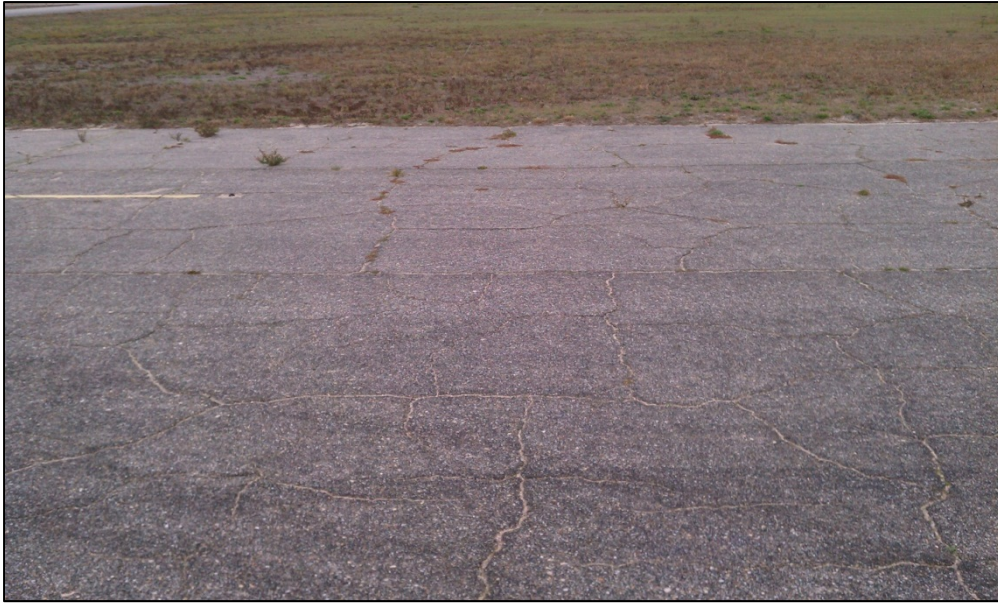
Taxiway Foxtrot, Section 620, Sample Unit 304 – Medium severity (43) Block Cracking, low severity (52) Weathering and Raveling

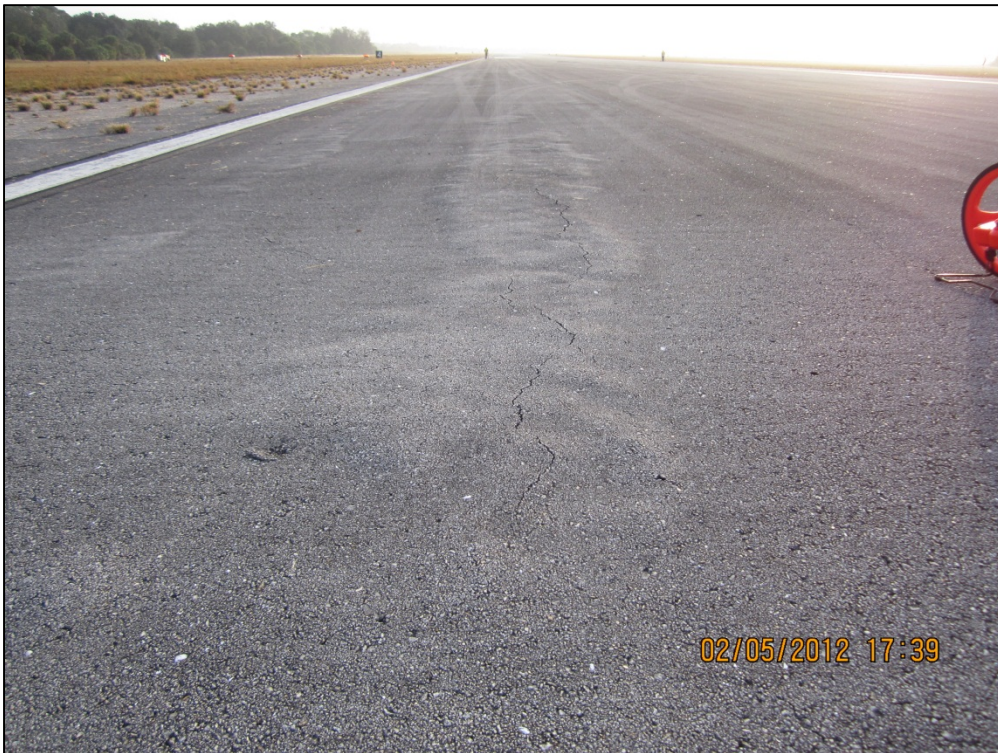
Runway 9-27, Section 6210, Sample Unit 190 – Low severity (48) Longitudinal and Transverse Cracking, low severity (52) Weathering and Raveling, low severity (56) Swelling

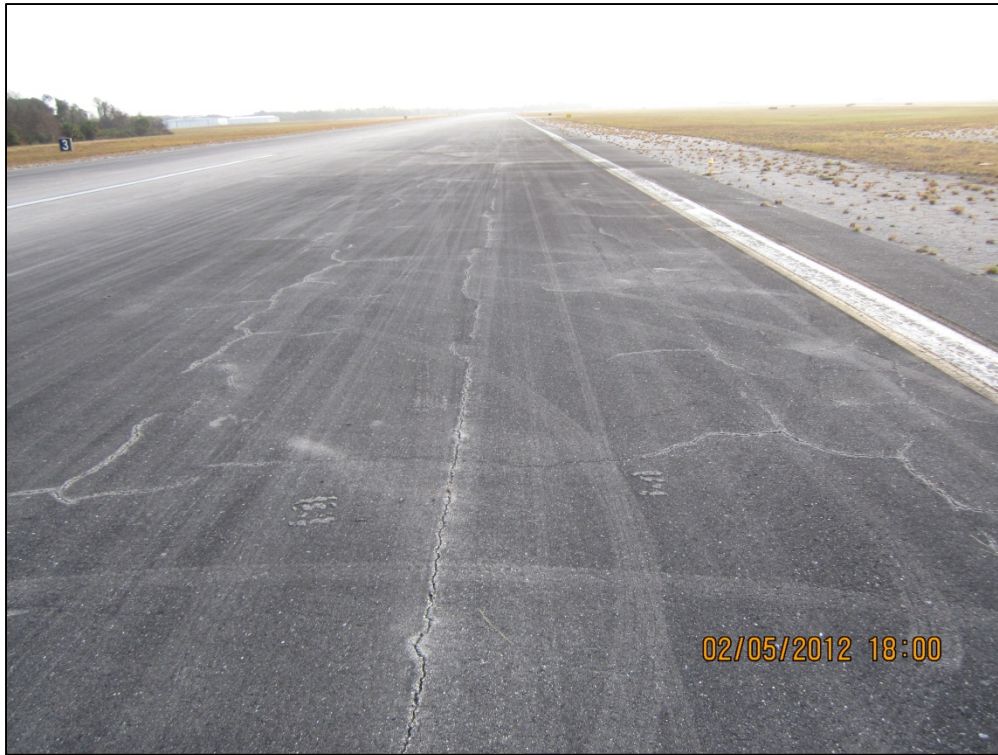
Runway 9-27, Section 6210, Sample Unit 165 – Low severity (43) Block Cracking, low severity (48) Longitudinal and Transverse Cracking, low severity (52) Weathering and Raveling

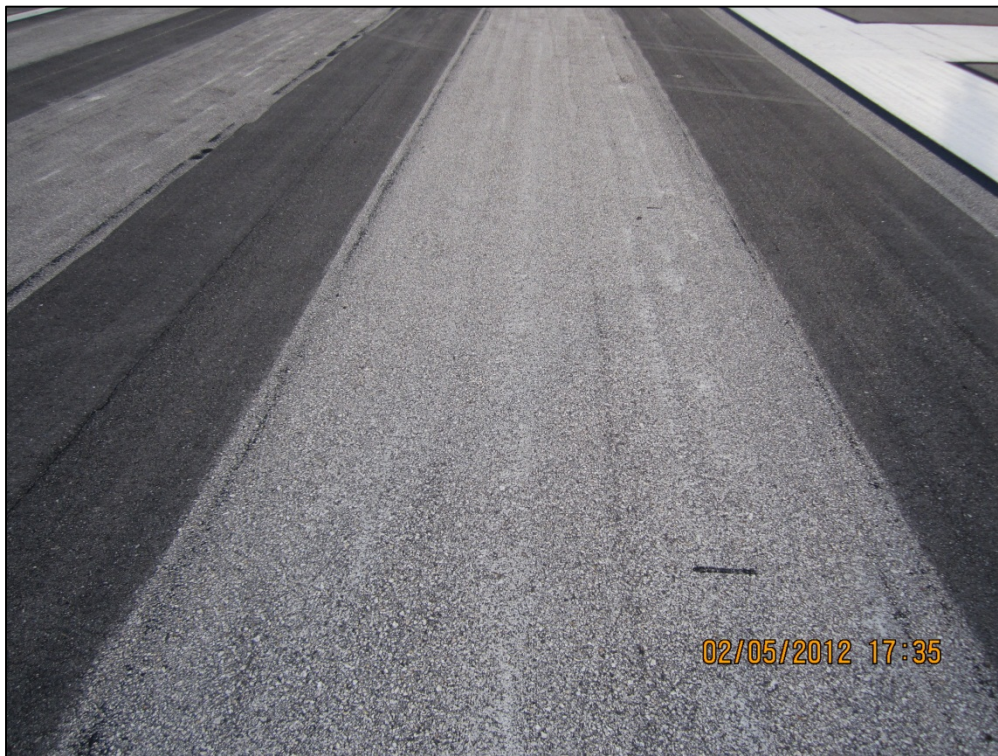
Runway 9-27, Section 6210, Sample Unit 194 – Low severity (48) Longitudinal and Transverse Cracking, low severity (52) Weathering and Raveling

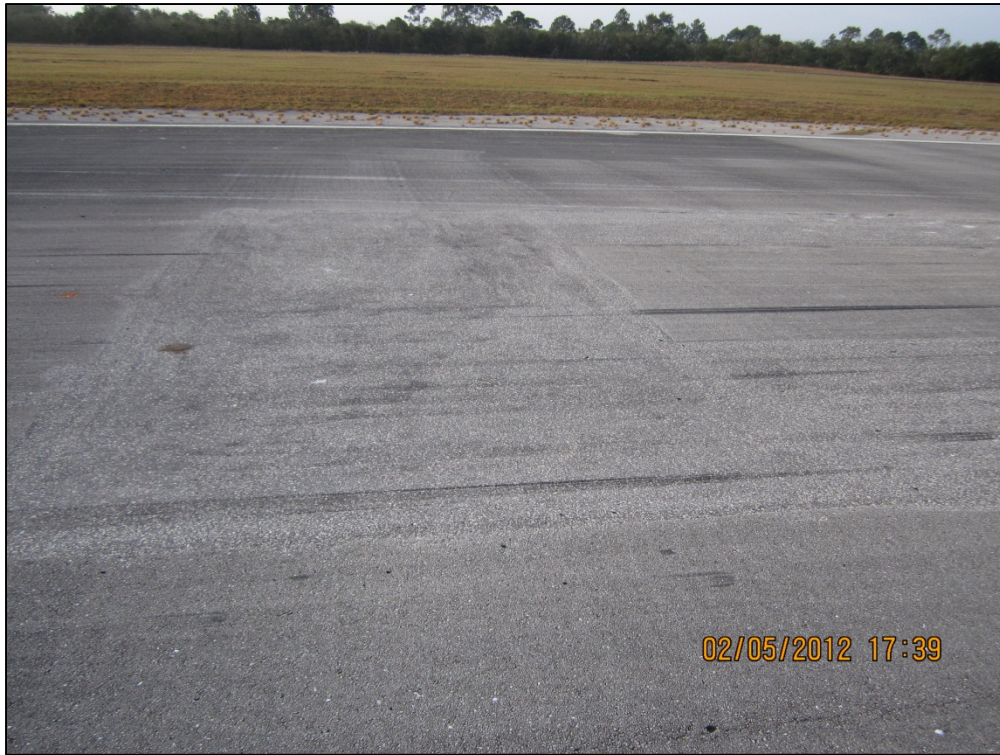
Runway 9-27, Section 6210, Sample Unit 190 – Low severity (52) Weathering and Raveling, low severity (48) Longitudinal and Transverse Cracking

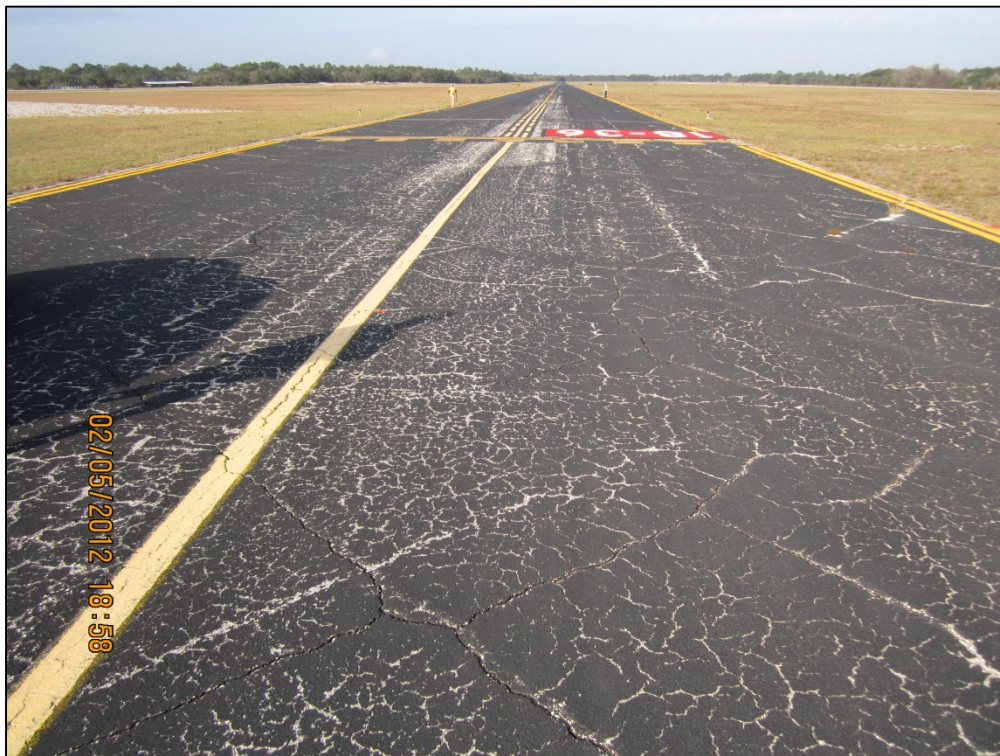
Taxiway Bravo, Section 210, Sample Unit 545 – Medium severity (43) Block Cracking, medium severity (52) Weathering and Raveling

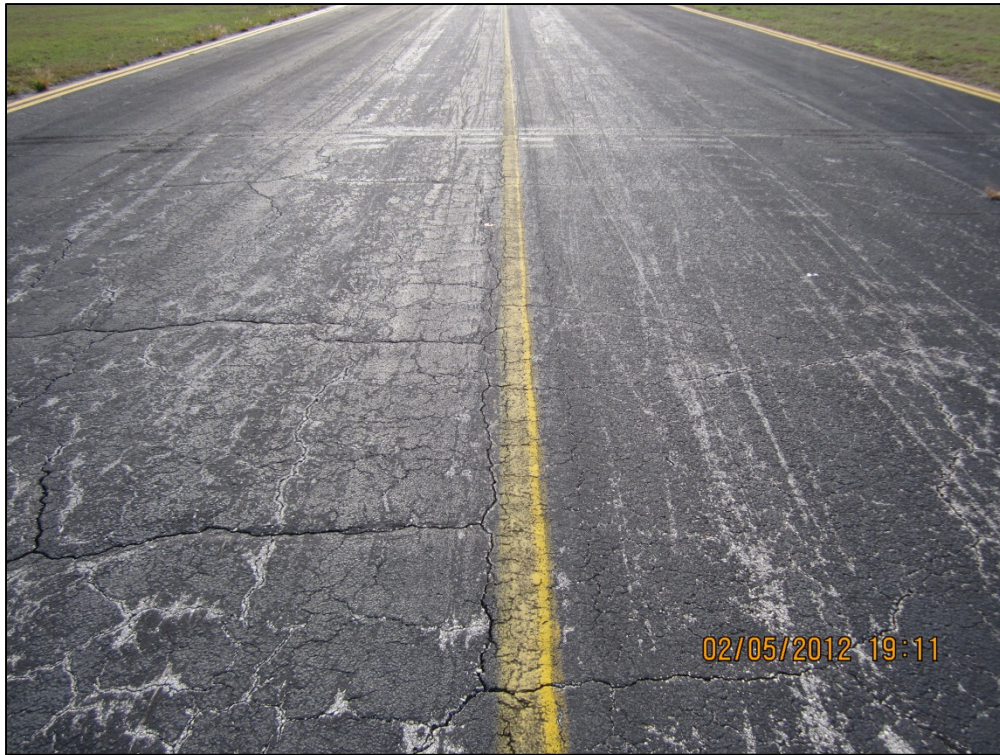
Taxiway Charlie, Section 315, Sample Unit 701 – Low severity (43) Block Cracking, medium severity (52) Weathering and Raveling

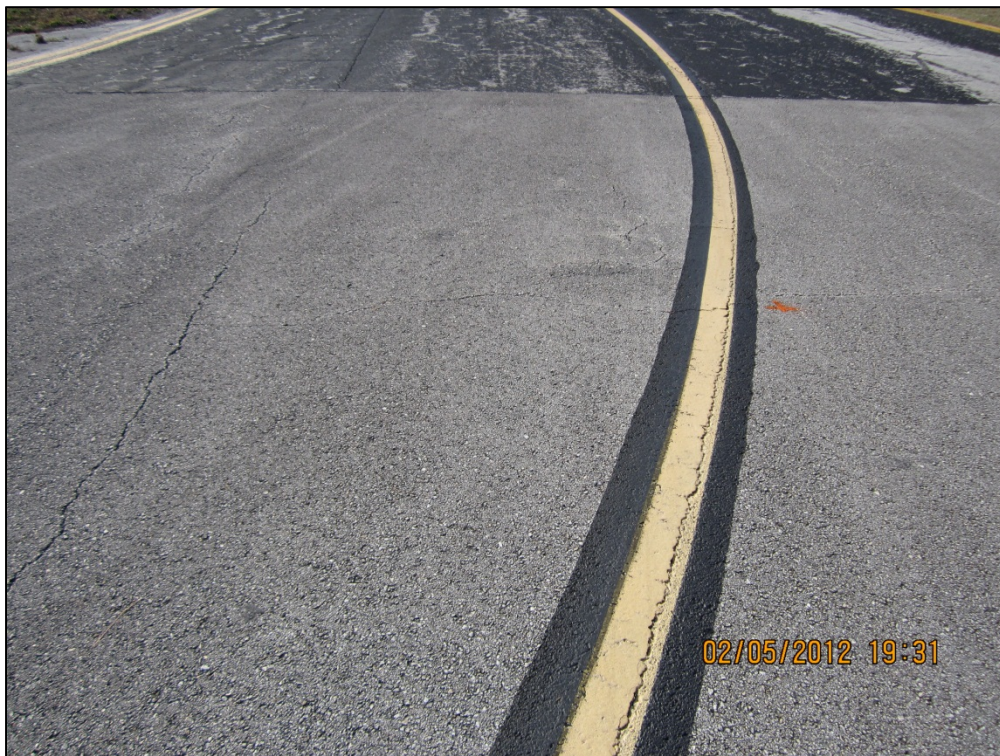
Taxiway Bravo, Section 220, Sample Unit 500 – Low severity (48) Longitudinal and Transverse Cracking, low severity (52) Weathering and Raveling, low severity (56) Swelling

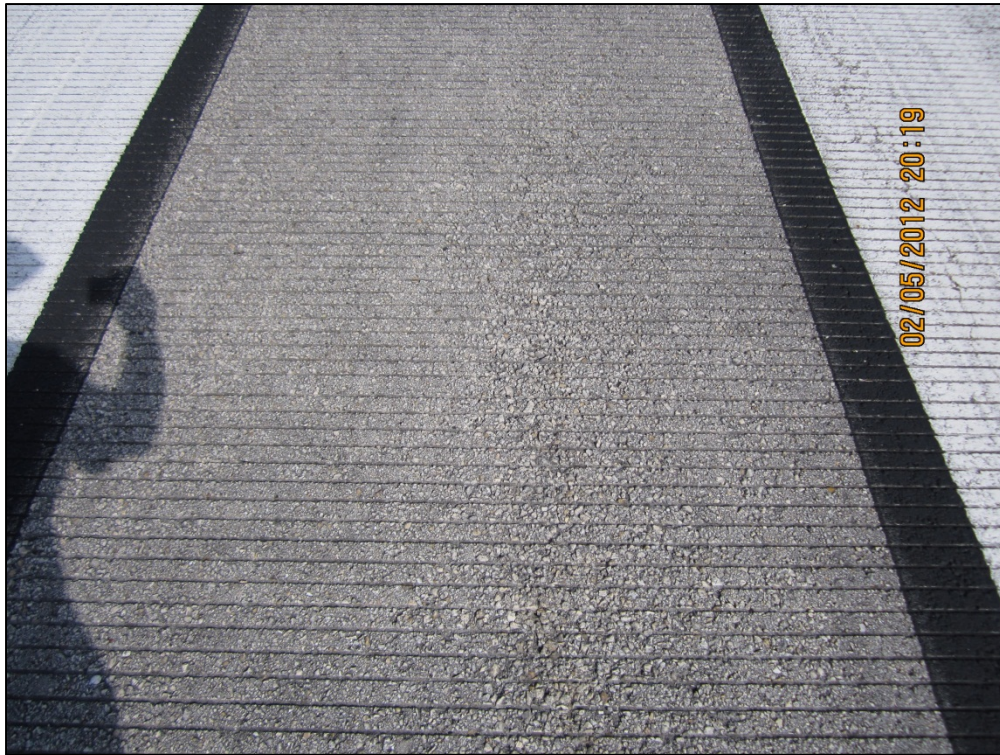
Runway 18-36, Section 6145, Sample Unit 437 – Low severity (52) Weathering and Raveling

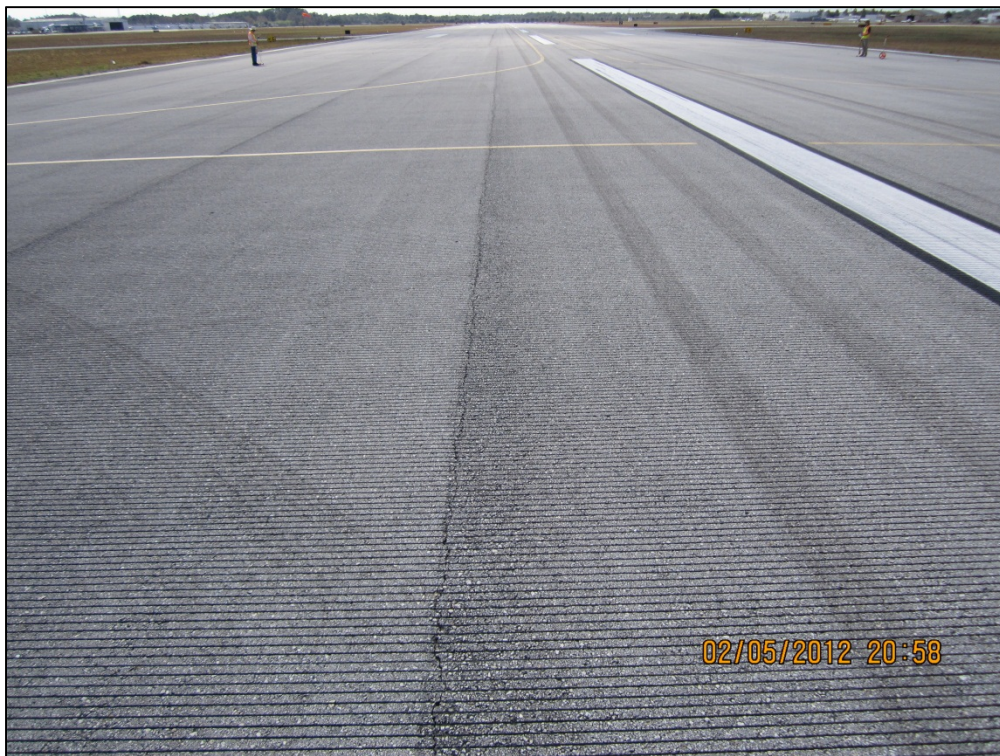
Runway 18-36, Section 6125, Sample Unit 368 – Low severity (48) Longitudinal and Transverse Cracking, low severity (52) Weathering and Raveling

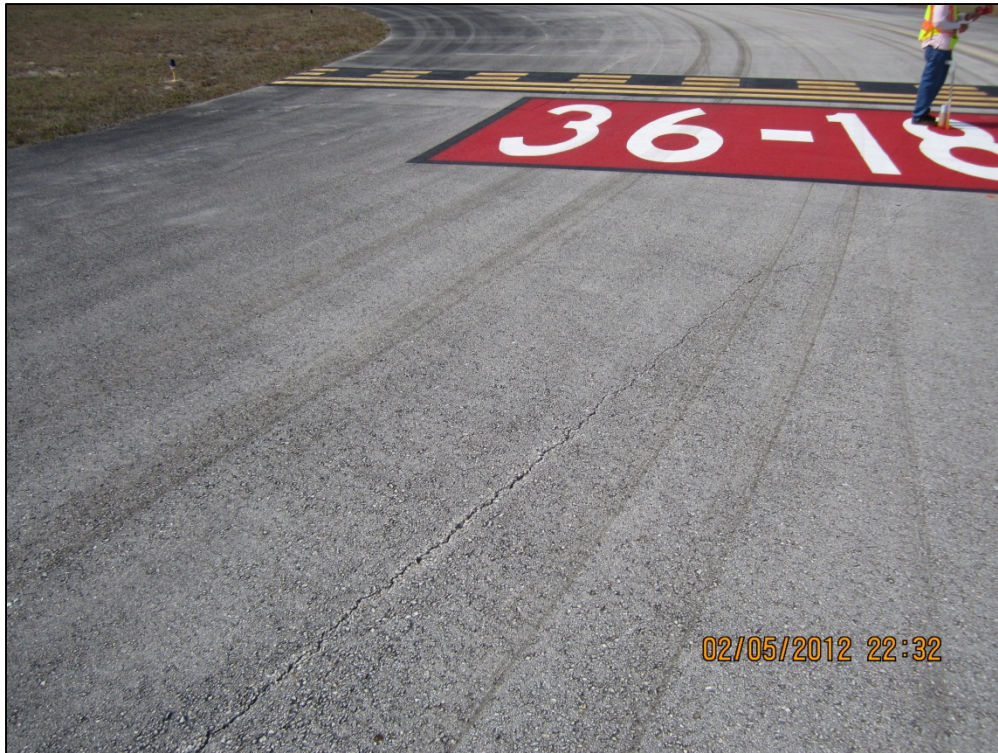
Taxiway Alpha, Section 120, Sample Unit 162 – Low severity (52) Weathering and Raveling, low severity (48) Longitudinal and Transverse Cracking

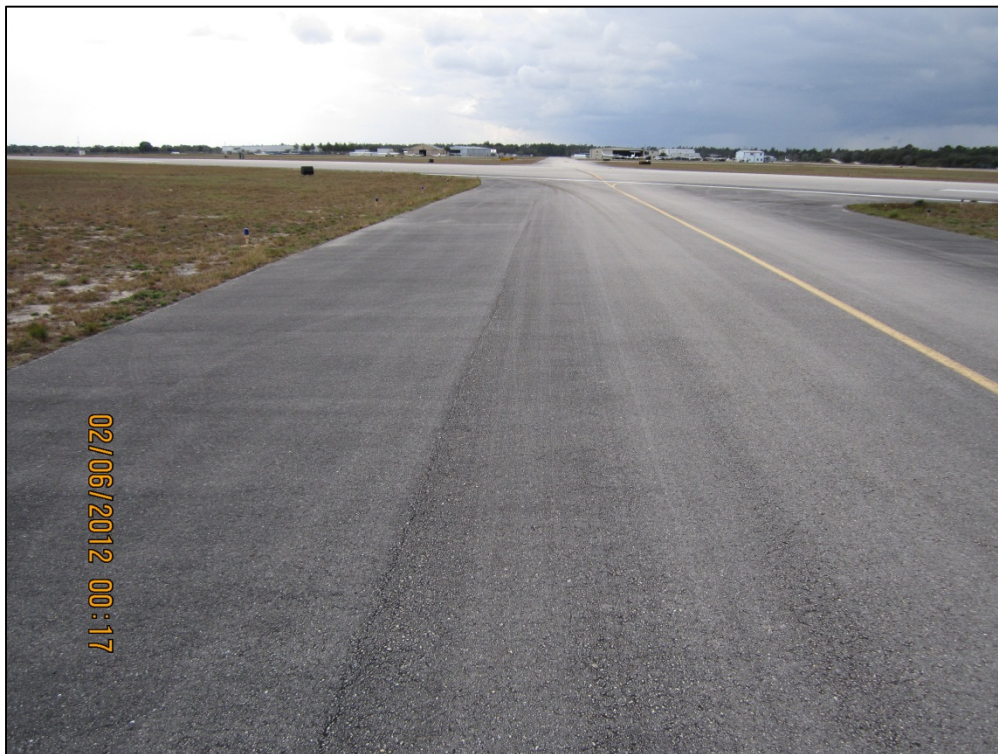
Taxiway Echo, Section 505, Sample Unit 601 – Low severity (48) Longitudinal and Transverse Cracking

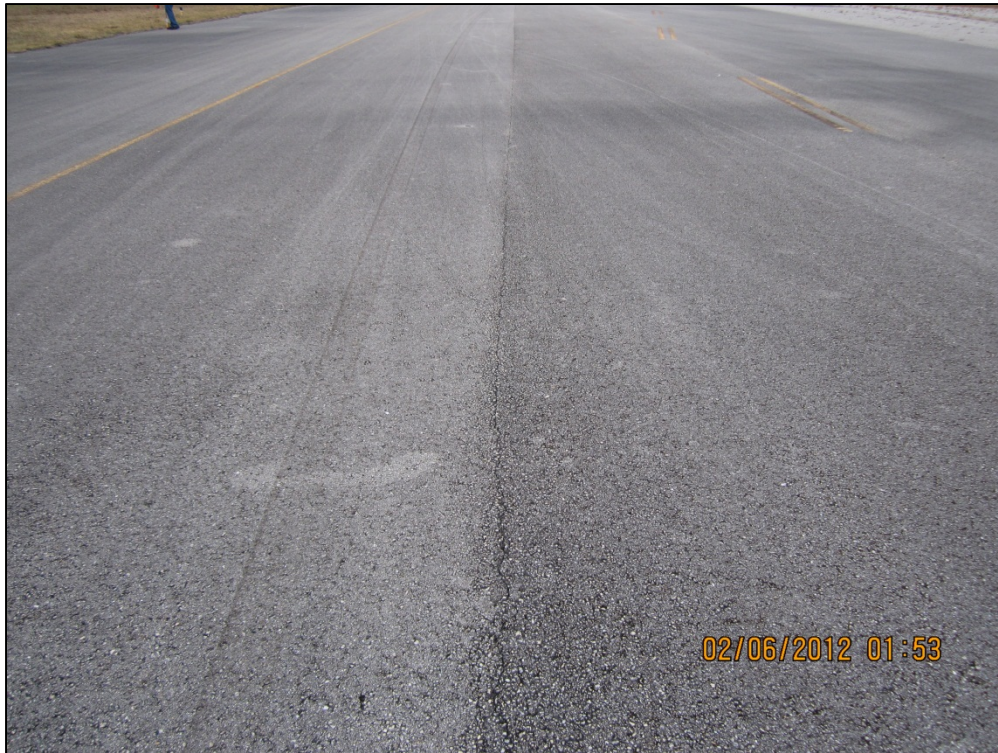
Taxiway Delta, Section 404, Sample Unit 402 – Low severity (48) Longitudinal and Transverse Cracking

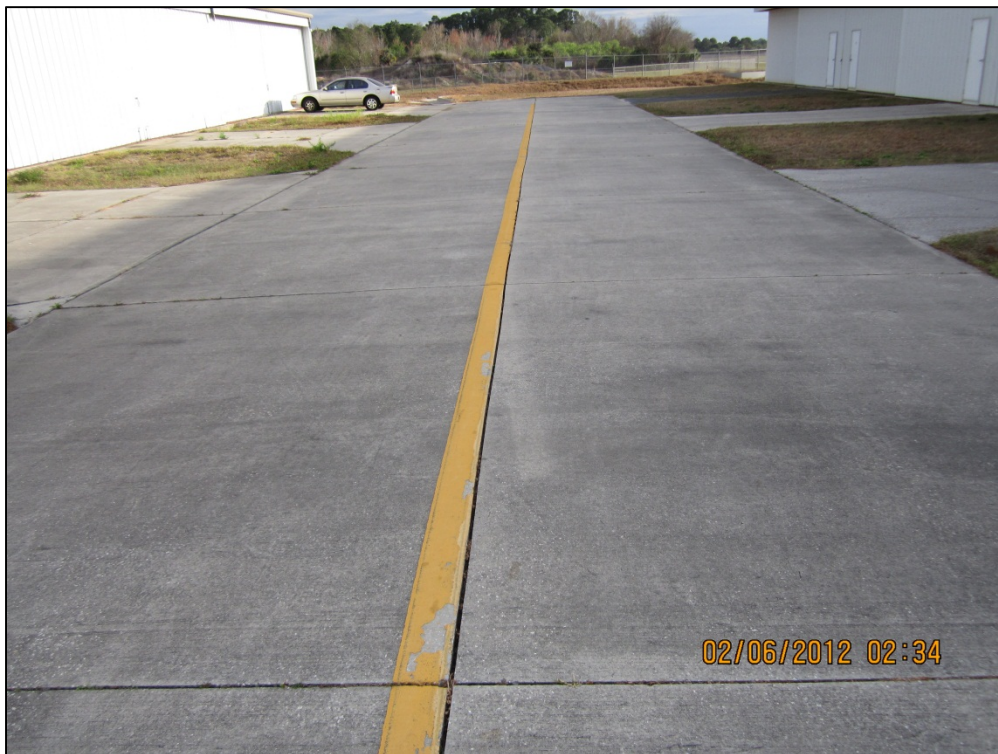
T-Hangar Taxiway, Section 4225, Sample Unit 201 – Low severity (65) Joint Seal Damage

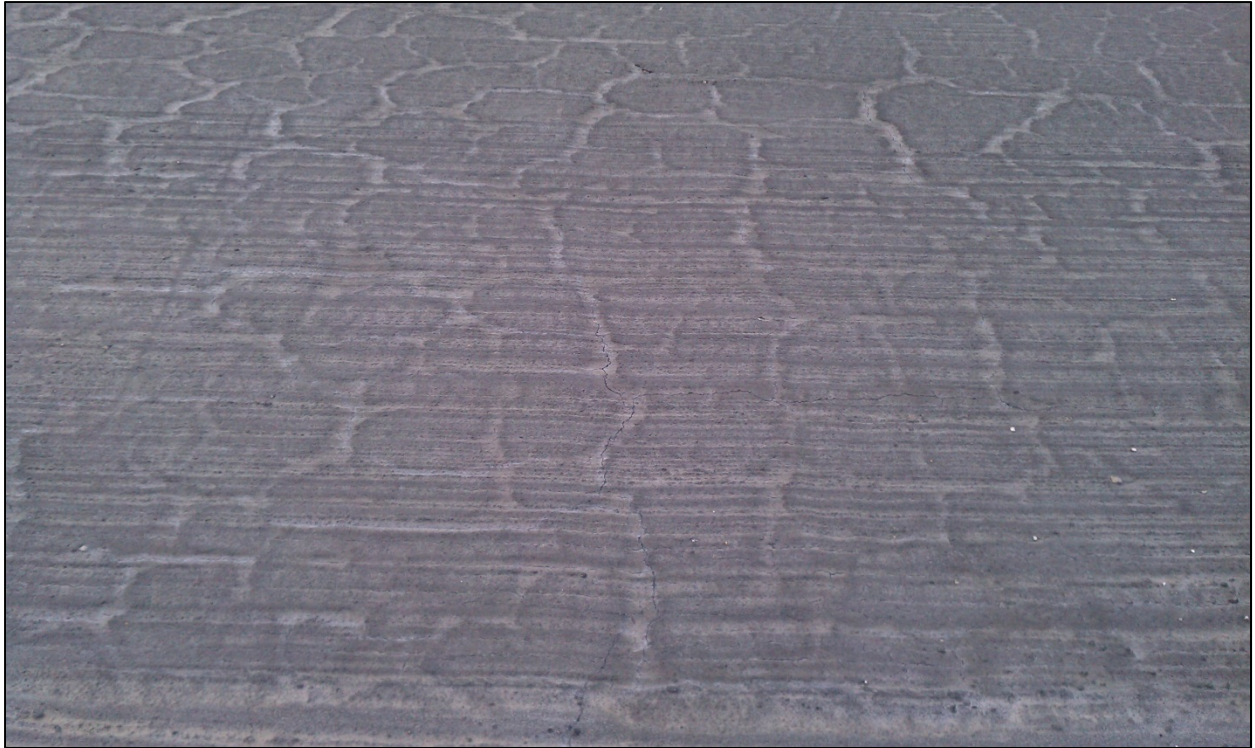
South Apron, Section 4215, Sample Unit 663 – Low severity (48) Longitudinal and Transverse Cracking
