STATE OF FLORIDA DEPARTMENT OF TRANSPORTATION AVIATION OFFICE

Statewide Airfield Pavement Management Program

Suwannee County Airport – 24J (General Aviation) Live Oak, Florida (District 2)

May 2011

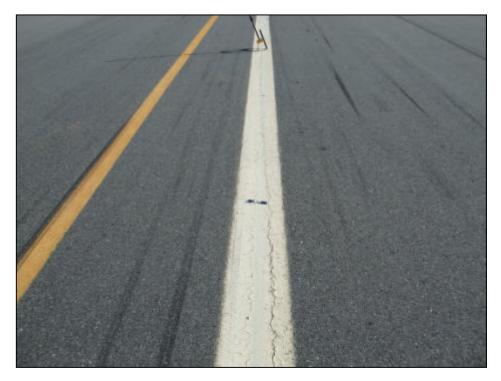
Runway 7-25, Section 6105, Sample Unit 115 – Low severity (48) Longitudinal and Transverse Cracking, low and high severity (52) Weathering and Raveling.

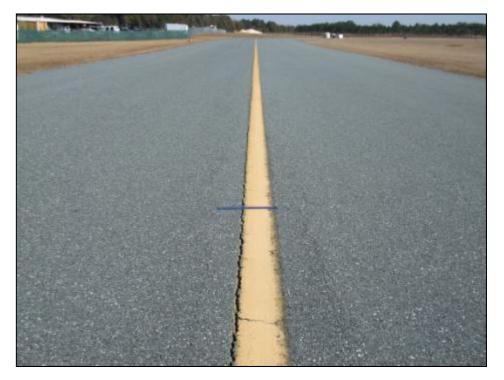
Taxiway, Section 105, Sample Unit 104 – Low and medium severity (48) Longitudinal and Transverse Cracking, low severity (56) Swelling.

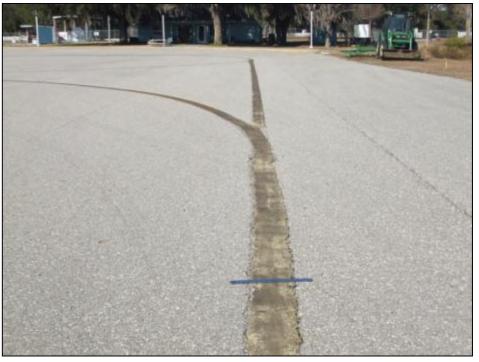
Taxiway, Section 120, Sample Unit 100 - Low and medium severity (48) Longitudinal and Transverse Cracking, low and medium severity (52) Weathering and Raveling.

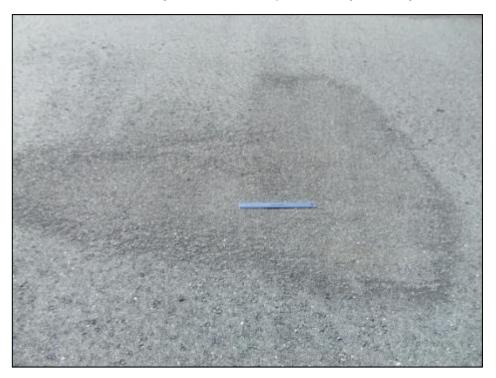
Runway 7-25, Section 6105, Sample Unit 103 – Low severity (48) Longitudinal and Transverse Cracking, low and medium severity (52) Weathering and Raveling.

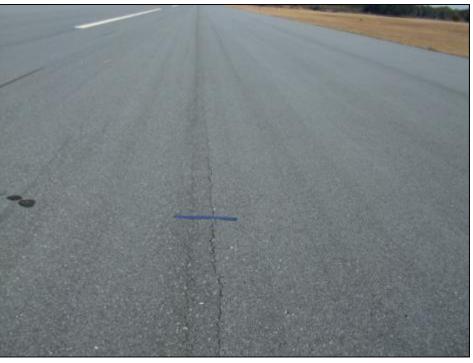
Runway 7-25, Section 6110, Sample Unit 146 - Low severity (48) Longitudinal and Transverse Cracking, low severity (52) Weathering and Raveling.
