**STATE OF FLORIDA
DEPARTMENT OF TRANSPORTATION
AVIATION OFFICE**

**Statewide Airfield Pavement
Management Program**

**Umatilla Municipal Airport – X23
(General Aviation)
Umatilla, Florida
(District 5)**

May 2011

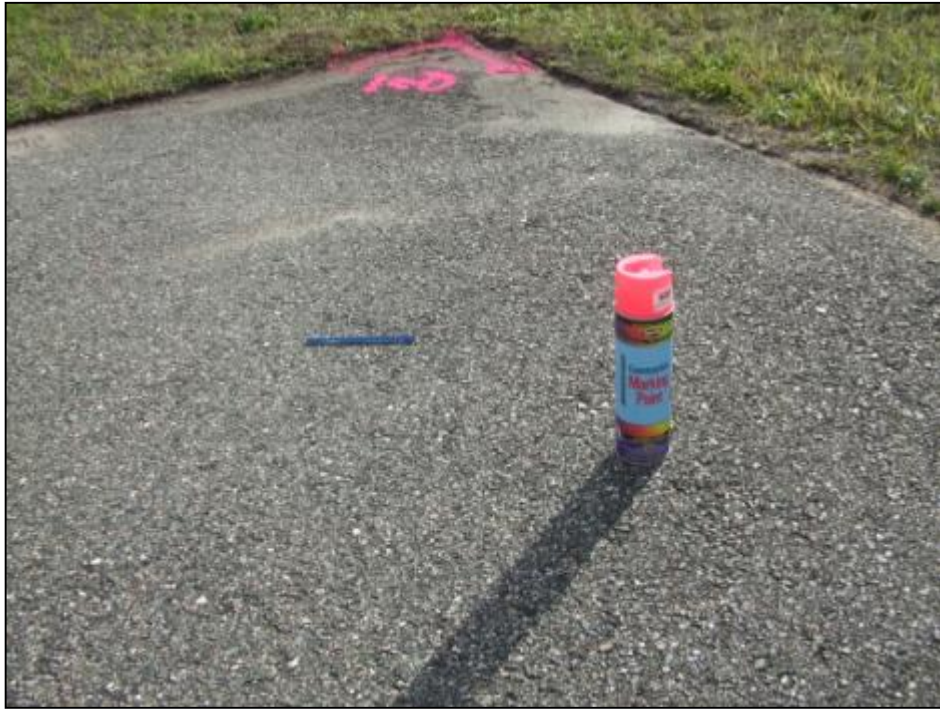
Runup Apron, Section 5105, Sample Unit 100 - Low severity (48) Longitudinal and Transverse Cracking, low severity (52) Weathering and Raveling.

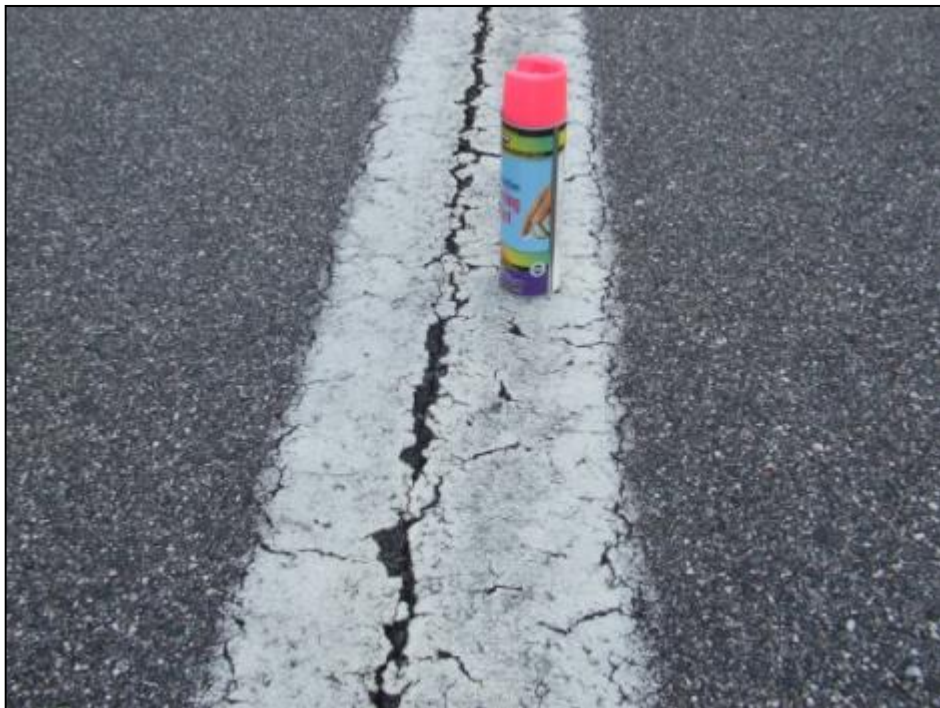
Runway 18-36, Section 6105, Sample Unit 222 - Low severity (48) Longitudinal and Transverse Cracking, low severity (52) Weathering and Raveling.

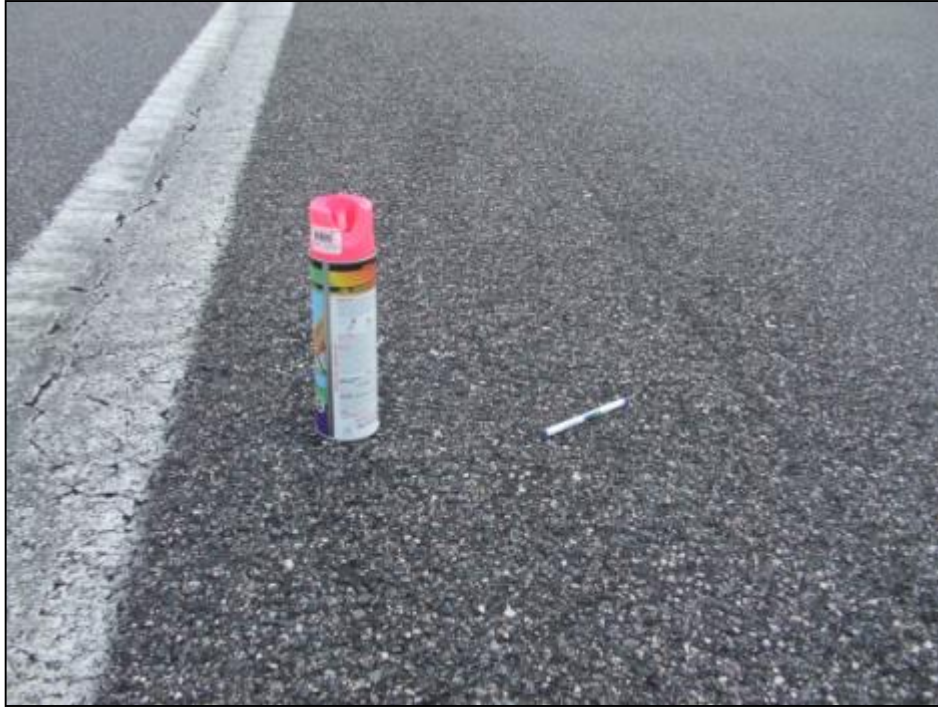
Runway 18-36, Section 6105, Sample Unit 207 – Low severity (48) Longitudinal and Transverse Cracking, low severity (52) Weathering and Raveling.

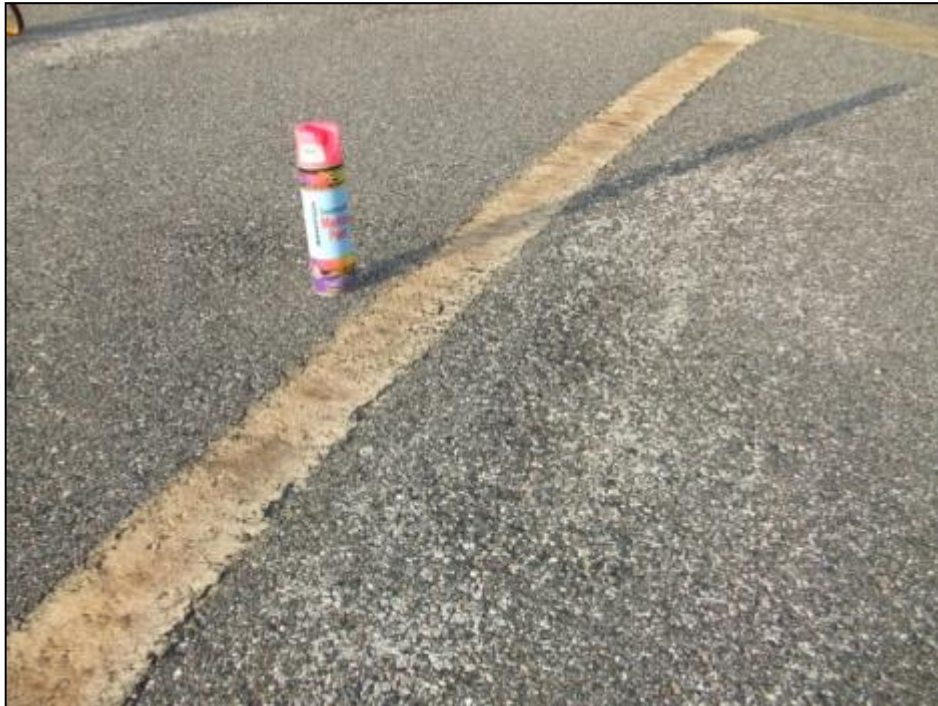
Terminal Apron, Section 4105, Sample Unit 100 – Low severity (48) Longitudinal and Transverse Cracking, low severity (50) Patching, low and medium severity (52) Weathering and Raveling.

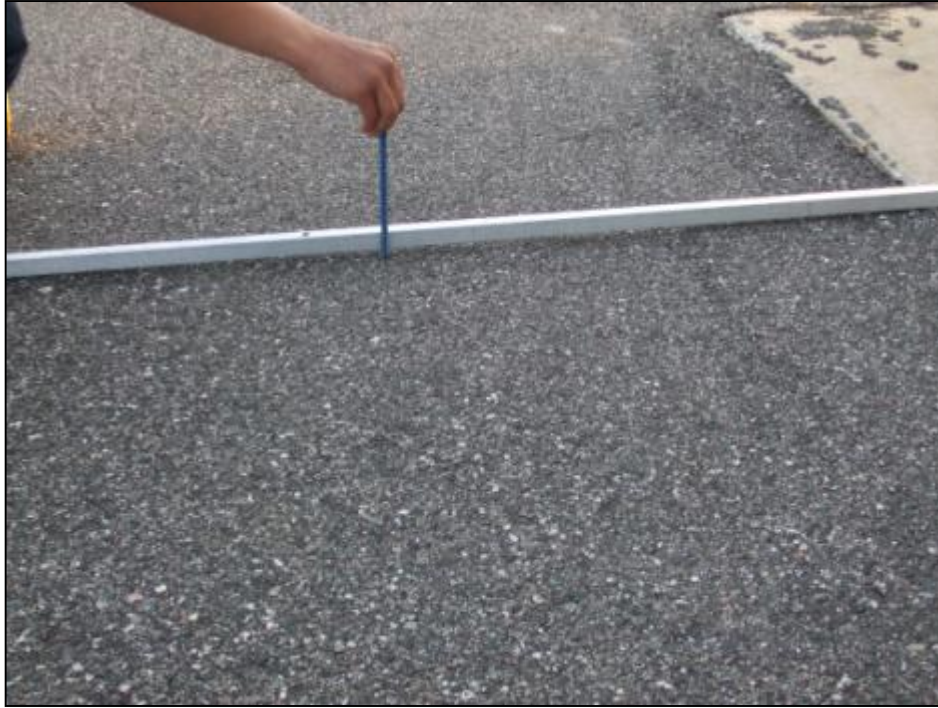
Terminal Apron, Section 4205, Sample Unit 101 – Low severity (48) Longitudinal and Transverse Cracking, low and medium severity (52) Weathering and Raveling, low severity (54) Shoving.
