**STATE OF FLORIDA
DEPARTMENT OF TRANSPORTATION
AVIATION OFFICE**

**Statewide Airfield Pavement
Management Program**

**Valkaria Municipal Airport– X59
(General Aviation)
Malabar, Florida
(District 5)**

May 2011

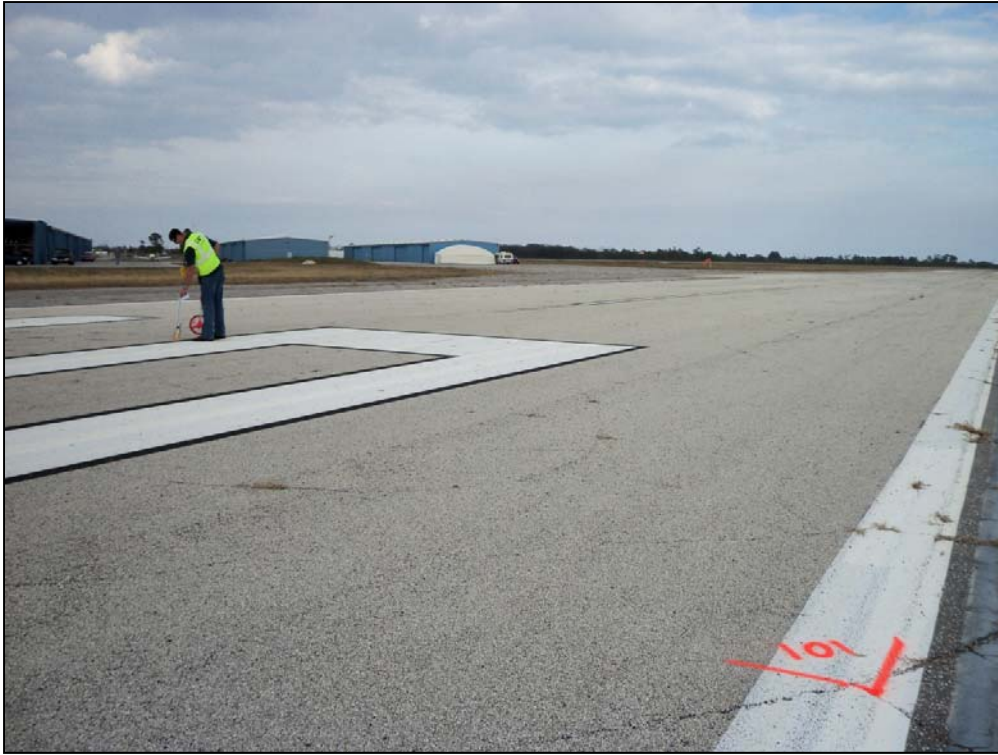
Runway 10-28, formerly 9-27, exhibited high severity weathering and raveling in addition to the longitudinal cracks along the paving joints. The pavement distresses observed indicates rehabilitative neglect. The surficial layer consists of aggregate with minimal bituminous binding material; inspectors observed aggregate to be easily dislodged with application of force. The shoulder pavement along RW 10-28, located between the runway and the golf course, appears to be in a neglected state with vegetation growing through the observed block cracking distresses with low to medium severity weathering and raveling. The condition analysis resulted in a PCI of 19 with a condition rating of ‘Serious’ for Runway 10-28. The PCI of 19 is significantly below both the FAA and FDOT minimum PCI values for runways.

Runway 10-28, Section 6205, Sample Unit 101 – High Severity (52) Weathering and Raveling

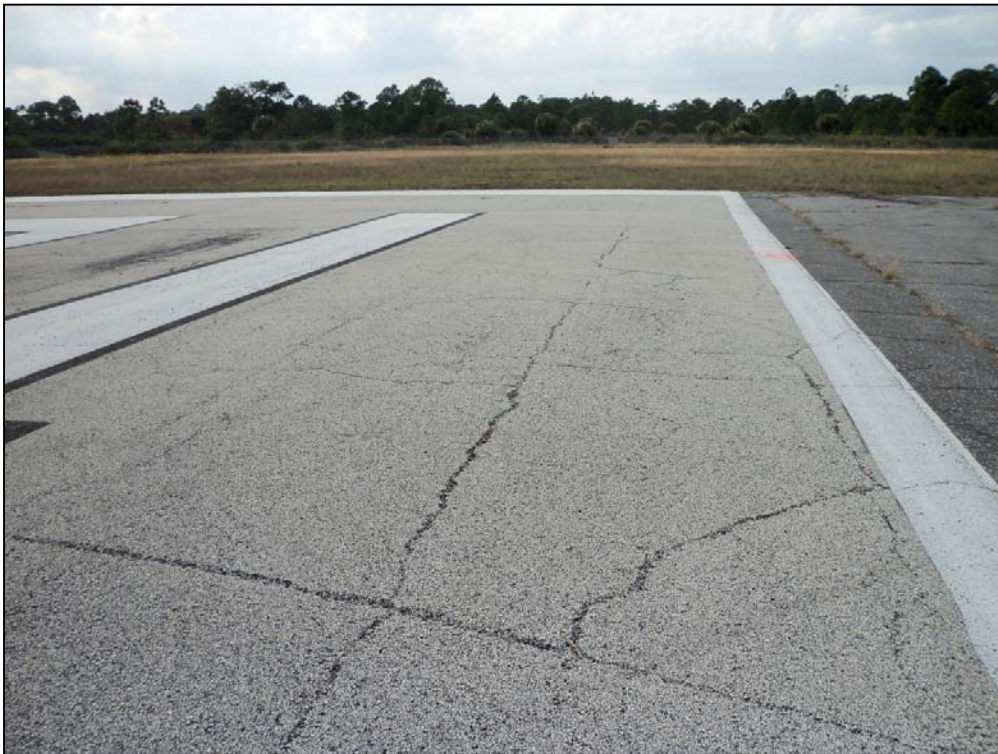
Runway 10-28, Section 6205, Sample Unit 101 – High Severity (52) Weathering and Raveling, Medium Severity (43) Block Cracking

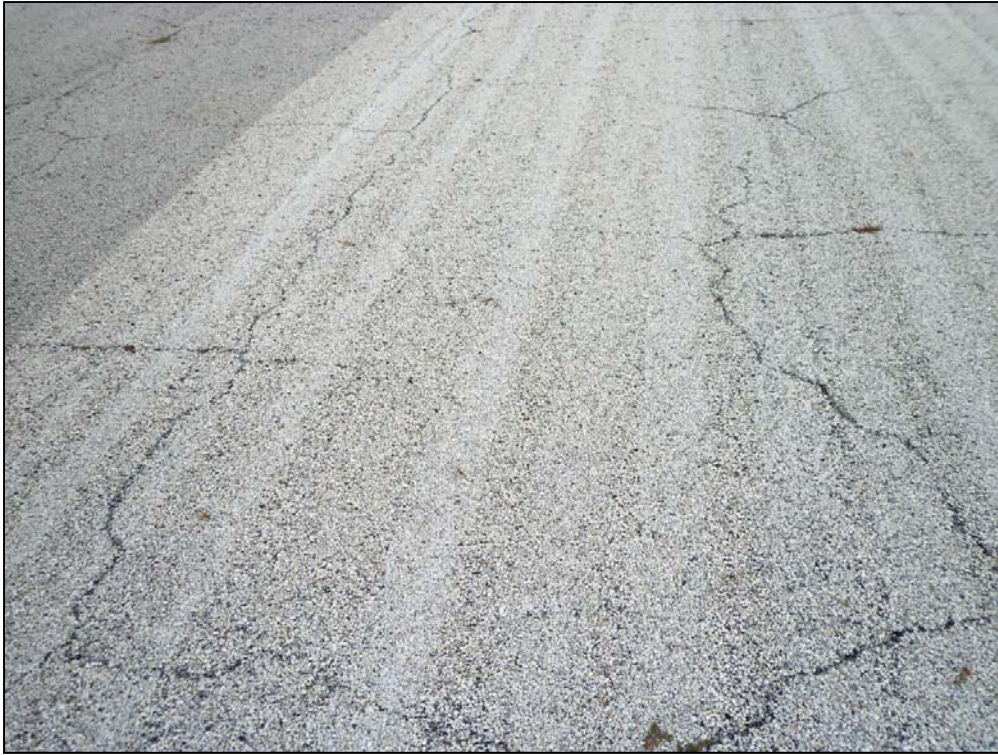
Runway 10-28, Section 6205, Sample Unit 125 – High Severity (52) Weathering and Raveling, Medium Severity (43) Block Cracking

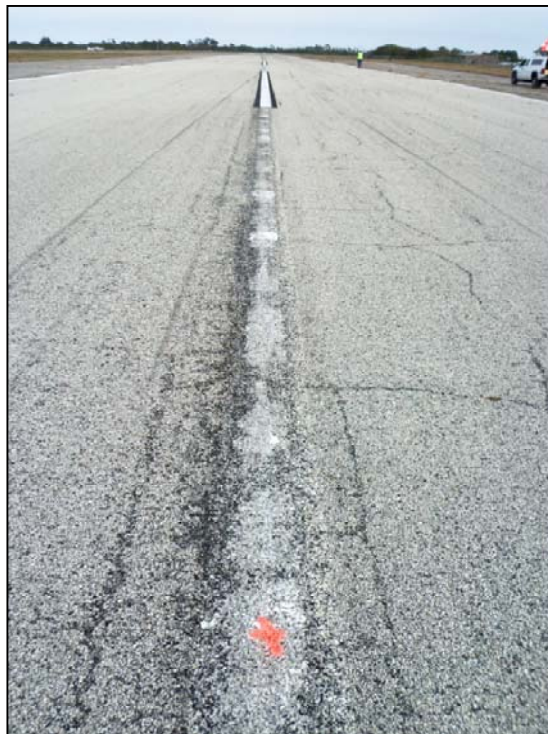
Runway 10-28, Section 6205, Sample Unit 125 – High Severity (52) Weathering and Raveling, Medium Severity (43) Block Cracking

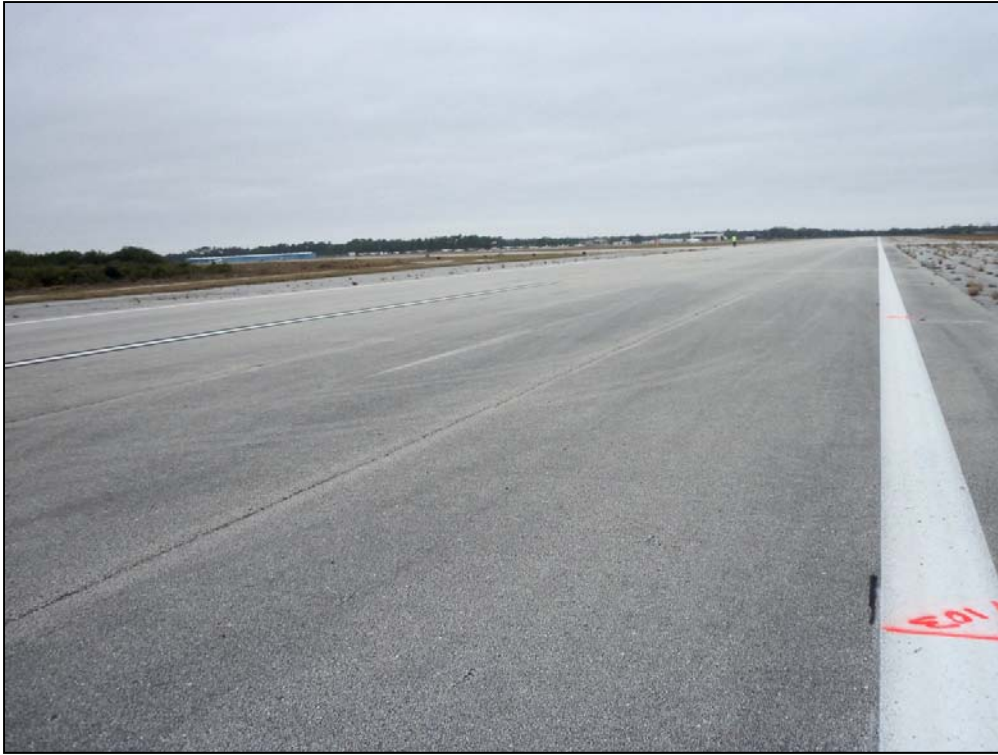
Runway 14-32, exhibited low severity weathering and raveling in addition to longitudinal cracks primarily located along the paving joints. Similar to RW 10-28, RW 14-32 has paved shoulders that exhibits block cracking and weathering/raveling distresses that appear to have high severities perhaps due to neglect. The condition analysis resulted in a PCI of 70 with a condition rating of ‘Fair’ for Runway 14-32. Runway 14-32 meets the minimum PCI for the FAA criteria however is below the FDOT recommended PCI.

Runway 14-32, Section 6105, Sample Unit 103 – Low Severity (48) Longitudinal/Transverse Cracking and low severity (52) Weathering and Raveling

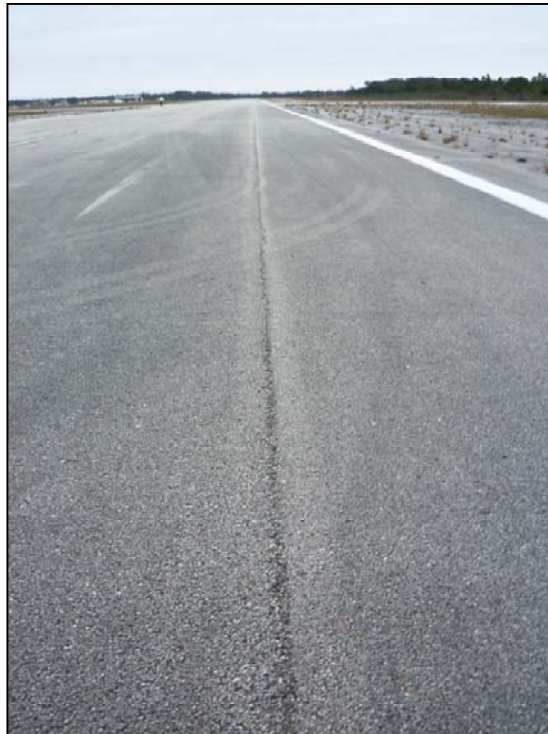
Runway 14-32, Section 6105, Sample Unit 103 – Low Severity (48) Longitudinal/Transverse Cracking and low severity (52) Weathering and Raveling

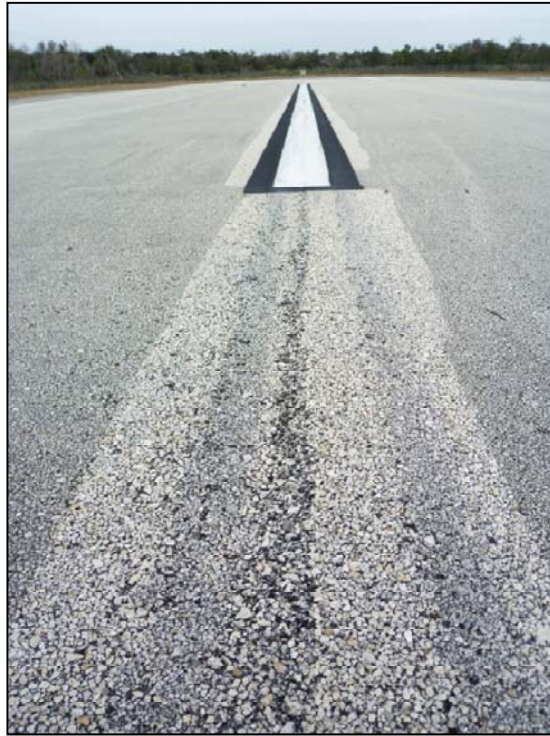
Runway 14-32, Section 6115, Sample Unit 175 – Low Severity (48) Longitudinal/Transverse Cracking and low severity (52) Weathering and Raveling

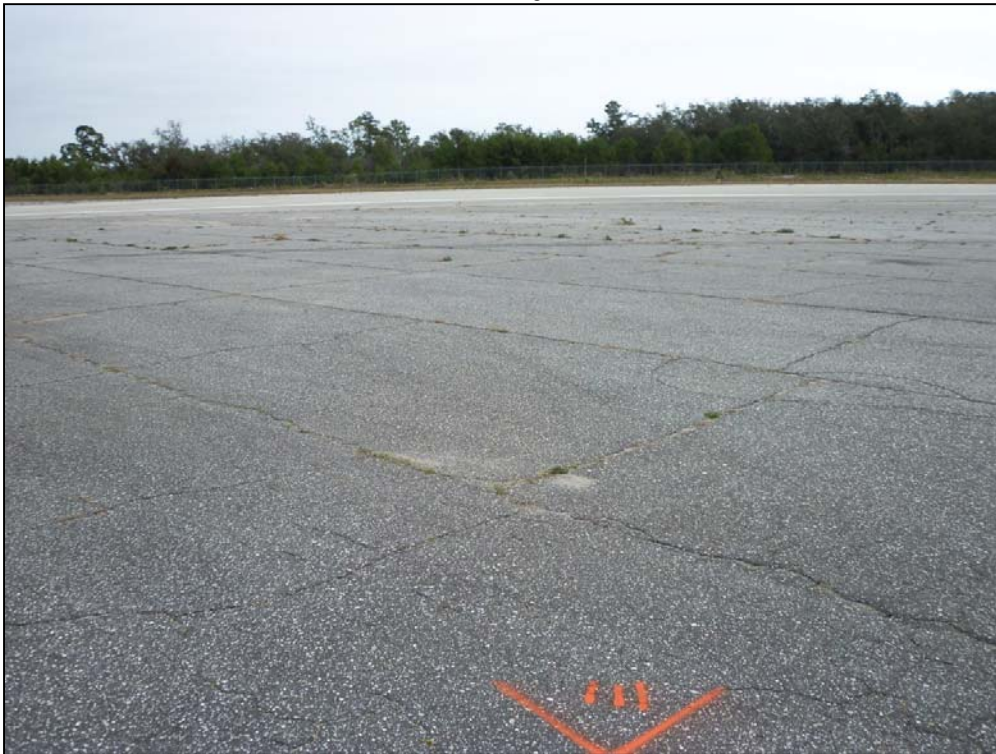
Taxiway Bravo, Section 105, Sample Unit 111 – Medium Severity (43) Block Cracking and low severity (52) Weathering and Raveling

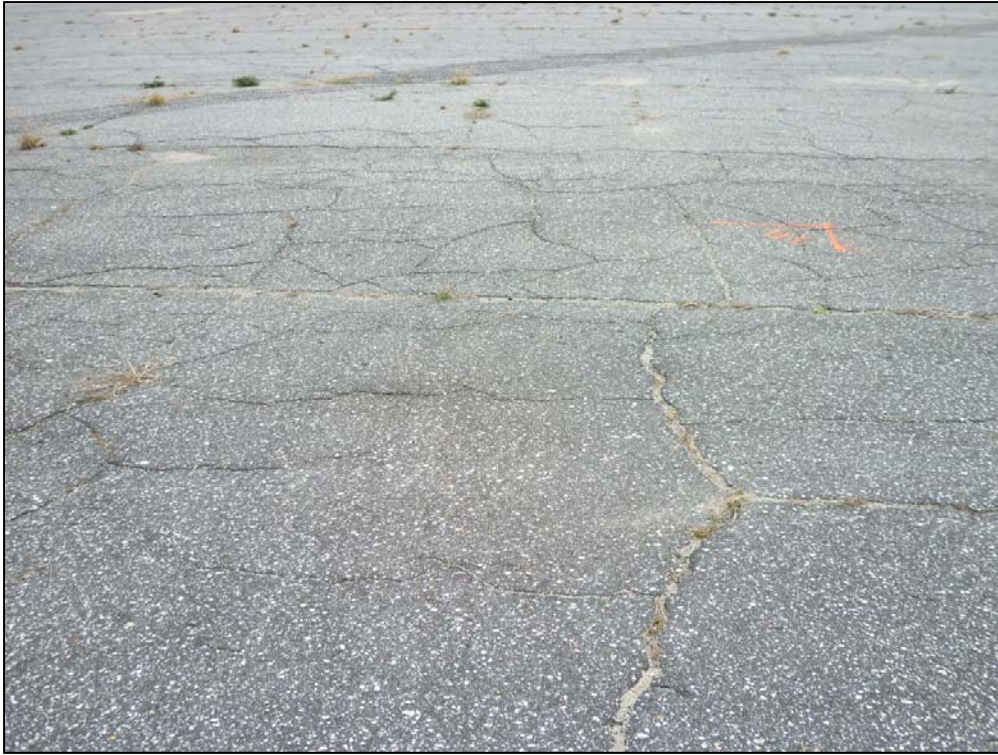
Taxiway Bravo, Section 105, Sample Unit 111 – Medium Severity (43) Block Cracking and low severity (52) Weathering and Raveling

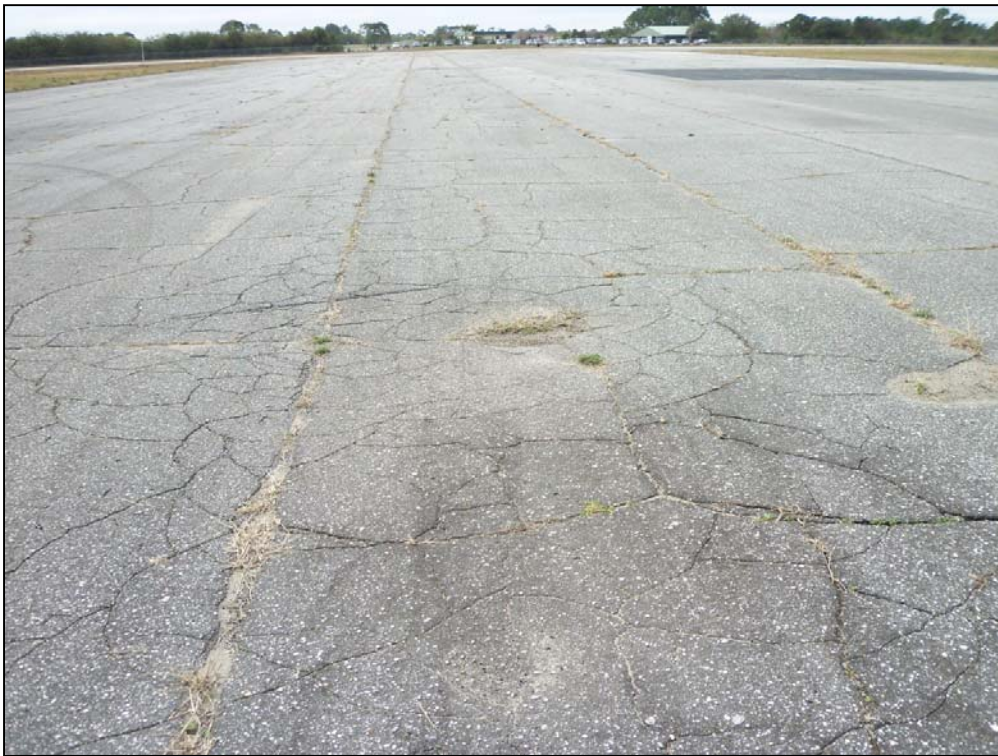
Taxiway Bravo, Section 105, Sample Unit 105 – Medium Severity (43) Block Cracking, high severity (45) Depression, and low severity (52) Weathering and Raveling

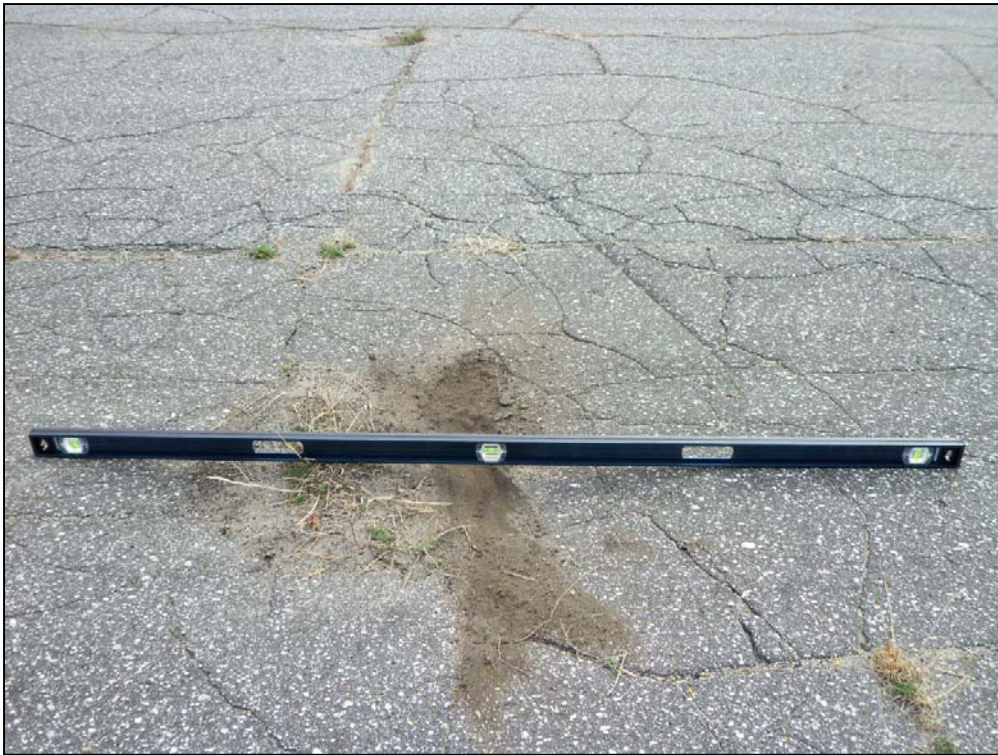
Taxiway Bravo, Section 105, Sample Unit 111 – Medium Severity (43) Block Cracking and low severity (52) Weathering and Raveling

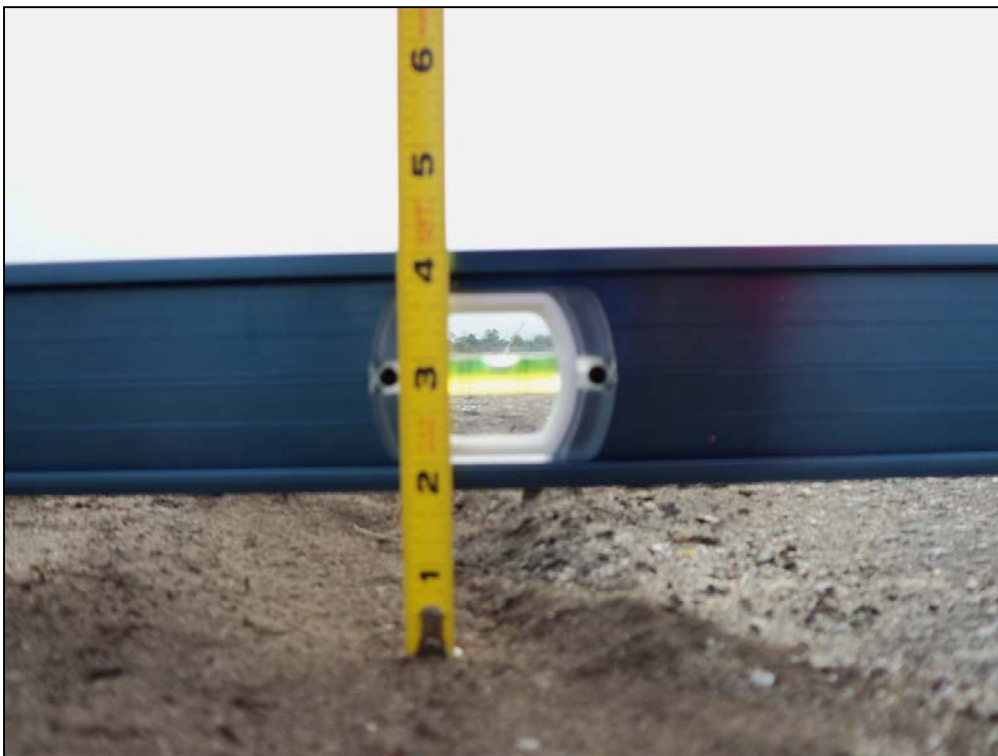
Taxiway Bravo, Section 105, Sample Unit 111 – Medium Severity (43) Block Cracking and low severity (52) Weathering and Raveling

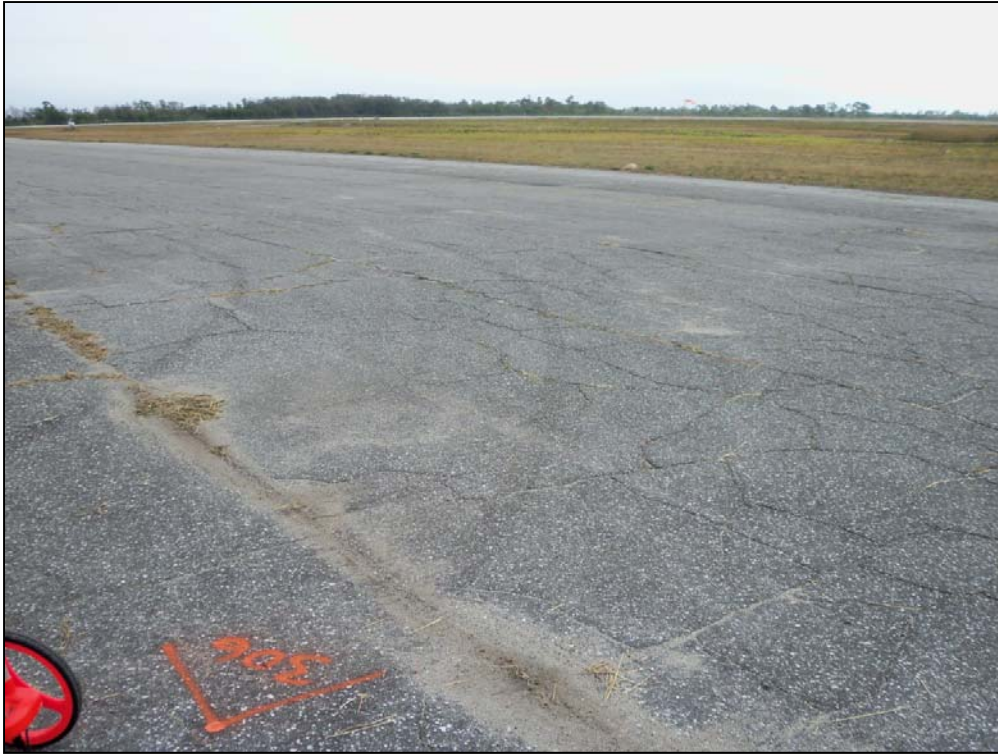
Apron, Section 4105, Sample Unit 306 – Medium/High Severity (43) Block Cracking, medium severity (52) Weathering and Raveling, and medium severity (45) Depression

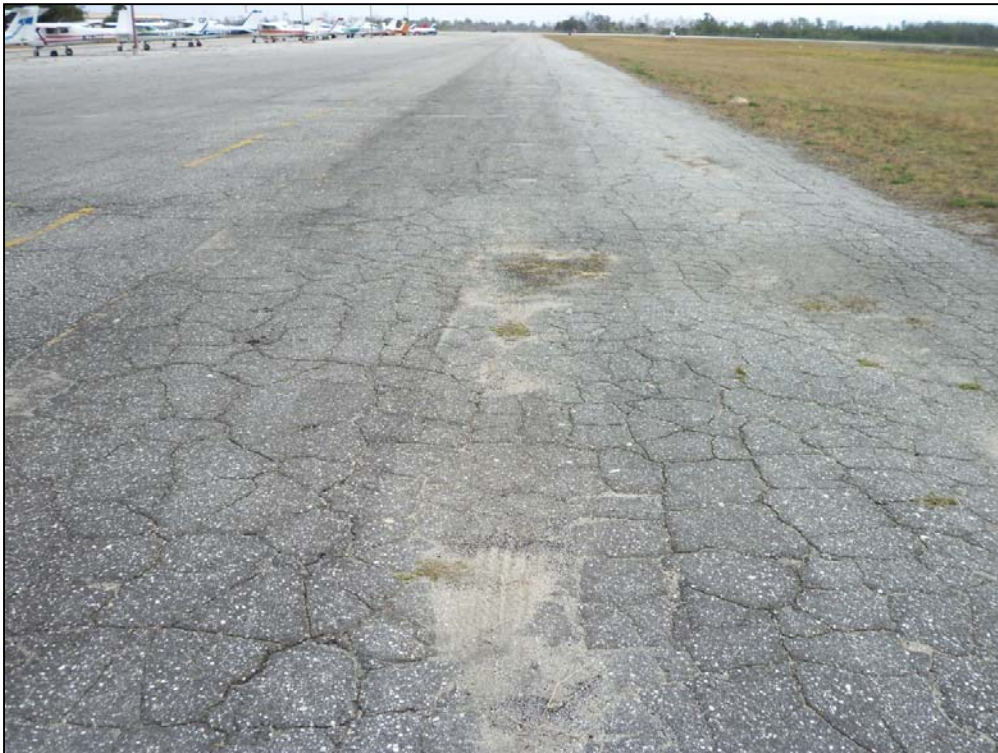
Apron, Section 4105, Sample Unit 306 – Medium/High Severity (43) Block Cracking, medium severity (52) Weathering and Raveling, and medium severity (45) Depression

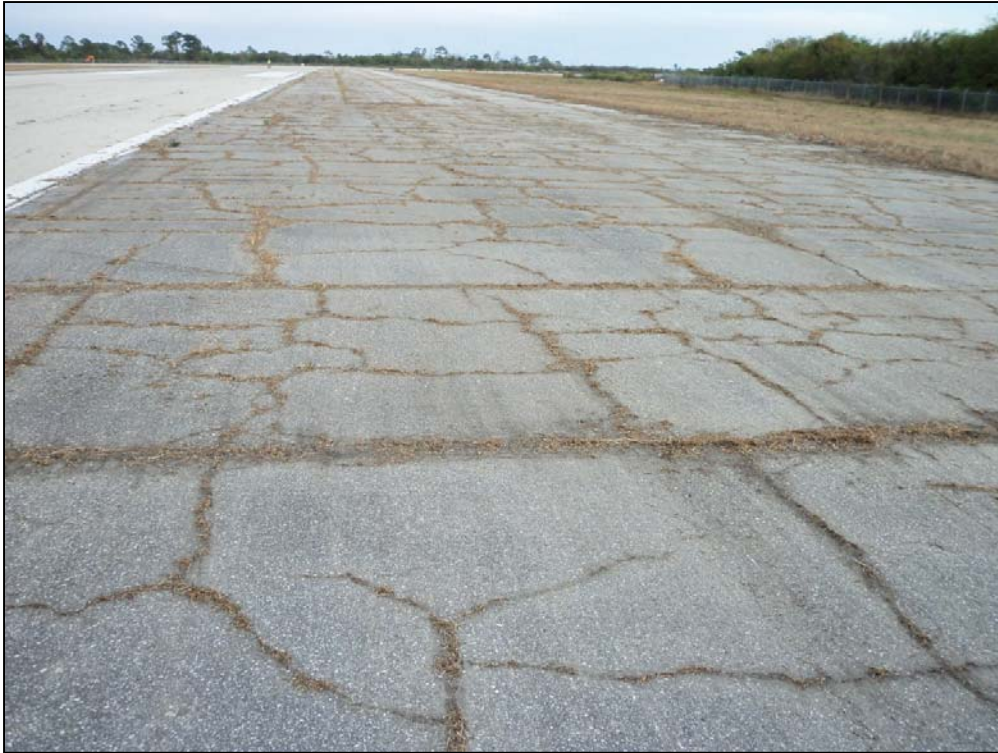
Shoulder pavement of Runway 10-28, located between runway and golf course. High Severity Block Cracking and High Severity Weathering and Raveling.

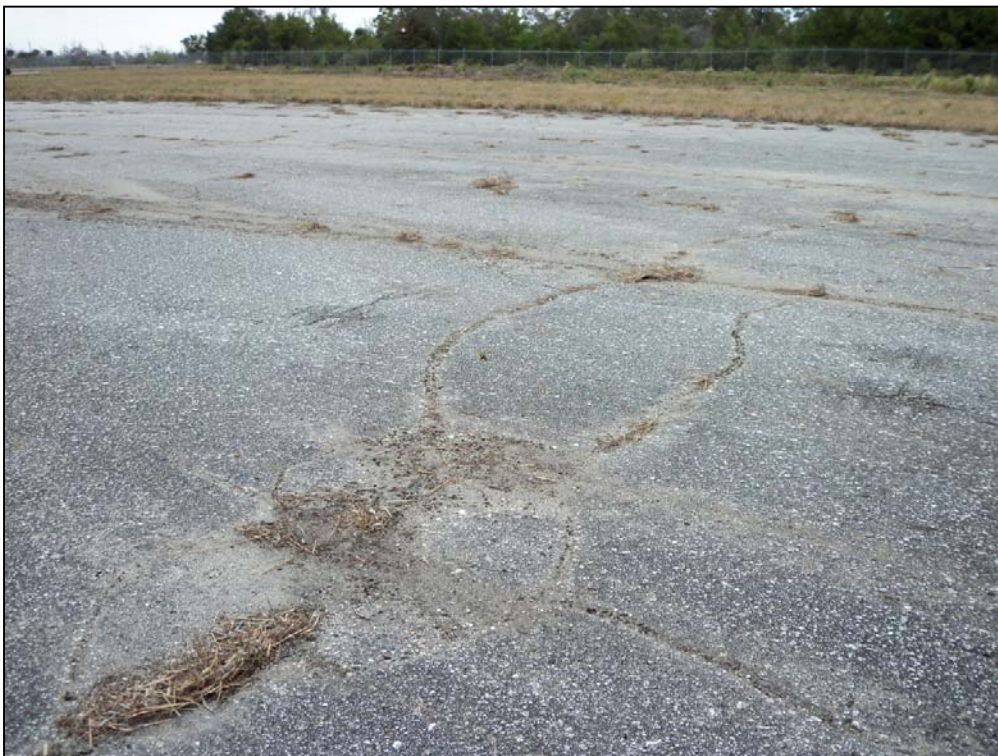
Shoulder pavement of Runway 14-32, located north of runway. High Severity Block Cracking and High Severity Weathering and Raveling.

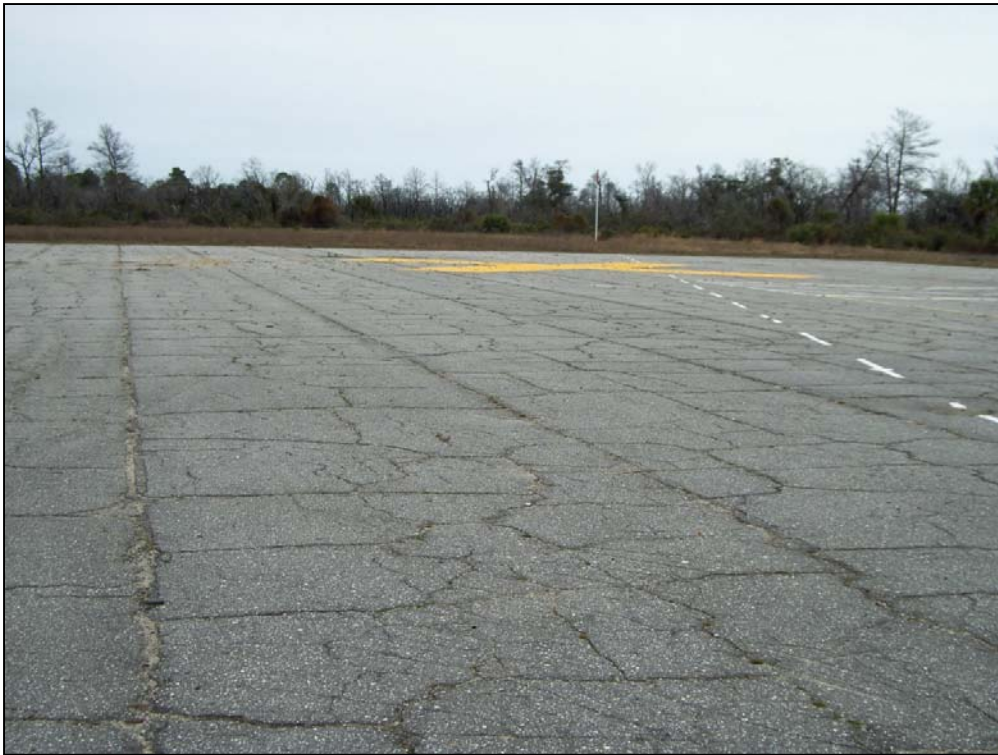
Former Runway 4-22, apron extension beyond Runway 14-32. High Severity Block Cracking and High Severity Weathering and Raveling.

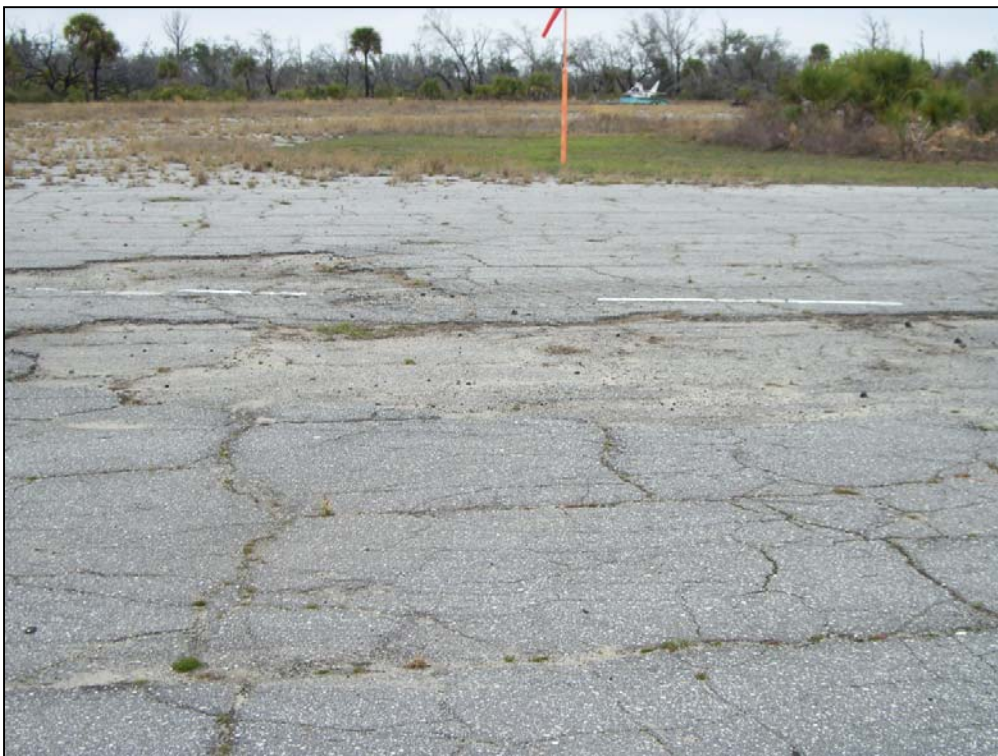
Former Runway 4-22, apron extension beyond Runway 14-32. High Severity Block Cracking and High Severity Weathering and Raveling.

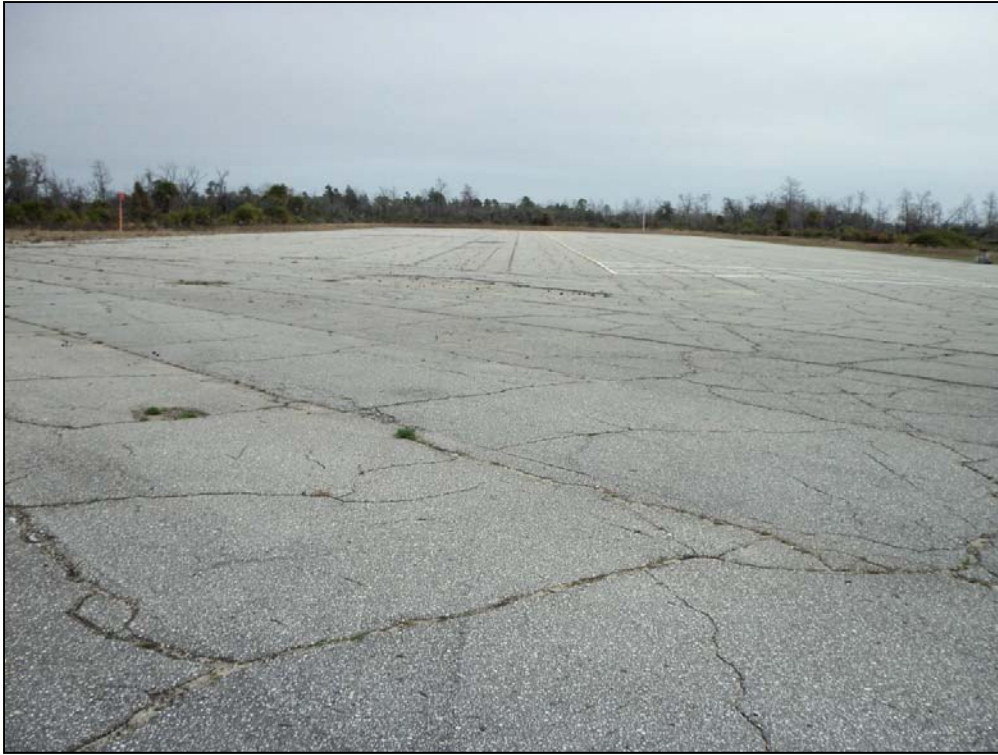
Former Runway 18-36, extension of Taxiway Bravo north of Runway 14-32. High Severity Block Cracking and High Severity Weathering and Raveling.

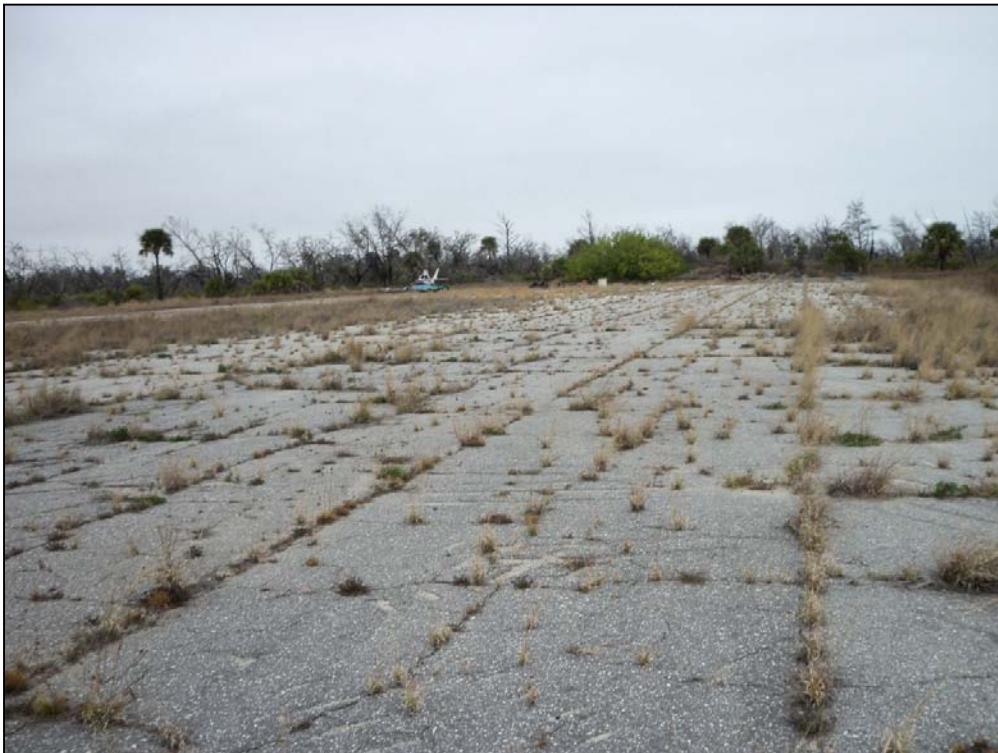
Former Runway 18-36, extension of Taxiway Bravo north of Runway 14-32. High Severity Block Cracking and High Severity Weathering and Raveling.
