STATE OF FLORIDA DEPARTMENT OF TRANSPORTATION AVIATION OFFICE

Statewide Airfield Pavement Management Program

Venice Municipal Airport – VNC (General Aviation) Venice, Florida (District 1)

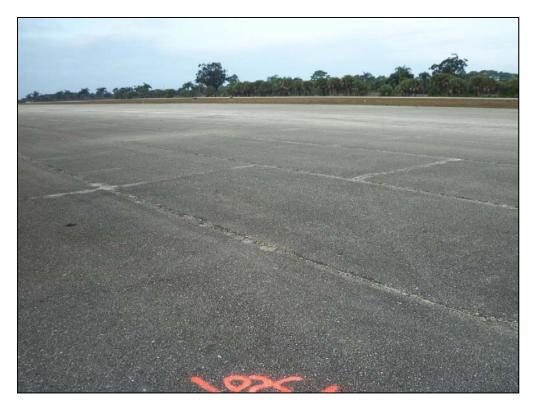
RW 4-22 exhibits rideability issues due to the medium to high severity of weathering and raveling along the keel section. Pilots have stated that during landing approaches, touchdown is attempted approximately 20 feet offset from centerline either to the left or right. The branch condition for the runway is considered to be 'Very Poor' at a PCI value at 29 which is below the recommended condition based on both the FDOT and FAA General Aviation minimum PCI.

Runway 4-22, Section 6205, Sample Unit 320 – Medium severity (43) Block Cracking, medium severity (48) Longitudinal and Transverse Cracking, medium and high severity (52) Weathering and Raveling

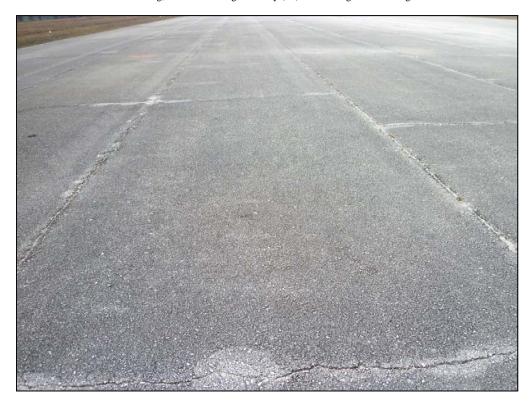
Runway 4-22, Section 6205, Sample Unit 320 – Medium severity (43) Block Cracking, medium severity (48) Longitudinal and Transverse Cracking, medium and high severity (52) Weathering and Raveling

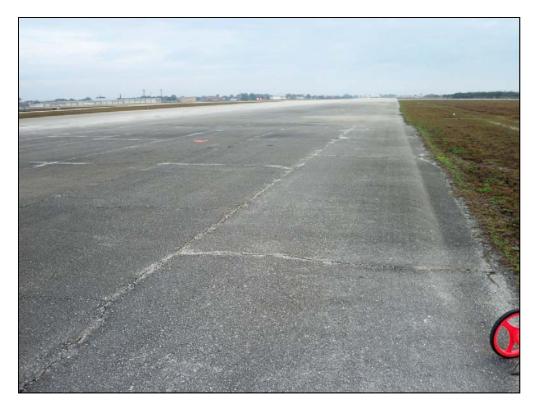
Runway 4-22 Shoulder, Section 6210, Sample Unit 520 – Medium severity (43) Block Cracking, medium severity (52) Weathering and Raveling

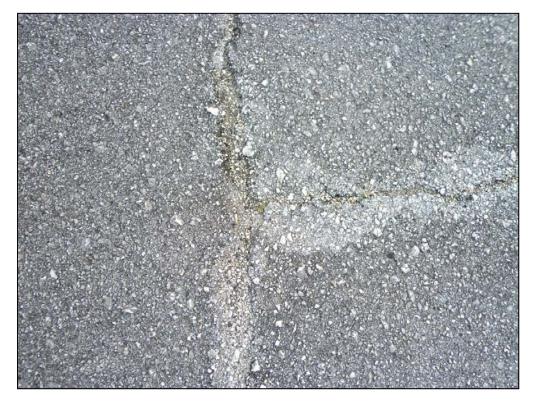
Runway 4-22 Shoulder, Section 6210, Sample Unit 520 – Medium severity (43) Block Cracking, medium severity (52) Weathering and Raveling

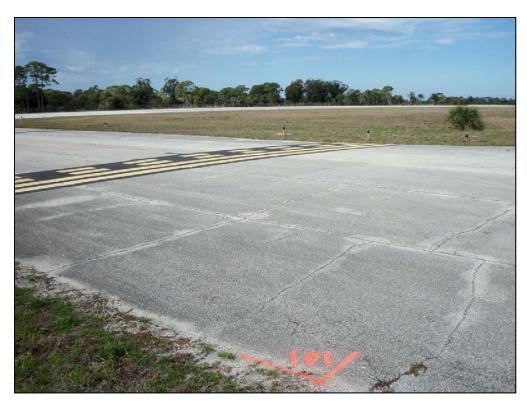
Taxiway Delta, Section 350, Sample Unit 101 – Medium and high severity (43) Block Cracking, medium severity (52) Weathering and Raveling

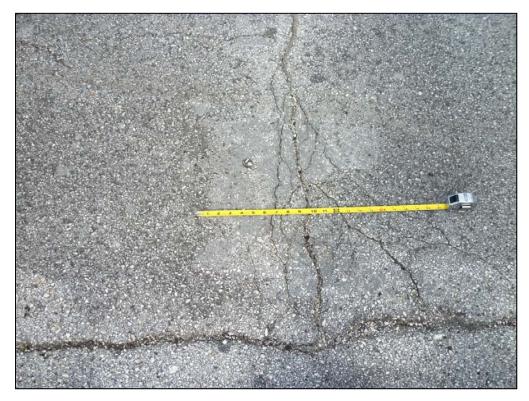
Taxiway Delta, Section 350, Sample Unit 101 – Medium and high severity (43) Block Cracking, medium severity (52) Weathering and Raveling

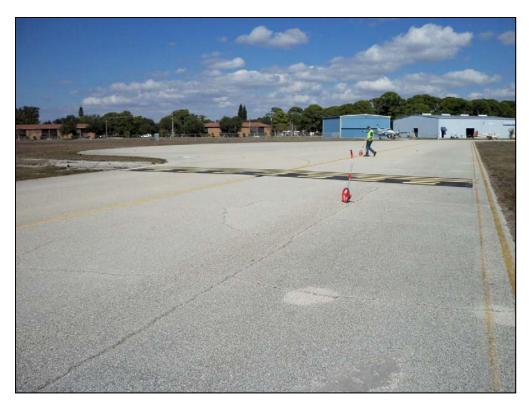
Taxiway Alpha, Section 115, Sample Unit 142 – Low and medium severity (43) Block Cracking, low severity (52) Weathering and Raveling

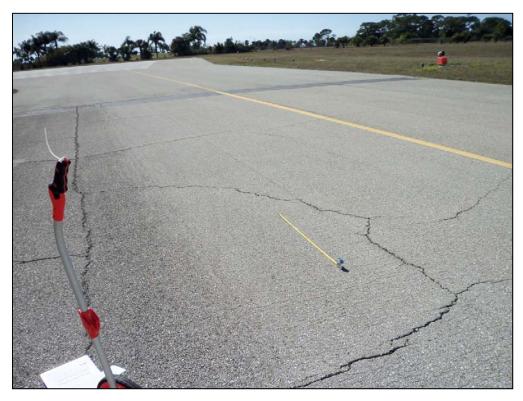
Taxiway Alpha, Section 115, Sample Unit 142 – Low and medium severity (43) Block Cracking, low severity (52) Weathering and Raveling

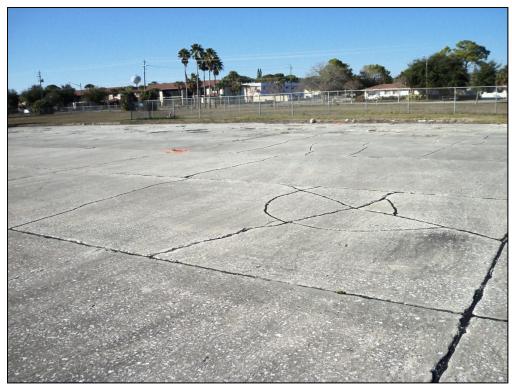
The main apron facility exhibited significant distresses attributed to both climate cycling and structural loading. The significant shattered slabs observed with the amount of spalling attribute to foreign object debris (FOD) generation and rideability problems. The terminal apron has a PCI of 23 with a condition rating of 'Serious'. It is currently below both the FDOT and the FAA General Aviation minimum PCI.

Apron, Section 4120, Sample Unit 351 – Low and medium severity (62) Corner Break, low, medium and high severity (63) LTD Cracking, medium severity (65) Joint Seal Damage, low severity (70) Scaling/Map Cracking, medium severity (72) Shattered Slab, low, medium and high severity (74) Joint Spalling, low severity (75) Corner Spalling

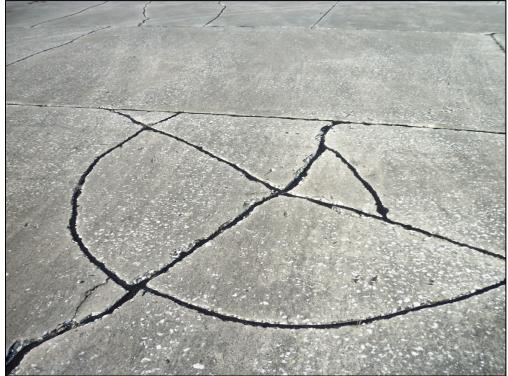
Apron, Section 4120, Sample Unit 351 – Low and medium severity (62) Corner Break, low, medium and high severity (63) LTD Cracking, medium severity (65) Joint Seal Damage, low severity (70) Scaling/Map Cracking, medium severity (72) Shattered Slab, low, medium and high severity (74) Joint Spalling, low severity (75) Corner Spalling

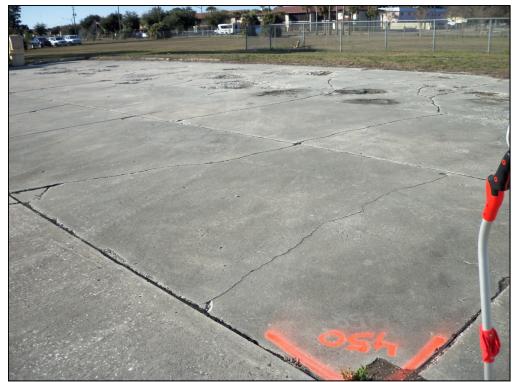
Apron, Section 4120, Sample Unit 450 – Low and high severity (63) LTD Cracking, medium severity (65) Joint Seal Damage, high severity (66) Small Patch, (63) Popouts, low and medium severity (70) Scaling/Map Cracking, medium and high severity (72) Shattered Slab, medium severity (74) Joint Spalling

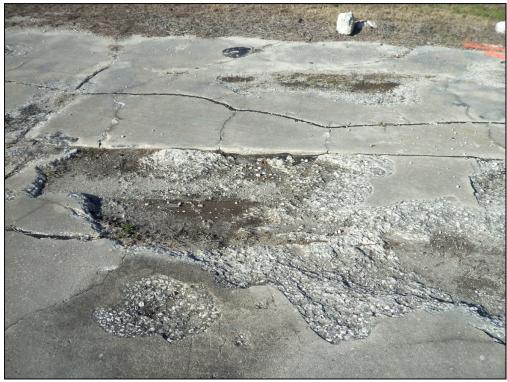
Apron, Section 4120, Sample Unit 450 – Low and high severity (63) LTD Cracking, medium severity (65) Joint Seal Damage, high severity (66) Small Patch, (63) Popouts, low and medium severity (70) Scaling/Map Cracking, medium and high severity (72) Shattered Slab, medium severity (74) Joint Spalling

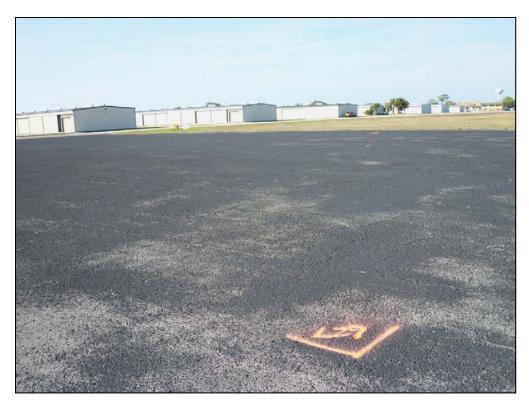
Former Runway 9-27, Section 6415, Sample Unit 627 – Medium severity (43) Block Cracking, medium severity (52) Weathering and Raveling

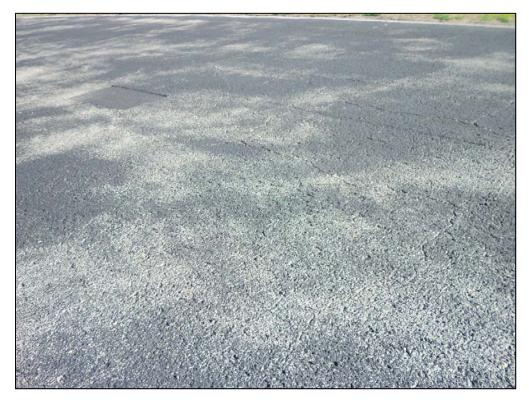
Former Runway 9-27, Section 6415, Sample Unit 627 – Medium severity (43) Block Cracking, medium severity (52) Weathering and Raveling
