# STATE OF FLORIDA DEPARTMENT OF TRANSPORTATION AVIATION OFFICE

# Statewide Airfield Pavement Management Program

Wauchula Municipal Airport– CHN (General Aviation) Wauchula, Florida (District 1)

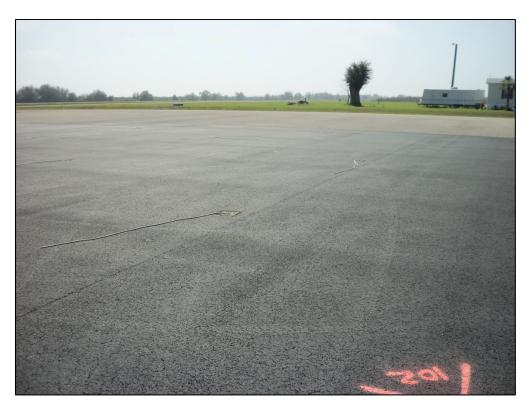
Apron, Section 4105, Sample Unit 102 - Low severity (48) Longitudinal and Transverse Cracking, low severity (52) Raveling and Weathering

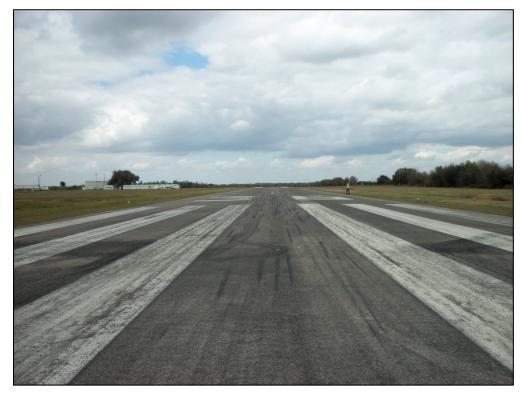
Runway 18-36, exhibited low to medium severity weathering and raveling in addition to longitudinal cracks primarily located along the paving joints. This is a common distress due to the pavement being weakest at the joint locations. There were also isolated locations along the runway which exhibited low severity block cracking.

Runway 18-36, Section 6105, Sample Unit 101 – Low severity (43) Block Cracking, low severity (48) Longitudinal and Transverse Cracking, low and medium severity (52) Raveling and Weathering

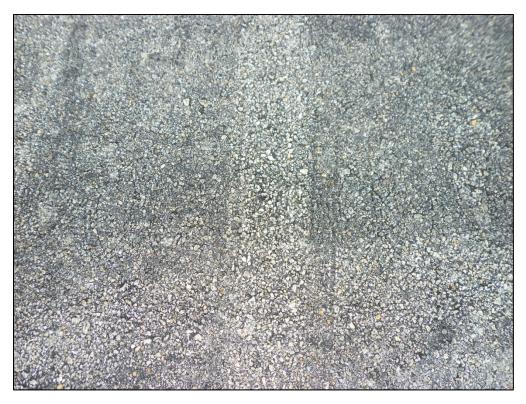
Runway 18-36, Section 6105, Sample Unit 101 – Low severity (43) Block Cracking, low severity (48) Longitudinal and Transverse Cracking, low and medium severity (52) Raveling and Weathering

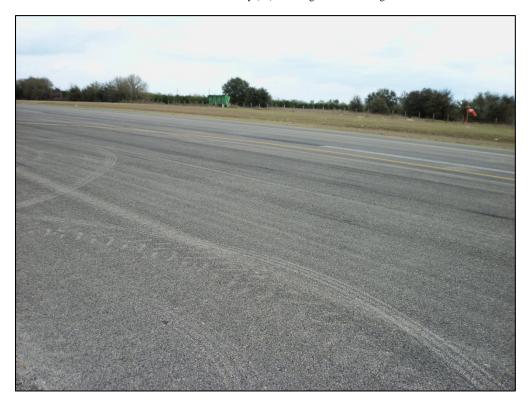
Runway 18-36, Section 6105, Sample Unit 124 – Low severity (48) Longitudinal and Transverse Cracking, low and medium severity (52) Raveling and Weathering

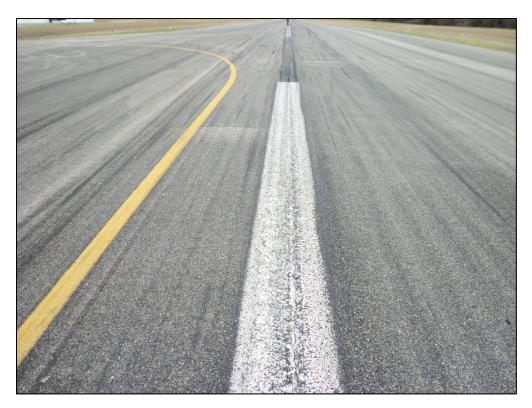
Runway 18-36, Section 6105, Sample Unit 124 – Low severity (48) Longitudinal and Transverse Cracking, low and medium severity (52) Raveling and Weathering

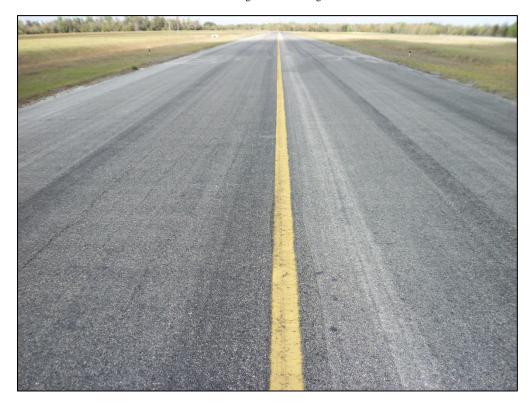
Taxiway Parallel, Section 120, Sample Unit 117 – Low severity (43) Block Cracking, low severity (48) Longitudinal and Transverse Cracking, and low severity (52) Raveling and Weathering

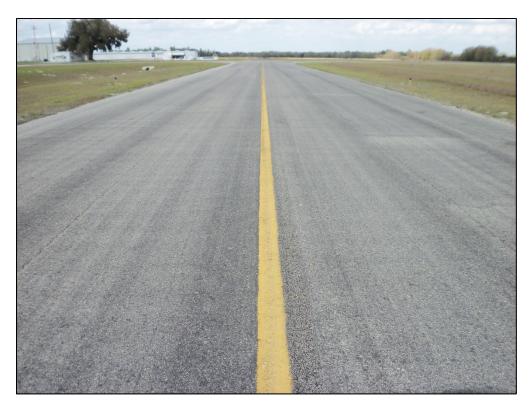
Taxiway Parallel, Section 115, Sample Unit 111 – Low severity (48) Longitudinal and Transverse Cracking, low severity (52) Raveling and Weathering

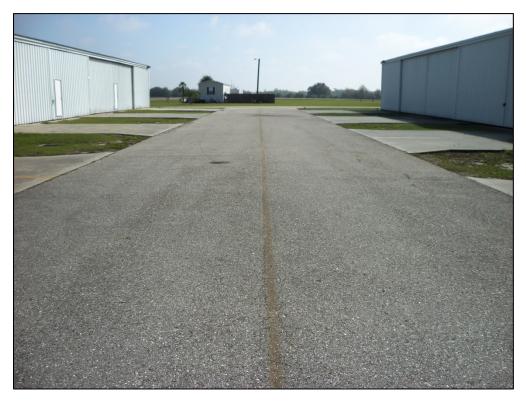
T-Hangar, Section 210, Sample Unit 201 - Low severity (48) Longitudinal and Transverse Cracking, low severity (52) Raveling and Weathering
