**STATE OF FLORIDA
DEPARTMENT OF TRANSPORTATION
AVIATION OFFICE**

**Statewide Airfield Pavement
Management Program**

**Williston Municipal Airport–X60
(General Aviation)
Williston, Florida
(District 2)**

May 2012

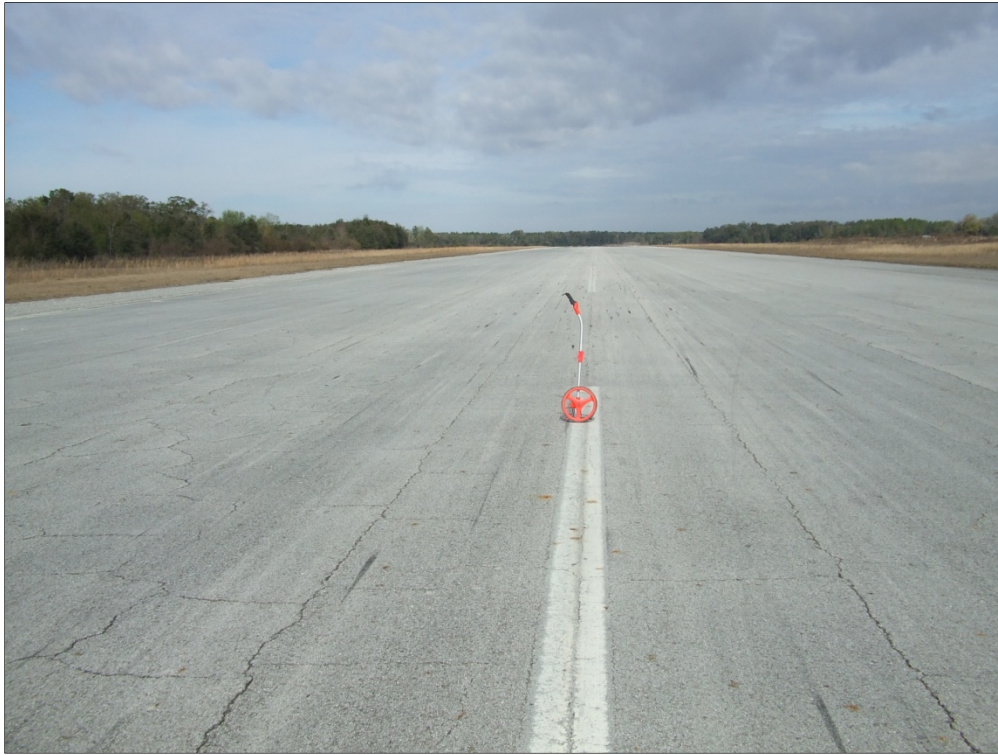
The asphalt concrete of Runway 14-32 exhibited low to high severity weathering and raveling, low to medium severity block cracking, along with low to medium severity longitudinal and transverse cracking. The PCC pavement sections of Runway 14-32 and Runway 5-23 exhibited low to high severity joint seal damage, low to medium severity linear cracking. Runway 14-32 also exhibited low to high severity joint spalling.

Runway 14-32, Section 6215, Sample Unit 326 – Low and moderate severity (43) Block Cracking; low severity (48) Longitudinal / Transverse Cracking, and low severity (52) Weathering and Raveling.

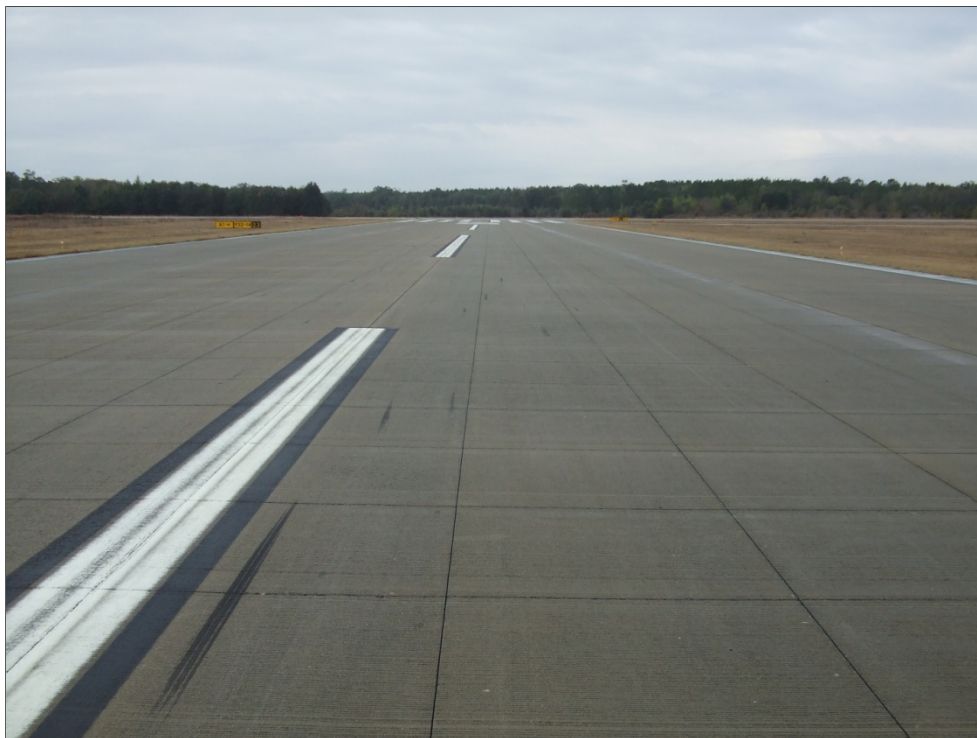
The whitetopping sections of Runway 5-23 exhibited low severity joint spalling, corner spalling, and faulting. A total of 27 sample units were evaluated on the runway. The PCI of the

whitetopping ranged from 85 to 93 (Good Condition) based on the age and observed conditions. Due to the age of the whitetopping pavement and PCI ranging between 85 to 93 no immediate Major M&R is recommended for the whitetopping pavement. Preventive maintenance is suggested to correct the minor issues that were observed on the runway. Per the airport the whitetopping pavement typically does not require any maintenance during the first 10 years. Since distresses were observed during the current inspections, it is recommended that the airport continue to monitor the whitetopping pavement. A 10 year condition prediction analysis was not conducted for the whitetopping pavement. For future 10 year pavement condition prediction analysis for whitetopping pavement, FDOT will use the inspection data from the current inspections and from the next inspection cycle to determine the pavement deterioration rate.

Runway 5-23, Section 6115, Sample Unit 315 – Overview of sample unit. Joint spalls observed on sample unit.

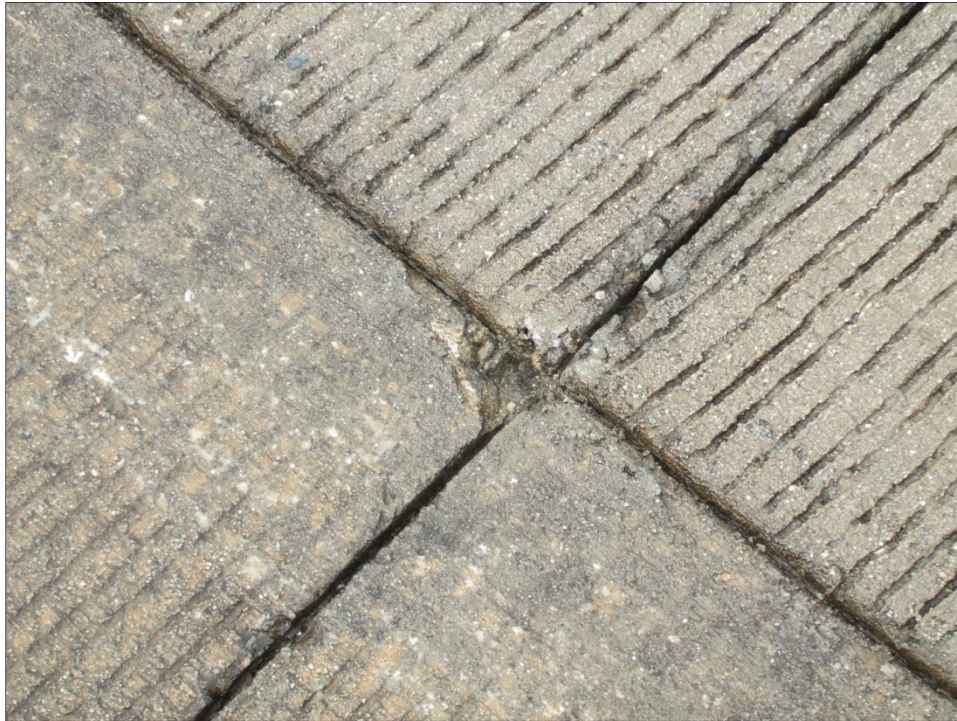
Runway 5-23, Section 6115, Sample Unit 349 – Corner spall observed in whitetopping.

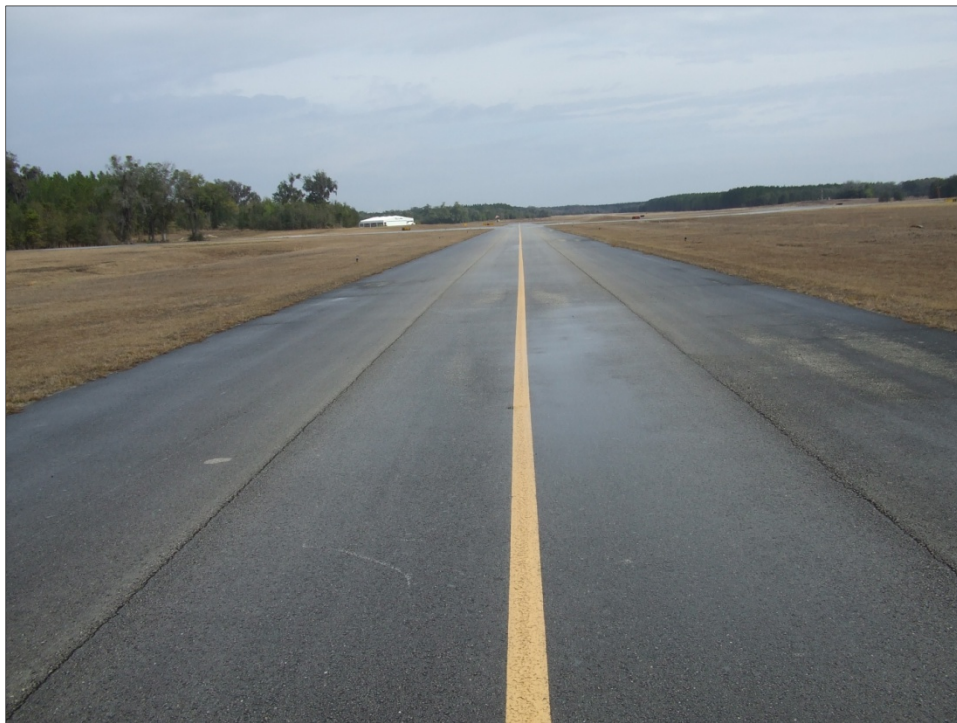
Taxiways throughout the airfield exhibited low to high severity longitudinal and transverse cracking, low to high severity block cracking, and low to high severity weathering and raveling.

Taxiway Alpha, Section 205, Sample Unit 108 – Low severity (48) Longitudinal / Transverse Cracking; and low to medium severity (52) Weathering and Raveling.

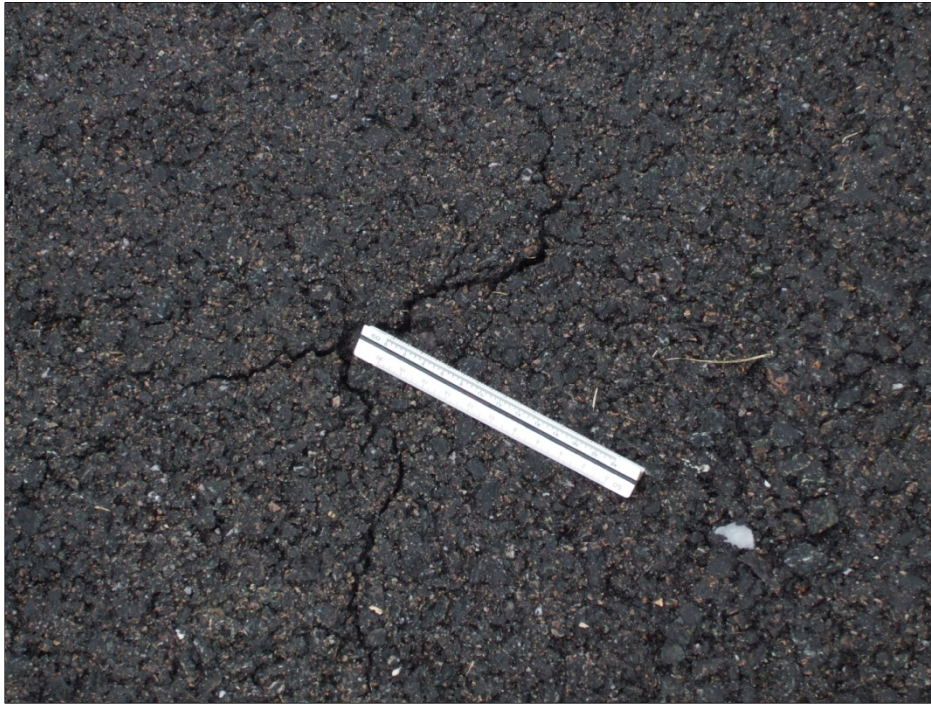
The asphalt pavement of the aprons exhibited low to medium severity block cracking, low to medium severity weathering and raveling, and low to medium severity patching.

Apron, Section 4105, Sample Unit 102 – Low severity (48) Longitudinal / Transverse Cracking.

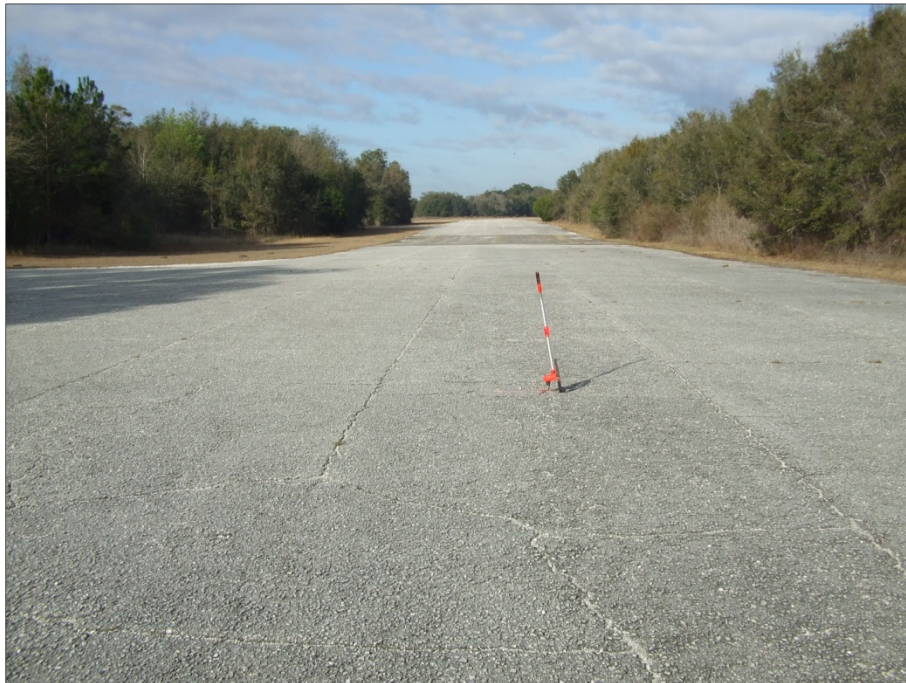
Taxiway Fox Trot, Section 550, Sample Unit 135 – Medium to high severity (43) Block Cracking; low to medium severity (48) Longitudinal / Transverse Cracking; and medium to high severity (52) Weathering and Raveling.
